A STUDY TO  
INVESTIGATE AND PROPOSE  
REMEDIES FOR  
RIVER QUALITY PROBLEMS  
IN THE  
MADFORD CATCHMENT

MARCH 1990

FWI/90/008

**R. Smith  
Freshwater Investigations Team  
Environmental Protection  
NRA South West Region  
Manley House  
EXETER**

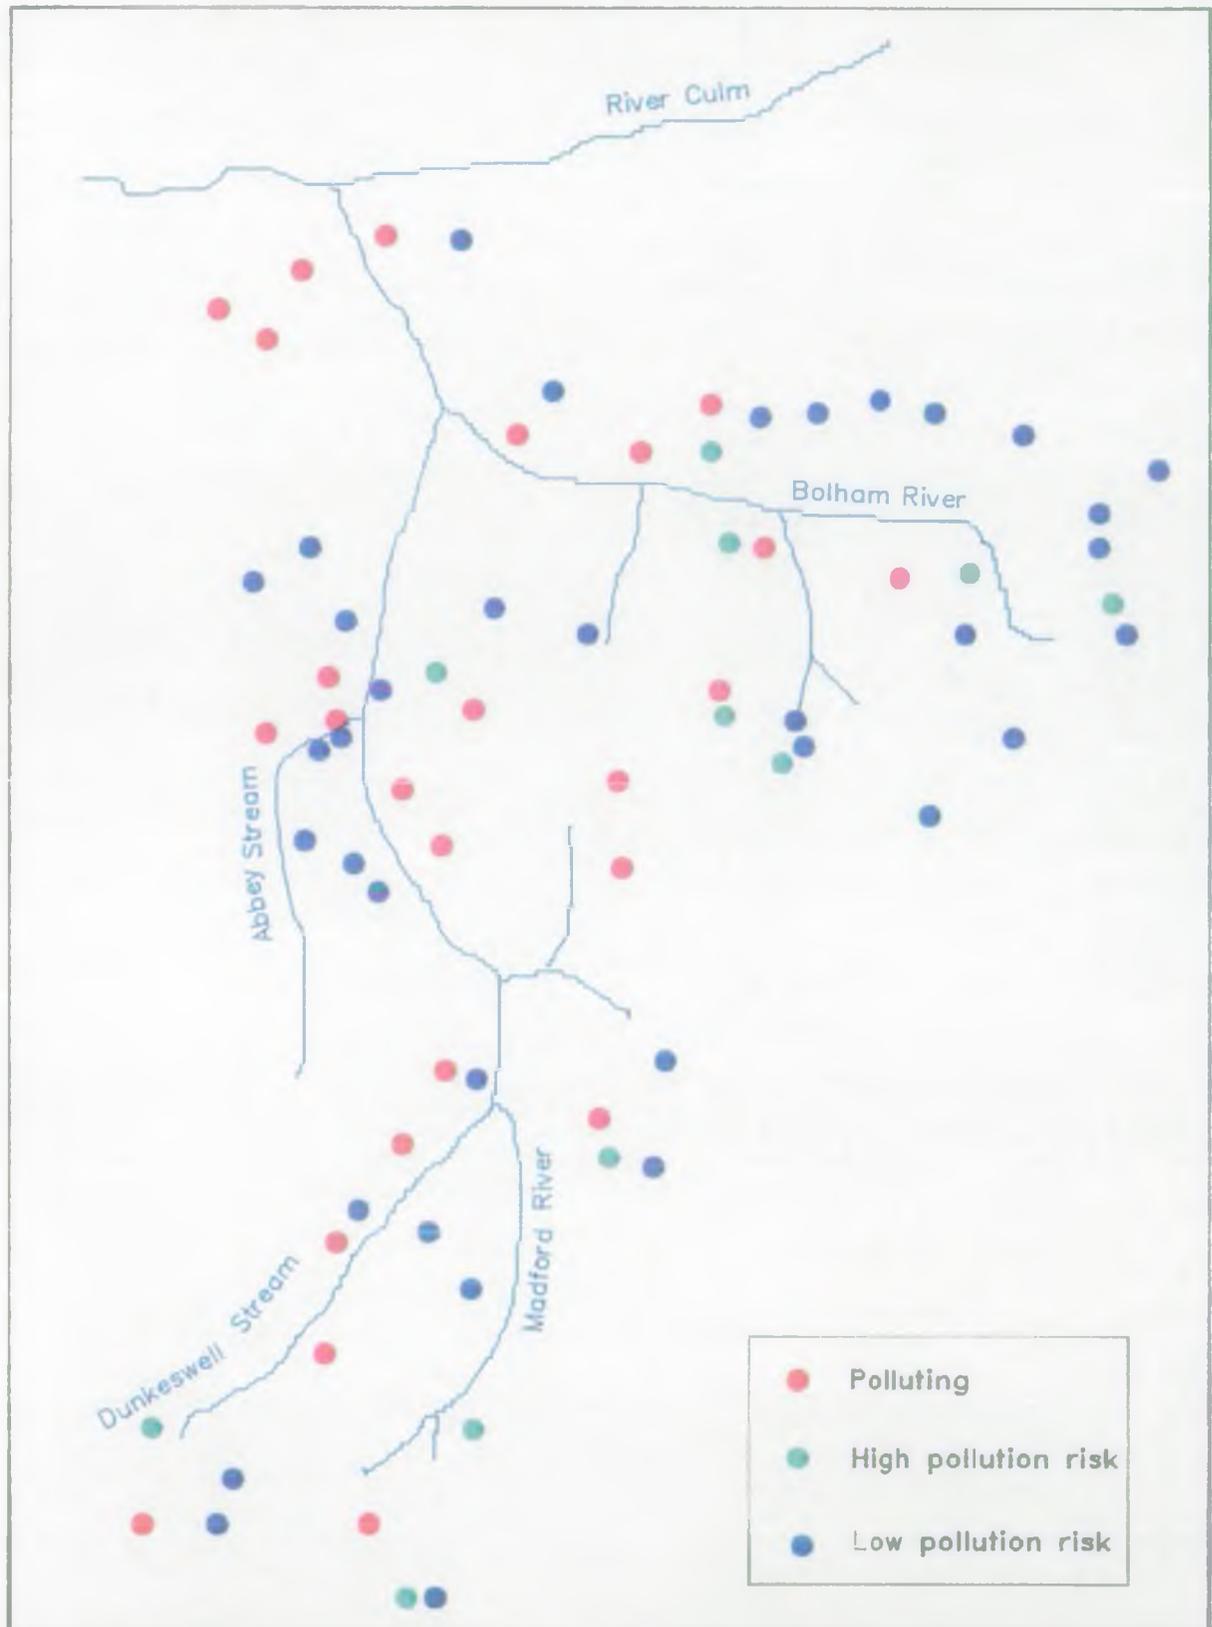
Fig. 2 Pollution codes allocated to farms in the Madford Catchment.

A high percentage of farms (35%) were found to have discharges to watercourses and were given a red pollution code (Table 9). All polluting farms were dairy and/or beef farms.

A greater number and density of red farms (0.88 per km<sup>2</sup>) were found in the Madford sub-catchment compared to the Bolham sub-catchment (0.43 per km<sup>2</sup>). This may account for the poorer chemical and biological quality of the Madford sub-catchment compared to the Bolham sub-catchment (see section 1).

Farms found polluting had larger herds (mean = 93 cattle per farm) than those farms not polluting (mean = 53 cattle per farm). The major cause of pollution was yard run-off during heavy rainfall and dairy/parlour

washings discharging to watercourses.

Many farms are not properly designed to keep large herds and have not adapted to the increases in stock size in recent years. Farms therefore generally have inadequate facilities to cope with dirty yard-water particularly during heavy rainfall when cattle are kept indoors during winter.

- (1) Formal samples must be taken at farms that fail to install remedial measures within an agreed timescale.
- (2) A new routine river quality monitoring point must be established in the Madford River upstream of the Bolham confluence.
- (3) SWW Services Ltd have been informed that it must apply for a new consent for Dunkeswell STW. When this is received numerical conditions must be applied.
