## DEVON AREA INTERNAL REPORT

**AN INVESTIGATION INTO POSSIBLE  
CAUSES OF POOR WATER QUALITY AT  
BLAKEWELL BRIDGE (R30A001) ON THE  
BRADIFORD WATER.**

**DECEMBER 1995  
DEV/E/19/95**

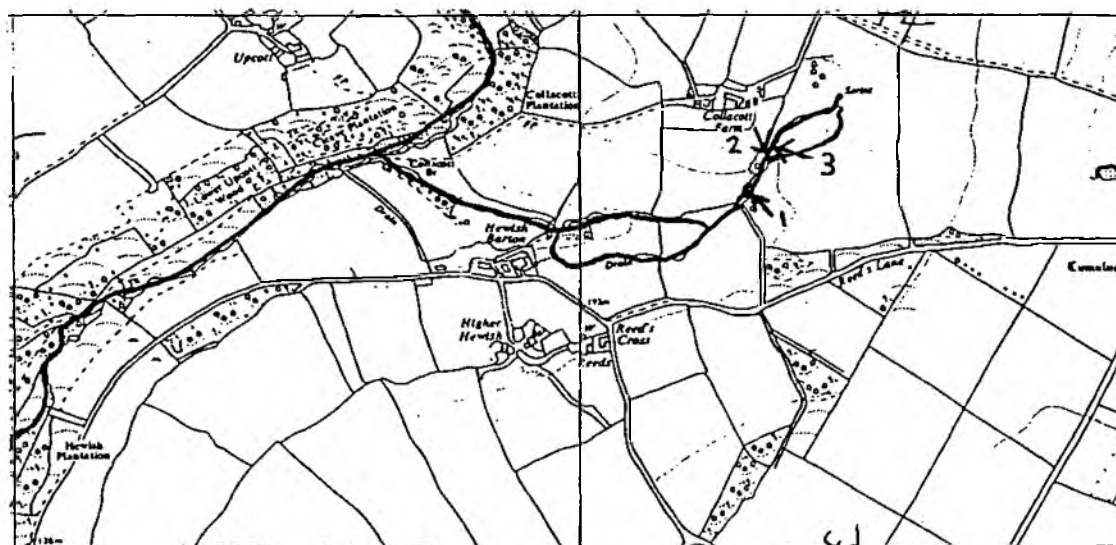
**SITE:** Collacott Farm

Tributary covered with 100% sewage fungus downstream of the farm. The stream tributary leading down from the Collacott Farm smelt of farm effluent. Sewage fungus apparent to approximately 2 km downstream in the Colam Stream.

Farm effluent was directly entering the head waters of the tributary. A land drain with clear running water was taken as the upstream site.

Collacott Farm has the potential to cause chemical impact of the Bradford water downstream and possibly at the routine monitoring site at Blakewell during heavy rainfall.

The Water Quality Officer has been notified and will be visiting the farm.

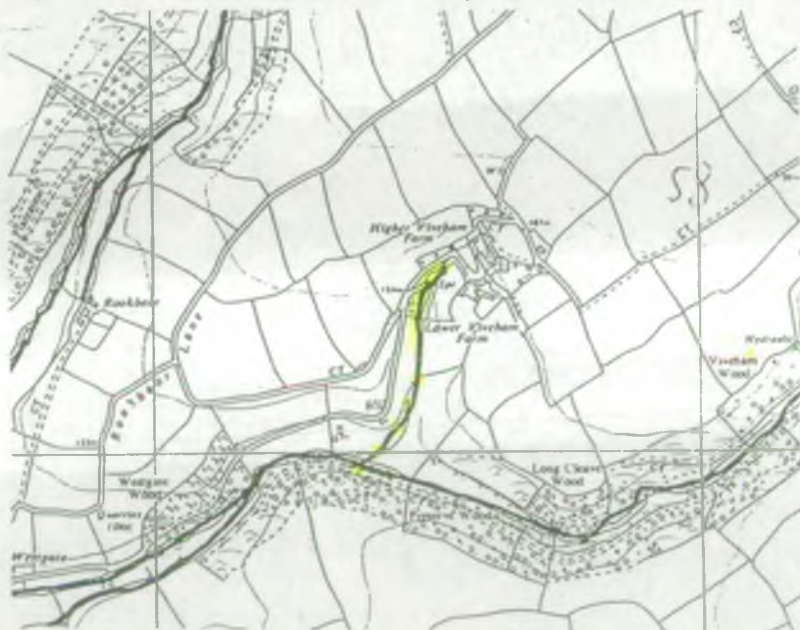
**SITE:** Viveham Farms

Tributary covered with approximately 10% sewage fungus downstream of the farm tributary. Chemical samples indicated no EQS exceedance within the receiving tributary but a total ammonia concentration of 0.64 mg/l (EQS =0.25 mg/l as 95 %-ile) in the farm tributary.

The small tributary leading down from the Viveham Farms was running turbid at the source but almost clear at the confluence downstream. Sewage fungus was detected downstream of the tributary for approximately 1 km (from 10 % cover to trace levels ). General run-off was entering the small tributary from the farm area.

Although the receiving water samples taken did not exceed EQS's, it is possible that under heavy rain Viveham Farms may pose a problem.

The Water Quality Officer to be aware of the potential problem that run-off from Viveham Farms may have on the Bradiford Water during wet weather.

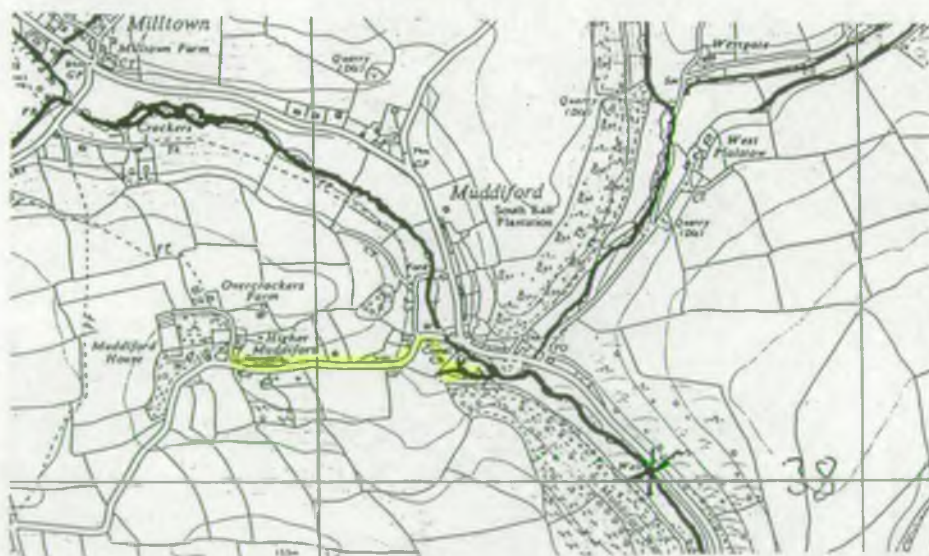
**SITE:** Higher Muddiford Farm

Tributary very turbid, entering clear water stream.  
Chemical samples indicated no EQS exceedance of tributary or receiving water.

Higher Muddiford Farm is directly adjacent to road. Road drains empty into near-by ditch and into a muddy tributary area which then enters stream as above. Farm waste evident along road; very likely that farm run-off will enter the watercourses during wet weather.

Although the samples taken did not exceed EQS's, it is possible that during wet weather, farm waste run-off may enter the river and cause localised impact.

The Water Quality Officer to be aware of the potential problem that run-off from Higher Muddiford Farm may have on the Bradiford Water during wet weather.

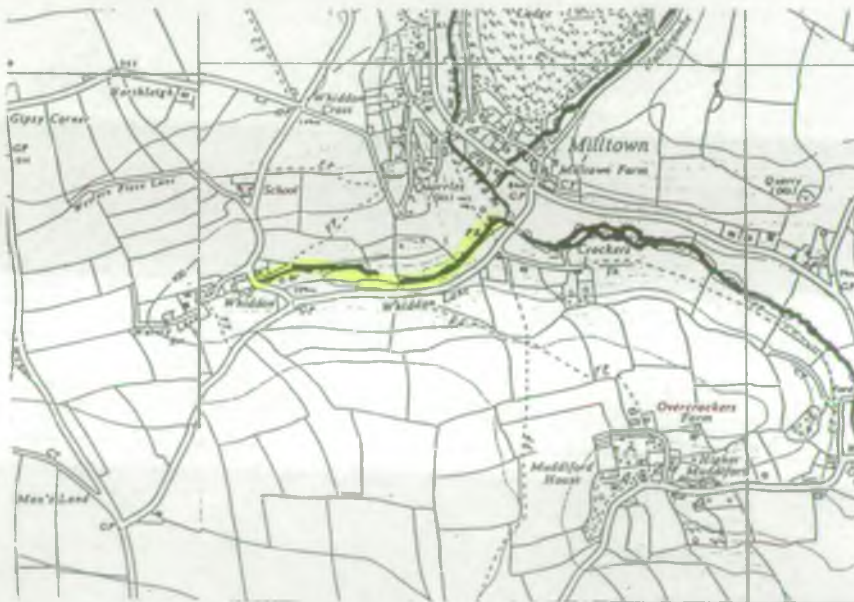
**SITE:** Whiddon Farm

Tributary covered with approximately 70% sewage fungus .  
Chemical samples indicated no EQS exceedance of tributary or receiving water.

A small ditch at Whiddon Farm was contaminated with farm effluent which in turn was entering a small tributary. The sewage fungus cover present suggests this to be a chronic problem, however, from the chemical results (no impact), a minor one.

Although the samples taken did not exceed EQS's, it is possible that due to the locality of the water course to the farm, during wet weather, some effluent may enter the river and cause localised impact.

The Water Quality Officer to be aware of the potential problem that run-off from Whiddon Farm may have on the Bradiford Water during wet weather.
