AN INVESTIGATION  
INTO THE INCIDENCE OF  
SPURTING FROM  
WEEPING WALL SLURRY STORES

Author: PIERS O'NEILL  
HND. Rural Resource Management  
Seale-Hayne Faculty  
University of Plymouth  
August 1992

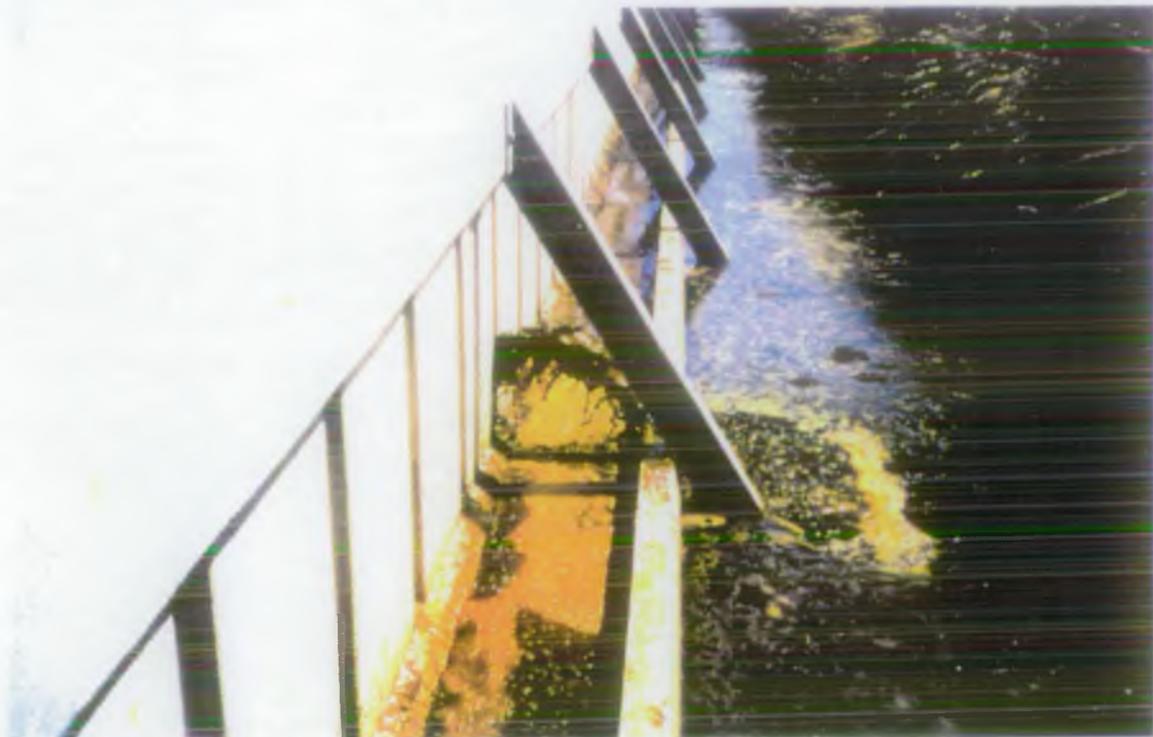
Please refer to figure two which shows a spurt in progress.

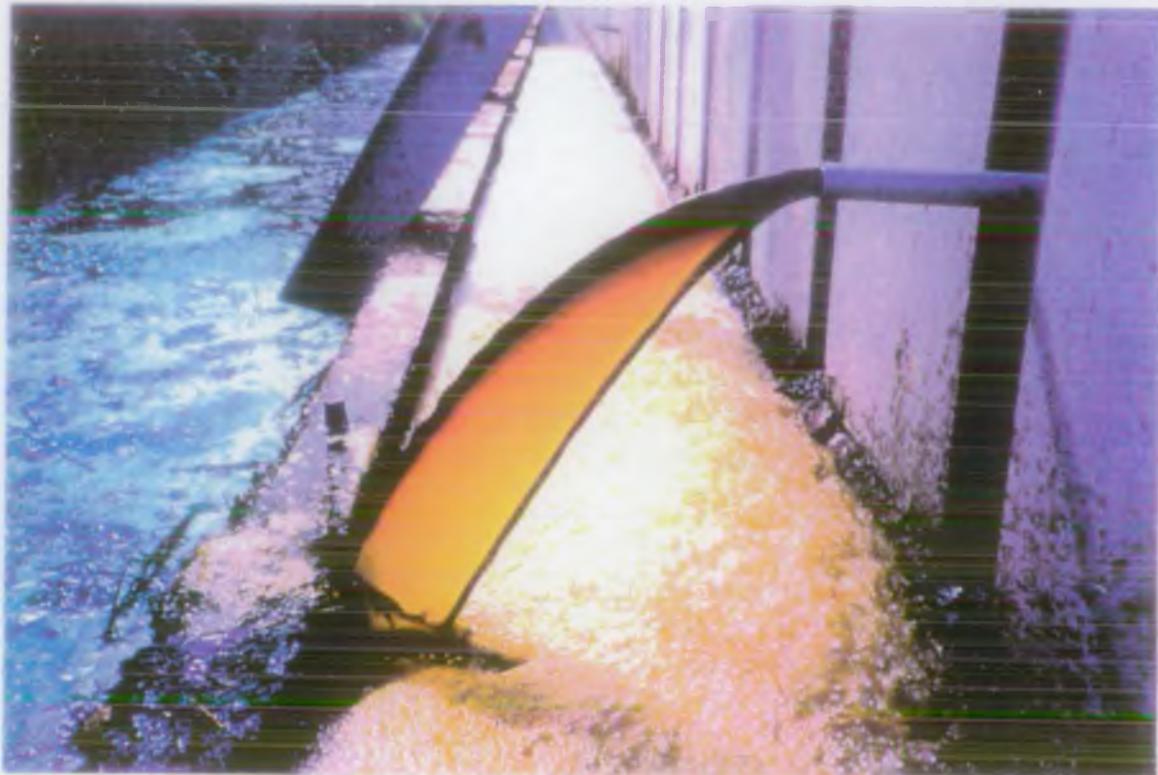
#### DIAGRAM

Rod number one had a couple of good discharges in the first two weeks of the experiment, but then the level of discharge dropped from about a one hour average to about ten minutes. It is important to note that the discharge in week one was in the form of a full blown spurt rather than a discharge from the pipe. Due to the duration and magnitude of this spurt it is possible to say that a very large quantity of liquid was drawn off the store and therefore the decline in discharge levels was inevitable. The continuing low flow discharges from this pipe could be attributed to the liquid moving from the inlet point to the pipe by capillary action along the solid back wall of the store.

Rods two and three remained dormant for the duration of the experiment except for two isolated incidents where the rods were moved slightly which resulted in the slats beginning to spurt. Each spurt lasted for approximately three-quarters of an hour and were both relatively low pressure discharges. However in the latter weeks of the experiment the rods were again moved but no further discharges were brought about.

Rod number four was one of the most reliable dischargers with an average discharge lasting about one and a half hours at a good constant rate. The no flow results in weeks four and five were due to the fact that the cork had been removed from the rod after the week three visit and had not been replaced, hence the rod became blocked. However, the cork was replaced in week five and the rod started discharging again in week six.

Rod numbers five, six, and seven all remained dormant for the first three weeks during which the weather was predominantly dry. However, a week of heavy rain between the weeks three and four visits led to very slight discharges which were very low pressure and lasted for no more than one minute.

Rods eight, nine, and ten all remained dormant even through the very wet weather of weeks four and five. In order to confirm this inactivity these rods were all moved and agitated but no discharges of any sort came about, thus it is possible to conclude that there were no substantial pockets of liquid in that area of the store.

Rods eleven, twelve, and thirteen, however, did all discharge on a regular basis. The average discharge from rod eleven was about two hours, rod twelve was about one and a quarter hours, and rod thirteen was about half an hour.

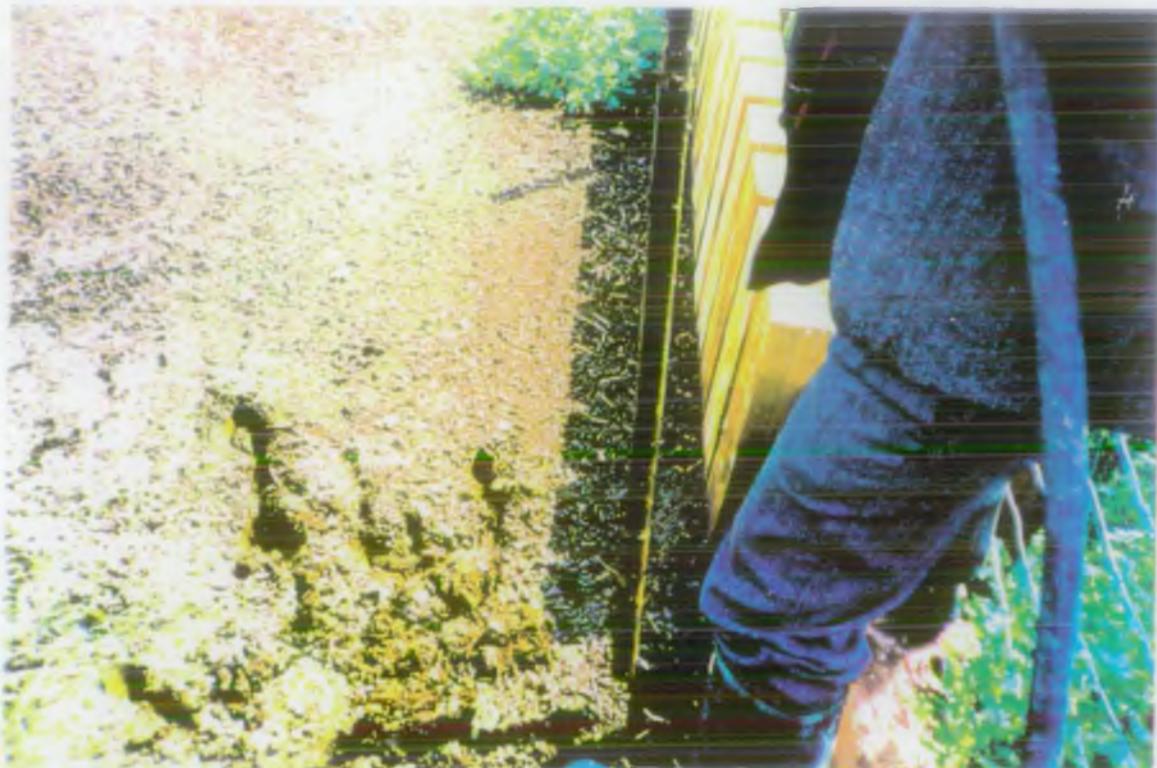
In order to gain access to the surface of the store a series of barge boards were placed on the crust in the areas where the poker was being inserted. The poker was then placed at the various points (as shown in figure 4) and left in place for varying amounts of time.

Unfortunately the vibrations didn't appear to have any effect on the slurry during the experiment. However, approximately twenty minutes after the experiment had finished a spurt did occur. It was of medium pressure and lasted about thirty minutes. The estimated volume of the discharge was between 1500 and 2000 litres.

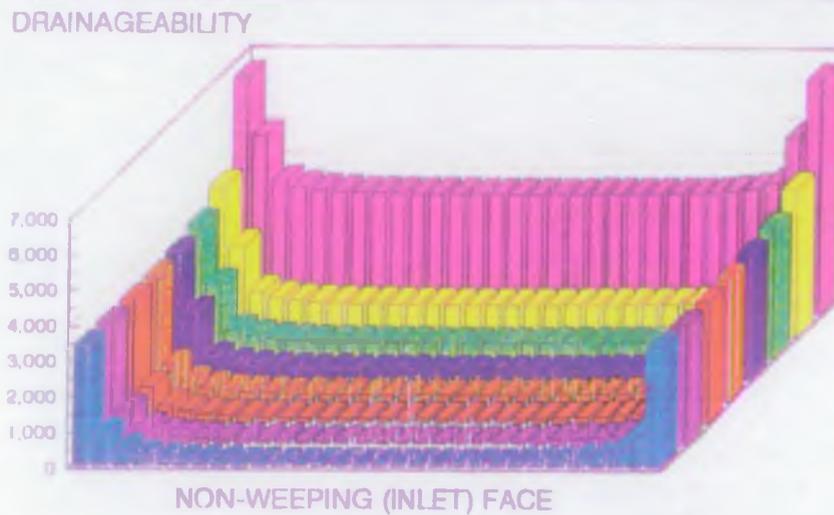
Figure.Five

The highest peaks on the chart correspond to the points where most drainage occurs. However from the information gathered to this point it also appears that these highest peaks also correspond with the areas that are most likely to spurt. Therefore it would be possible to use this method to predict where spurts are most likely to happen so that remedial action may be taken.

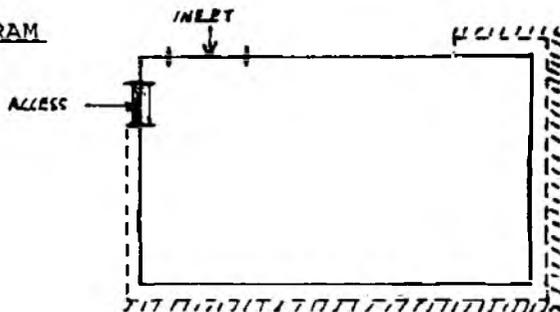
On inspection of the store there was evidence of a small spurt from the bottom left hand corner. Individual slats were of a 'v' notch nature, with the notch narrowing towards the outside of the store. Individual concrete sections lean outwards from the inside of the store into a retaining metal rail.

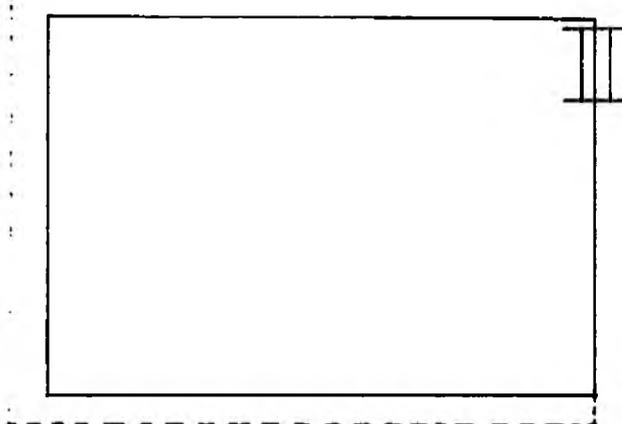
Only one inlet point into storage area.Farmer witnessed a small spurt approximately one week before my visit from the bottom left hand corner as in photographs.

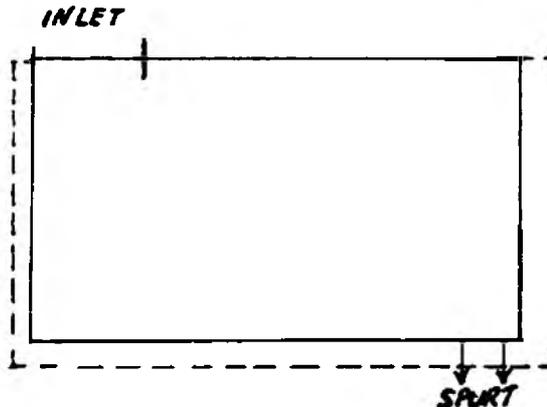
Had a large spurt which caused a pollution on the 20th April 1990. Spurt occured at furthest point from inlet.Since this incident Mr.Holland has put corrugated sheets along the bottom parts of the weeping walls. Mr.Holland now also rods the store on a regular basis.

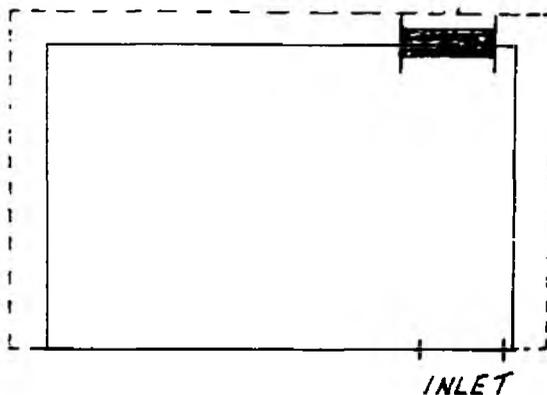
Has previously spurted in March 1991 from bottom left hand corner(furthest point from inlet).No problems since.

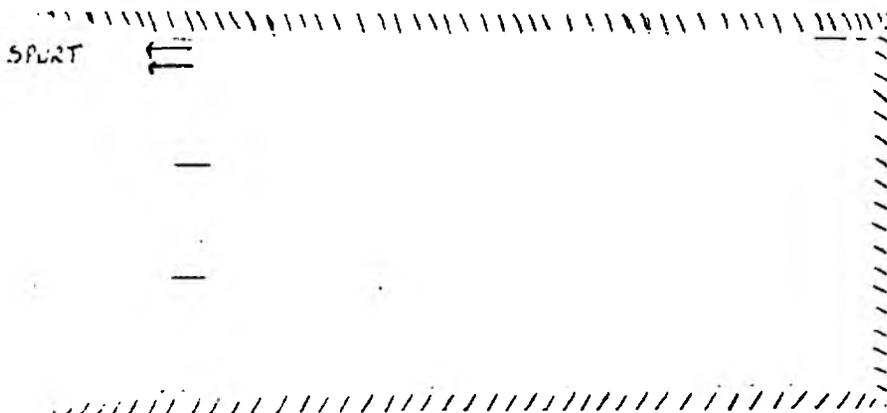
NOTES: THE STORE IS A PAGES ENGINEERING STORE WHICH FEATURES  
VERTICAL WALK SUITS OF A 'V' NOTCH FASHION, WITH THE  
'V' OPENING OUTWARDS ON THE OUTSIDE EDGE OF THE STORE.  
SINCE ITS ERECTION IN JULY 1991 THE STORE HAS  
SPUNTED 3 TIMES, (NOT INCLUDING THIS INCIDENT). PAGES DO  
ADVISE THAT THE FARMERS RUD THEIR STORES ON A  
REGULAR BASIS, BUT MR. MUNDAY FOUND THAT THE (~~SPUNTING~~)  
EFFLUENT WHICH EMERGED WAS TOO THICK AND TENDED TO  
CHOKE UP THE PUMP. MR. MUNDAY SAYS THAT EACH  
SPURT WAS FOLLOWED W/ET WEATHER. AFTER ONE OF THE  
EARLIER SPURTS MR. MUNDAY CONTACTED PIMS WHO ADVISED  
HIM TO USE MORE STRAW BEDDING, BUT THIS SEEMS TO  
HAVE HAD LITTLE OR NO EFFECT ON THE SPURTING  
INCIDENTS.

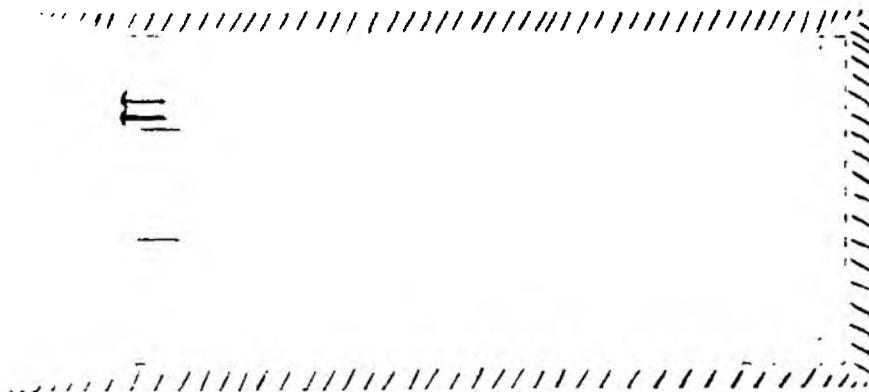
NOTES: THE SPILL OCCURRED UNDER MUCH THE SAME CONDITIONS AS THAT OF THE 15/3/92. MR. MUNDAY CALLED IN A CONTRACTOR ONCE AGAIN TO EMPTY HIS TANKS, THE CONTRACTOR ALSO REORDERED THE STORE TO A CERTAIN EXTENT IN ORDER TO TAKE OUT AS MUCH DRY WATER AS POSSIBLE.
