NRA THAMES REGION:

AUDIT SURVEYS 1991/92

A report on the re-surveys of selected reaches of  
river following maintenance dredging.

March 1992

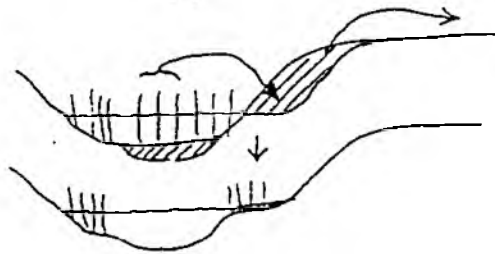
DREDGING RECOMMENDATIONS ①

Sods coppiced

No shelf-tree planting instead  
 Cut a low shelf at normal water-level, 0.5m wide min., 10m+ long if possible, & plant with some of sedge from channel

new pipe

Toe of both banks scraped

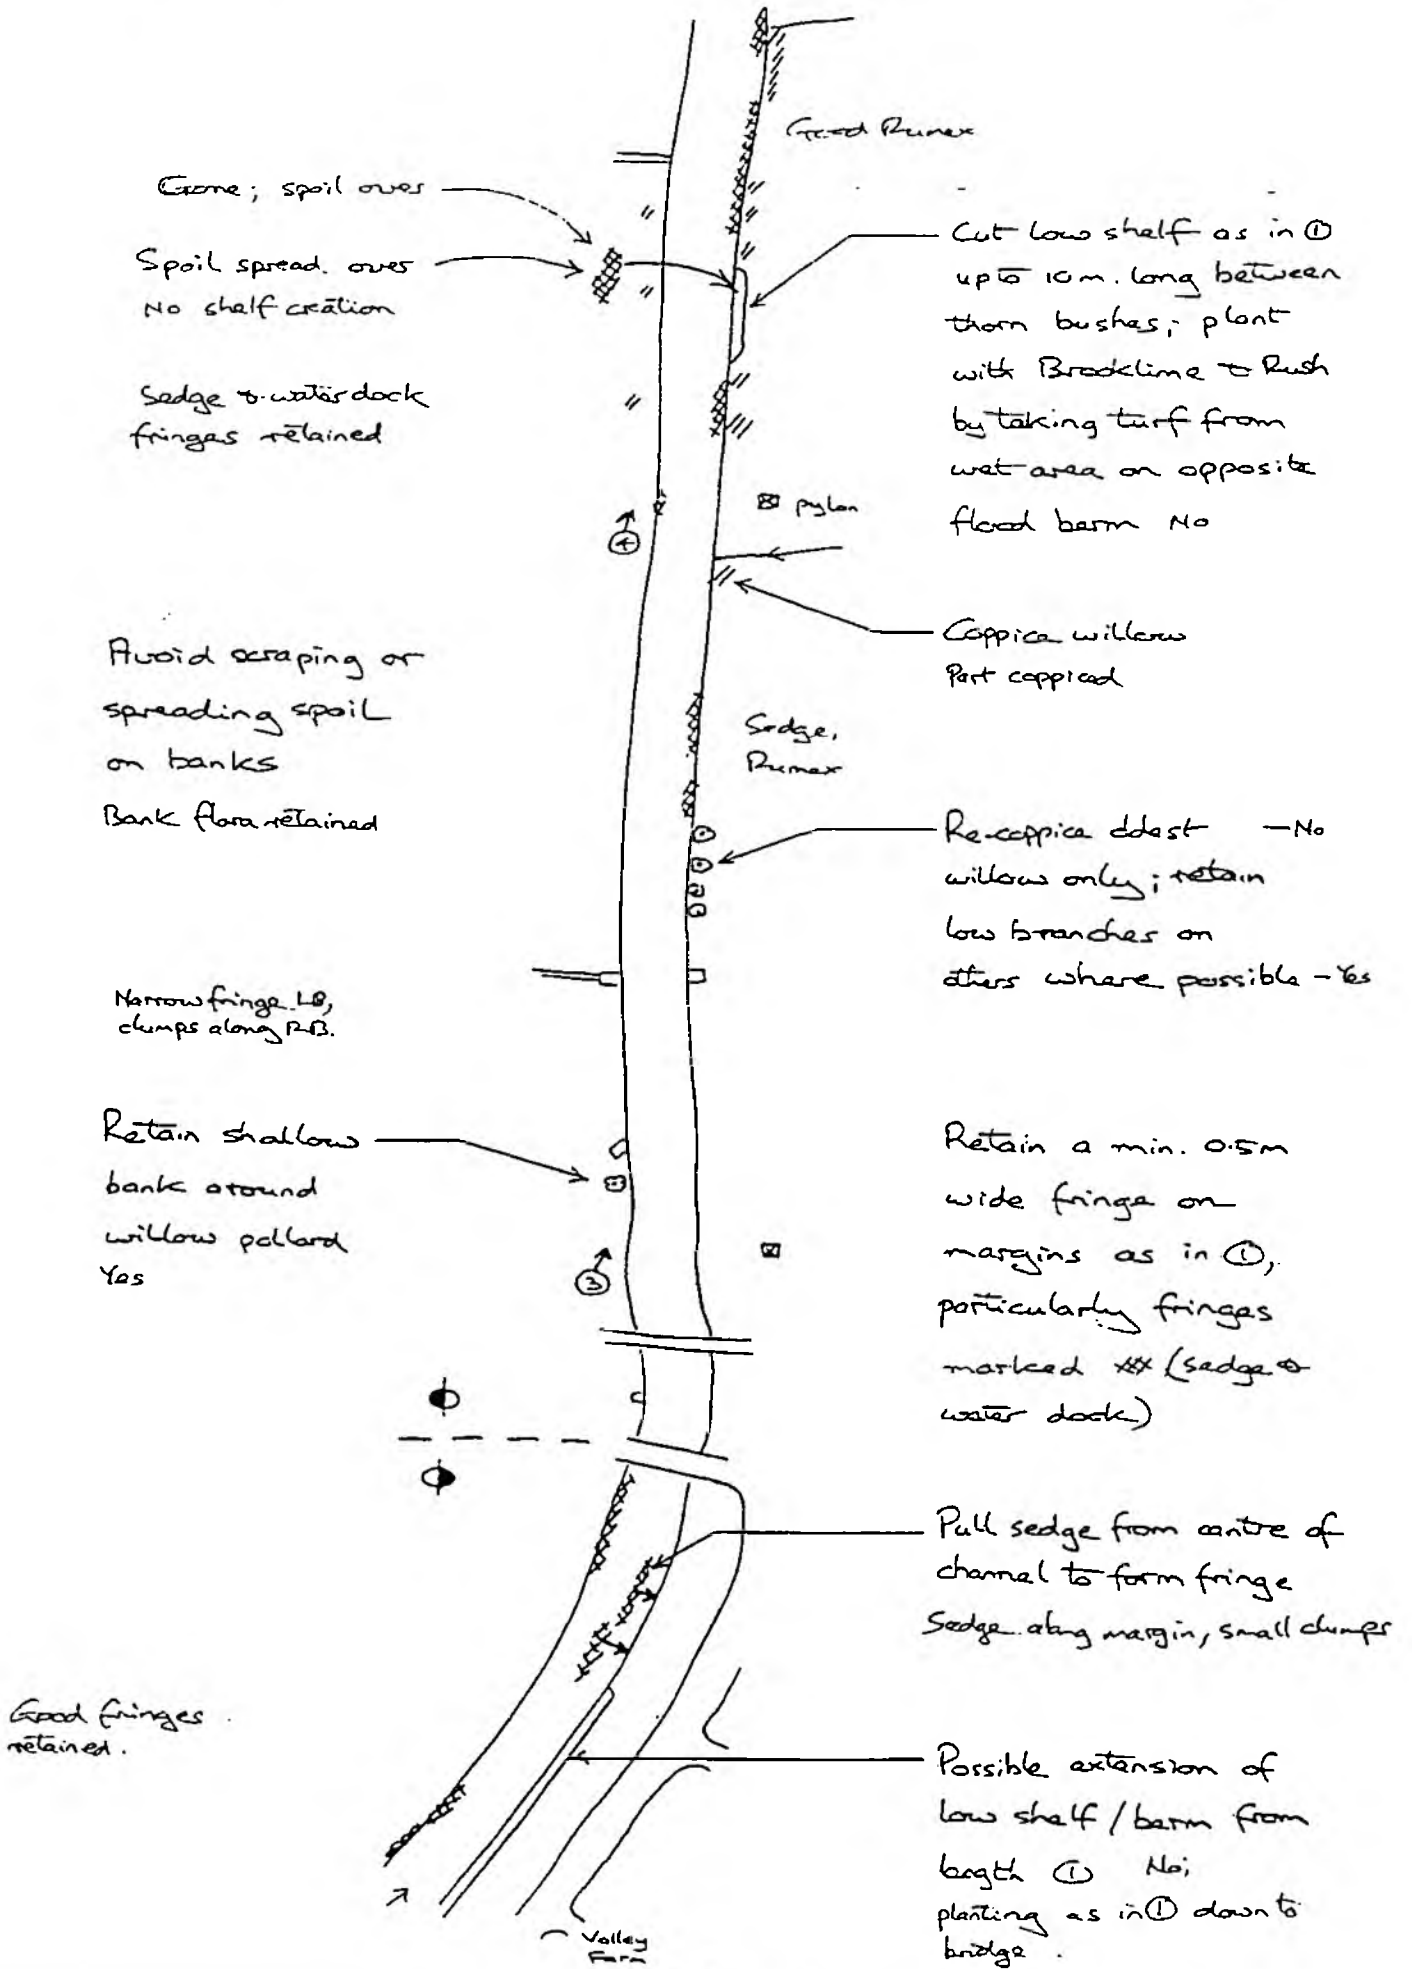
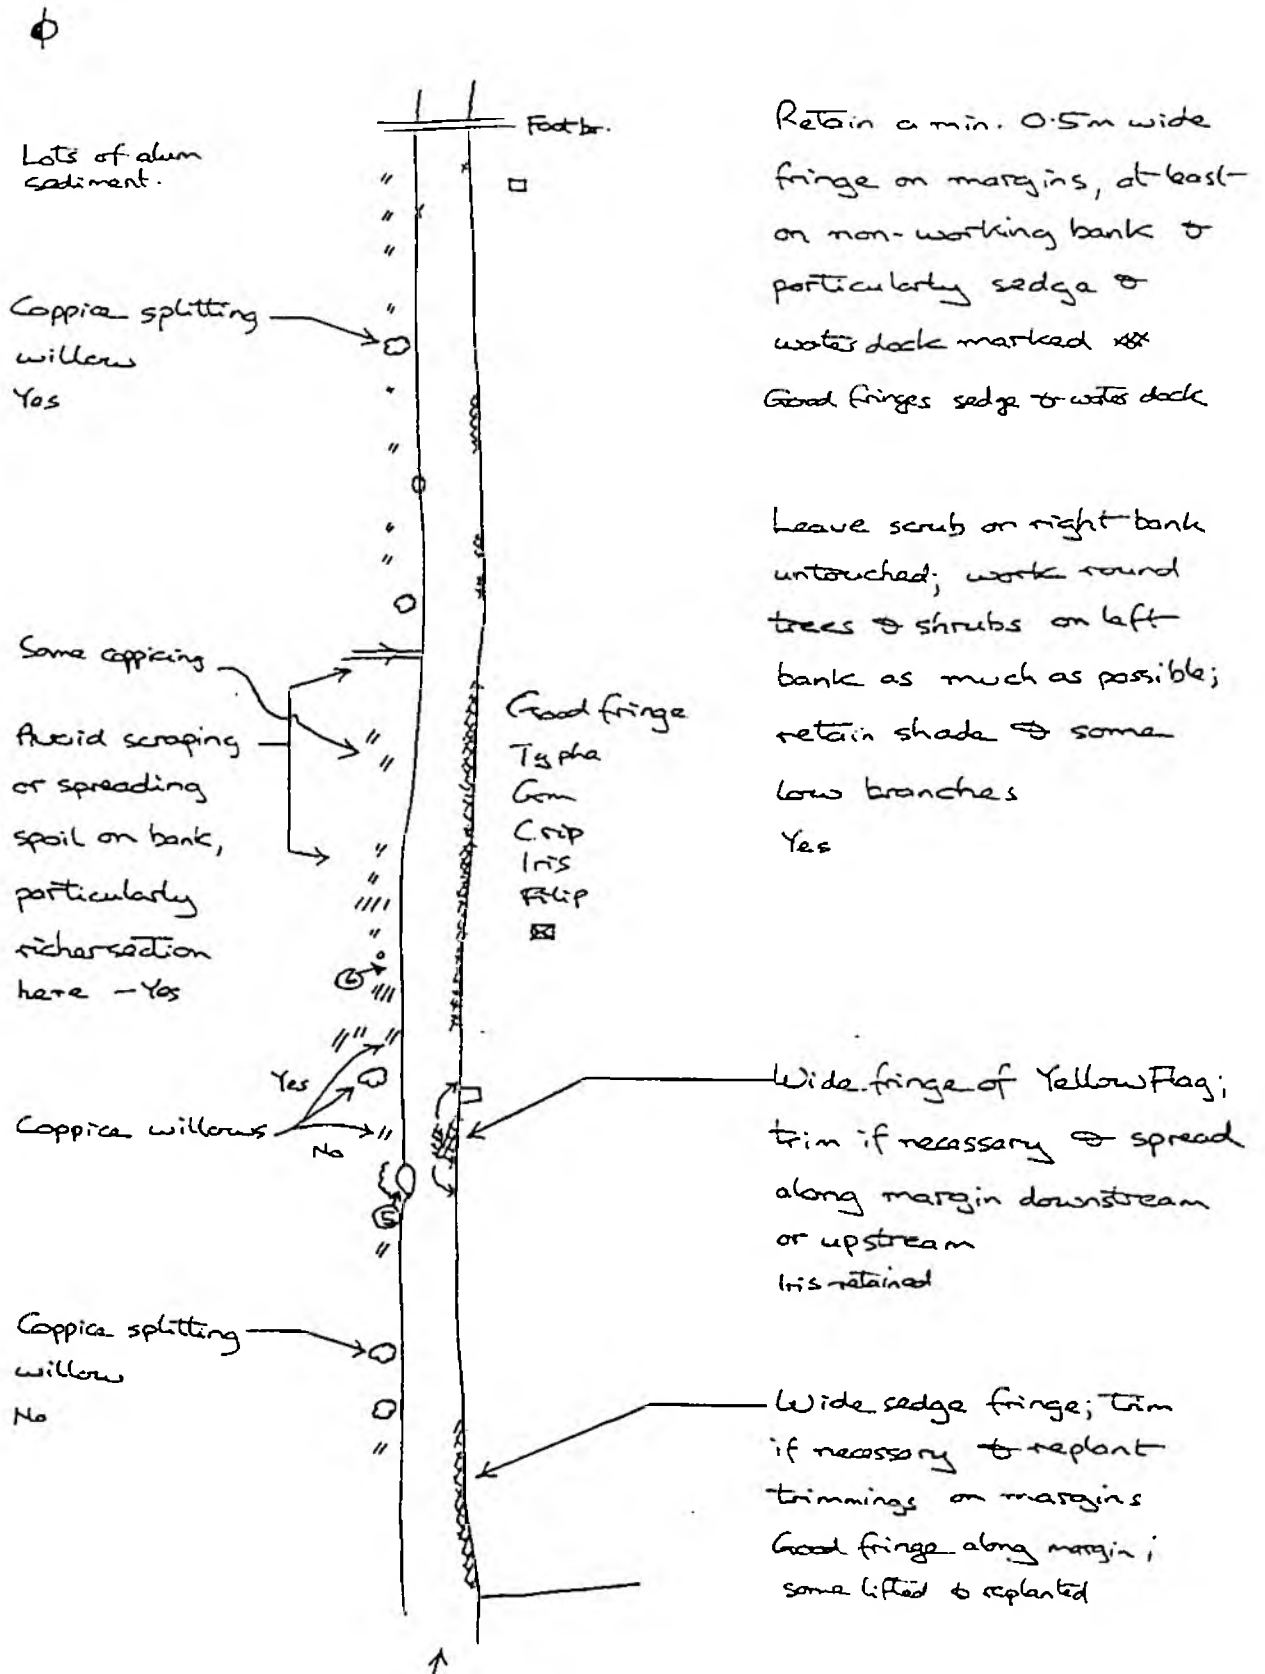
DREDGING RECOMMENDATIONS ②

SURVEY SECTION	BANK AND CHANNEL FEATURES		BANK VEGETATION		CHANNEL VEGETATION		COMMENTS
	RET.	ENH.	RET.	ENH.	RET.	ENH.	
1	5	0	4	3	5	NA	No shelf creation or planting with sedge; shrub/ tree-planting instead; coppiced willows good; Top of bank - loss of richer area of grassland
2	5	0	5	3	5	NA	No shelf - treeplanting instead as ① Good fringes to bank flora, but loss of small marshy area due to spoil;
3	5	NA	5	5	5	5	Coppicing willows good; Good fringes to bank flora, including lifting & replanting sedge along margin
