FINAL DRAFT REPORT

**PORTH STREAM EC SURFACE
WATER ABSTRACTION FAILURE
1993**

September 1995

INV/95/007

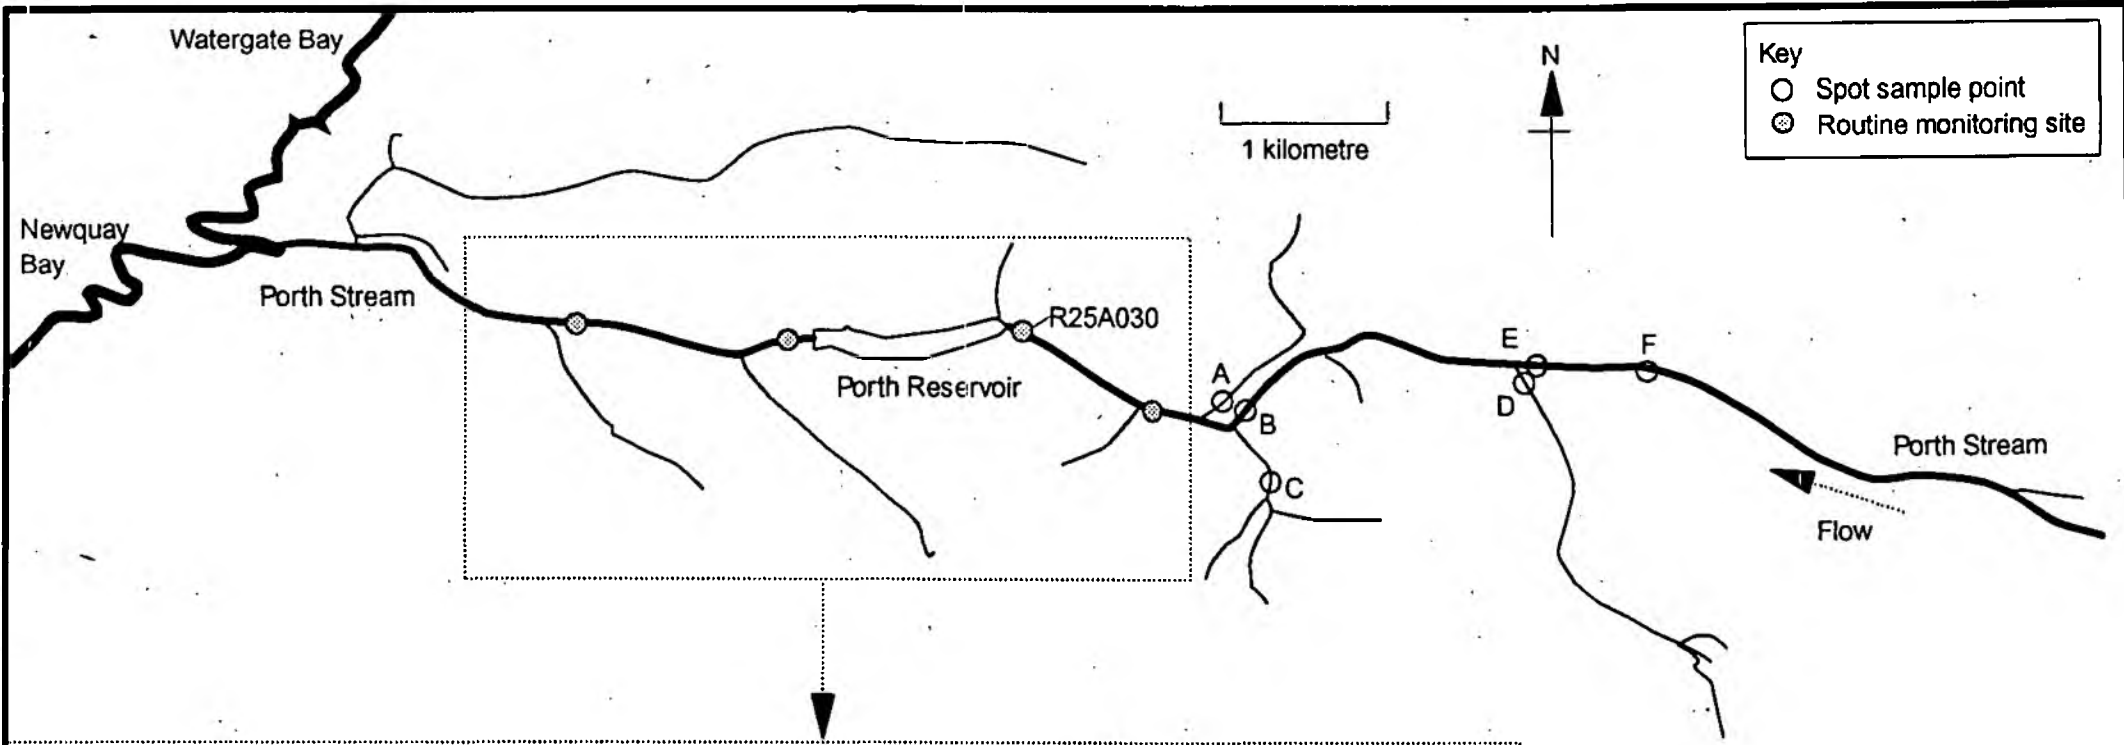
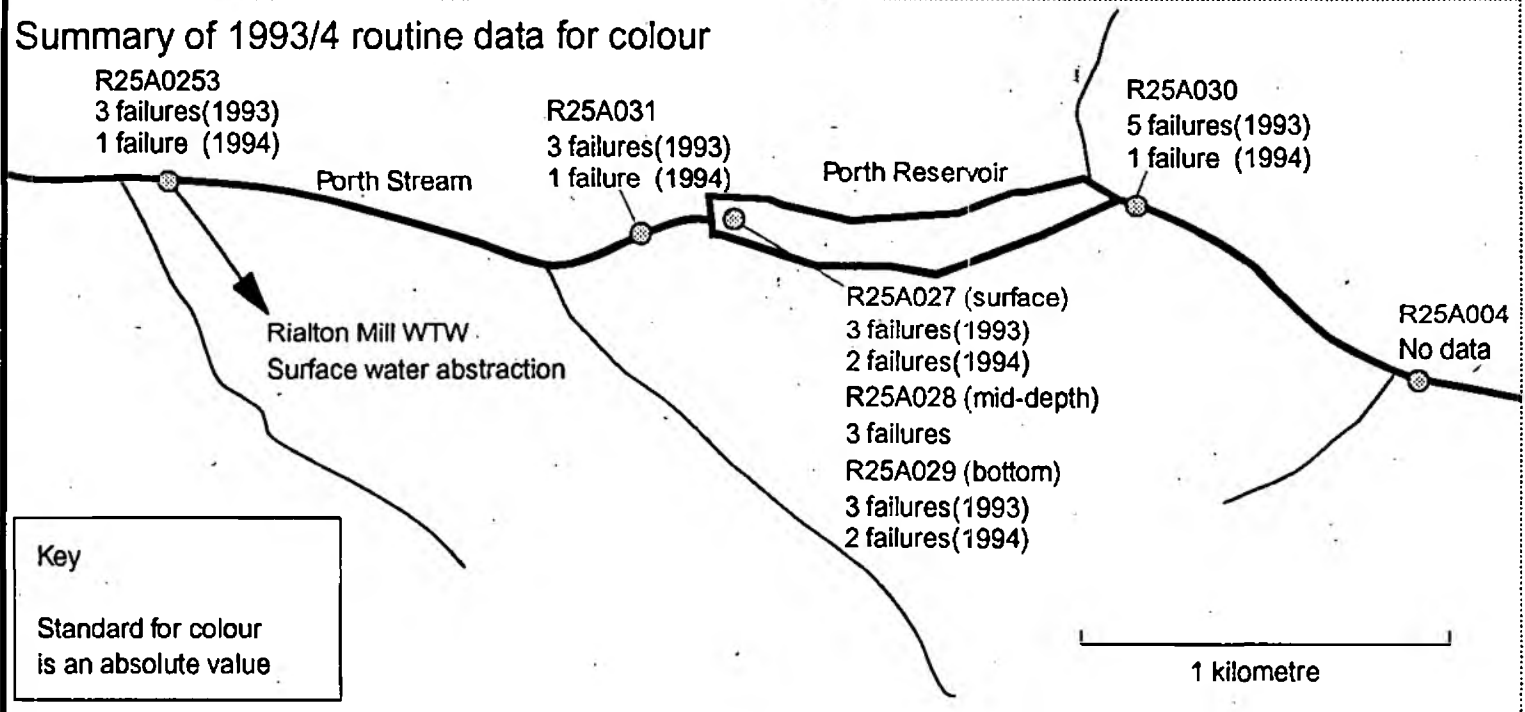
Fig 1. Porth Stream catchment showing sampling sites

The Porth Stream at R25A025 failed for colour in 1993. R25A025 is the abstraction point for Rialton Mill water treatment works (WTW). The locations of monitoring sites and summary of water quality data are shown in figure 1.

A summary of the two chemical spot surveys and details of the 1993 failures are contained in figure 1 and table 1.
