**Trewinnard Manor Pond  
Pollution Incident November 1990**

**Draft Internal Report NRA South West  
December 1990**

**Geoff Bowen  
Consultant Hydrogeologist**

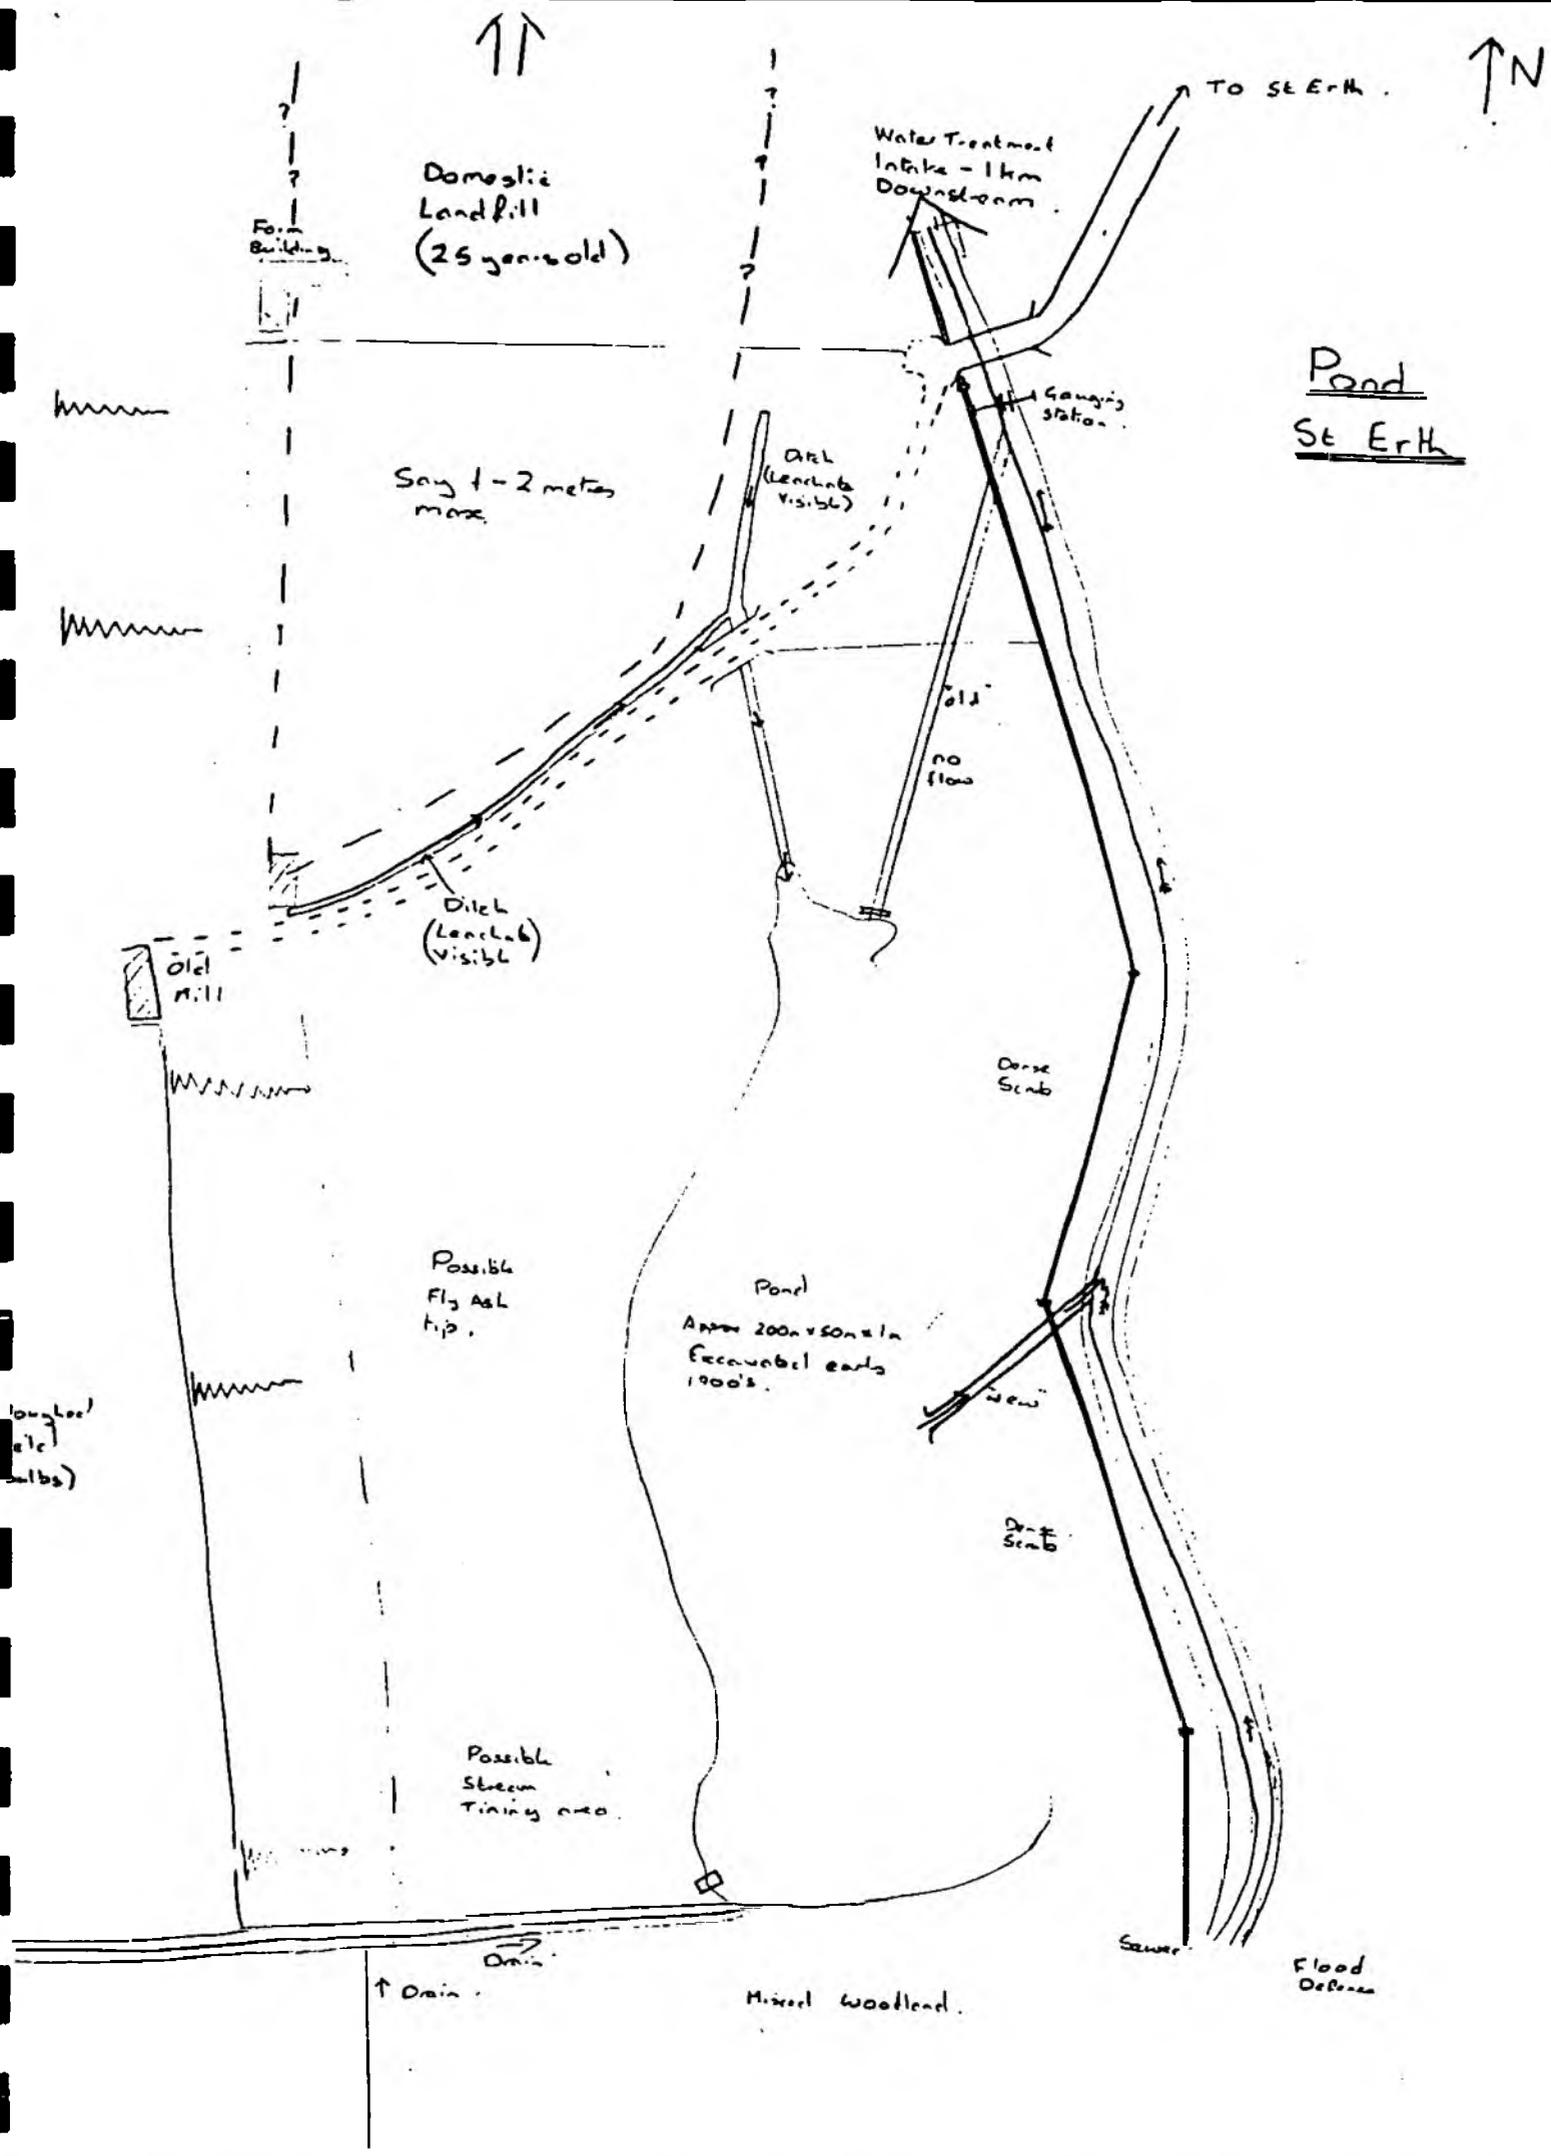
DRL (Leachub visible)

Ditch (Leachub visible)

Possible Fly Ash tip.

Pond  
Approx 200m x 50m in  
Eccumbel early 1900's.

Possible Stream Tining area.
