**WATER QUALITY SECTION
CORNWALL AREA**

FINAL DRAFT REPORT

**RIVER TAMAR
EC FRESHWATER FISH
DIRECTIVE FAILURE 1994**

**June 1996
COR/96/005
Author: Phil Luxton
Water Quality Officer**

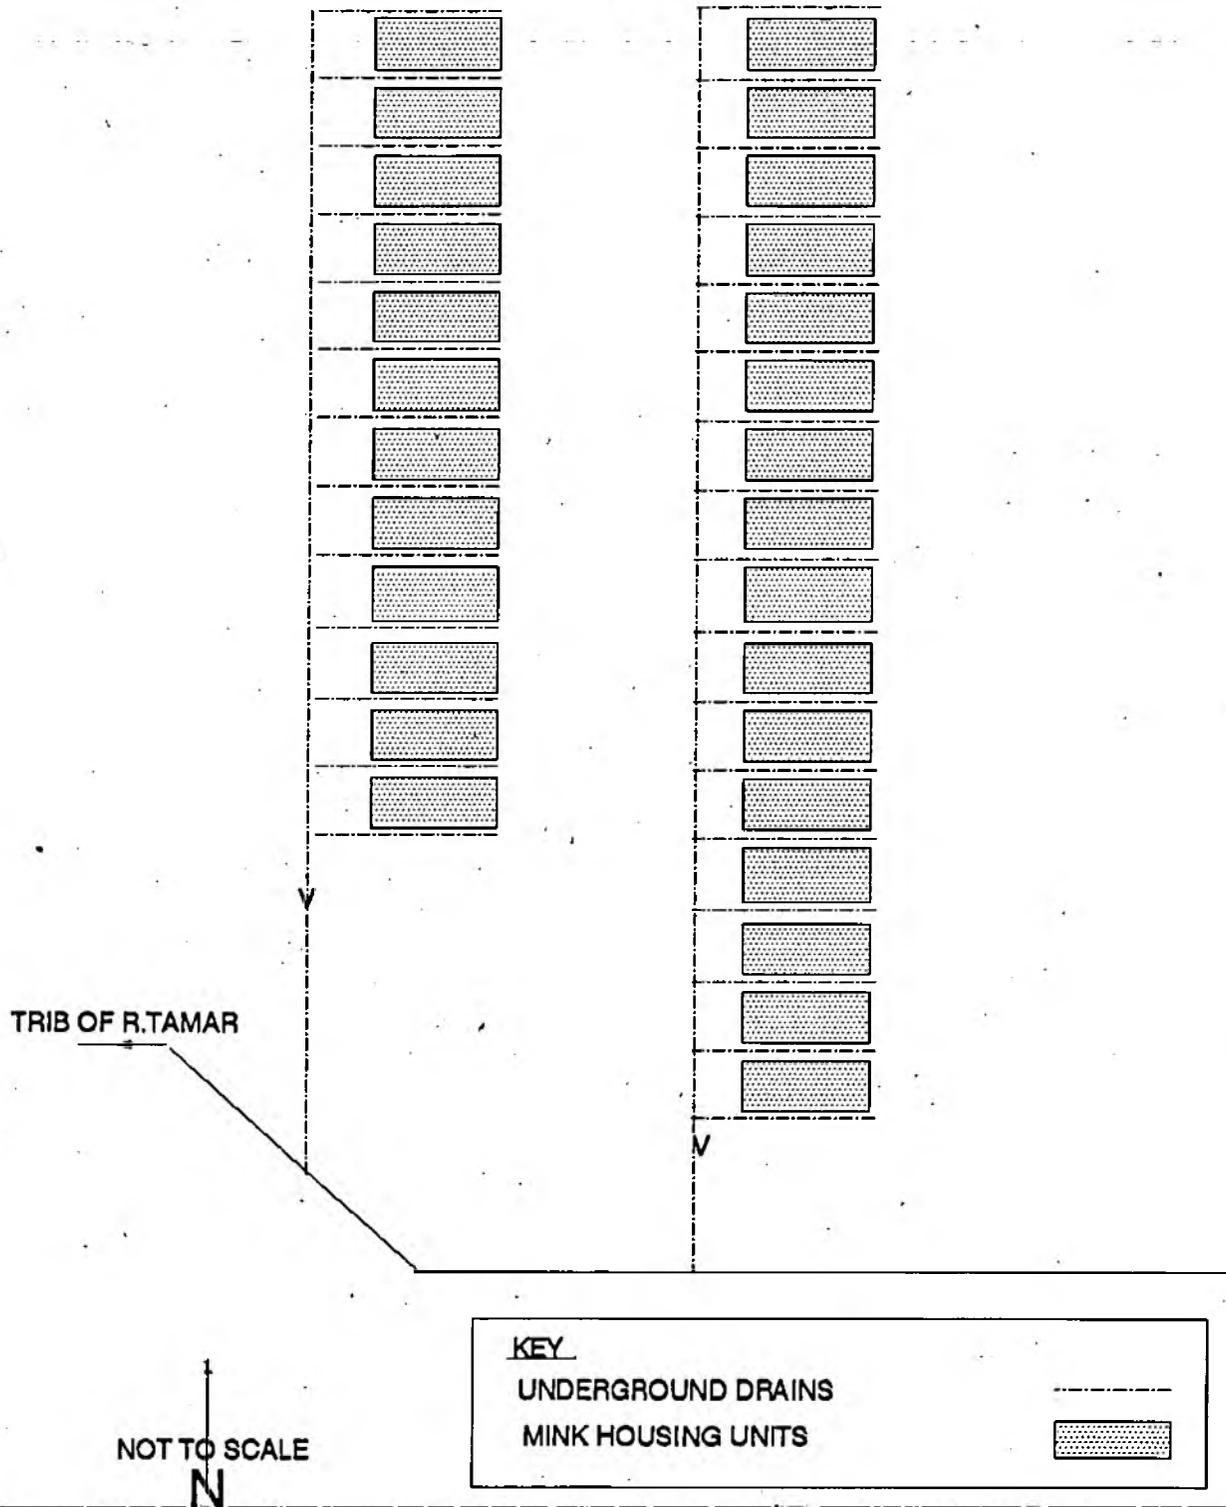
Fig 2.

Following initial spot sampling programme and Catchment Inspection a Water Quality Monitor was installed at Buses Bridge. Simultaneous to this action Catchment Inspection found a discharge to be emanating from a site known as Woodview Mink Farm and entering a tributary of the River Tamar at Trentworthy Cross, Youlstone some 4.5 Km upstream of the monitoring point (R12L001/R12L039). On site readings and subsequent analysis of samples highlighted high ammonia content. Statutory samples were taken due to the discharge and a report submitted for instigation of legal action. By comparing the readings from the monitoring points on the Youlstone Tributary and the River Tamar at Buses Bridge the peaks of ammonium and conductivity can be seen to be related. The trend of the peaks indicate that Woodview Mink Farm is the principle source of ammonium causing non-compliance of the E.C. Freshwater Fish Directive at Buses Bridge. Following remedial action by the site owner, using water quality data and onsite photometer readings, it has been confirmed that the point source has been identified. Due to the nature of the site ie. Mink Farming, the discharge has been seasonal and at present animal stocking is low in comparison with the summer months. Remedial action by the owner is continuing along with onsite monitoring and water quality monitoring by the one monitor left installed on the Youlstone Tributary. As remedial action progresses it would appear that the peaks are becoming less frequent however in times of rainfall some discharges do occur. Once total remedial work has been completed it is envisaged that the site drainage will be on completely separate systems and therefore manageable. Whilst the Fresh Water Fish Directive has been breached the impact on the watercourse is thought to have been minimal due to the sporadic nature of the discharge, the nature of the pollutant ie. no high BOD content and the flow levels at time of discharge.

WOODVIEW MINK FARM

- i) Continued inspections of Woodview Mink Farm to ensure improvement works continue to satisfactory standard. -Water Quality.
- ii) Reinstall Water Quality monitors at Buses Bridge and Youlstone Trib during Autumn 96 to monitor improvements. -Investigations Team.
- iii) Continue onsite photometer readings during site inspections.
- iv) Continue close liaison with site owner with regard to improvement works and Water Quality data. -Water Quality.

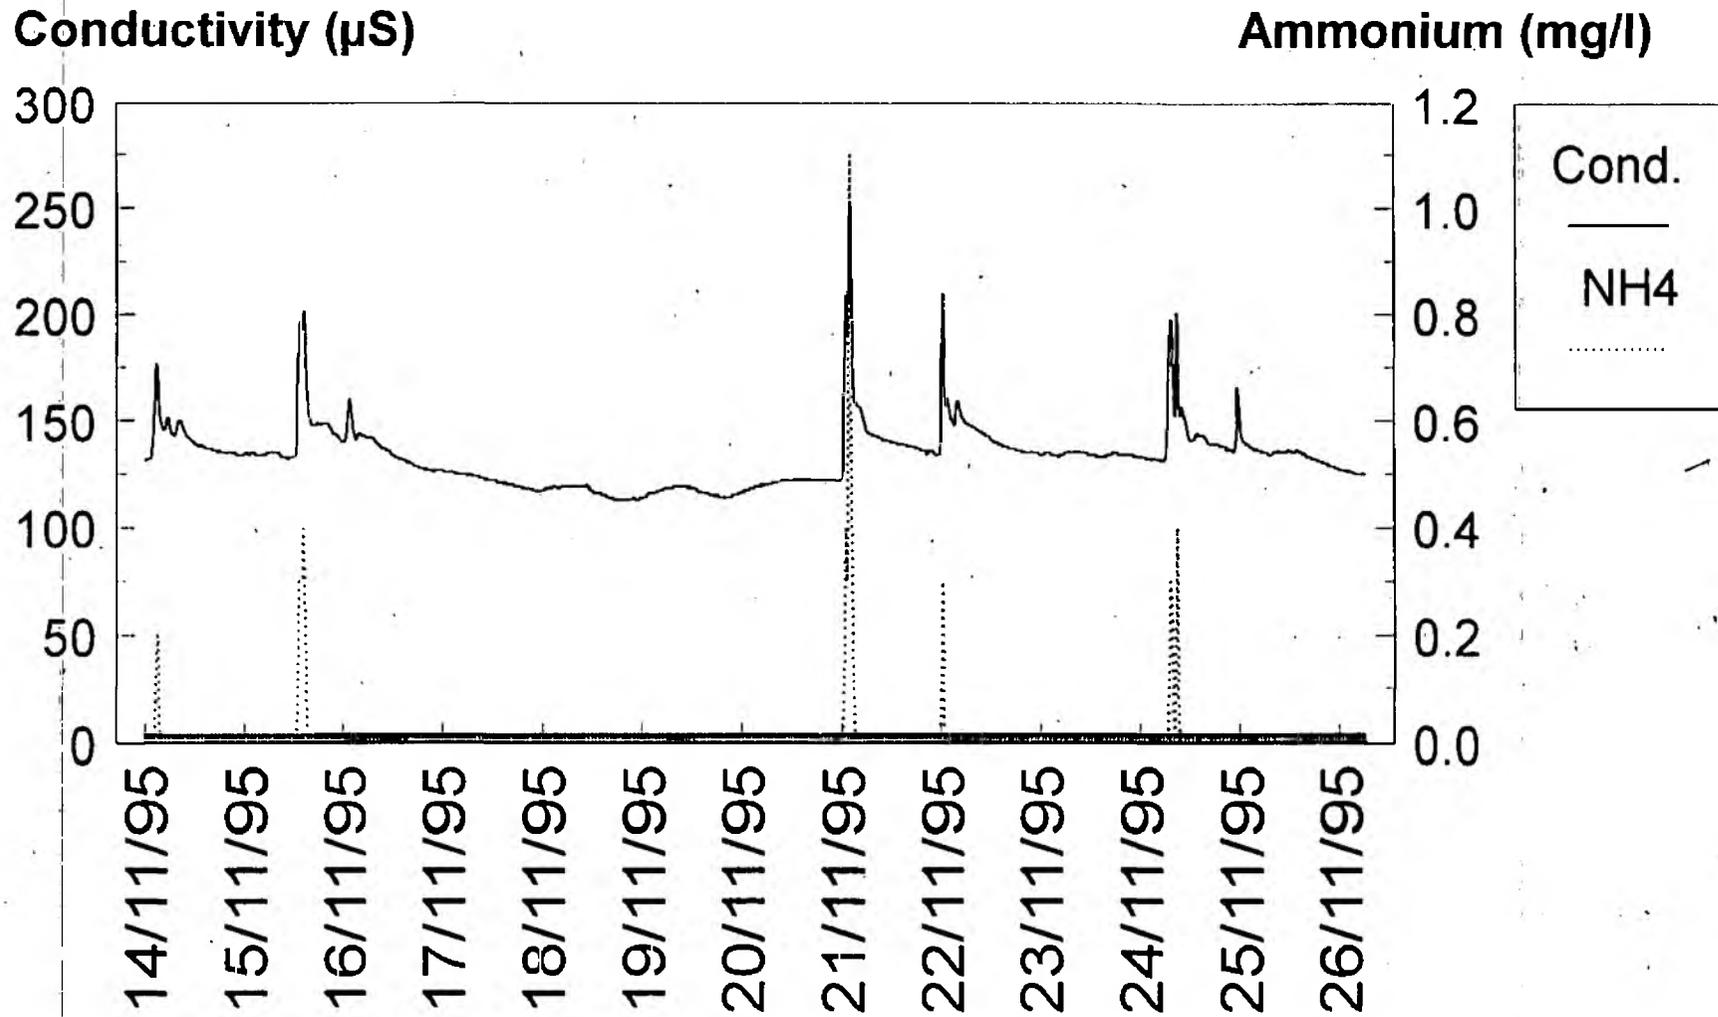
River Tamar upstream of Blatchborough Tributary - November 1995.

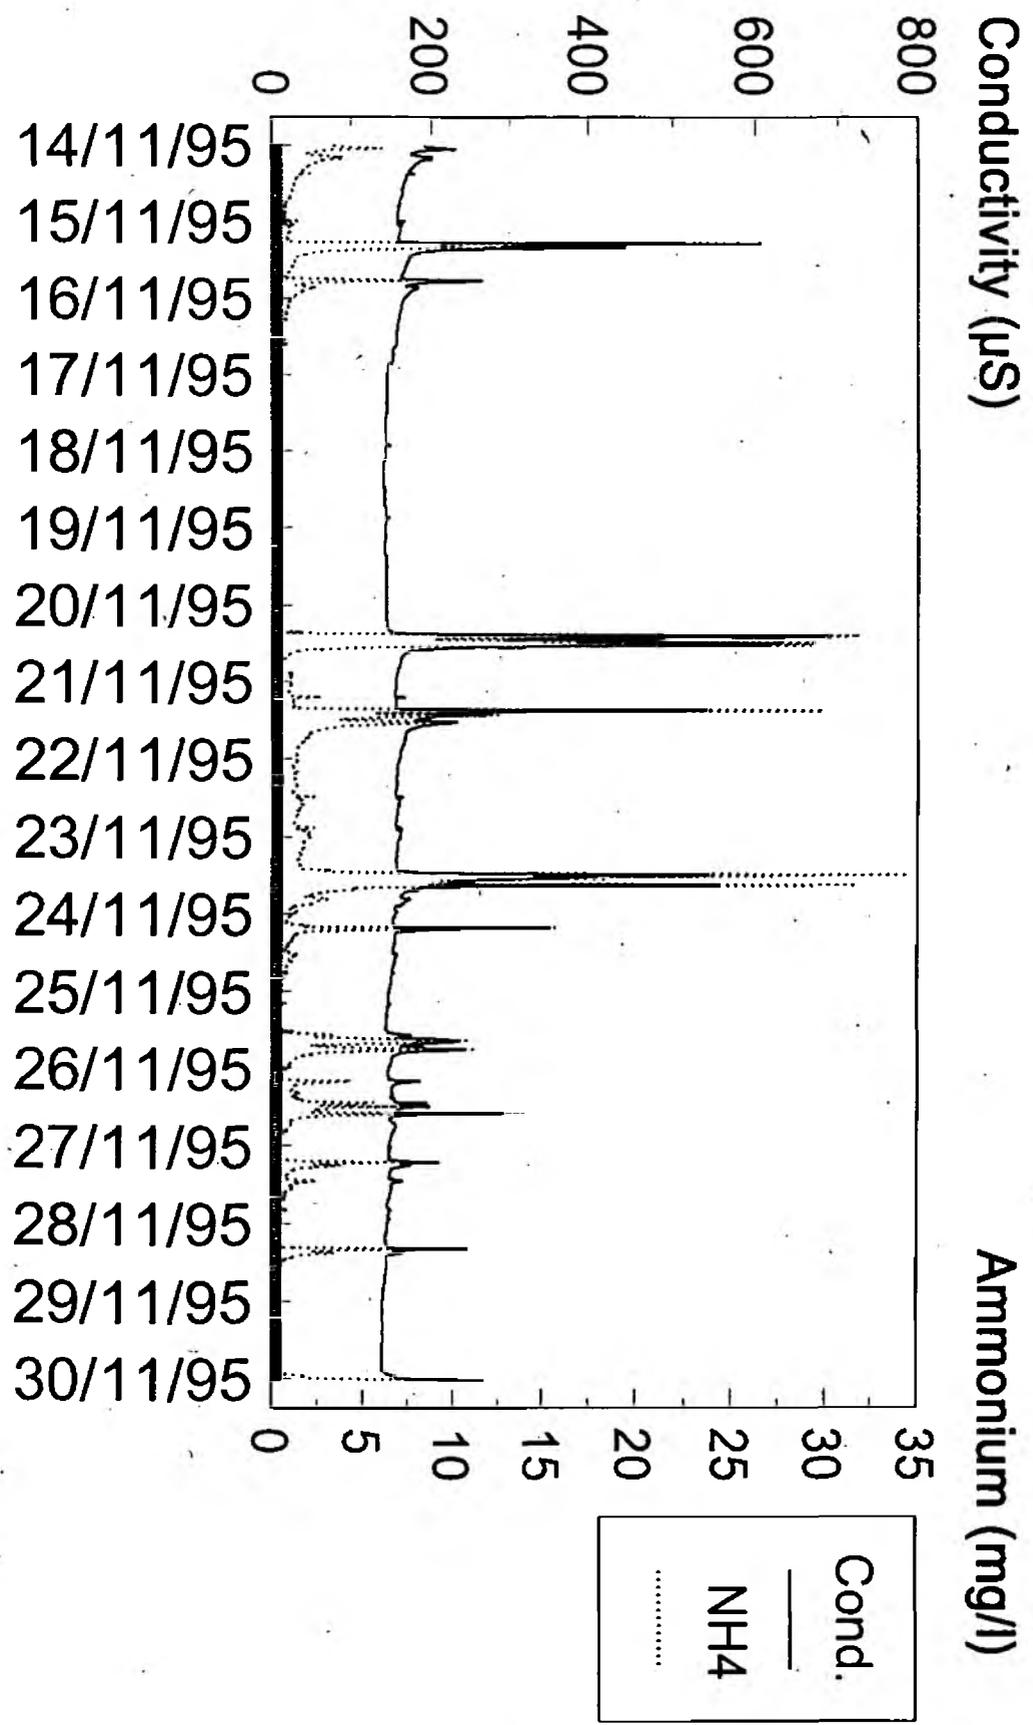
Fig 7

Youlstone Tributary - November 1995.

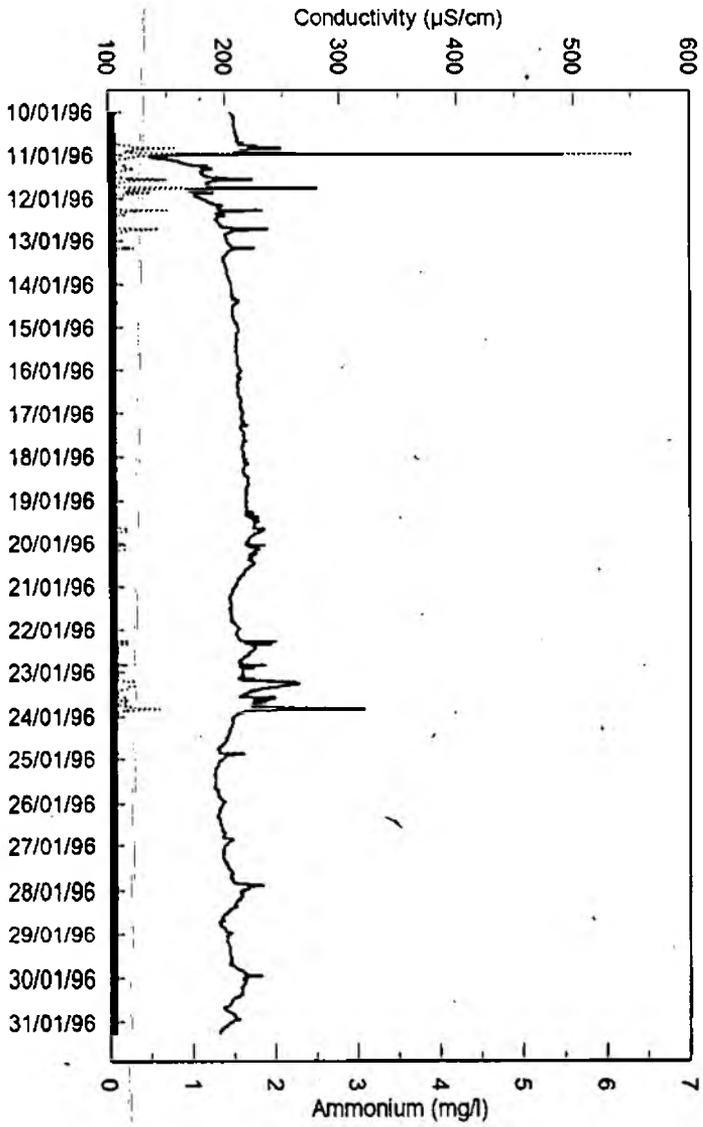
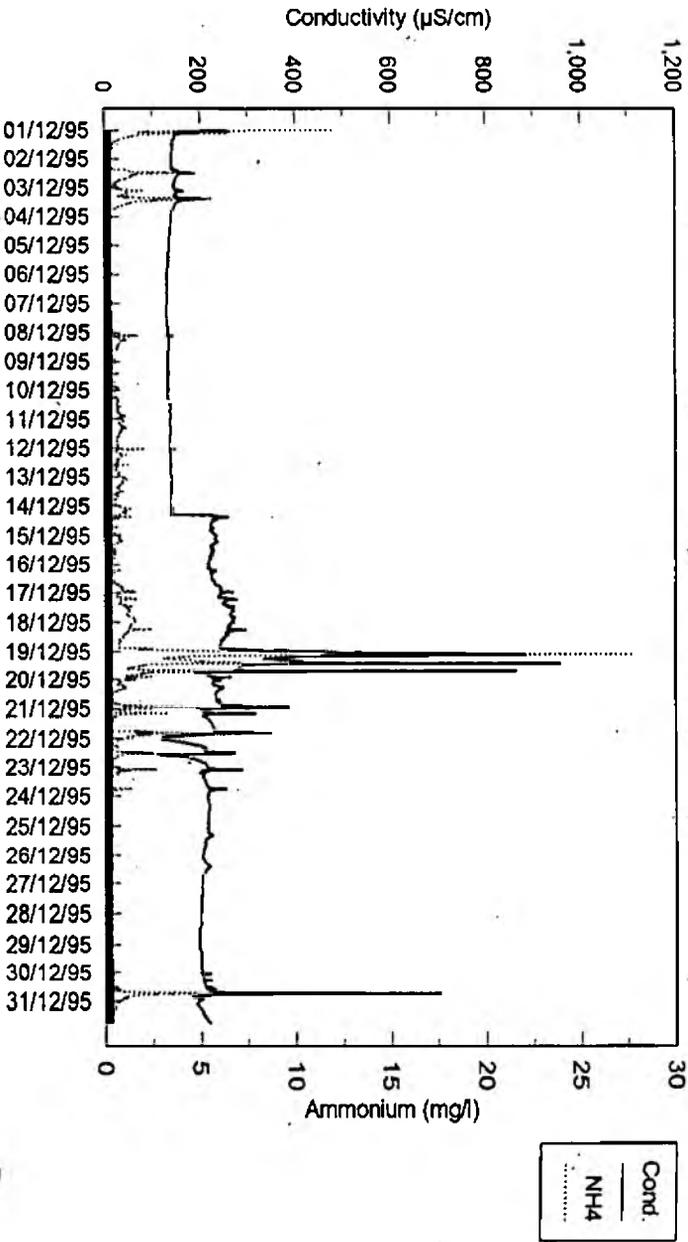
FIG. 8

Youlstone Tributary - 12/95 & 01/96.

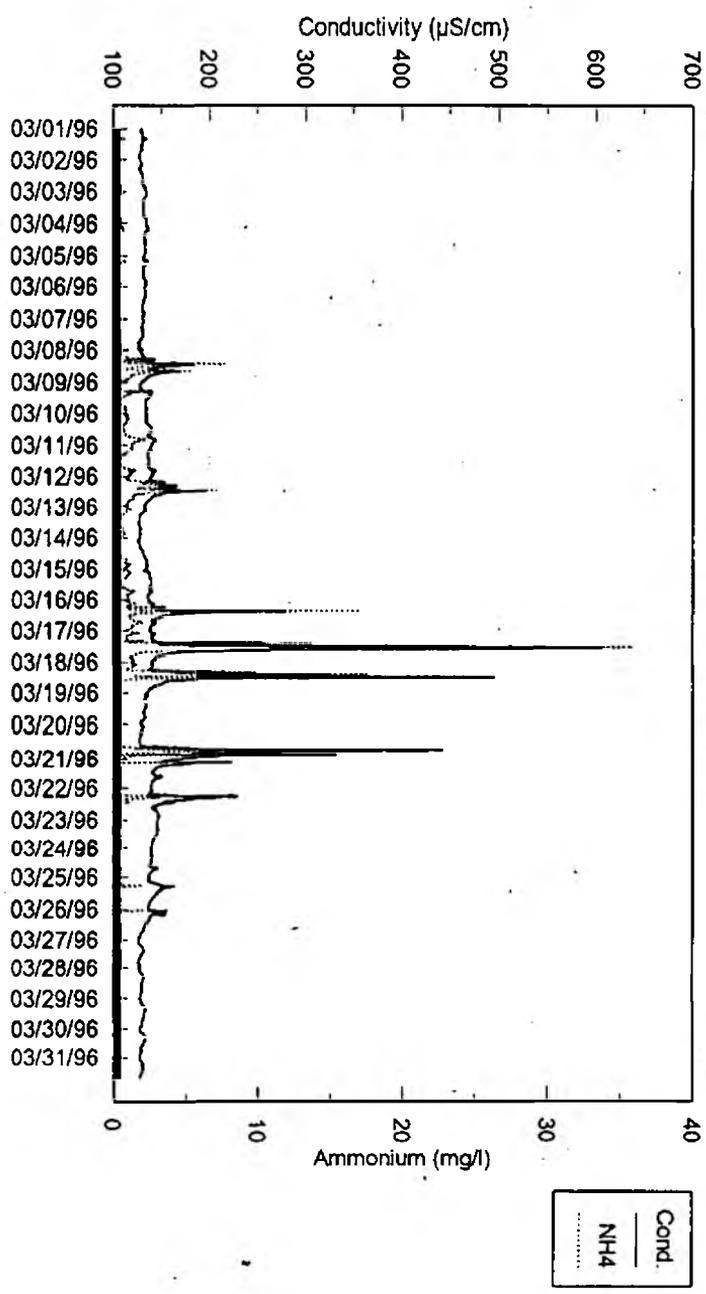
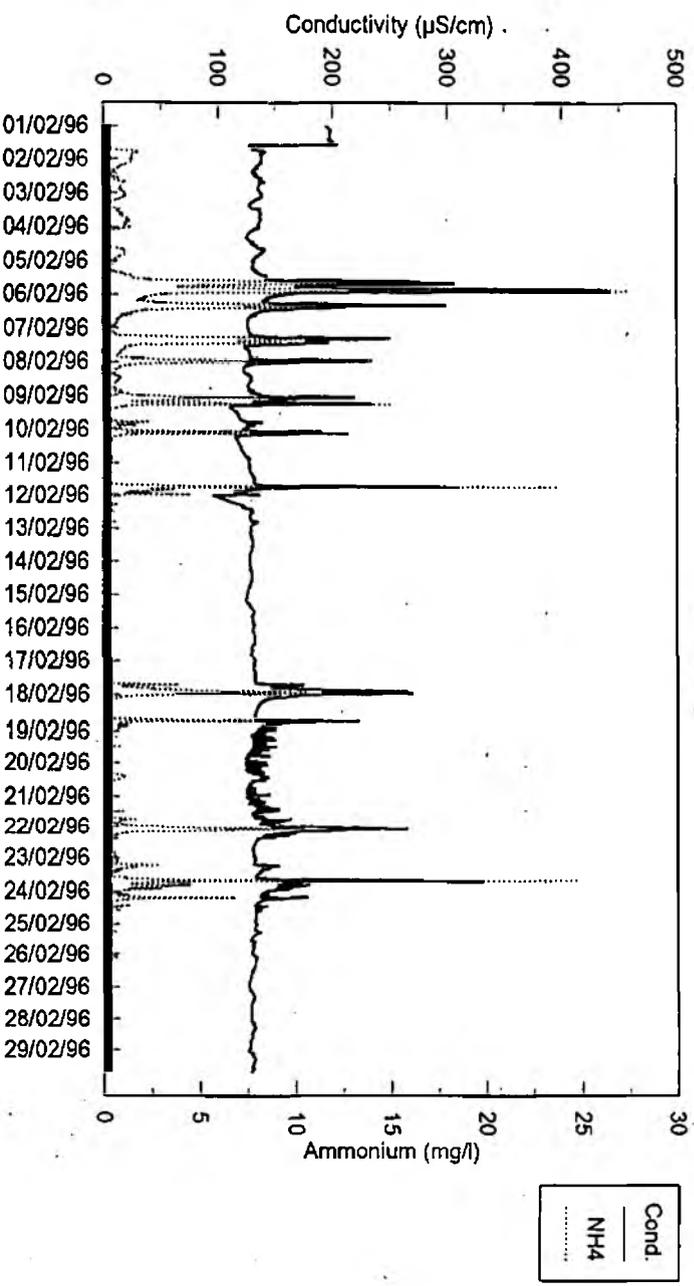
Fig 9

Youlstone Tributary - 01/96 & 02/96
