DEVON AREA INTERNAL REPORT

AN INVESTIGATION TO DETERMINE IF SOUTH MOLTON STW IS THE CAUSE OF ELEVATED COPPER AND ZINC CONCENTRATIONS DOWNSTREAM IN THE RIVER MOLE

> DECEMBER 1995 DEV/E/18/95

Author: P ROSE INVESTIGATIONS TECHNICIAN

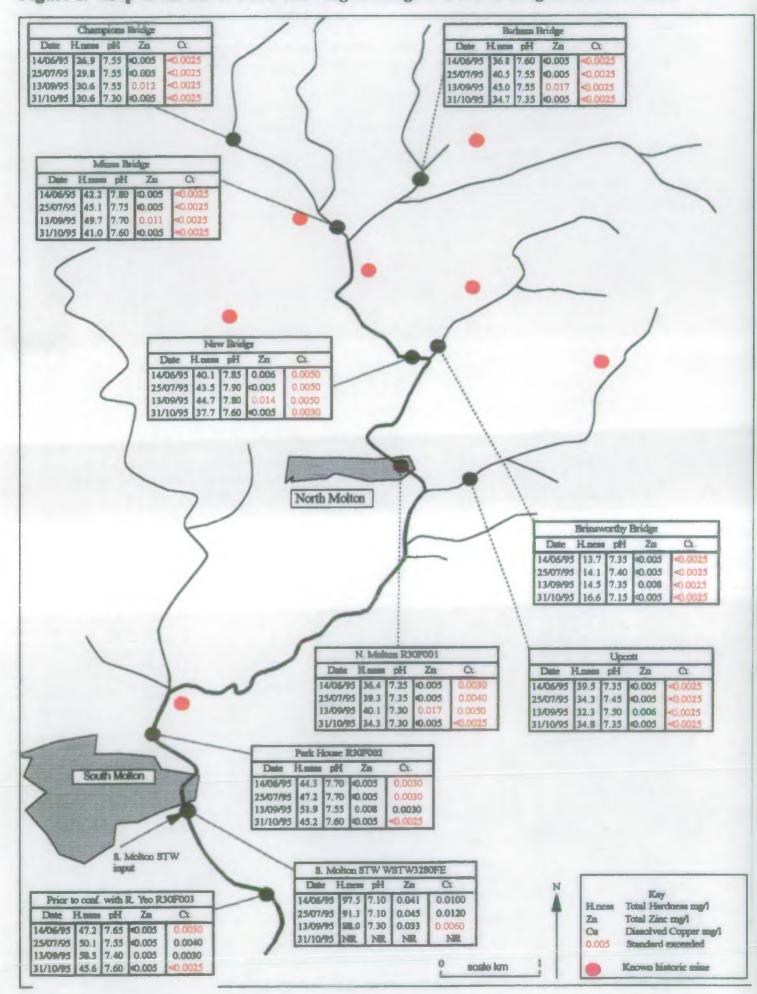
Figure 1. Map of the River Mole showing investigation monitoring sites and results.

Firstly, although there were concentrations of copper and zinc above current levels of detection (LoD) within the discharge (total Zinc LoD 0.005 mg/l, dissolved copper LoD 0.0025 mg/l), there was no appreciable impact downstream of the works at R30F003 (see Figure 1).

During the investigation, the concentrations of dissolved copper increased by approximately 60 % at sites upstream of South Molton STW discharge up to and including Newbridge (above North Molton, see Figure 1, comparison of data from R30F003 and Newbridge). Above this area, the concentration immediately falls to below detection limits.

The area in question is known for historic mines. Indeed, upstream of the Newbridge site and D/S of the Mines Bridge site there are old mine workings and shafts near the watercourse. It is very probable that this combined with natural geology is causing the elevated metal concentrations downstream.

- 1. Continue monitoring for dissolved copper and total zinc at routine monitoring sites on the River Mole.
- 2. Enquire as to possibility of setting detection limits at or below strictest water quality standards for appropriate substances.
