National Rivers Authority

AN
INVESTIGATION
OF THE
MADFORD RIVER
POLLUTION INCIDENT
OF 29 JULY 1989

FWI/89/002

Freshwater Investigation Team
Environmental Protection
NRA South West Region
Manley House
Exeter

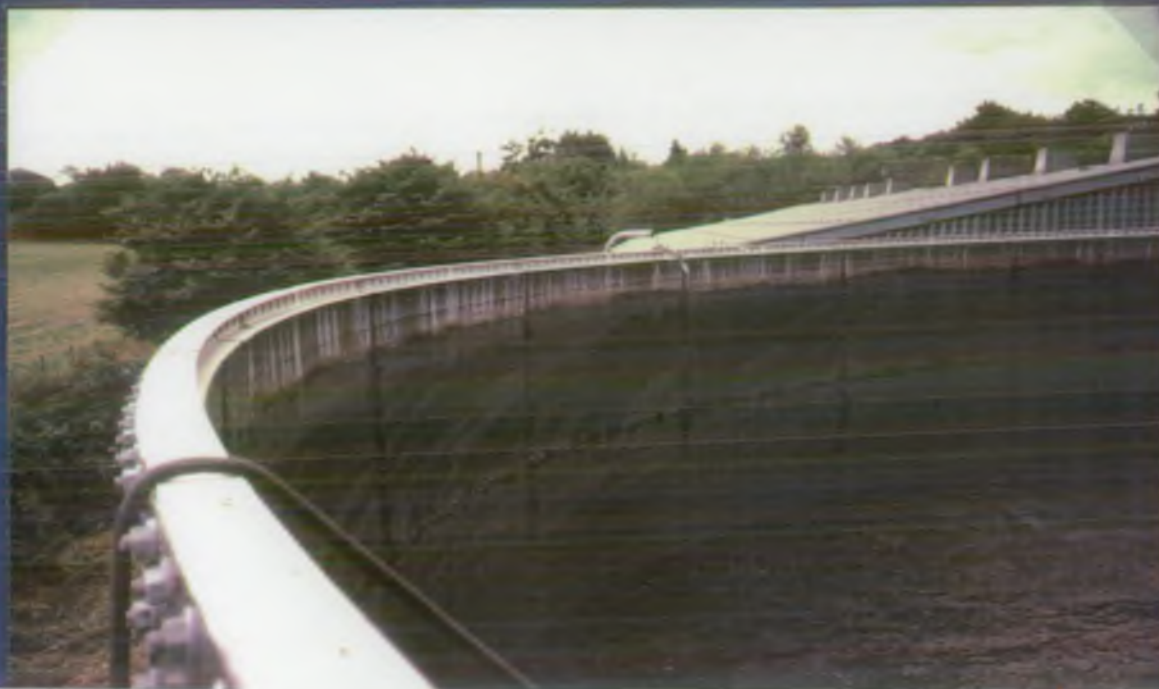
Early in the morning of 29 July 1989 approximately 100,000 gallons of pig slurry were discharged from the slurry store at Westerhope Pig Farm, Dunkeswell. The slurry overflowed a catch-pit into an area designed to hold such a spillage. However, a pipe within the earth bund, installed to drain rain-water from the containment area, allowed the slurry to discharge into a ditch which ultimately flows into the drainage network of Dunkeswell Aerodrome and thence to the headwaters of the Dunkeswell Stream (Figure 2, photographs 1 and 2).

PHOTOGRAPH 1. Slurry Storage Tank at Westerhope Farm Showing the Fall in Level Associated with the Discharge.

As soon as the pollution was discovered, staff at Westerhope Farm closed the sluice gate on the slurry store, blocked the drain through the bund and reported the incident.

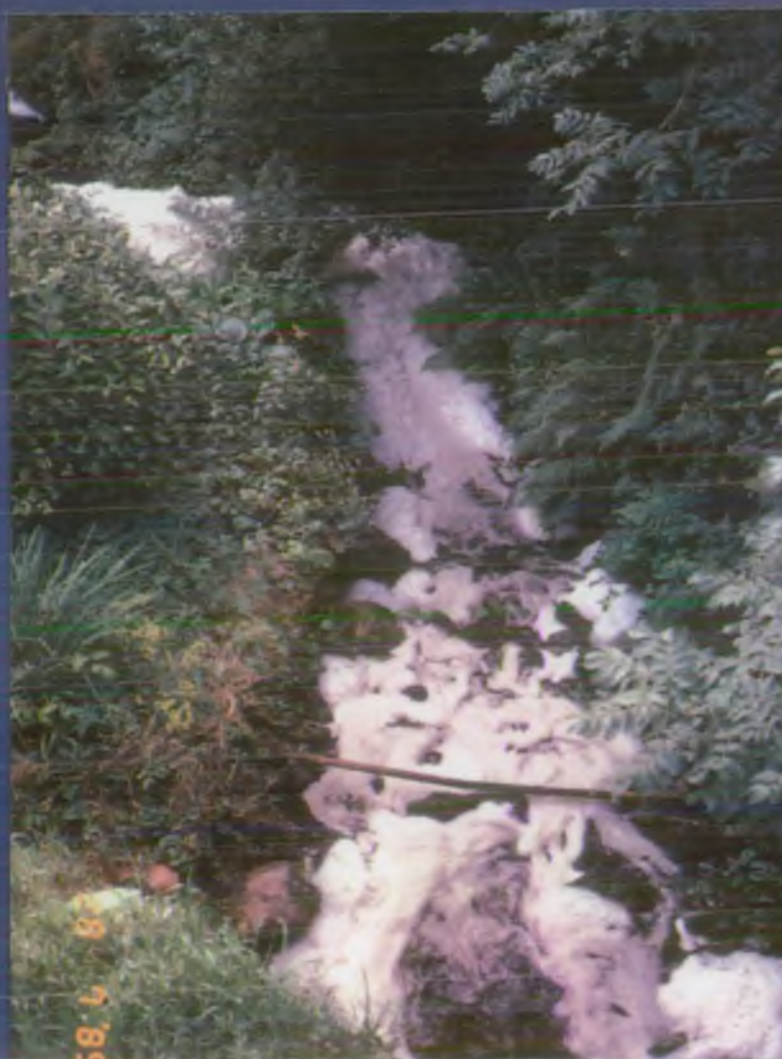
At Dunkeswell Bridge at 1020 hours on 29 July water quality was bad, with BOD at 1650 mg/l, ammonia at 1088 mg/l, suspended solids at 1450 mg/l and dissolved oxygen less than 1% saturation.

PHOTOGRAPH 2. Dunkeswell Stream at Dunkeswell Bridge During the Pollution Event.

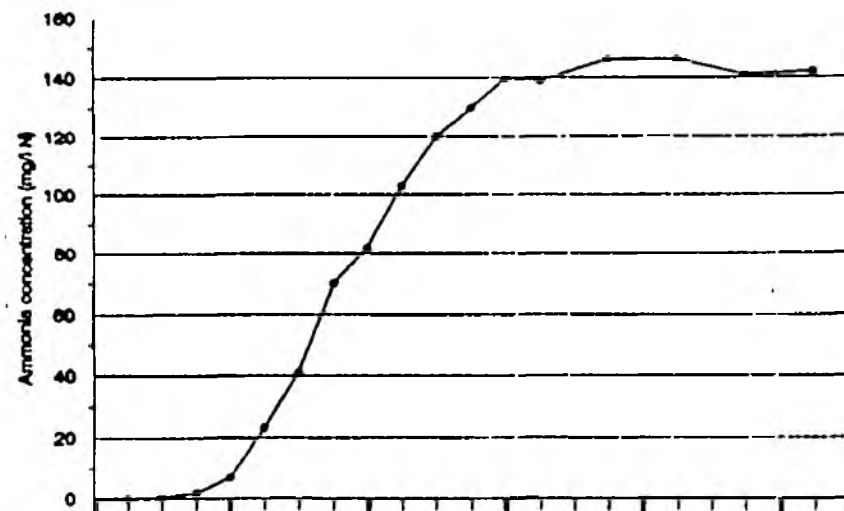
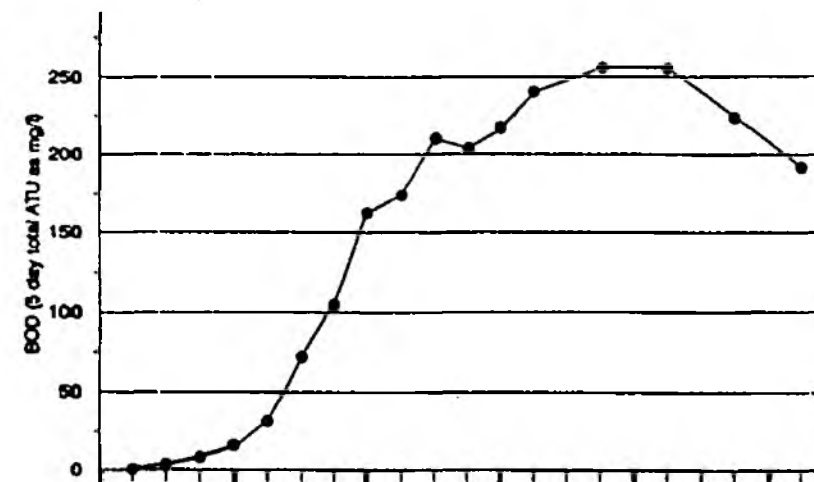
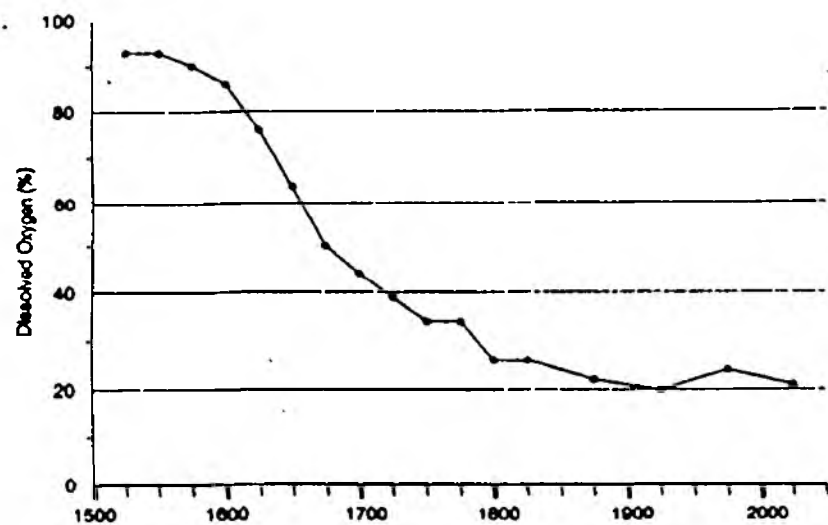
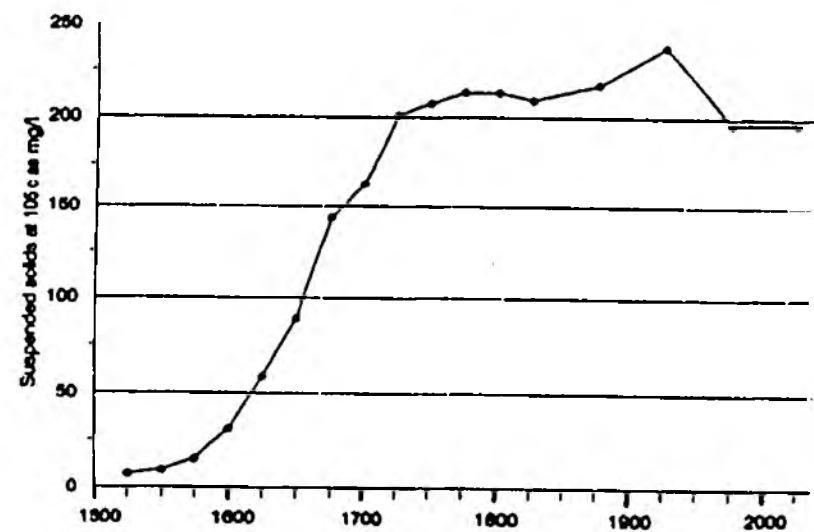
Fig. 4. Variation in ammonia, dissolved oxygen, BOD and suspended solids concentration at Madford Bridge during the pollution event on 29 July 1989.

Further downstream at Madford Bridge water quality was good at 1035 and remained so until 1545 hours after which it deteriorated rapidly. This is shown in Figure 4. The peak of the pollution at this point occurred at approximately 1900 hours. At 2220 hours water quality was still bad although some recovery was apparent.

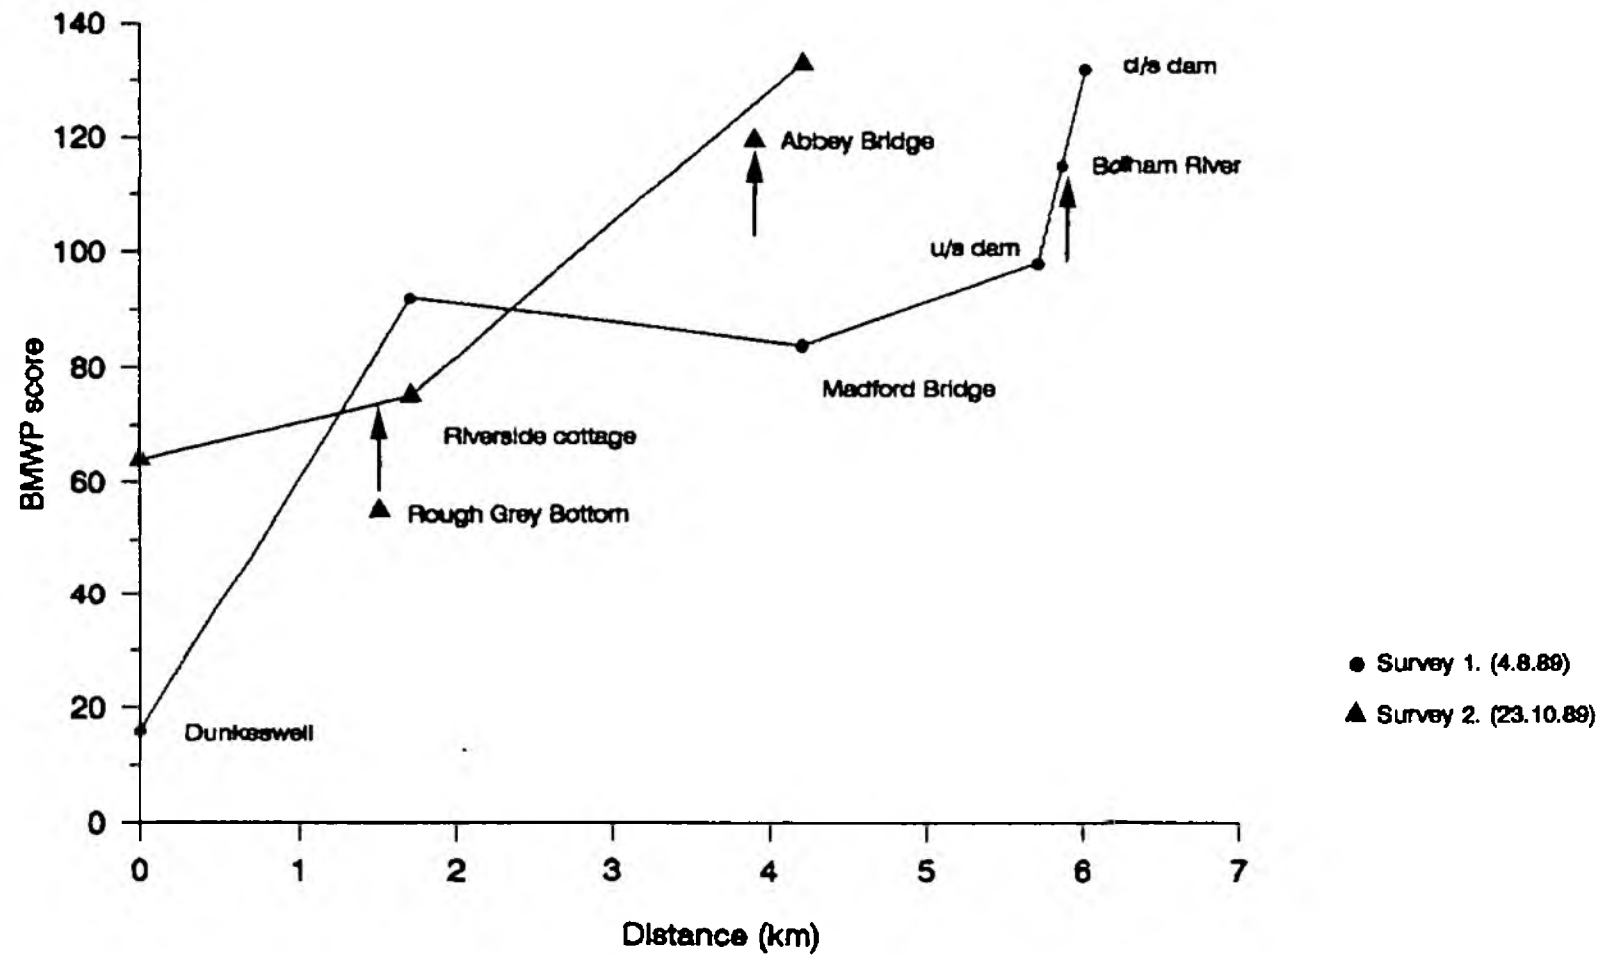
Fig. 5. Variation of BMWP Scores at 8 sites in the Madford Catchment
4 August 1989 and 23 October 1989.

There had been a considerable recovery at Dunkeswell Bridge but at Riverside Cottage (site 3) a further deterioration was apparent. The control site at Rough Grey Bottom (Site 2) had an impoverished fauna restricted to pollution tolerant taxa. This implies that the cause of the reduced score at Riverside Cottage was probably due to a water quality problem in the upper reaches of the Madford River and was unlikely to be connected with the pollution incident from Westerhope Farm.

The fauna at Madford Bridge was fully recovered and had a similar composition and diversity to that of the second control site on the Abbey Stream (Site 4).
