FINAL DRAFT REPORT

**RIVER TAMAR EC DANGEROUS
SUBSTANCE DIRECTIVE FAILURE -
1993**

**May 1995
INV/95/005**

*National Rivers Authority
South Western Region*

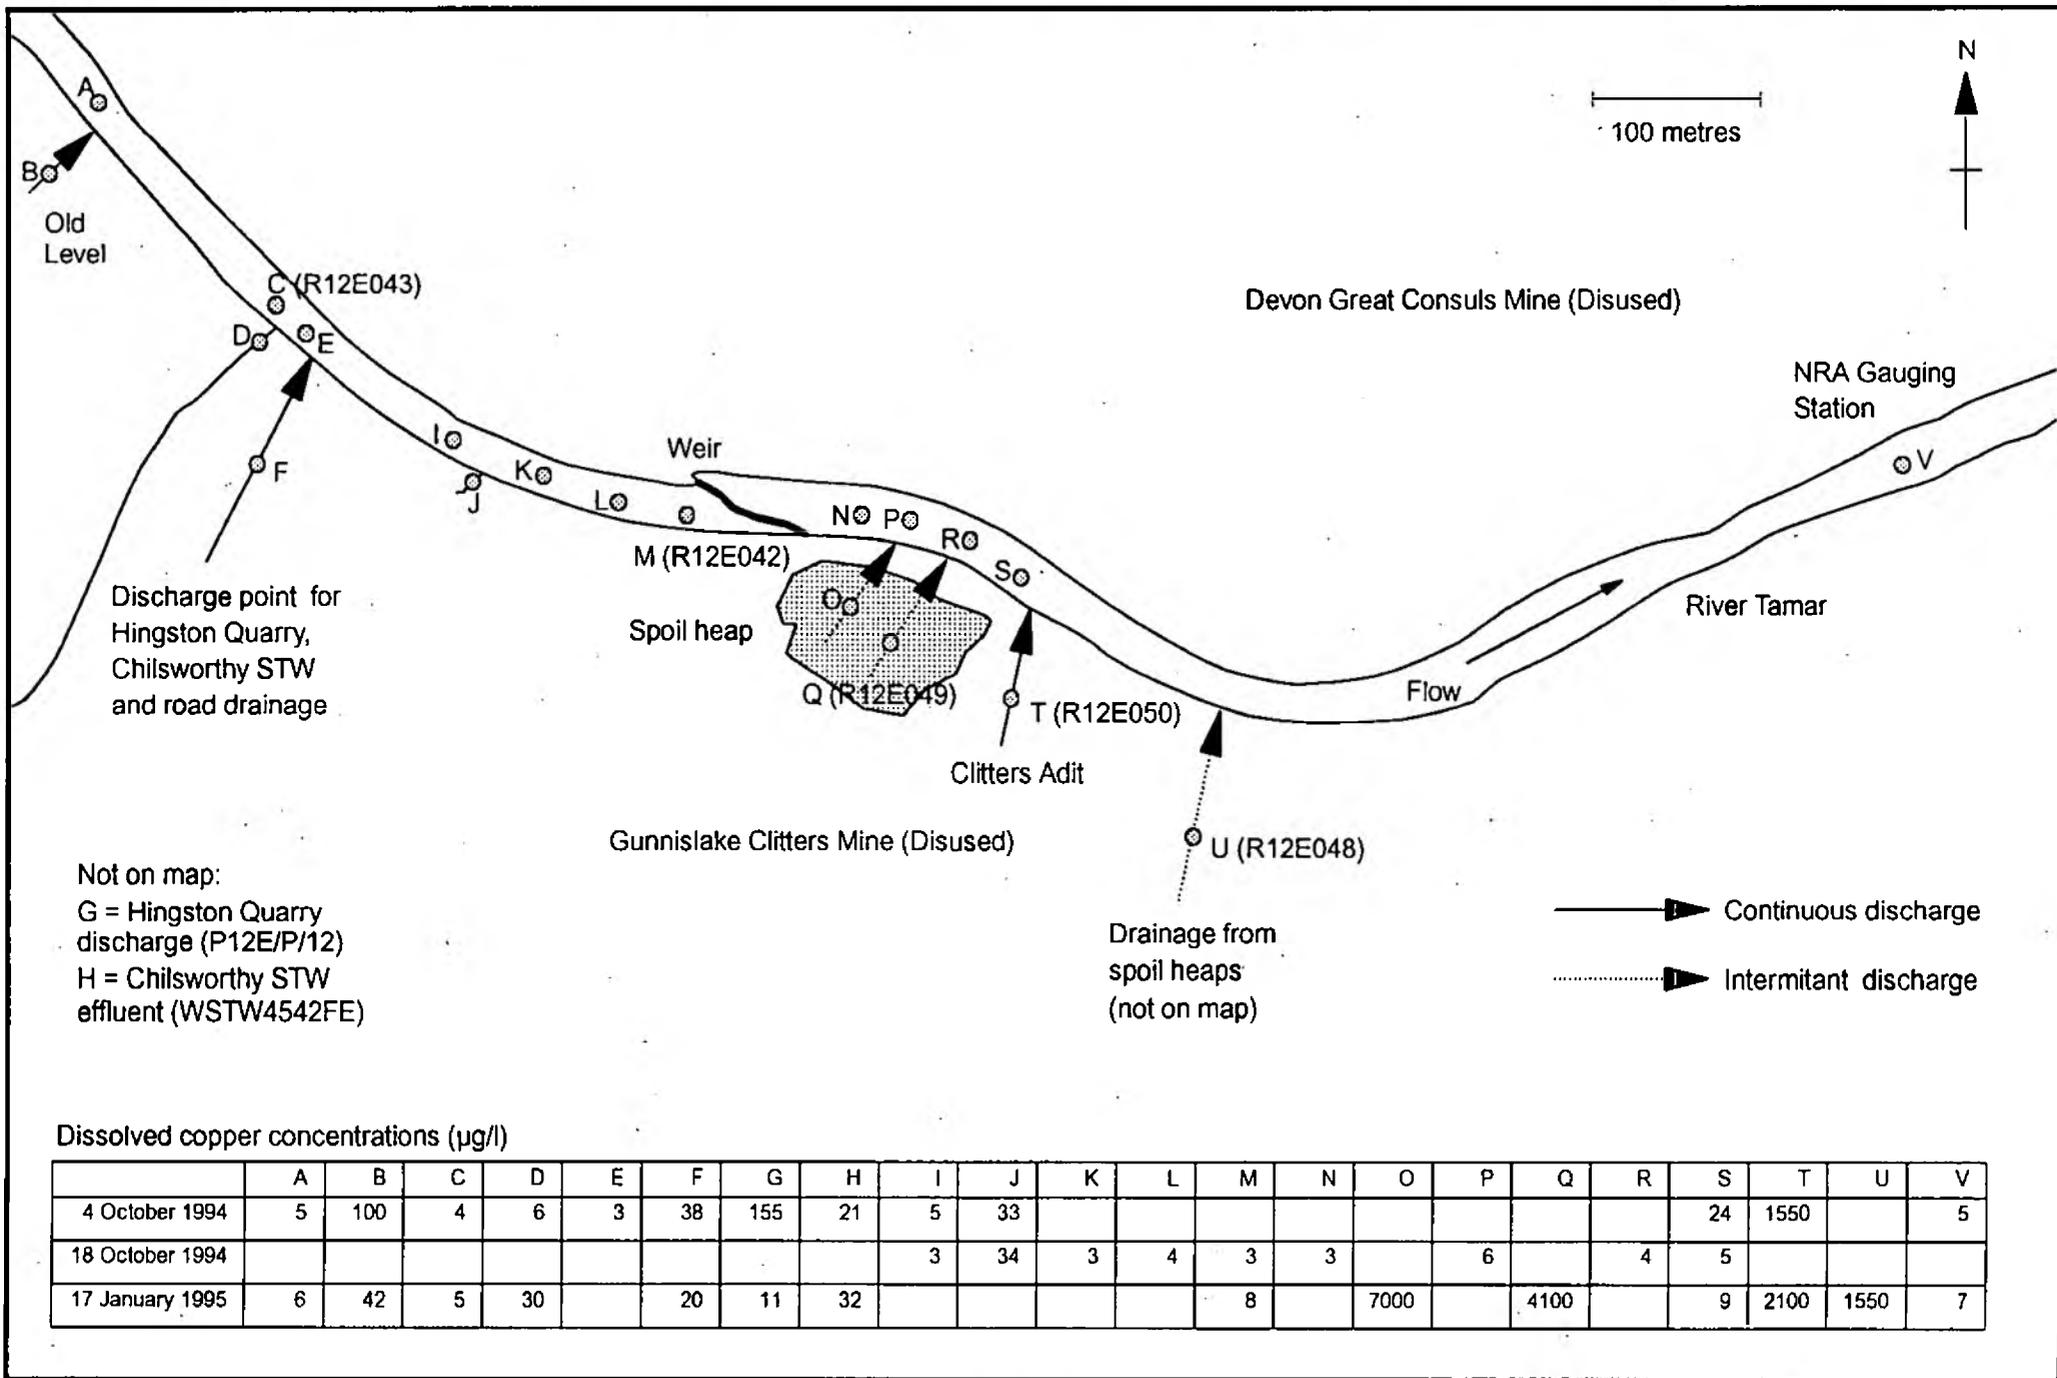
Figure 1. Location of sampling sites and summary of dissolved copper concentrations of spot surveys

The location of R12E042 was considered well within the mixing zone for Hingston Quarry discharge (see figure 1). This would have led to elevated dissolved copper results at R12E042 when Hingston Quarry discharge was operating.

Investigation of the reach from Gunnislake Gauging Station to the old level upstream of Hingston Quarry discharge identified several significant sources of dissolved copper to the River Tamar. In dry weather Clitters Adit was estimated to contribute over 40% of the dissolved copper loading to the River Tamar reach investigated. Hingston Quarry discharge contributed only 2%. Most of the remainder was thought to originate from the mine spoil heaps. Immediately upstream of Clitters Adit elevated dissolved copper was identified on several occasions although no point source was identified. Diffuse inputs from the mine spoil was suspected.

In wet weather additional point sources, via runoff from the mine spoil heaps, were identified. All were high in dissolved copper far exceeding Hingston Quarry discharge. The greater dilution capacity of the River Tamar (see appendix 2) minimised the impact.

1. R12E042 to be relocated to Gunnislake Gauging Station (SX 4265 7250) to ensure full mixing of Hingston Quarry discharge.

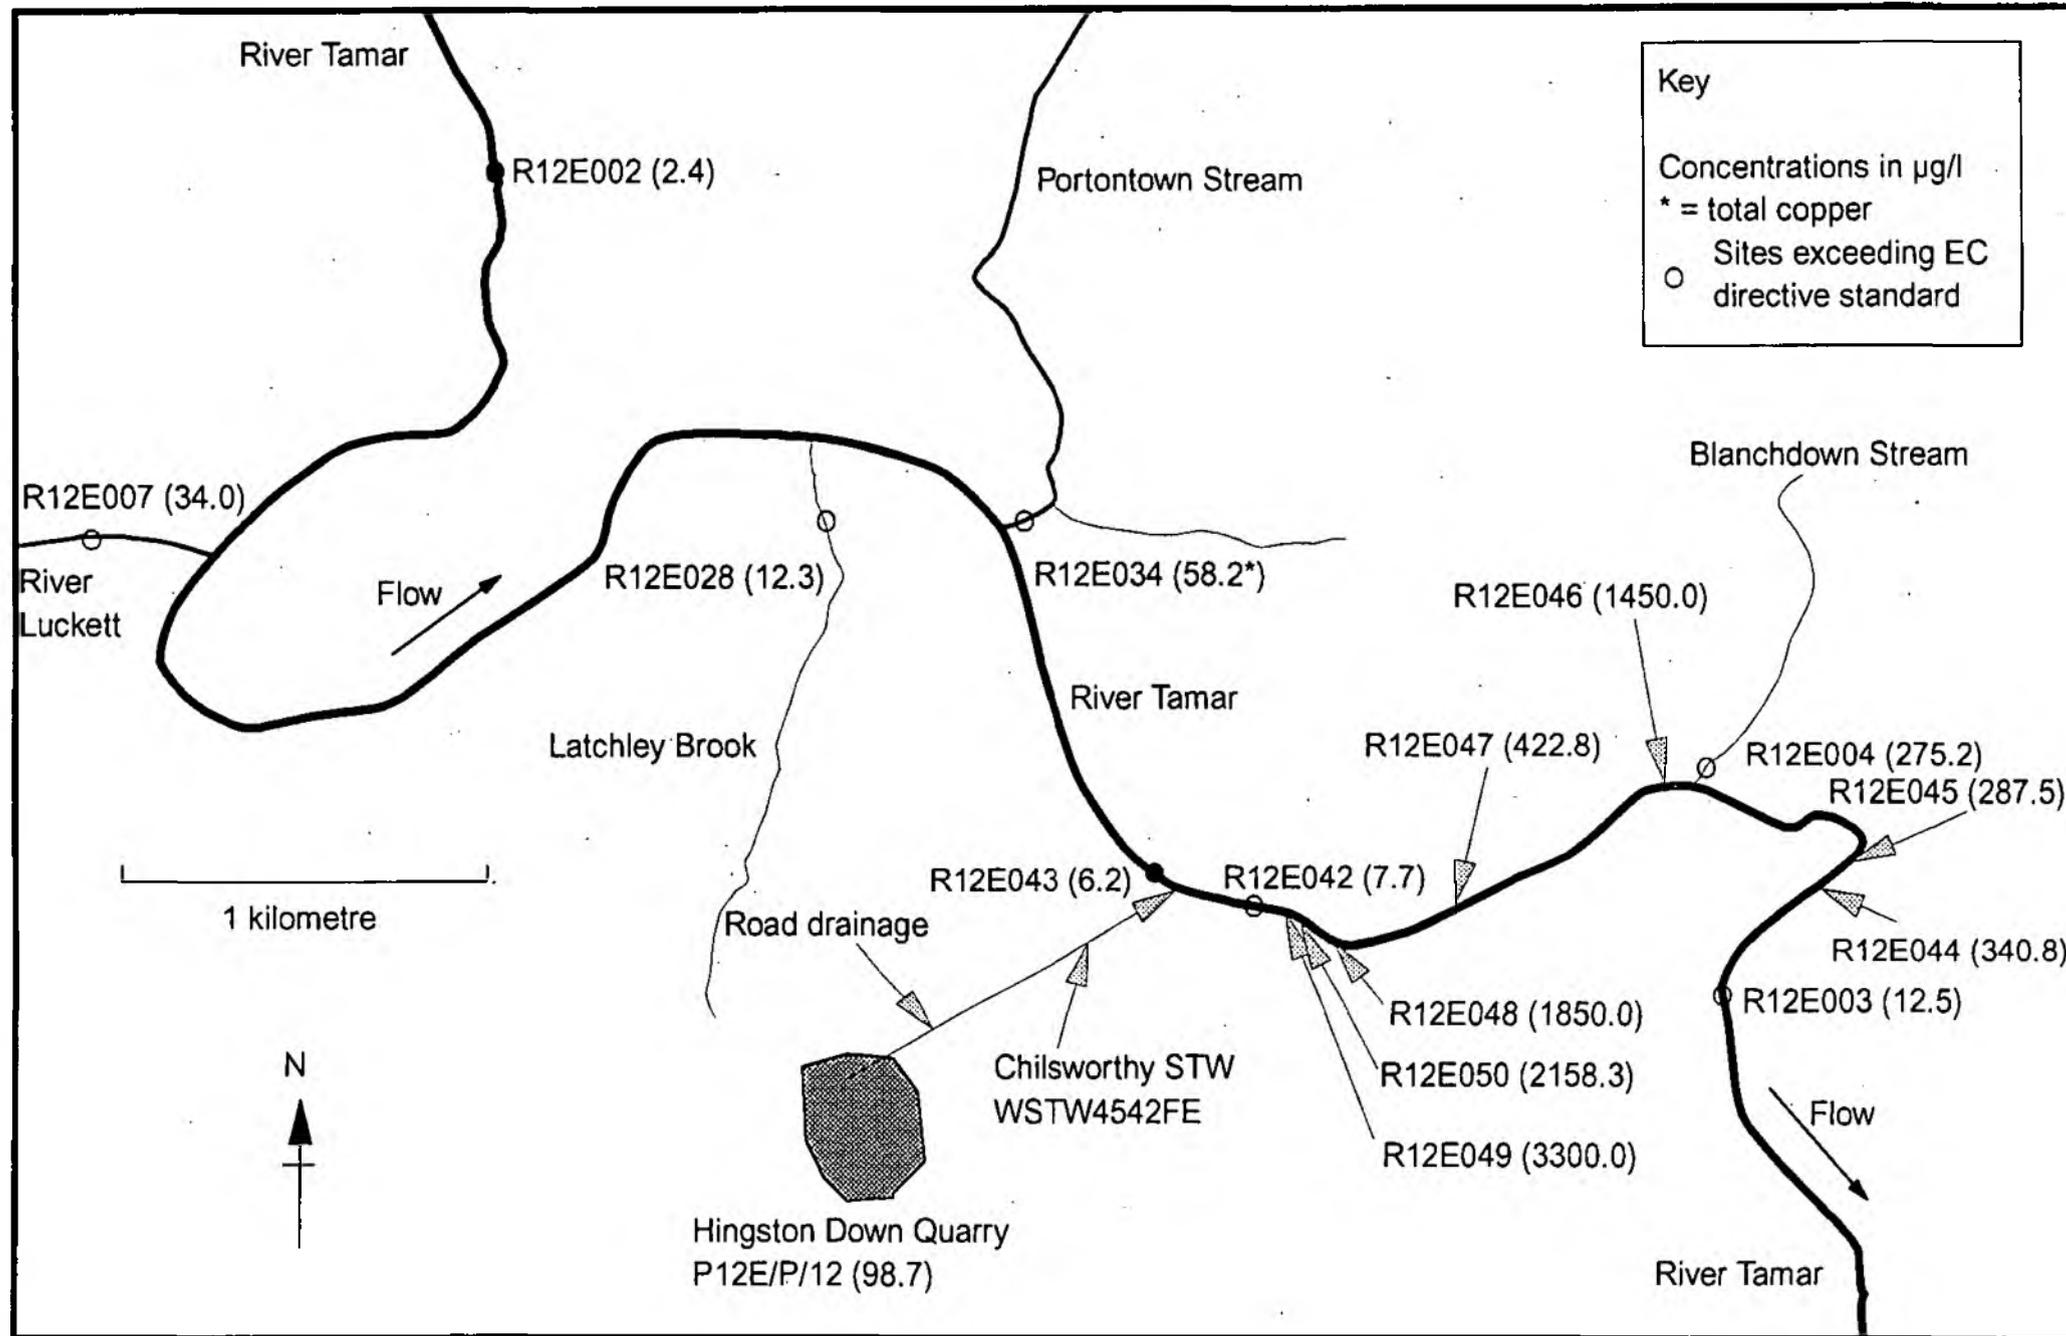
Appendix 1. Lower reach of River Tamar showing monitoring sites and annual average dissolved copper concentrations for 1993

In 1993 dissolved copper concentrations steadily increased from Horsebridge (R12E002) to Gunnislake Bridge (R12E003). The lower reaches of the River Tamar passes through an area of historic mining. Drainage from adits and mine spoil heaps contributes substantially to dissolved copper concentrations in the River Tamar.

The annual average dissolved copper concentration upstream of Hingston Quarry discharge (R12E043) was equal to the EC directive standard for 1993. Downstream of Hingston Quarry discharge (R12E042) seven of the twelve samples exceeded the EC directive standard in 1993. Hingston Quarry discharge was known to have been operating on two occasions, not operating on two occasions and no record was available on the other three occasions.
