Audit of 20 Rehabilitation Projects Environment Agency Thames Region

Janes, M. D. and Holmes, N. T. H.
River Restoration Centre
1998

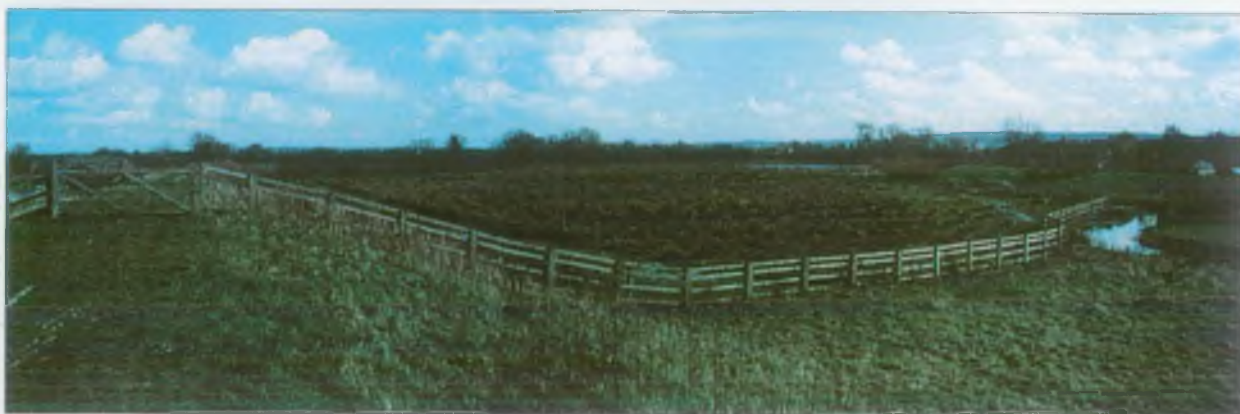
PLATE 10 The area of wet grassland has increased significantly. – March 1998

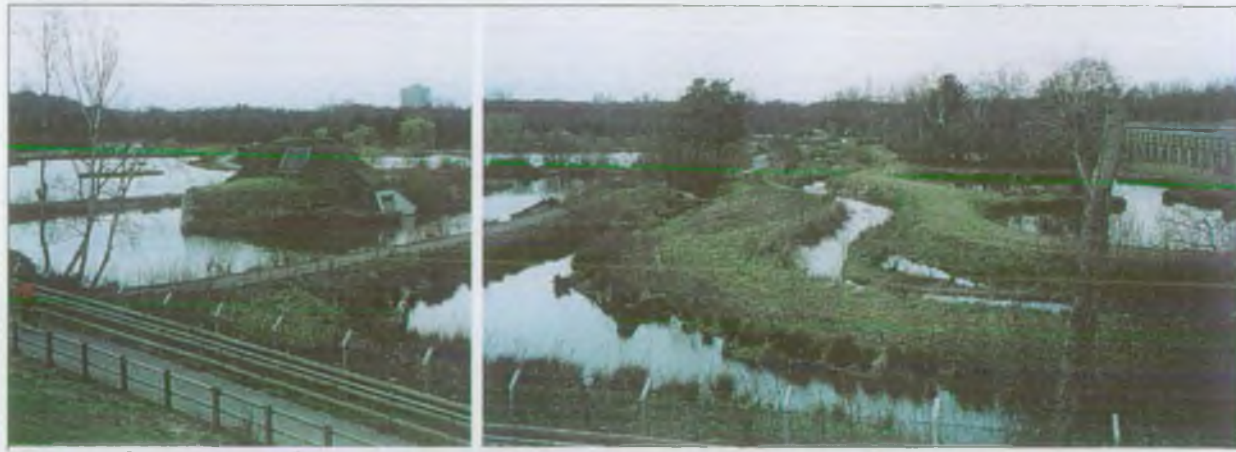
PLATE 5 Central section – Spring Lakes. New sinuous course with low wet berms. Bat cave to the left of picture.
– March 1998

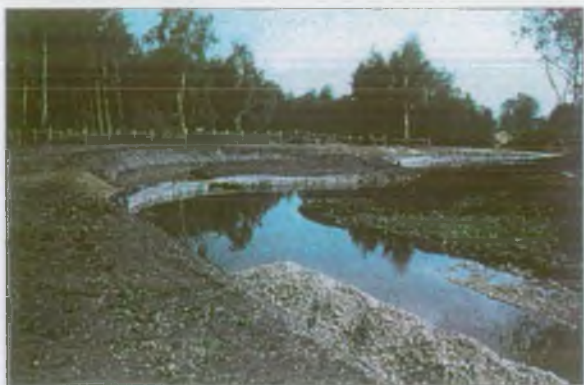
PLATE 8 Central section – Gravel 'riffles' were introduced to create flow and depth diversity to the very low energy reach.

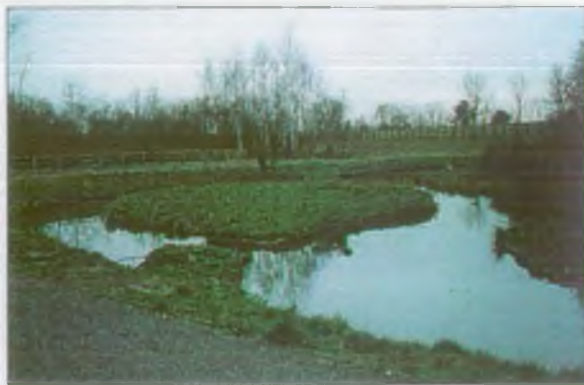
PLATE 9 Central section – Secondary channel/backwater. – March 1998

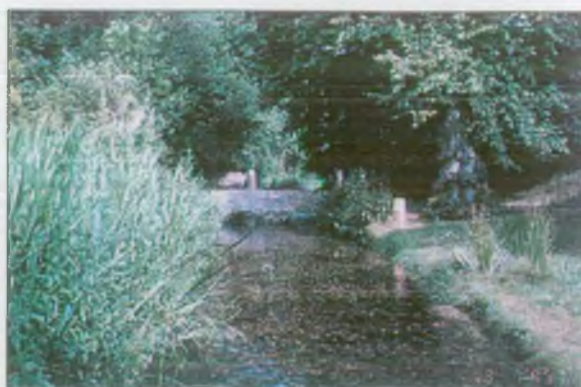
PLATE 2 Looking upstream through the garden. The right bank is free from vegetation, providing the requested open view of the stream.

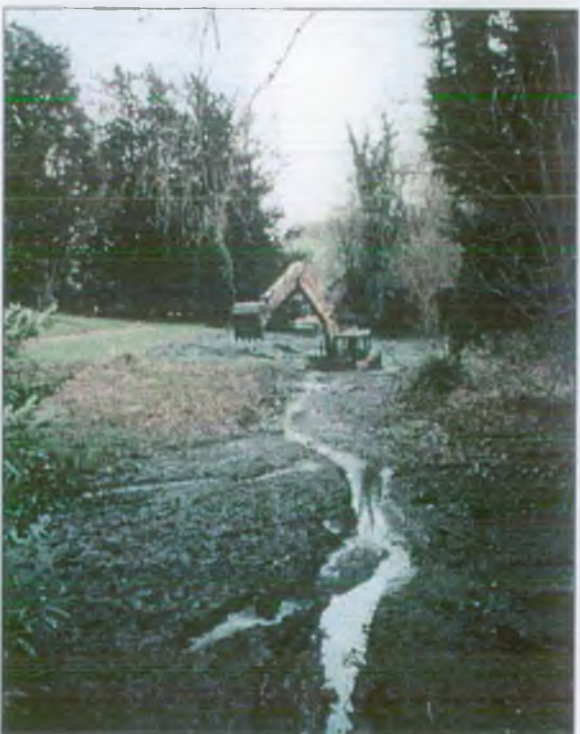
PLATE 5 Before – On removal of the old mill head 1300m³ of material (up to 2m deep) was dredged from the channel.

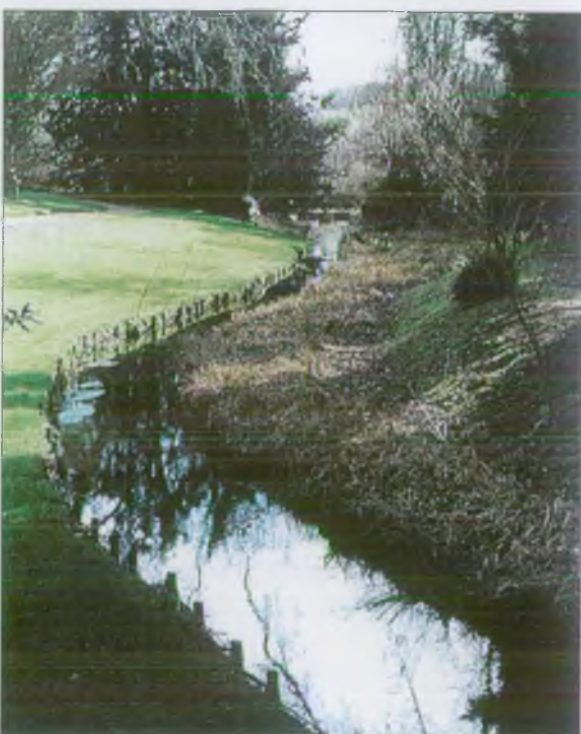
PLATE 6 After – faggoting was used to form the new narrow sinuous channel. – February 1998

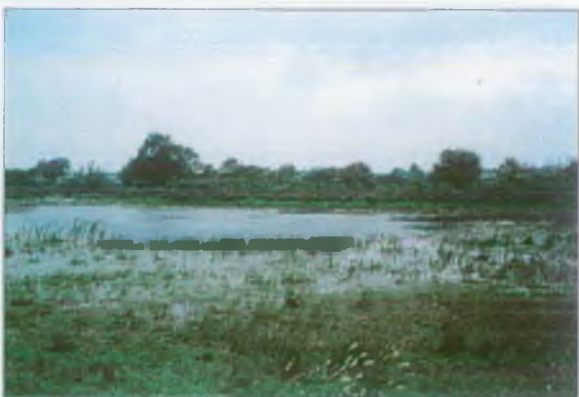
PLATE 4 Wetland scrape. Good diversity of self seeded plants supporting waders and wildfowl. – May 1998

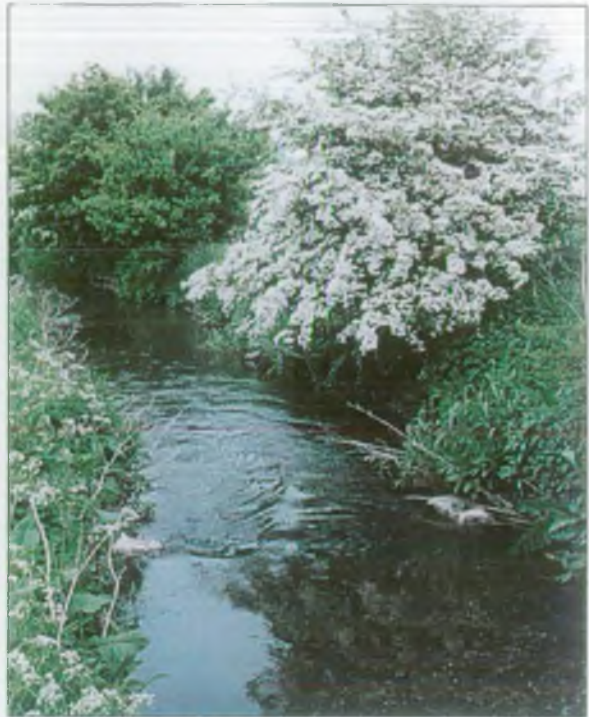
PLATE 2 Constructed 'riffle'. – May 1998

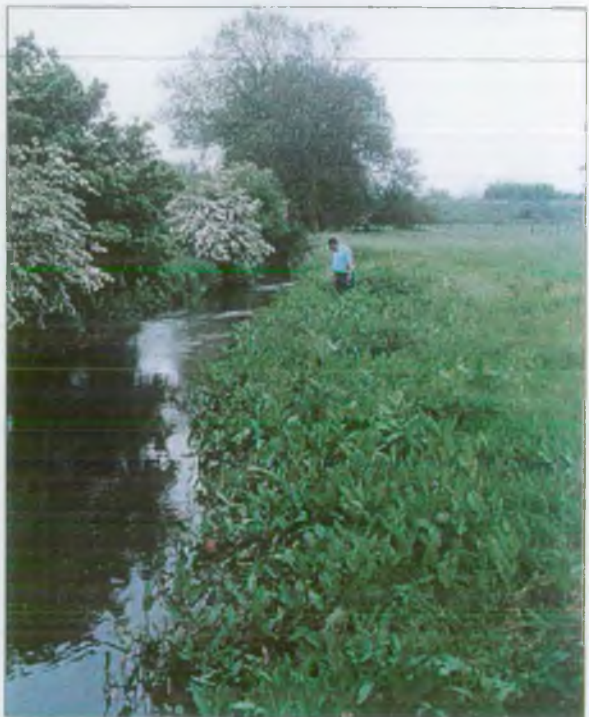
PLATE 5 No. 3 – Doc and nettle have colonised the re-profiled bank. – May 1998

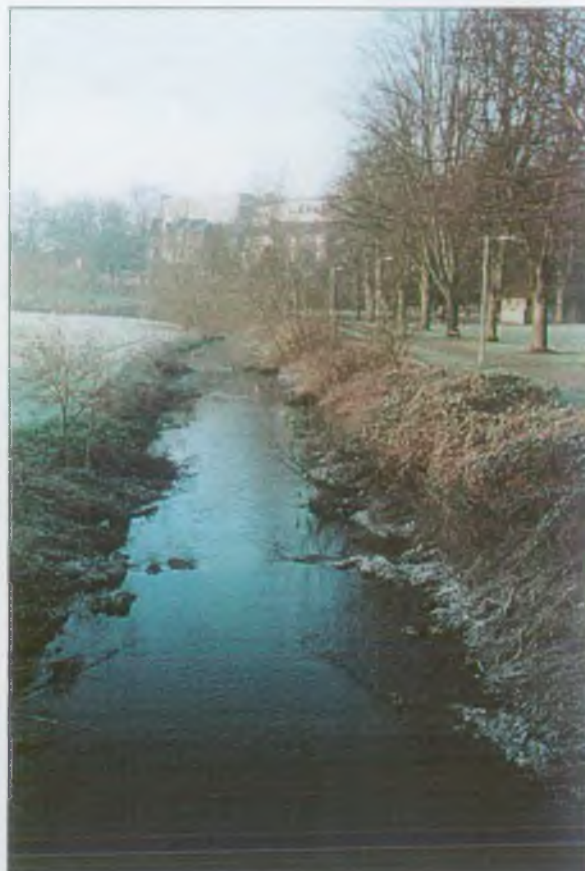
PLATE 4 Groynes introducing flow diversity (downstream of the railway bridge). – February 1998

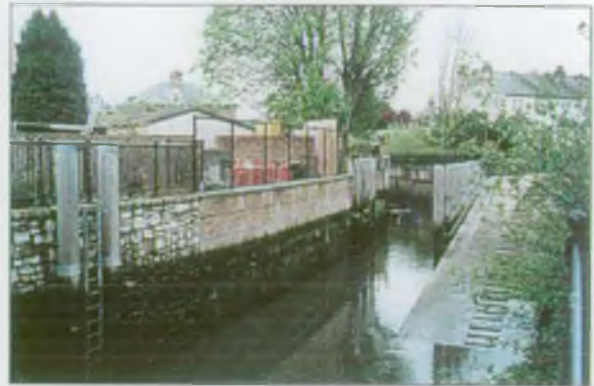
PLATE 2 A variety of finishes to break up the vertical bank. Mooring posts portray the theme of 'navigation'. – April 1998

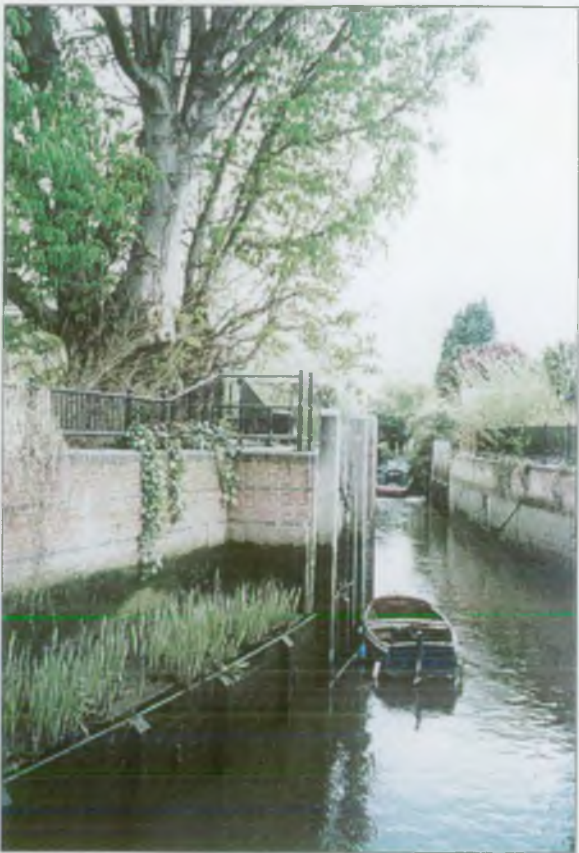
PLATE 3 Hardy marginal plants were planted in the tidal ledges. – April 1998

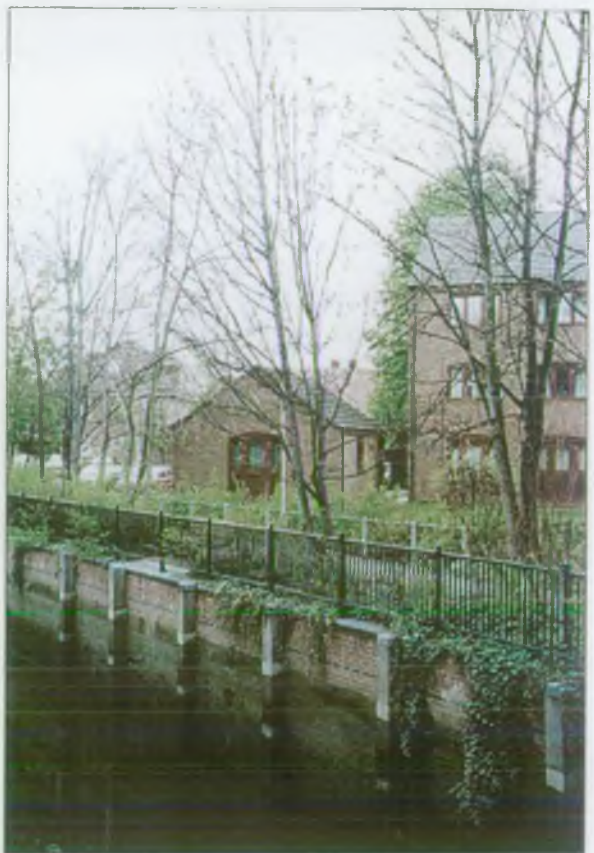
PLATE 4 Existing trees were retained unharmed and trailing plants used to soften the brickwork face. – April 1998

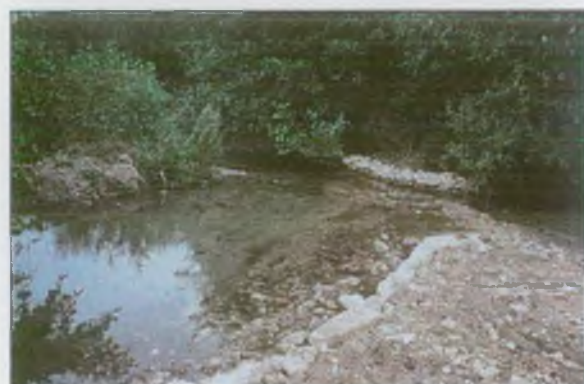
PLATE 7 Weirs removed and levels lowered. A low stone drop weir is the replacement.

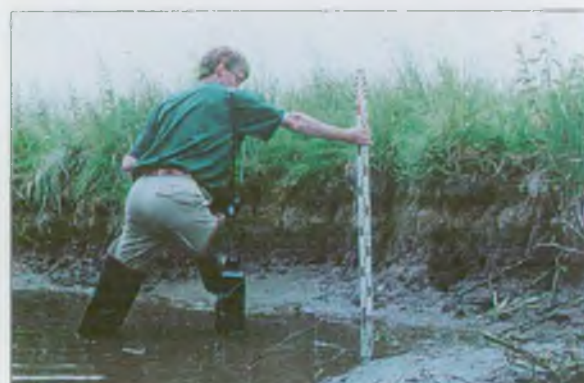
PLATE 8 Levels lowered considerably after the silt was washed away; more than originally expected.

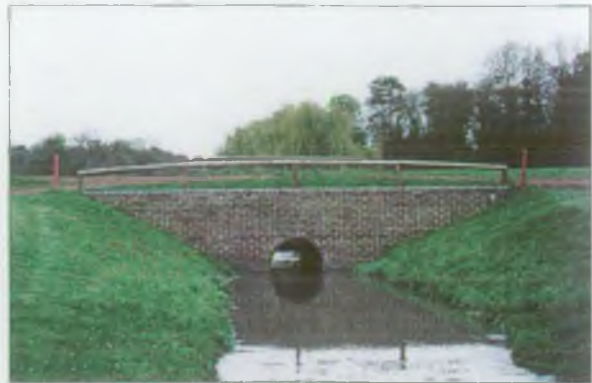
PLATE 2 The channel design was engineering driven.
– April 1998

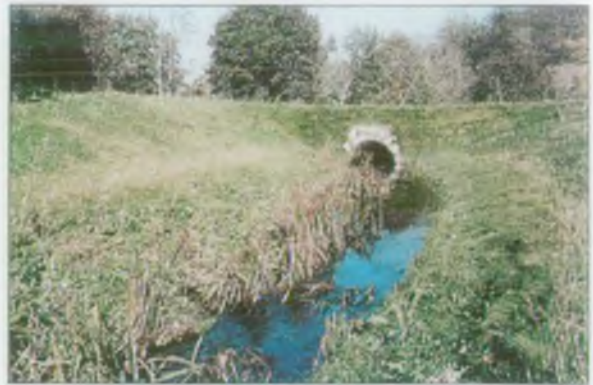
PLATE 2 Access culvert with blockstone facade. – March 1998

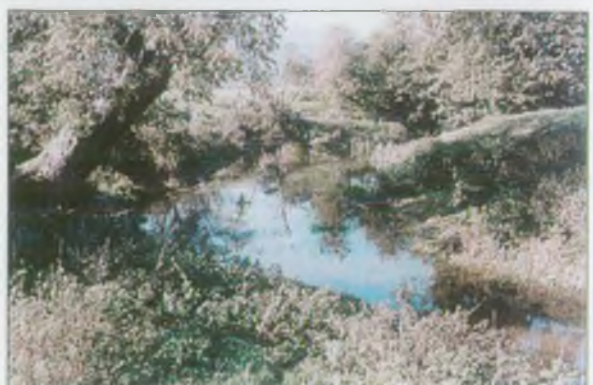
PLATE 4 Wide, slow, shaded backwater. – March 1998

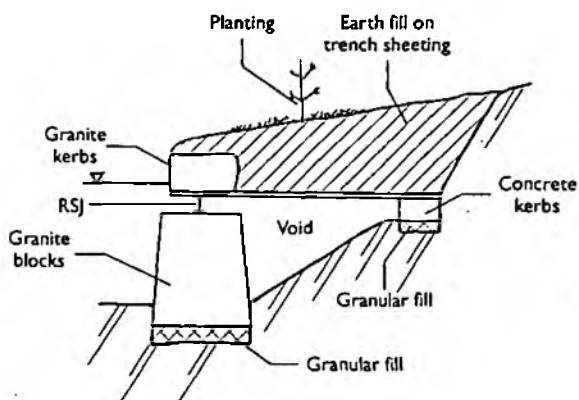
The fish shelters have remained free from sediment accretion, and have not been damaged. At the interface between shelter and original toe board there are signs of erosion and collapse of the old bank which may impact on the shelters. Due to the difficulties involved in surveying their use no data exists to show fishery benefits.

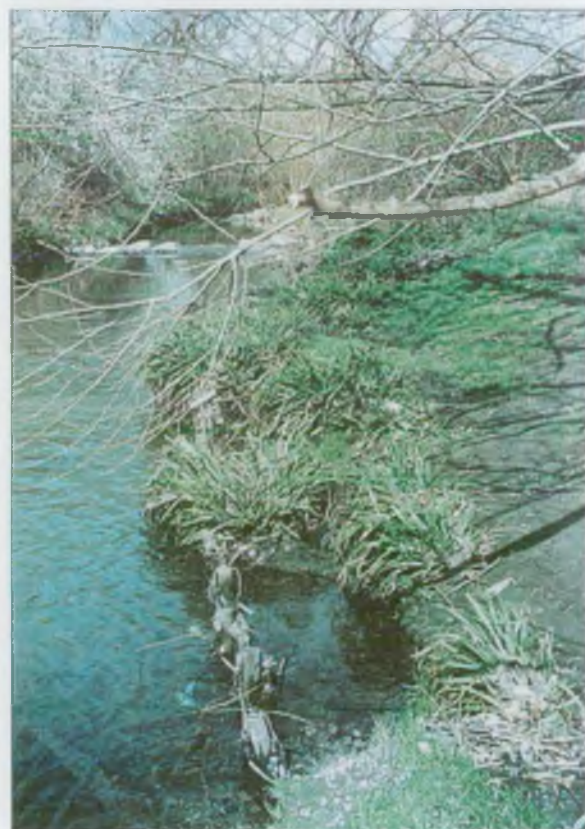
PLATE 5 Though some fines were washed out marginal vegetation is developing. – March 1998

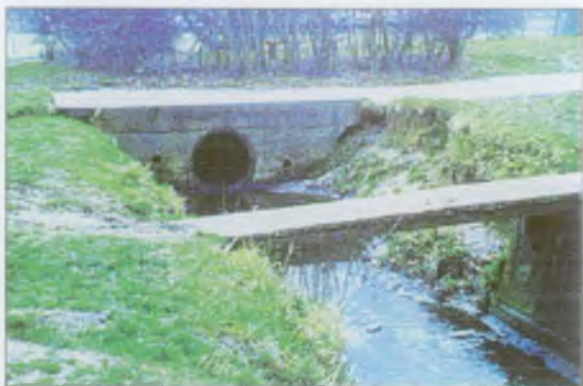
PLATE 1 The stream entering the golf course via a concrete culvert.

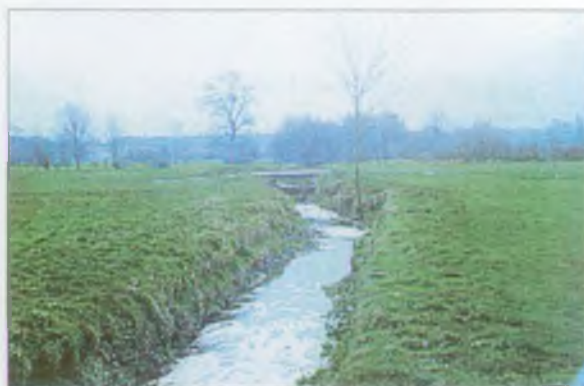
PLATE 2 Before, steep banks, little habitat.

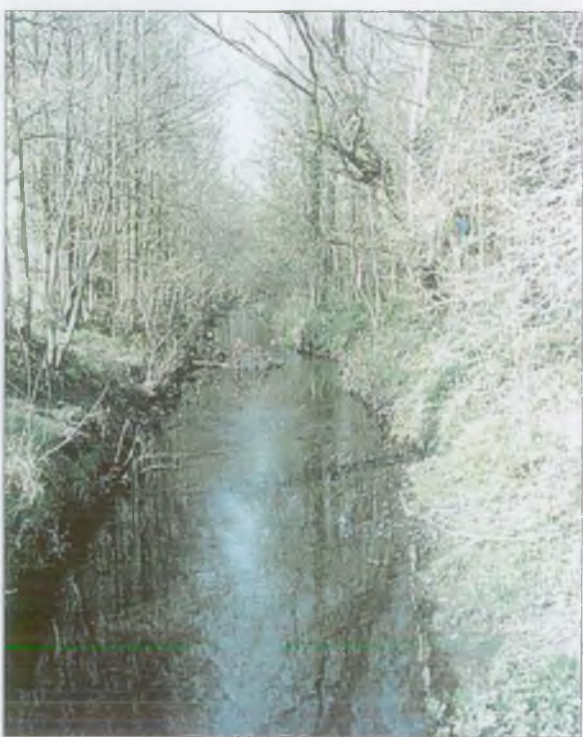
PLATE 4 Re-profiled edges and blockstone facing.
– March 1998

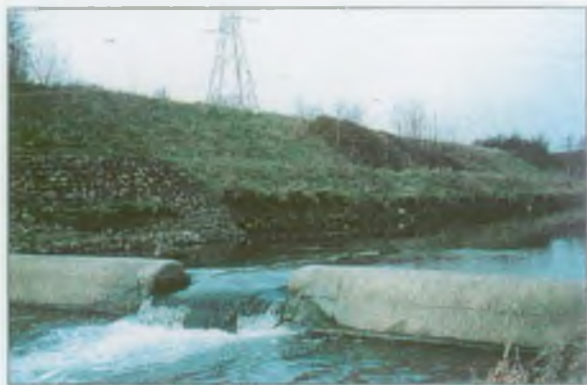
PLATE 1 Notch cut in weir. – February 1998

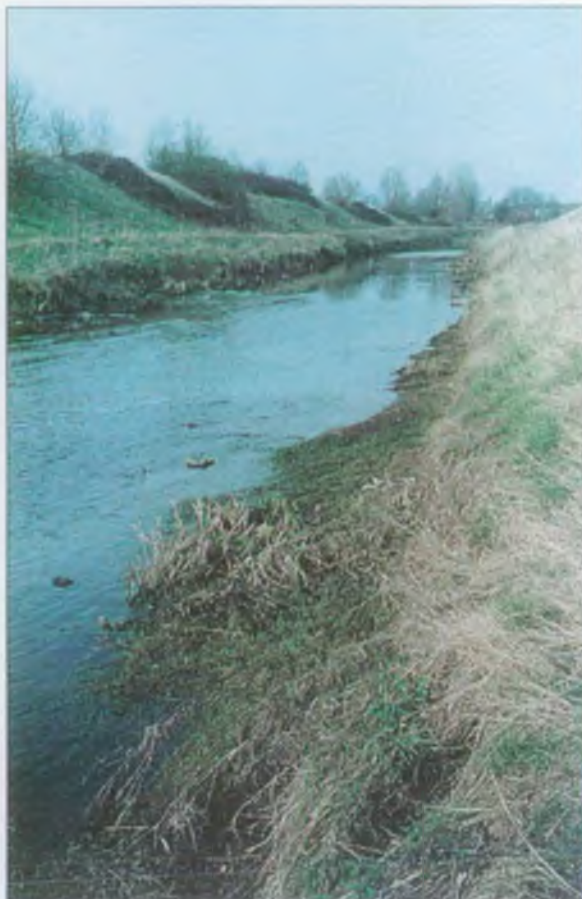
PLATE 2 Levels lowered and marginals establishing.
– February 1998

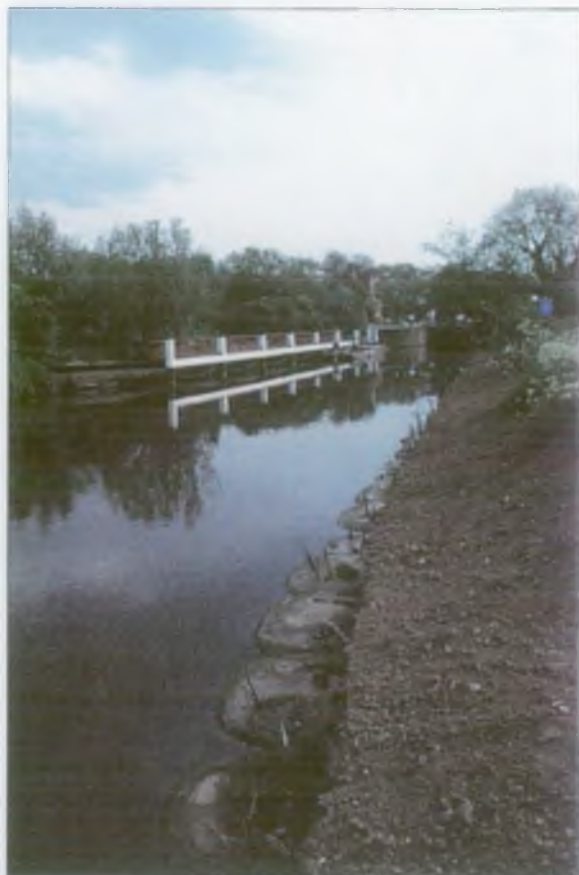
PLATE 1 New bankline backfilled behind Nicospan. Nicobags planted with rhizomes.

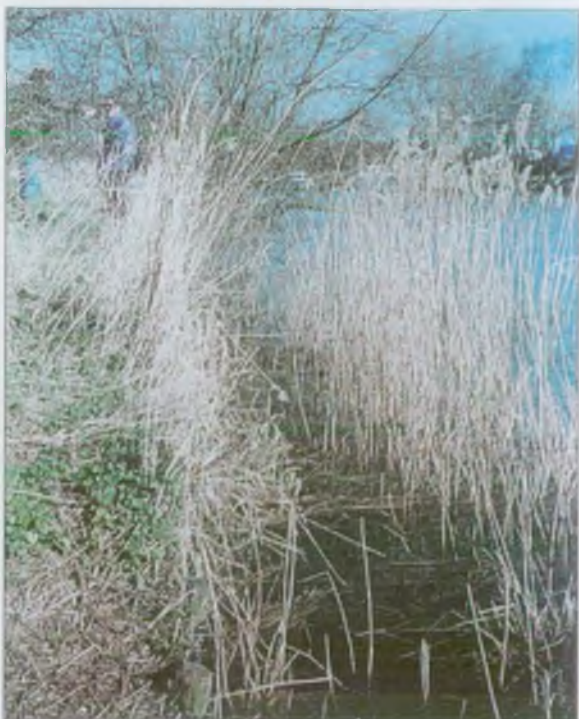
PLATE 4 *Phragmites* dominates the ledge, spreading out into the channel. Posts are visible where fishermen gain access to the bank. – March 1998

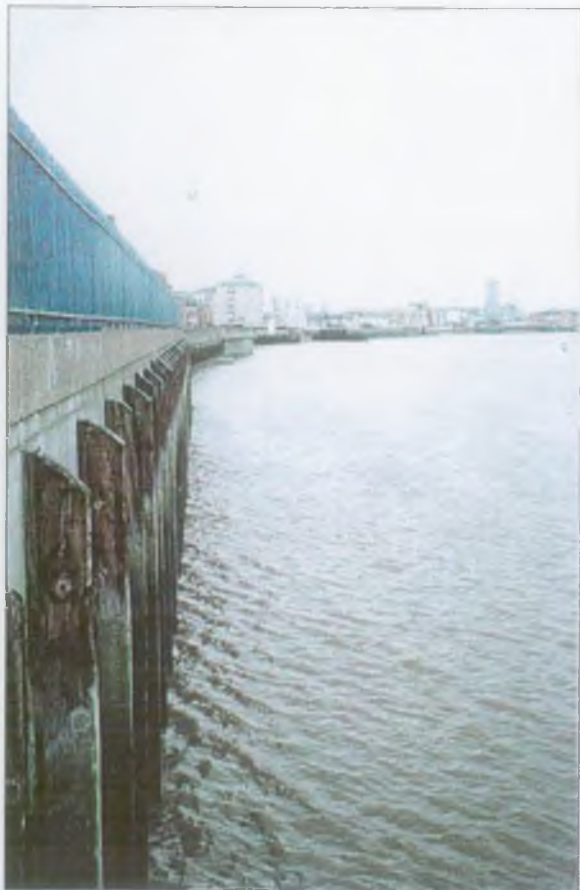
PLATE 1 Concrete banks for flood defence allow development right up to the water's edge.— April 1998

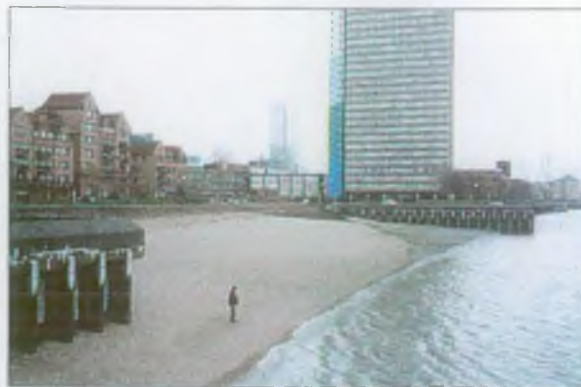
PLATE 2 The defenses are set back from the adjacent bank lines.— April 1998

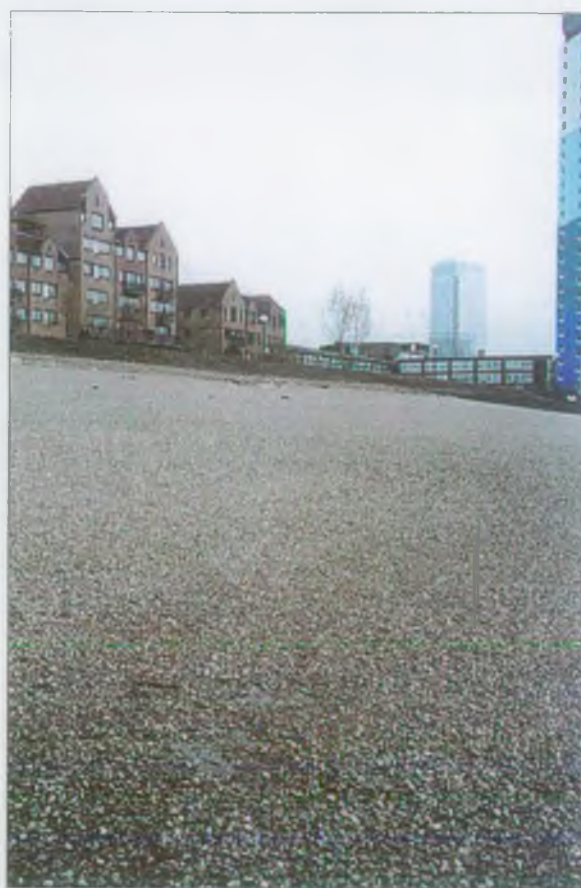
PLATE 3 A shingle beach provides access to the riverside.— April 1998

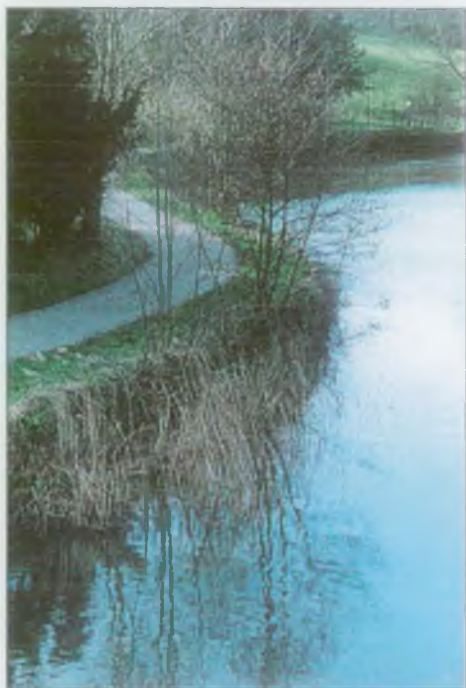
PLATE 1 Section A. *Phragmites* growing on the ledge. - March 1998

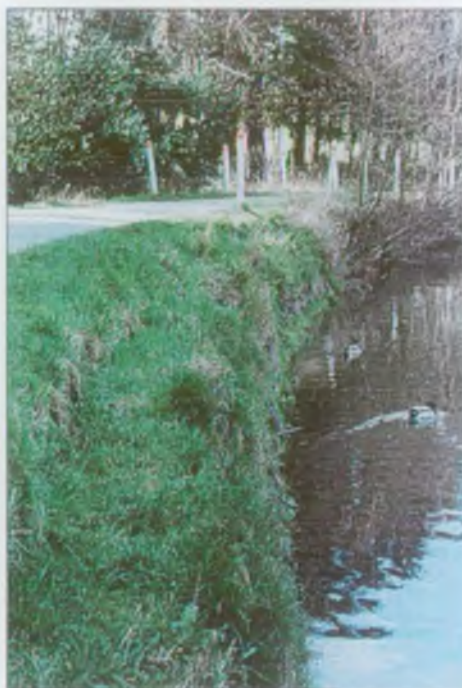
PLATE 2 Section B. Grass cover, but the soil filled bags are starting to slump. - March 1998

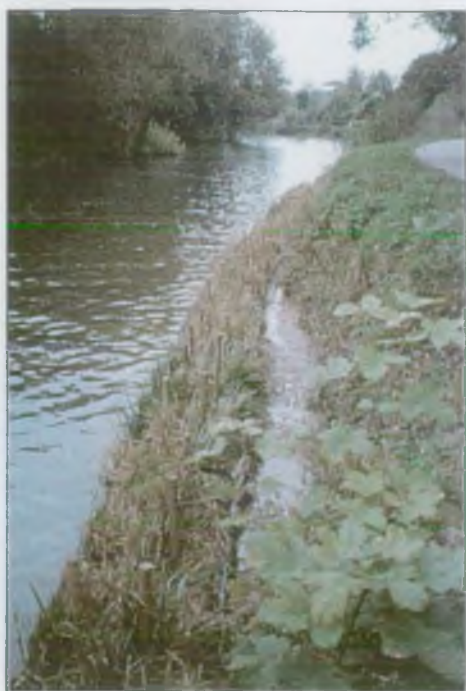
PLATE 3 Section C. Planted coir rolls being installed, looking downstream.

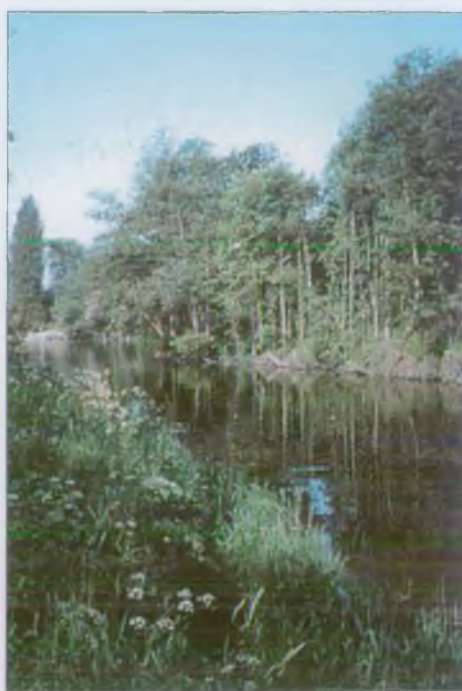
PLATE 4 Section C. Planted coir rolls well established, looking upstream.

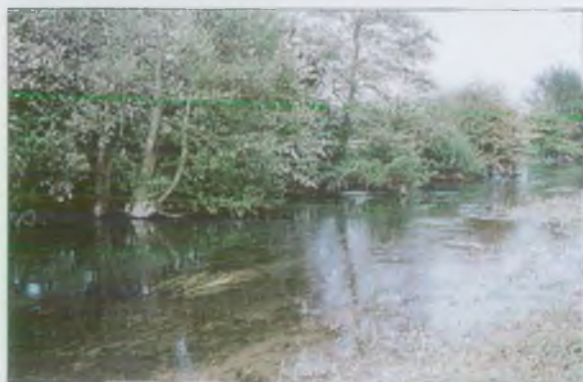
PLATE 5 The replacement blockstone has prevented the same thing occurring again. – May 1998

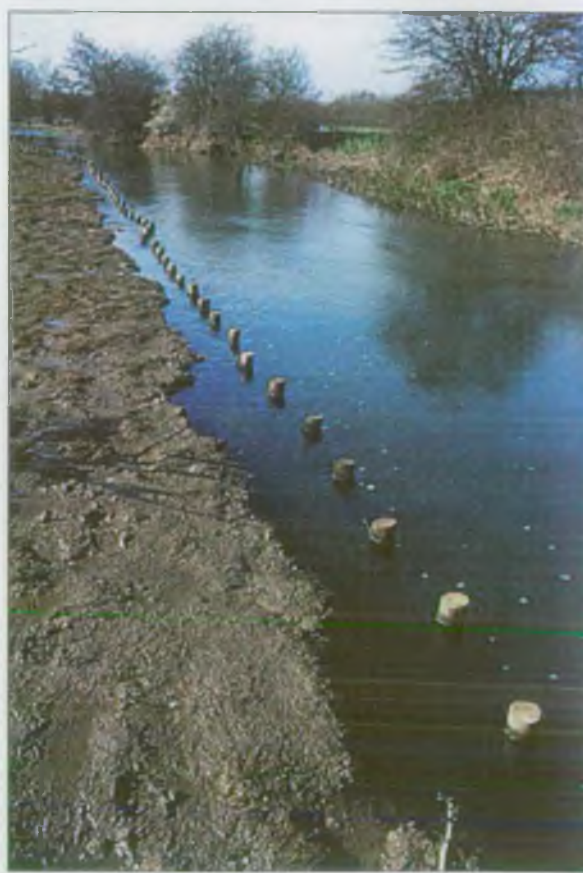
PLATE 4 Coir fibre stapled to posts and backfilled. Washout was almost immediate as the coir degraded within a few months.

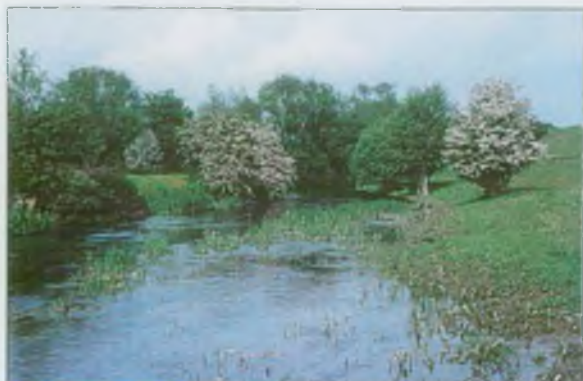
PLATE 6 Water levels are variable between years so the ledge is both wet and dry. – May 1998
