Environmental Management Audit THAMES BARRIER and associated on-site activities.

January 1996

AUDITEE Thames Barrier Operational Site,
Charlton, London,
and associated on-site activities.

DATE OF AUDIT 22/23 November 1995.

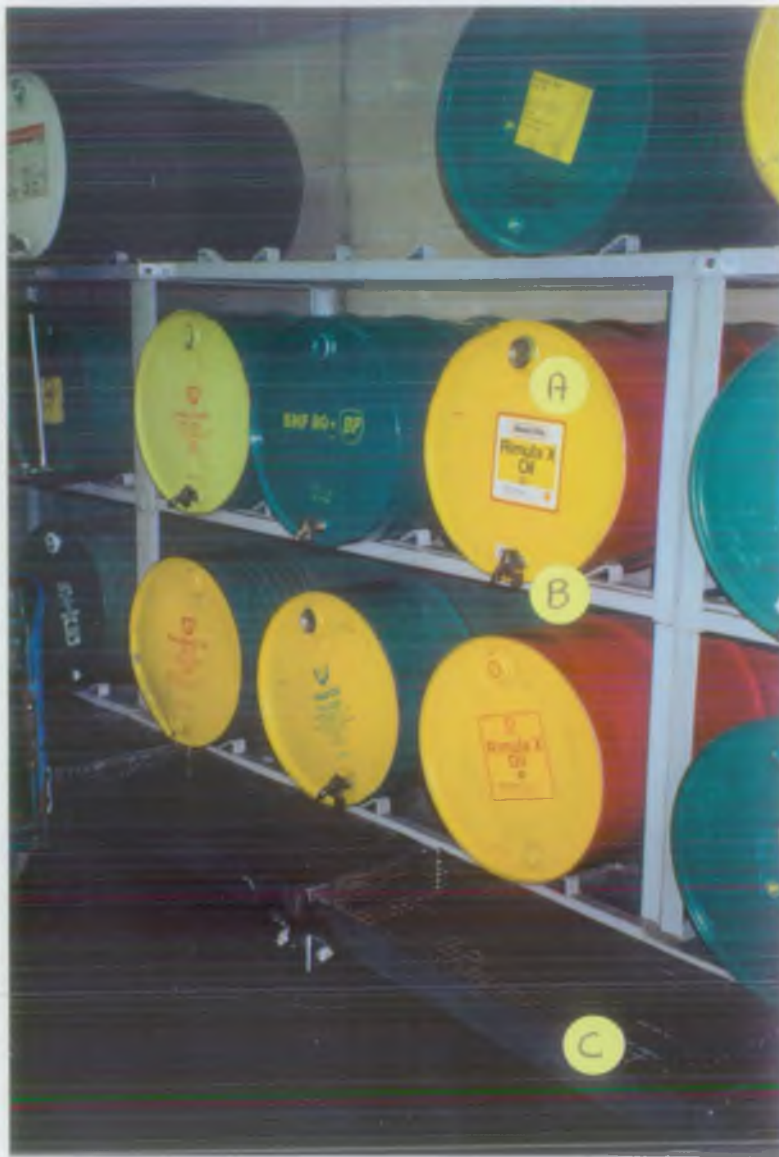
Photographs 6 & 7 Drums in the Flammables store; showing labels (A), locked outlets (B), and drip trays (C). Excess drums are kept in an overflow storage container (D), incorporating drip tray (E).

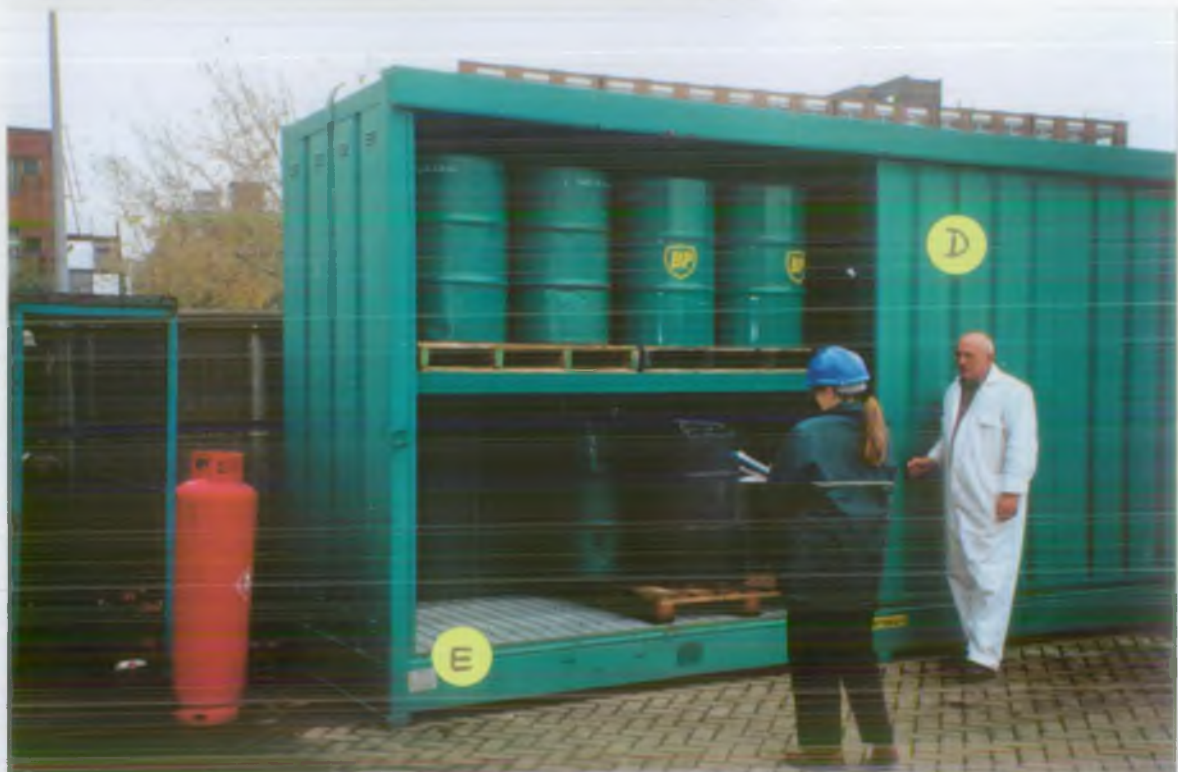
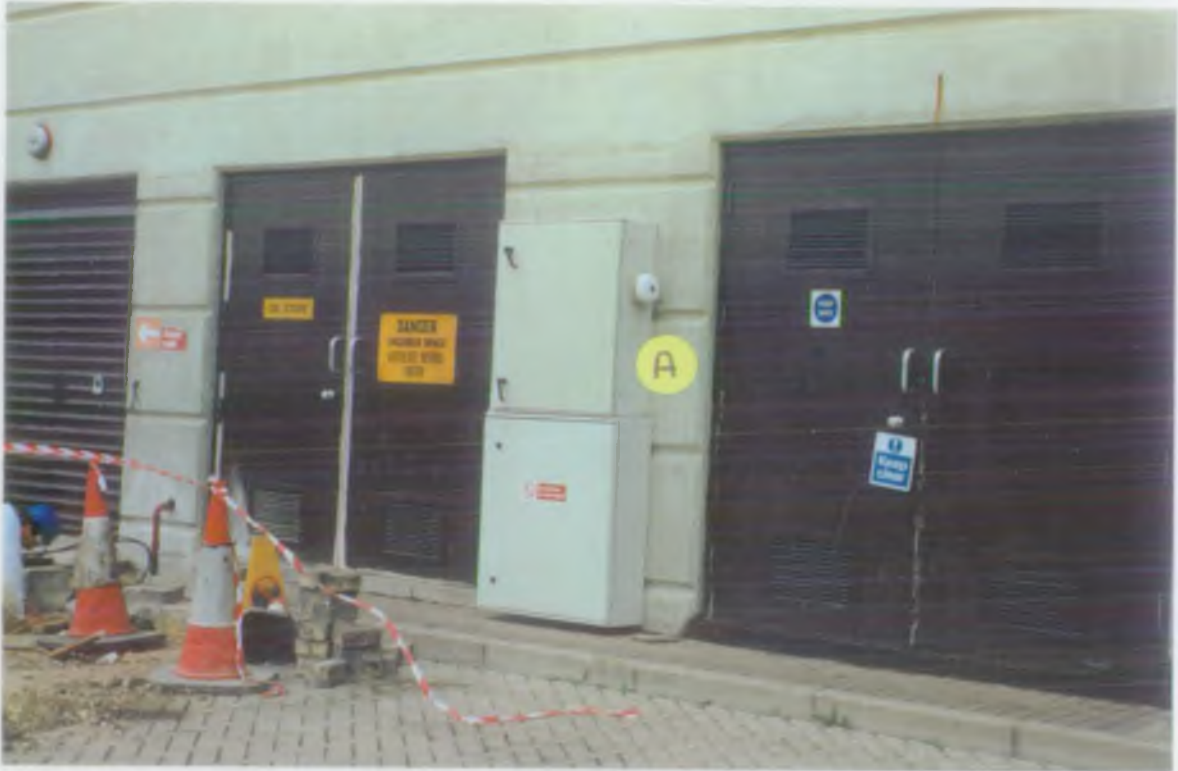
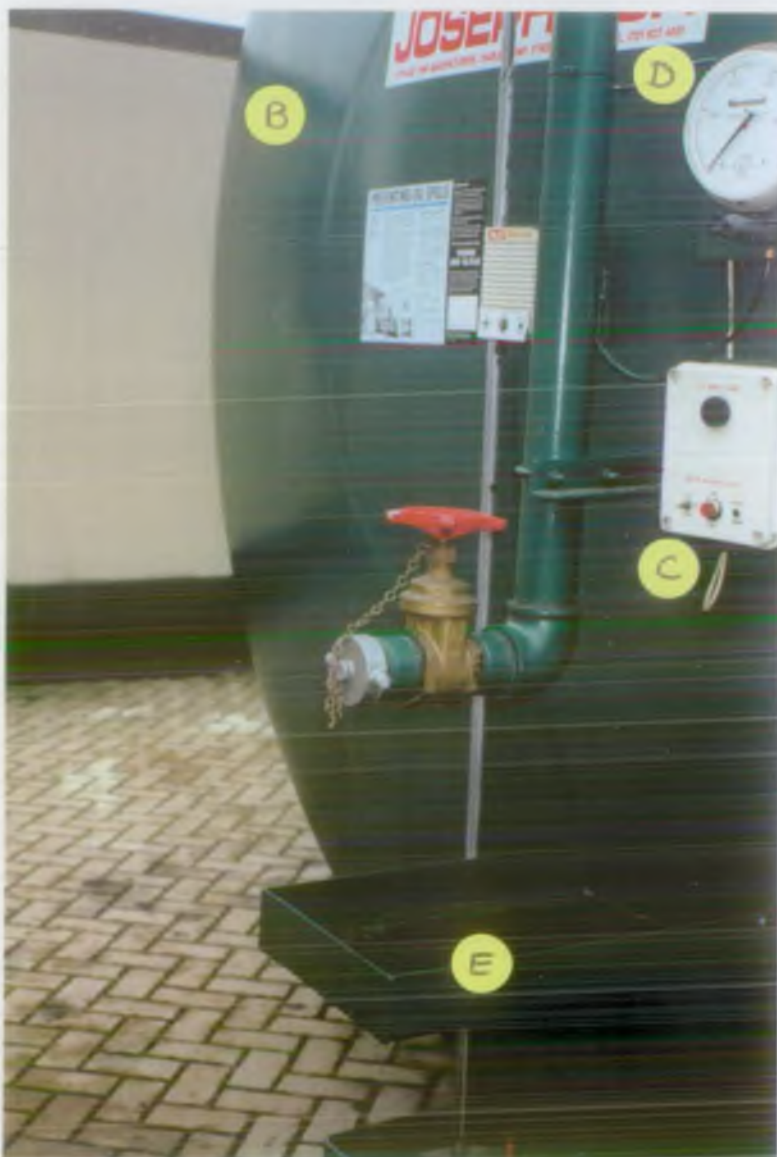
- **Bulk Oil Tanks** The two bulk diesel oil storage tanks serving the site are located in the workshop building adjacent to the flammable store. The tank provides a refuelling facility for plant and fuel for the generators (a back-up power supply to close the Barrier, in case the power supplies from North and south banks fail). The tanks have a combined capacity of 24,000 litres, but are kept partially empty to evacuate diesel supplies from the daily service tanks in case of fire. The tanks appear to be surrounded by an adequately sized concrete built bund compound. The tank store door bears an NRA oil store sticker. The delivery point is located in a locked cabinet on the exterior wall adjacent to the tanks. It is not within a bunded area. (Photograph 8) Oil absorbents are always available on site and the Storeman is aware of the spill procedure.

A third bulk diesel tank is being installed in the compound, opposite the internal bulk tanks. This will have a 40,000 litre capacity and be directly connected to the existing two tanks. The site staff inform us that the tank has an integral bund and believe that an additional bund is not required. We did not inspect the design of the tank to determine the adequacy of the containment, in particular for the filling arrangements and level gauges. Protection from damage caused by vehicles will be required and the fill point will need adequate containment. Staff seem to be aware of the requirements of PPG2. The new tank is fitted with a sight gauge and prevent oil spills sticker. The drip tray may need extending slightly (Photograph 9).

Photographs 8 & 9 Bulk oil storage is at present inside the building with unbunded, locked fill point (A). In future an exterior oil tank will be used (B). The new tank is labelled, with overfill alarm (C), level guage (D). The drip tray may need extending to fully collect drips (E).

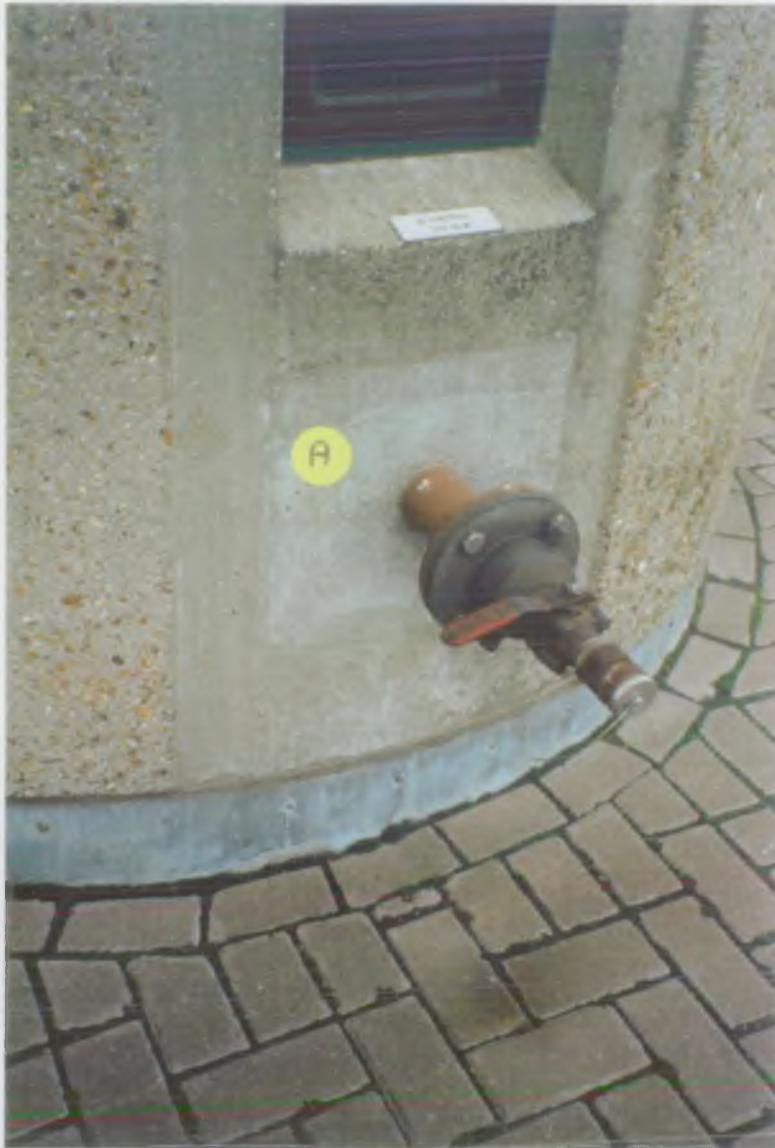
- **Barrier Hydraulic and Generator Systems** The hydraulic rams that close the Barrier operate in a closed system containing approx. 150,000 litres of hydraulic mineral oil. An estimated 2-3,000 litres pa are lost due to leaks and filter changes. We were unable to fully clarify the refilling procedures. Fill points are located on the North and south banks which, we understand, feed bulk tanks on the abutments. These bulk fill points should be fitted with sumps and surrounded by a lockable kiosk. (Photograph 10) The bulk tanks on each of the major piers (piers 4 to 8 inclusive) are filled from 205 litre drums carried out to the piers on a boat and lifted by crane onto the pier. The oil is transferred by barrel pump. Small patches of leaked hydraulic oil are evident on many of the piers. These appear to come from both the header tanks above each power pack (3 packs per pier) and from the hydraulic rams themselves. Absorbents are at hand in yellow Hazchem buckets but they do not appear to be used for minor spills. Biodegradable alternatives to mineral oil are being investigated. The generators each have lube oil filling lines and waste oil tanks inside the generator houses. Each waste oil tank showed evidence of recent minor leaks (Photograph 11).

Photographs 10 & 11 Filling point for south abutment bulk hydraulic oil tank (A). It is unbunded in an exposed location. Waste oil tank (B) for one of the generators showing leakage of oil to the floor and thence to the drain (C).

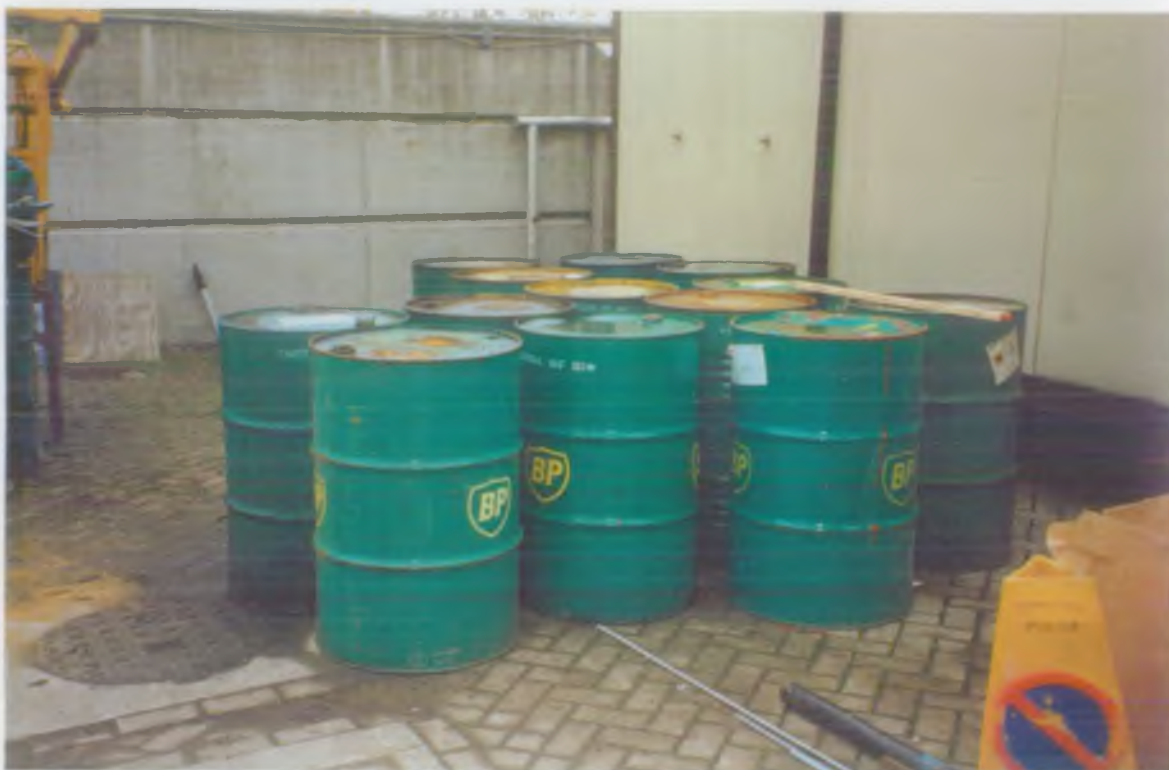
Photograph 12 Drums of waste oils, etc, stored in the open in the compound. They are unbunded on block paving. The drums are labelled.

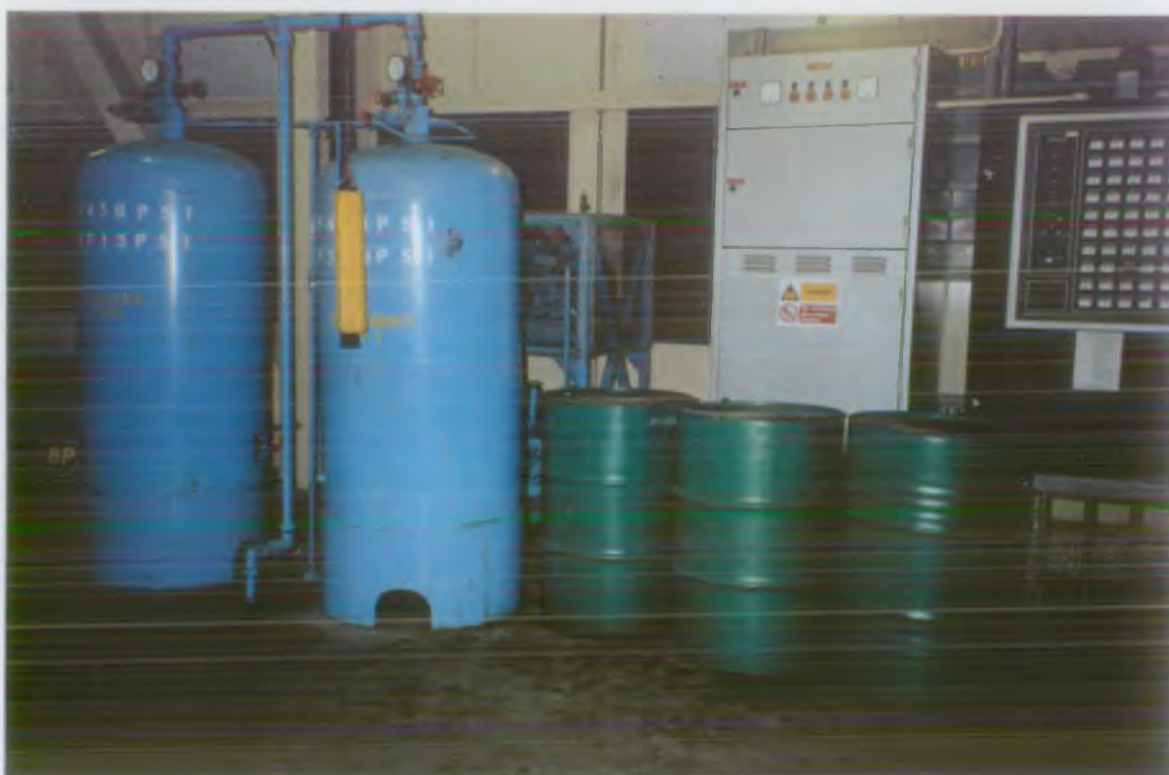
Photograph 13 Drums of oil stored in the north generator house. Any spill would escape into the compound and then either to surface drain or through the paving to ground.
