DEVON AREA  
INTERNAL REPORT

ENVIRONMENT  
AGENCY

**INVESTIGATION INTO  
THE CAUSE OF HIGH  
PHENOLS IN BUDLEIGH  
BROOK**

**FEBRUARY 1998  
DEV/EP/04/98  
(CATCHMENT 04A)**

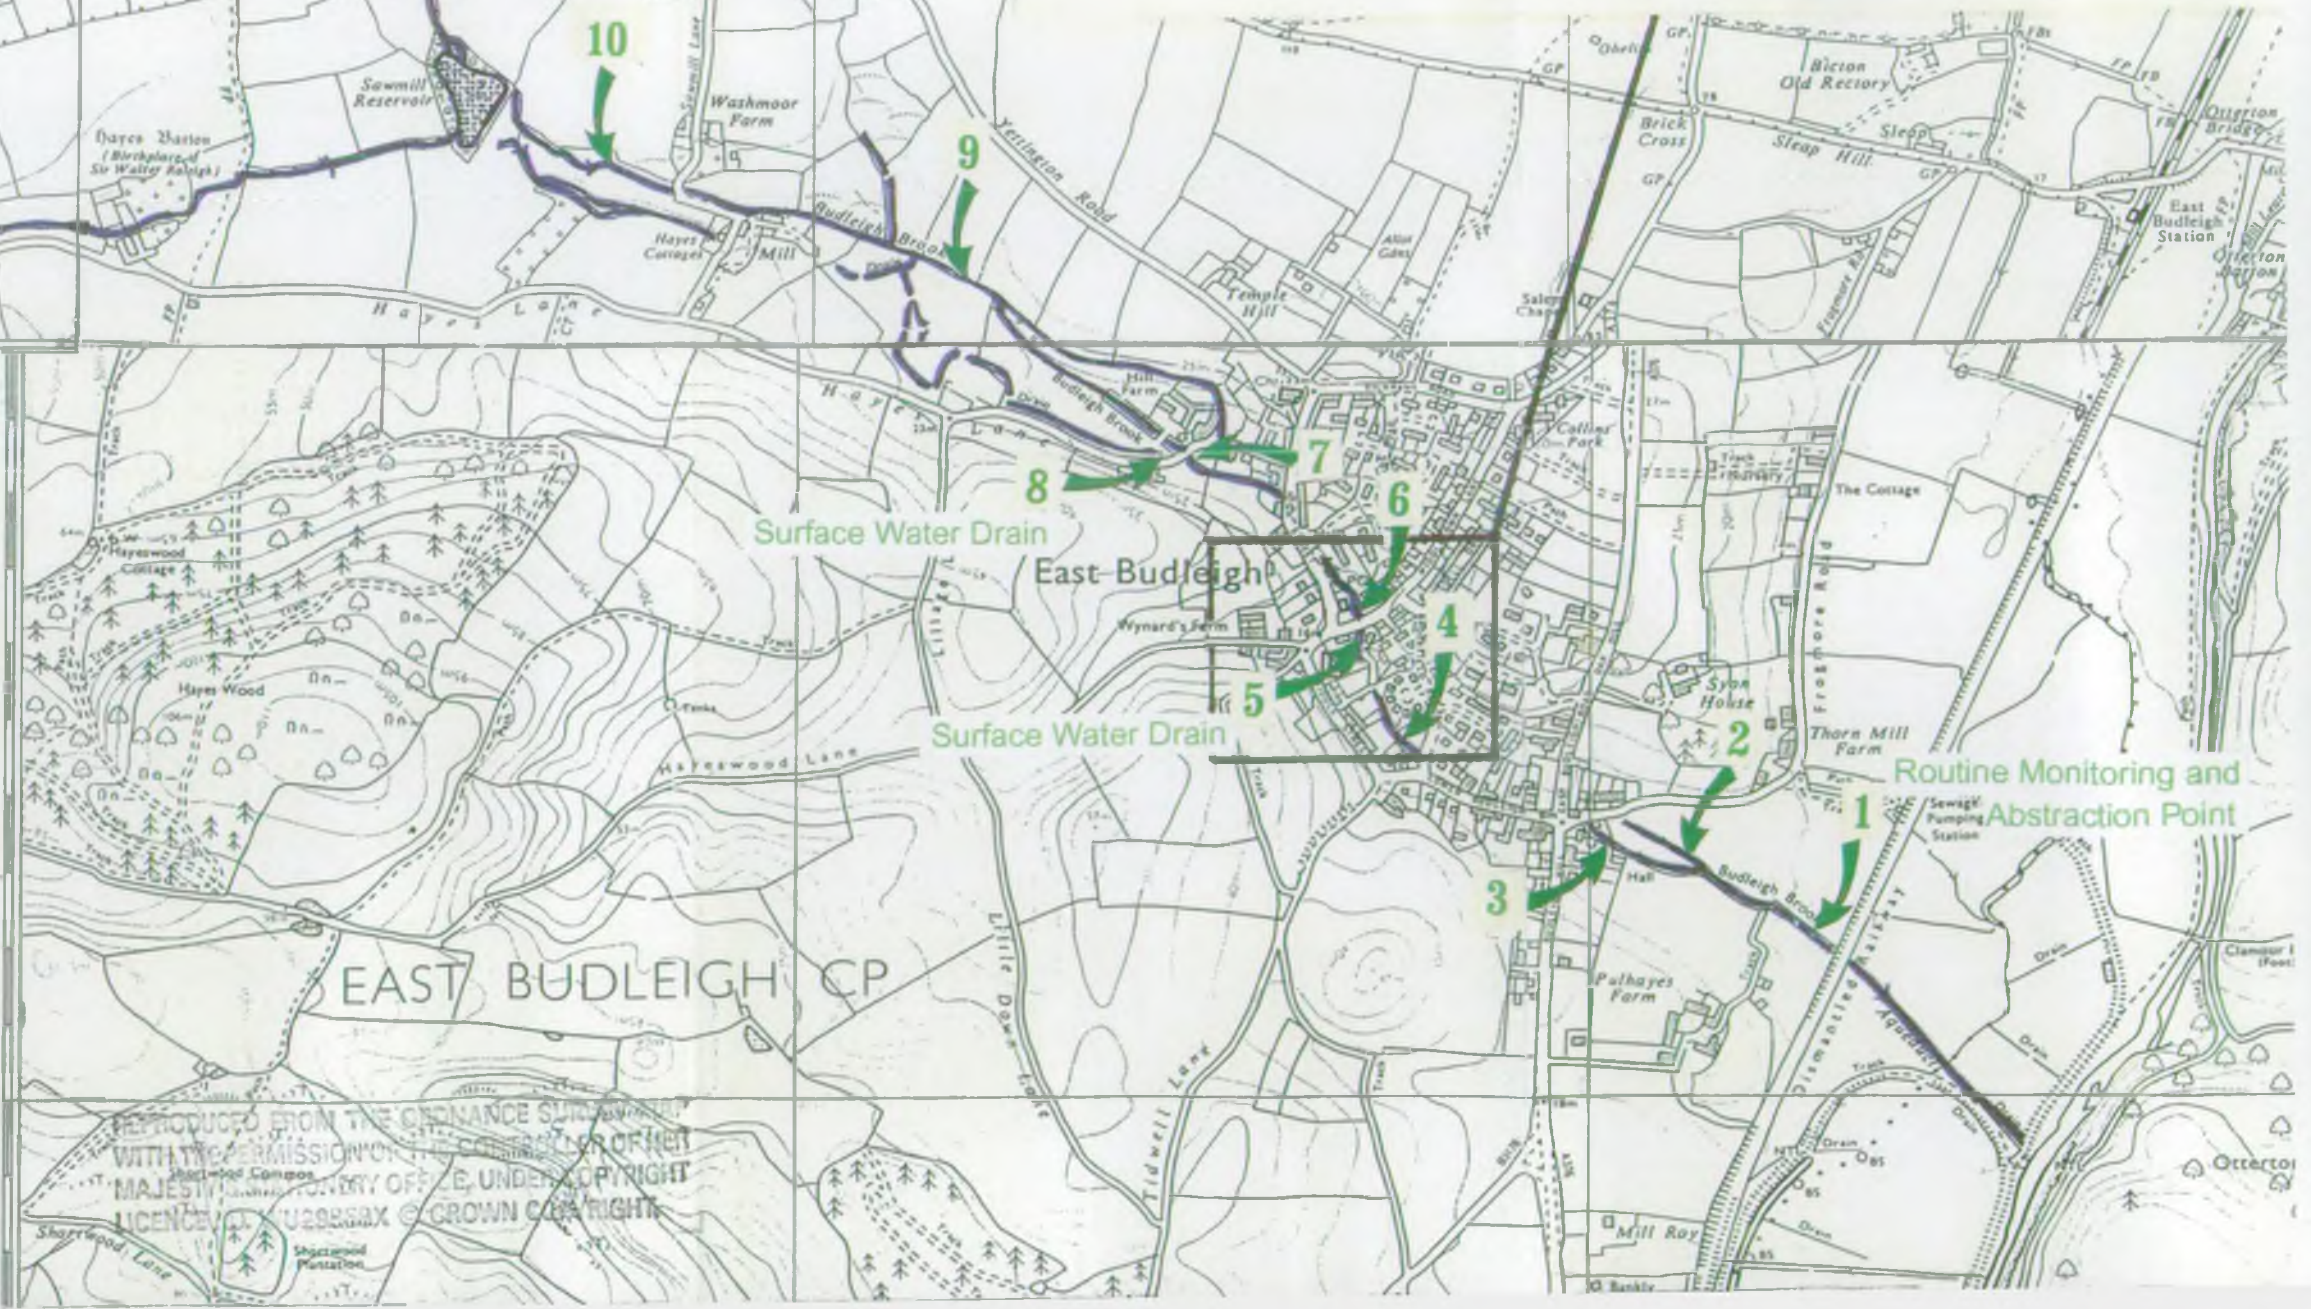
Figure 1. Sampling Point Locations on Budleigh Brook

Sampling site locations are shown on Figure 1.

Sites 8 and 5 are surface water drains which discharge into the watercourse. Site 8 is located near Hill Farm, site 5 is the outfall pipe from a surface water drain which collects in the area at the top of Middletown Lane near Wynard's Farm (see Figure 1).

The only site to record significant levels of 3-Methyl Phenol (over 1500 ng/l) was site 5. This is the discharge from the surface water drain originating in the vicinity of Wynard's farm. The lab stated that the majority of water samples contain less than 100 ng/l phenols and consequently levels over 1000 ng/l are rare and considered to be significant. The drain appears to originate near the farm, but it is not known what additional inputs there are before it reaches the watercourse.

The historic high phenol levels (3930 ng/l of 3-Methyl Phenol, and 163 ng/l of 2,4,6-Trichlorophenol) were picked up at site 1 during dry weather conditions. Site 1 is approximately 700m downstream from site 5. During the investigation, under similar dry weather conditions, an input of over 16000 ng/l (3-Methyl Phenol) at site 5 was found to have diluted down to <100 ng/l at site 6, a distance of 150m.
