*National Rivers Authority  
South West Region*

### INVESTIGATION INTO THE CAUSE OF HIGH pH IN THE BUDLEIGH BROOK

September 1991  
FWI/91/019  
Author: L. Wilcock.

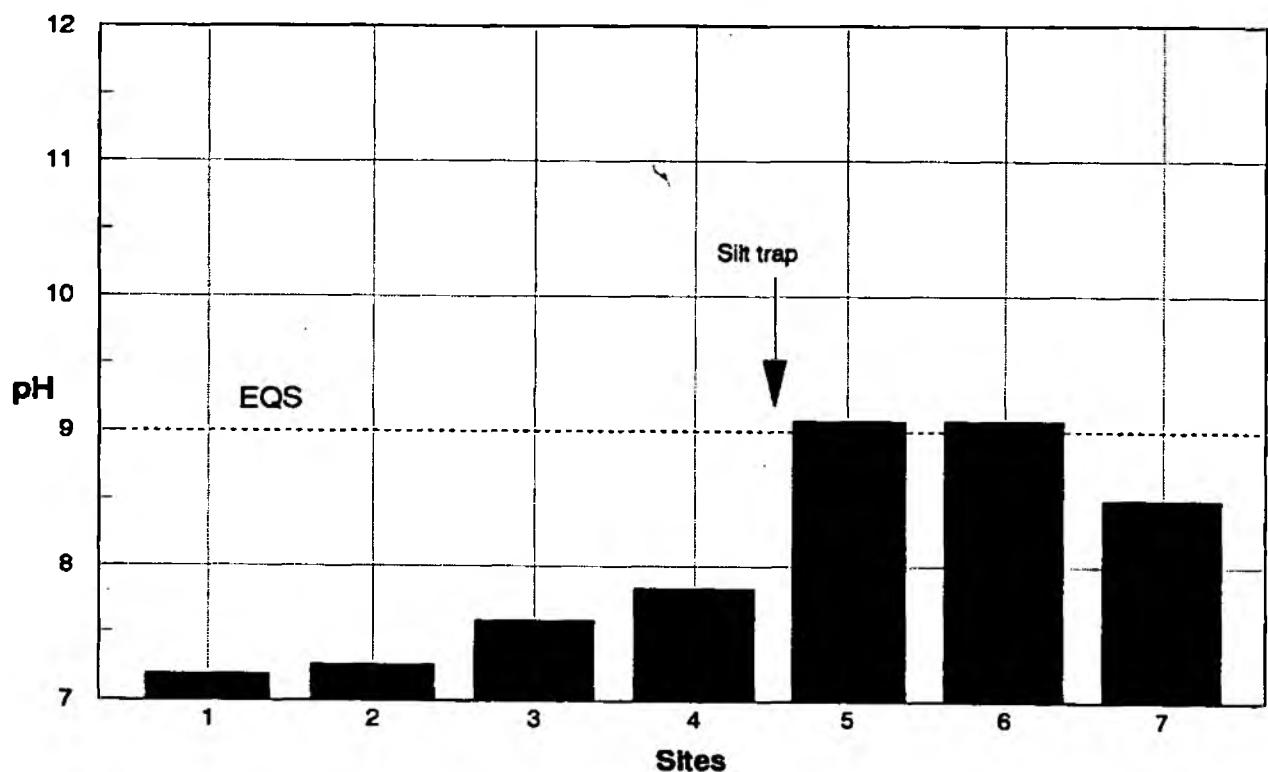
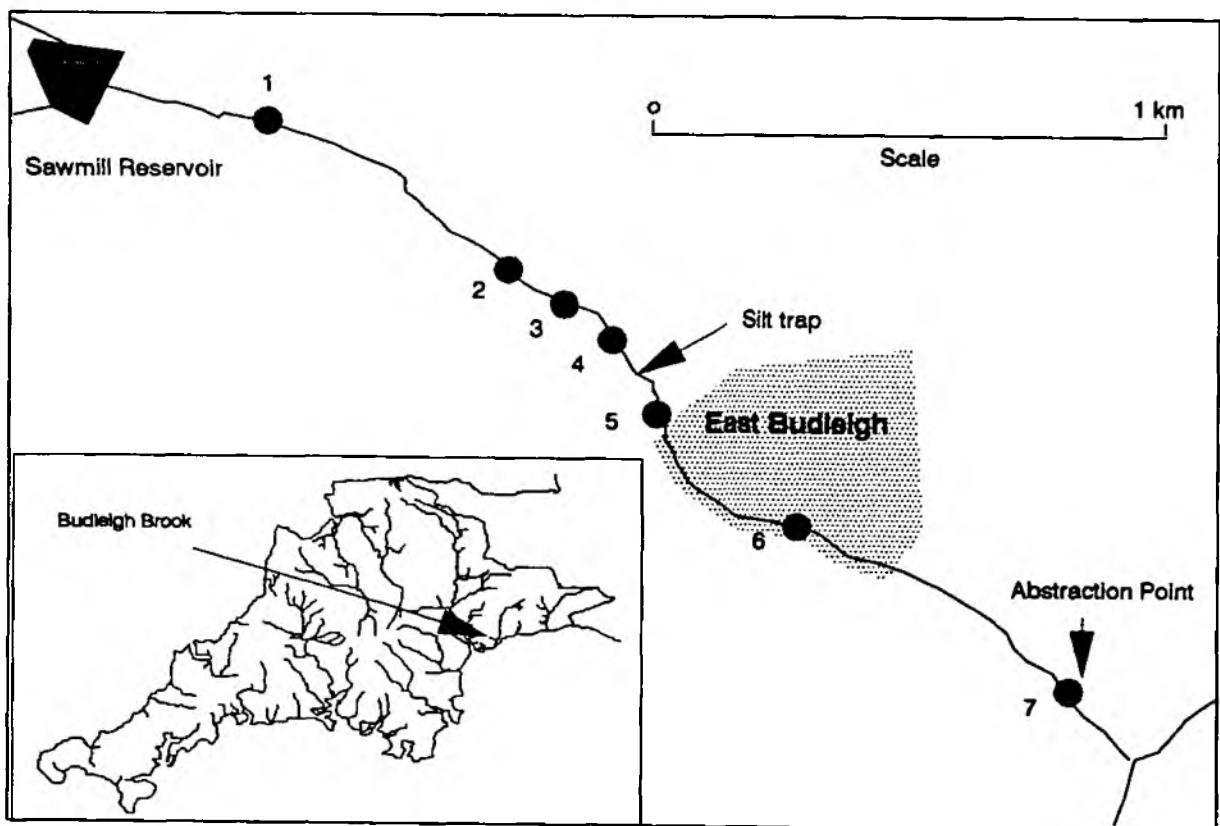
FIGURE 1. LOCATION OF SAMPLING SITES AND CHANGES IN pH ALONG THE BUDLEIGH BROOK

pH was found to steadily increase downstream (see Figure 1 & Table 2.). At site 5, immediately downstream of the silt trap at East Budleigh, pH increased to 9.08. Immediately upstream of the silt trap, pH was 7.89.

The pH of the Budleigh Brook at the abstraction was measured using a WTW pH meter. pH readings were taken upstream at the sites shown in Figure 1.

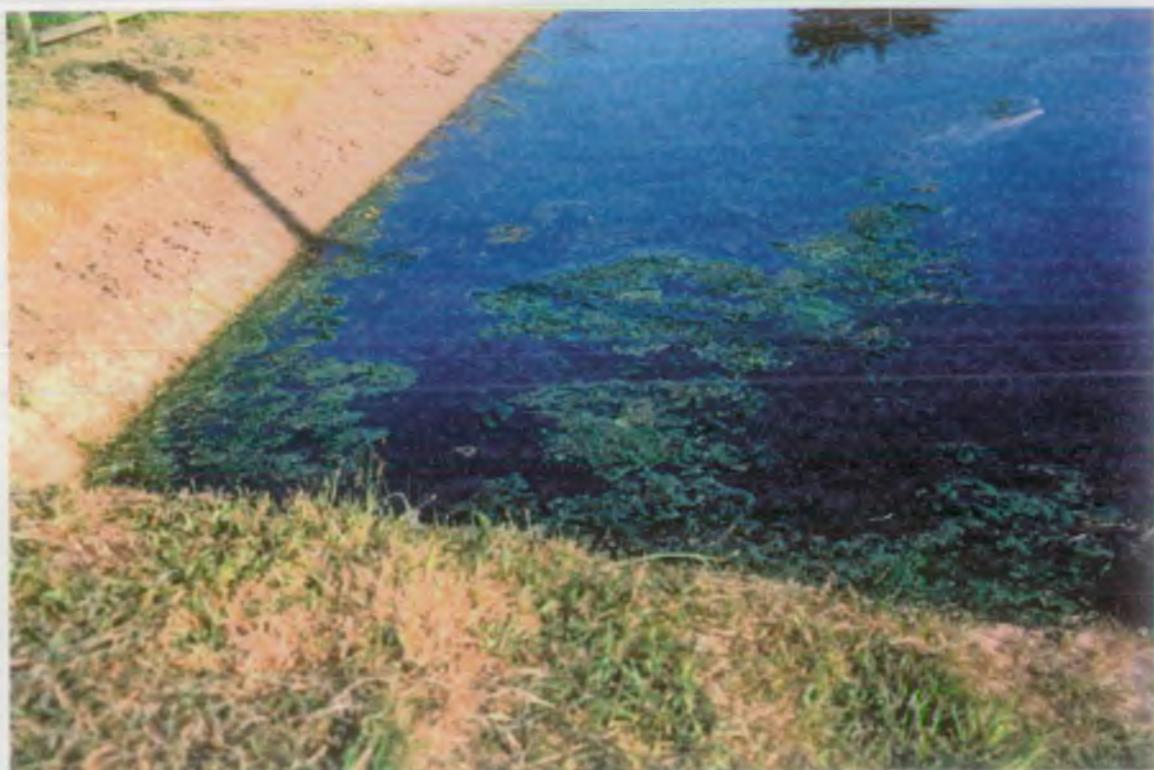
The cause of the high pH in the Budleigh Brook was found to be a silt trap constructed by the National Rivers Authority (SW) Land Drainage Section (see Figures 2-4). The silt trap had dense blooms of algae growing in it which were undoubtedly the cause of the high pH. The proliferation of algae in freshwaters can cause a rise in pH (-log [H<sup>+</sup>]). This is due to carbon dioxide or hydrogen carbonate being utilised during photosynthesis resulting in a decrease in the number of [H<sup>+</sup>] ions.

FIGURE 4. DENSE GROWTH OF ALGAE IN SILT TRAP

1. Consultation should take place with the Land Drainage Section to assess if the silt trap can be altered to avoid the development of algal blooms.
  - Action by Freshwater Officer.
2. To ensure maximum protection of river quality routine monitoring samples should be collected randomly.
  - Action by Freshwater Scientist.

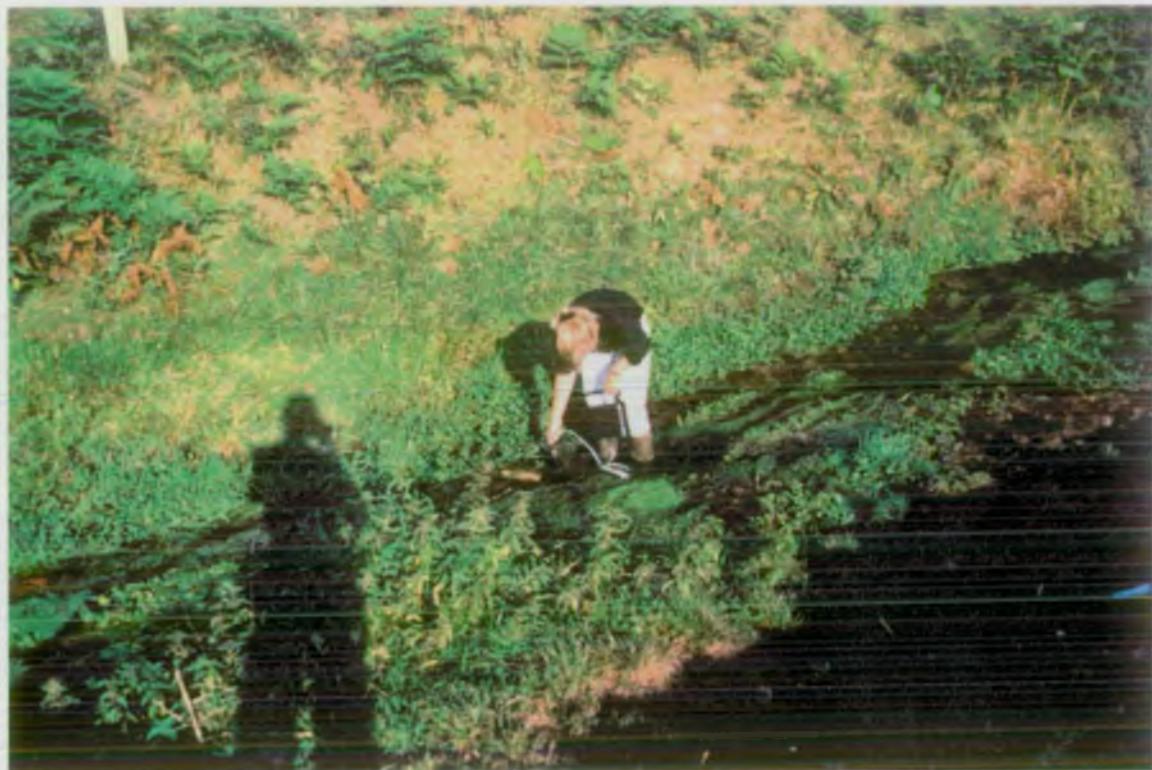
The slight rise in pH between Site 1 and Site 4 is thought to result from dense growths of the macrophyte Callitrichie sp.(see Figure 5). Algae are capable of raising the pH to a higher level than macrophytes as they can utilise sources of inorganic carbon other than carbon dioxide, which affect pH.

FIGURE 5. BUDLEIGH BROOK U/S OF SILT TRAP SHOWING DENSE GROWTH OF CALLITRICHE

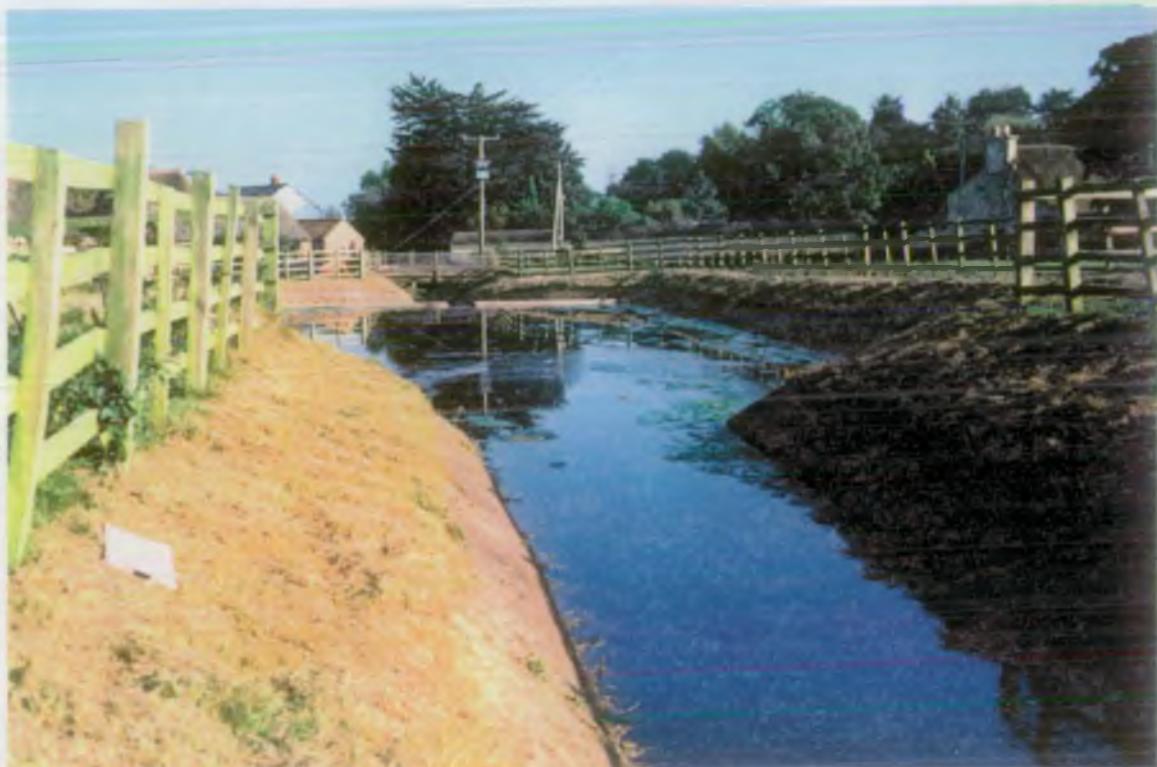
Algae were particularly abundant in the silt trap because of its location and design. Undesirable features include:

1. The large surface area of the silt trap (approx. 40 metres by 20 metres).

2. The shallow depth of the silt trap (approx. 0.4 metres deep).
3. The lack of shade in the immediate vicinity of the silt trap allowing maximum sunlight for photosynthetic activity at high temperatures.
4. The low velocity of the water in the silt trap.

FIGURE 2. GENERAL VIEW OF SILT TRAP

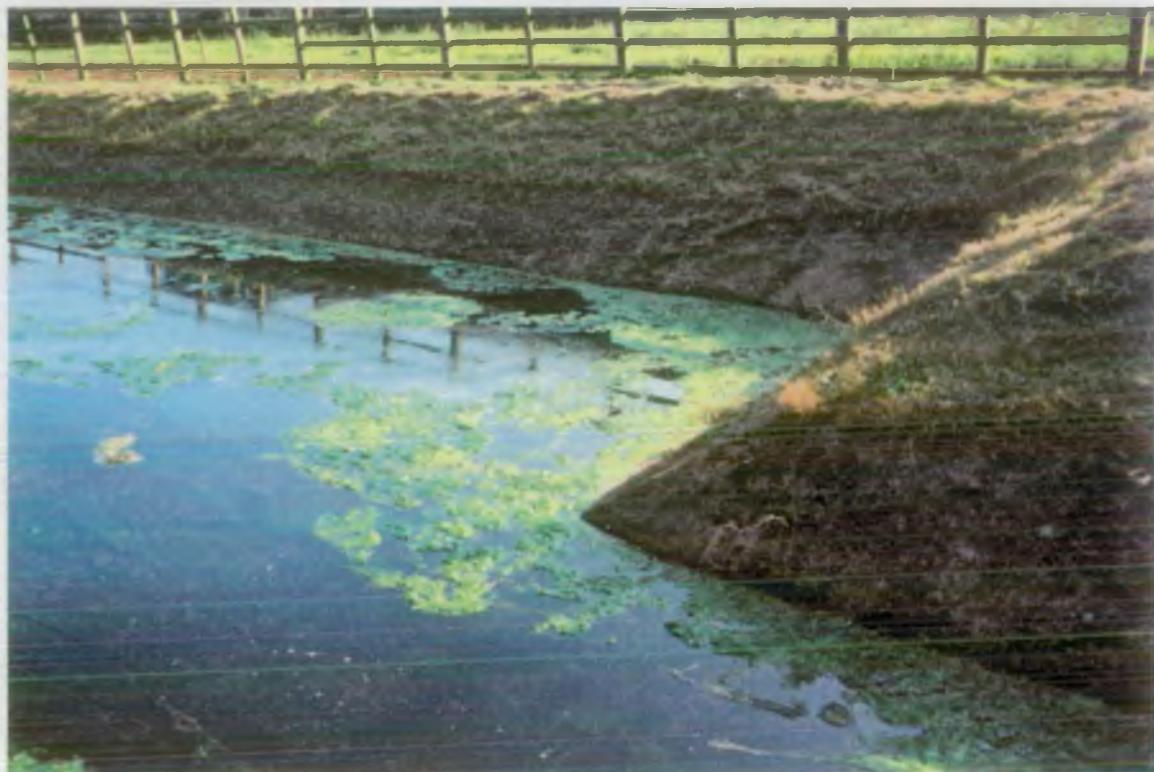
FIGURE 3. CLOSE UP OF ALGAE IN SILT TRAP
