## DEVON AREA INTERNAL REPORT

**AN INVESTIGATION INTO POSSIBLE  
CAUSES OF POOR WATER QUALITY AT  
NYMPHAYES BRIDGE (R30D009) ON THE  
GISSAGE LAKE**

**DECEMBER 1995**

**DEV/E/21/95**

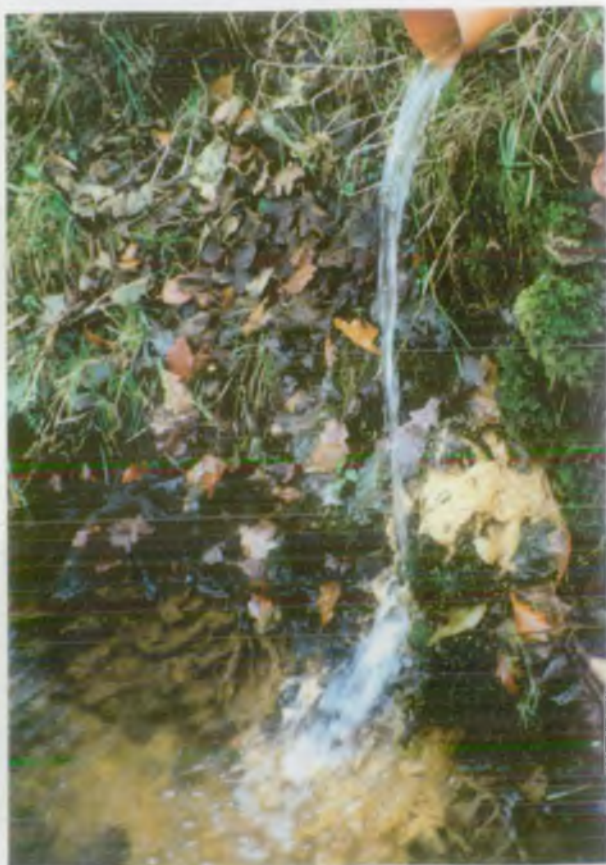
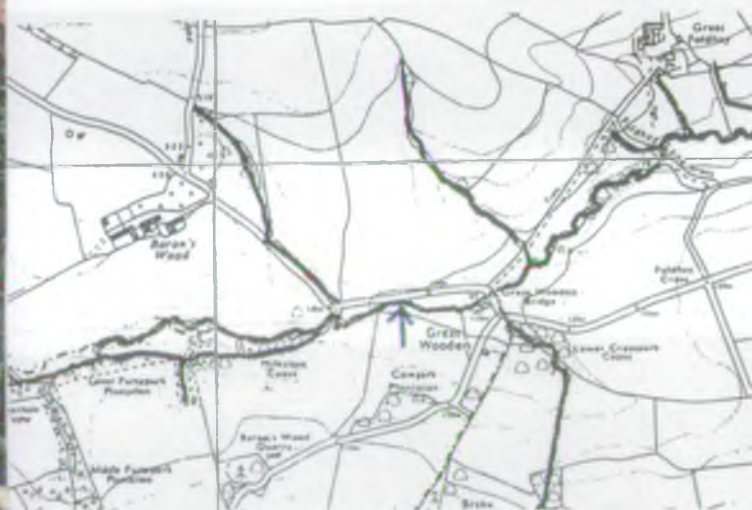
**SITE:** Land drain pipe, Great Wooden

Field land drain pipe with 100 % sewage fungus cover within mouth of the pipe. Approximately 10 % sewage fungus cover downstream of pipe, trace upstream. Discharge smelt like off-milk. Chemical samples indicated no EQS exceedance in receiving water.

Land drain pipe, possibly connected to a septic tank / dirty water system of some kind. Discharge running at approximately 0.3 litres per second.

Although the samples taken did not exceed EQS's, origin of the contamination needs to be ascertained

The Water Quality Officer to visit the site.

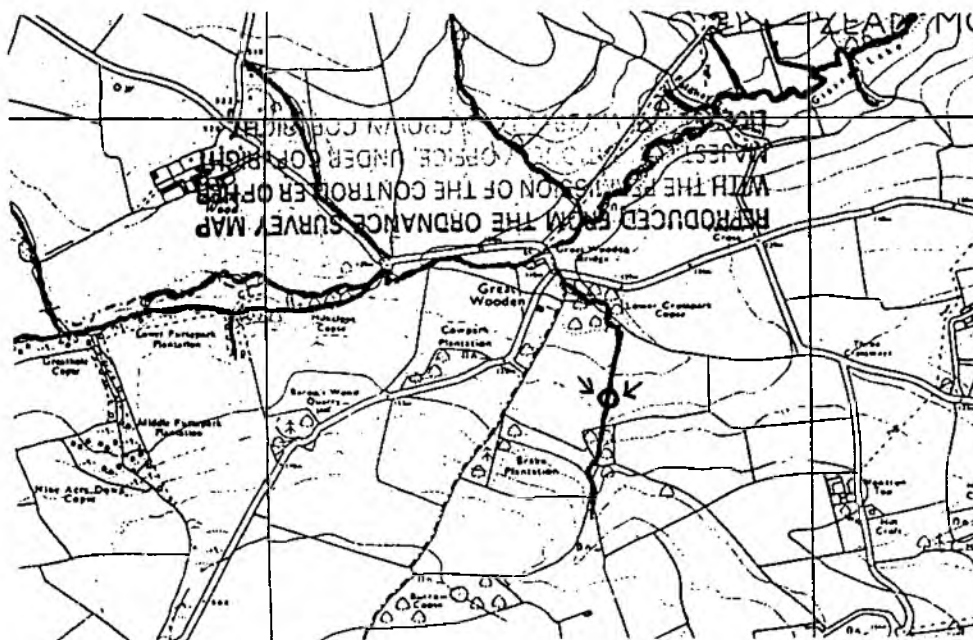
**SITE:** Cattle drinking area, Crosspark Copse

A tributary entering Gissage Lake had 10 % sewage fungus cover. Impact on Gissage lake difficult to determine due to close upstream input (see Field drain Pipe). Tributary much more muddy / silty than rest of watercourse.

Cattle drinking area in field. Stream entering drinking basin and overflowing to form very muddy area. Cattle will trample / defecate in this area whilst drinking. Problem will be exacerbated during wet weather.

No samples were taken during the investigation as no cattle were in the field. During periods of wet weather when the cattle are in the field it is possible that there could be an impact in Gissage Lake.

The Water Quality Officer to visit the site.  
Investigations Team Devon Area to carry out Wet Weather survey.
