**BAT BOX INSTALLATION
IN ENVIRONMENT AGENCY
GAUGING STATIONS
(Hampshire & Isle of Wight Area)**

June 1999

Ken Monro (Sparsholt College)
Joe Stevens (Environment Agency)

BAT BOX INSTALLATION IN ENVIRONMENT AGENCY GAUGING STATIONS

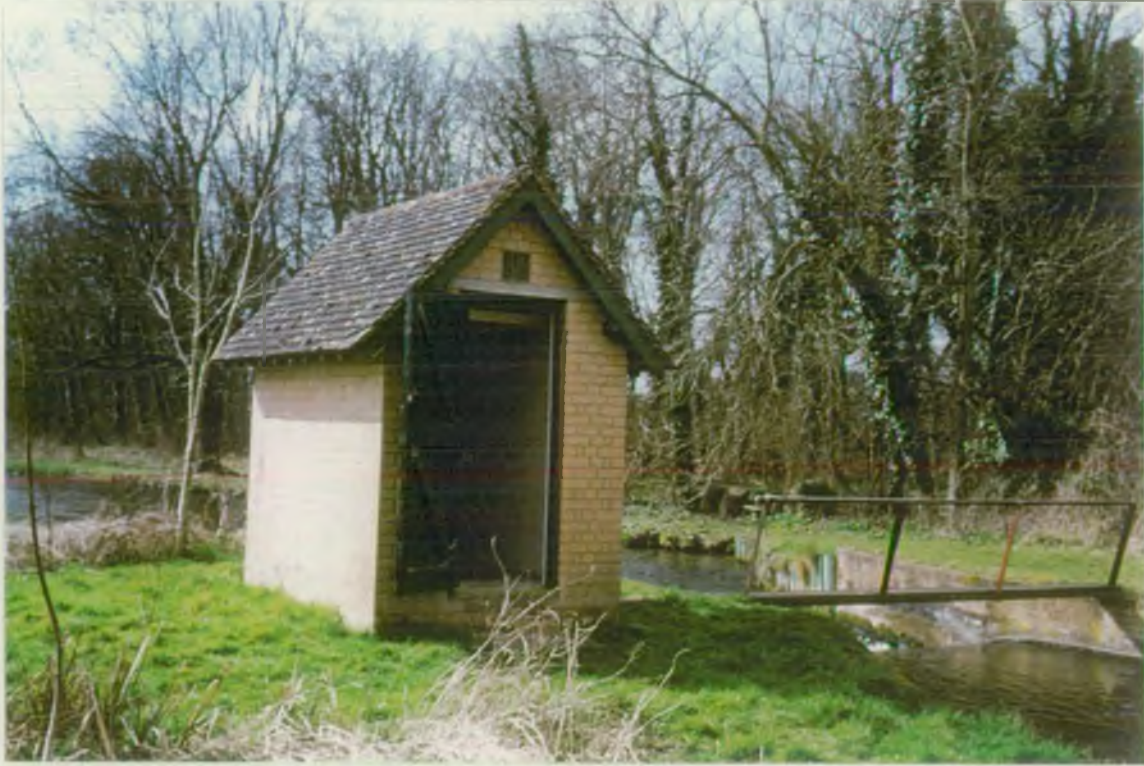
(FULLERTON GAUGING STATION - RIVER TEST - HAMPSHIRE)

A TYPICAL ENVIRONMENT AGENCY GAUGING STATION HUT.

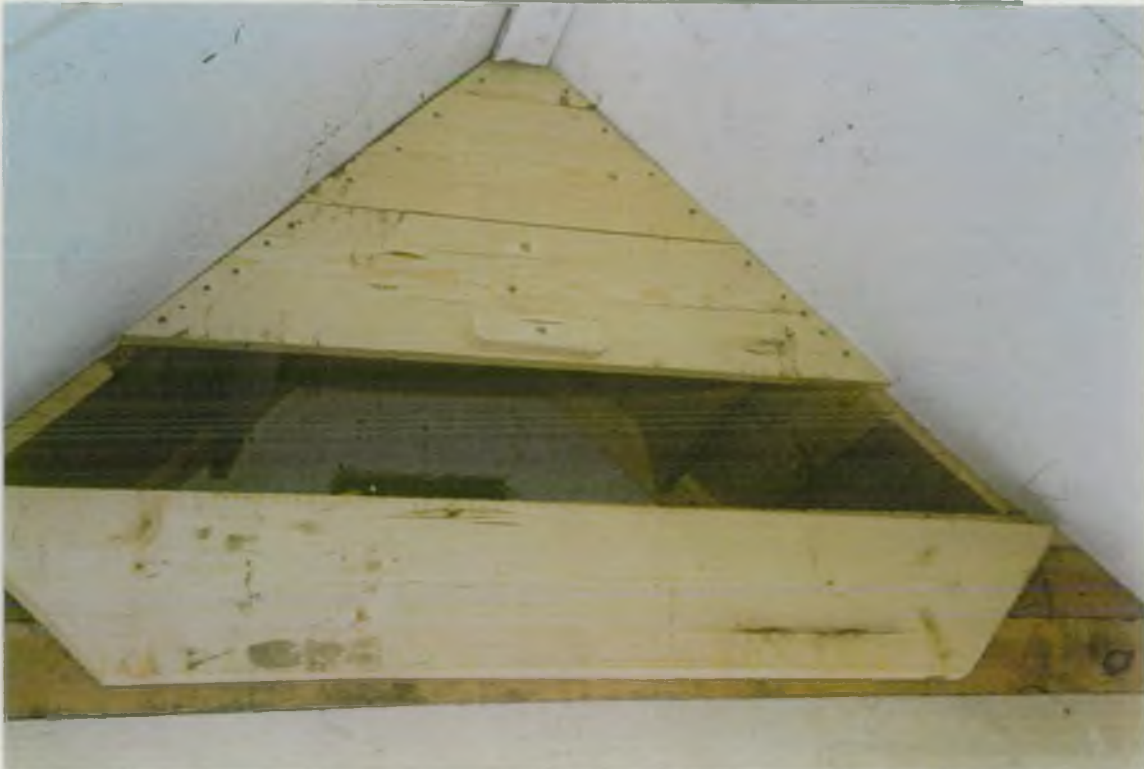
(FULLERTON GAUGING STATION - RIVER TEST - HAMPSHIRE)

THE FULLERTON RIDGE BOX - INSPECTION FLAP OPEN

- 1 “Fullerton Ridge” bat box was fitted.
- 1 direct-to-box entry point was provided – a hole in corner of air brick.

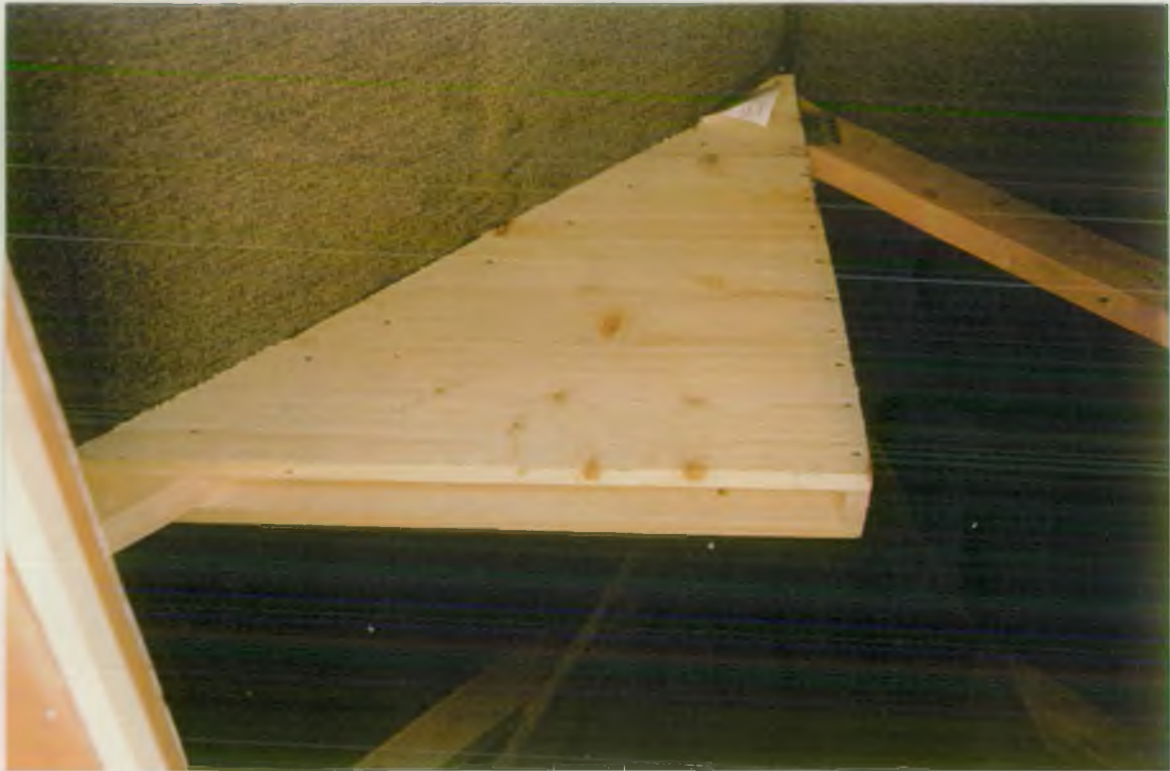
(BOSSINGTON GAUGING STATION - RIVER TEST - HAMPSHIRE)

THE NEW CREVICE DESIGN - LOOKING UP THROUGH LOFT HATCH

- 2 bat boxes were fitted: 1 crevice box; 1 hibernation box.
- 1 extra entry points was added - a hole in corner of air brick.
- A man-way inspection hatch was added to the ceiling of the building.

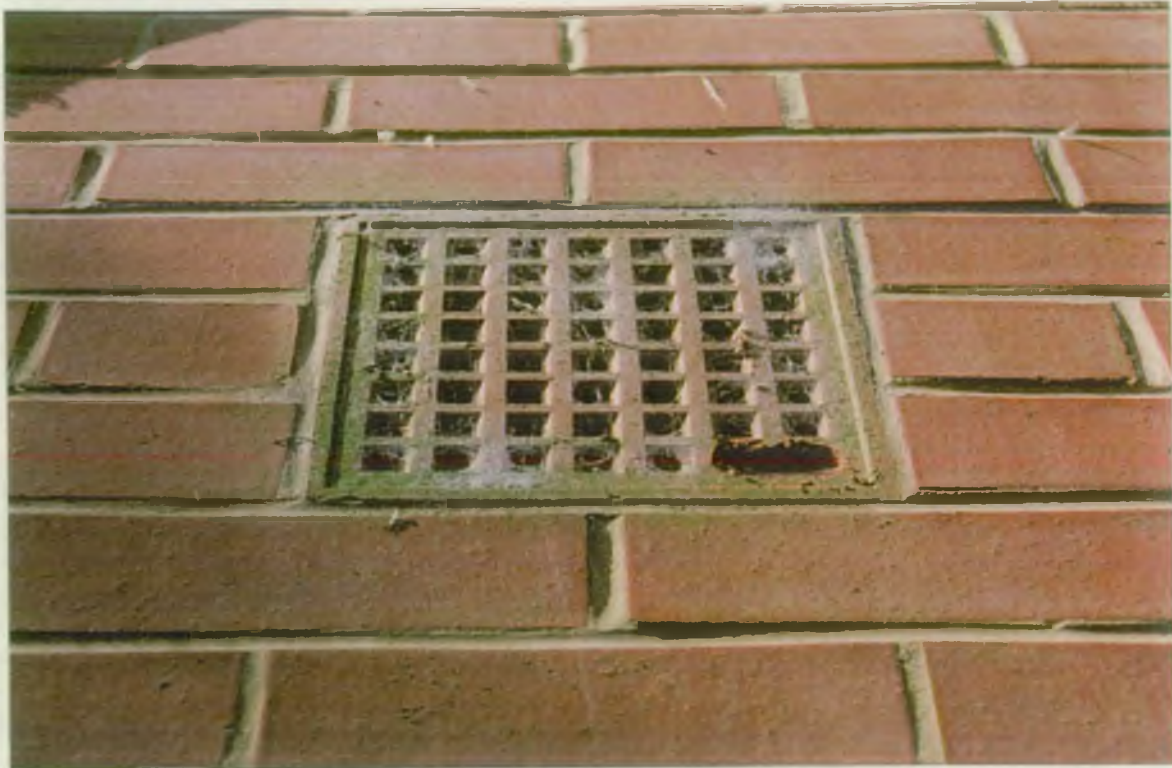
(BOURNE GAUGING STATION - RIVER TEST - HAMPSHIRE)

AIR BRICK ACCESS POINT

Often, bat access to the roof space was already possible via existing gaps and holes. In most cases extra access routes were provided: by drilling holes in the soffit boards; chiselling out slot gaps in the mortar of gable end walls; or chipping gaps in the corners of air bricks. Access to cavity wall habitat was also provided by creating small, slot gaps in the mortar.

- 2 bat boxes were fitted: 1 crevice box; 1 hibernation box.
- 1 extra entry points was added - a hole in corner of air brick.
- A man-way inspection hatch was added to the ceiling of the building.

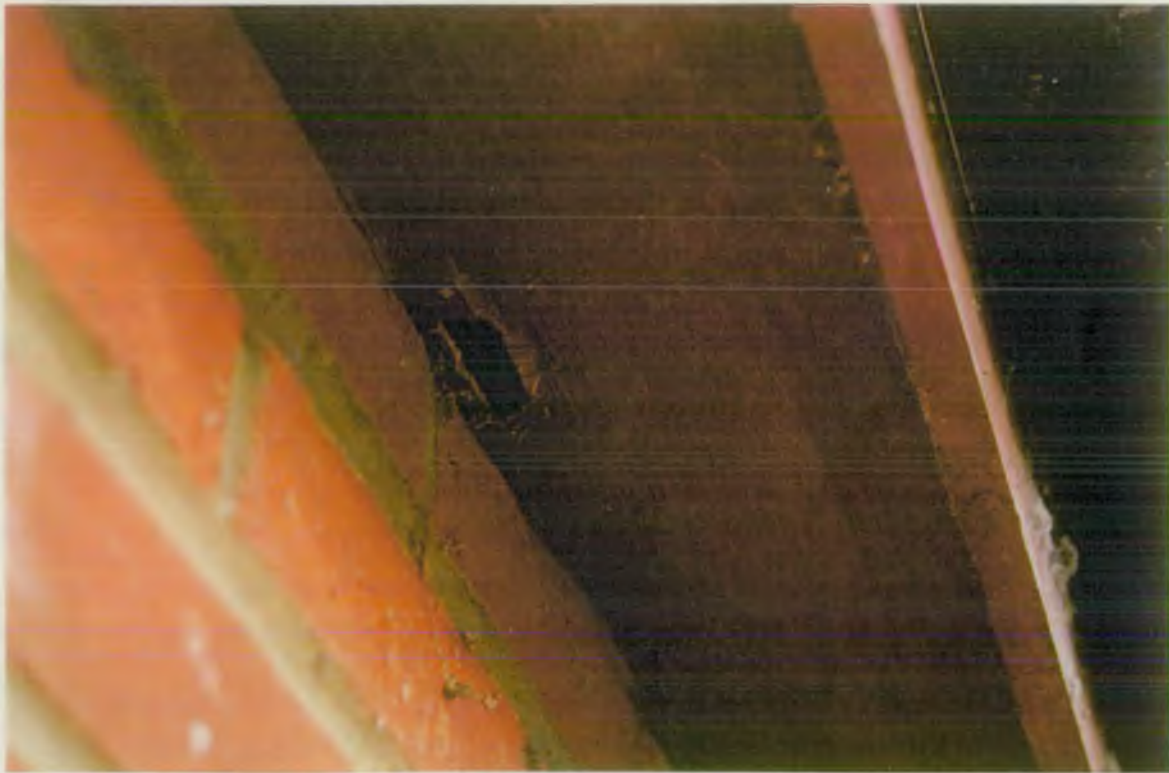
(CHILBOLTON GAUGING STATION - RIVER TEST - HAMPSHIRE)

SOFFET ACCESS POINT

- Droppings in the roof space suggest bats were using this site prior to this project.
- 2 bat boxes were fitted: 1 eaves box; 1 crevice box.
- 3 extra entry points were added: 2 slots in soffits; 1 hole in corner of air brick.
