**DEVON AREA
INTERNAL REPORT**

**INVESTIGATION INTO STORM
DISCHARGES AT IPPLEPEN
SEWAGE TREATMENT WORKS.**

**MAY 1999
DEV/EP/13/99
(CATCHMENT 07B)**

Investigation into Storm Discharges at Ipplepen Sewage Treatment Works

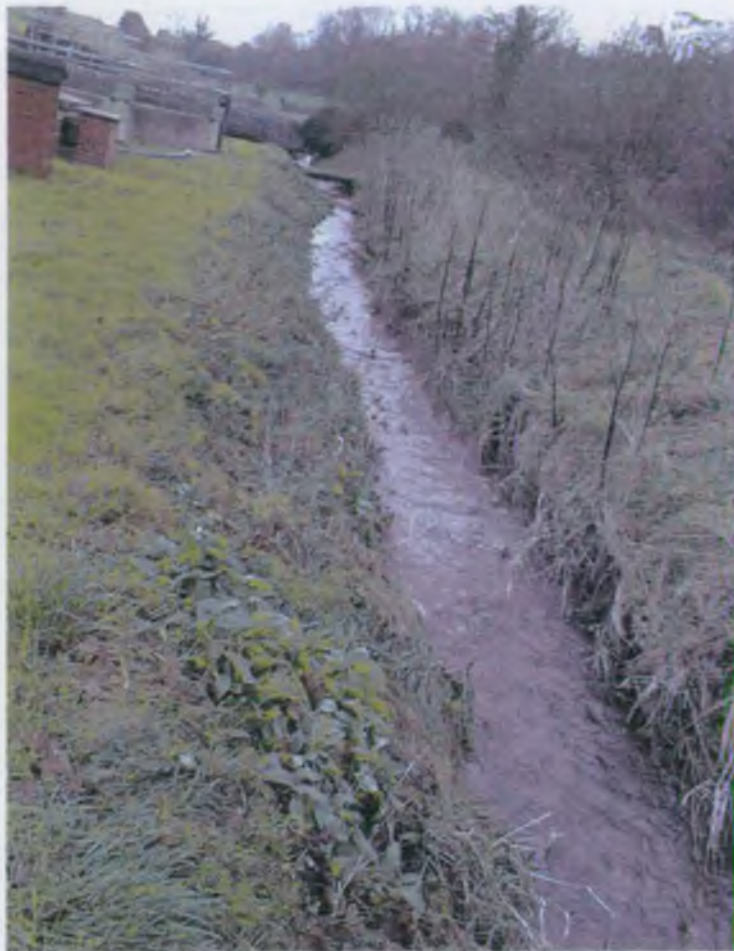
Plate 1. Looking up the stream into which the storm discharges below Ipplepen STW.

A request was received from Environment Protection to investigate the frequency of storm sewage discharges to the stream (Appendix 1, plate 1) from Ipplepen Sewage Treatment Works (see figure 1).

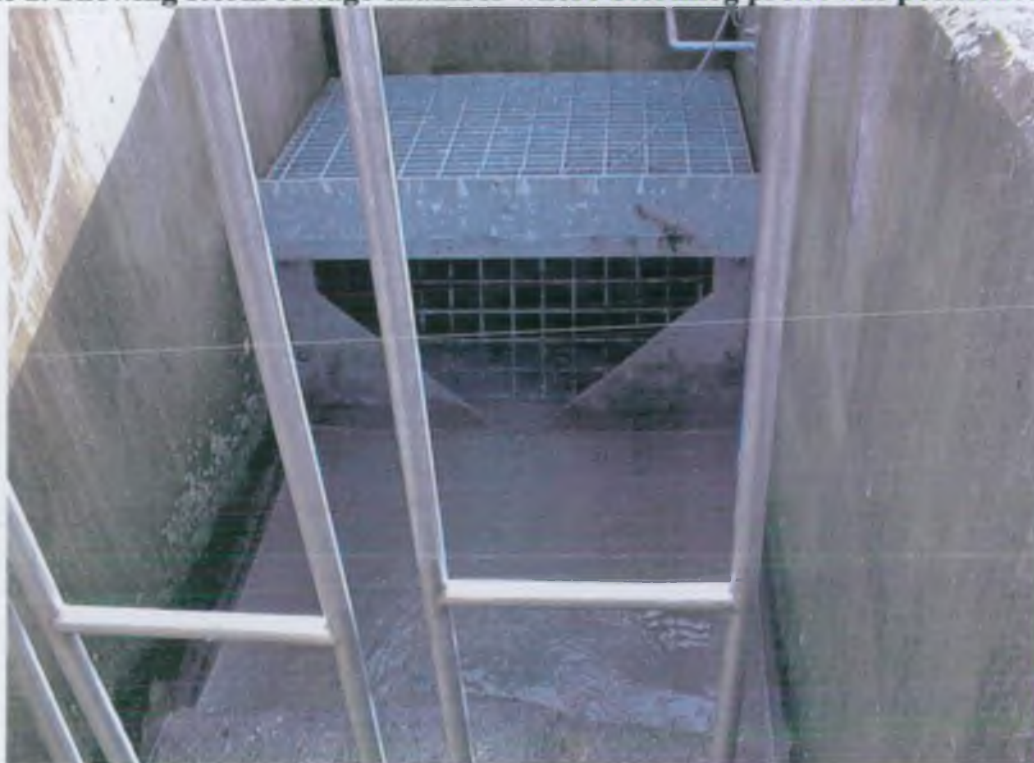
Plate 2. Showing storm sewage chamber where Stormlog probe was positioned.

A Stormlog event monitor was installed at Ipplepen Sewage Treatment works on 28th November 1998. The sensor was positioned in the exit pipe of the storm discharge chamber (see figure 2 & plate 2).

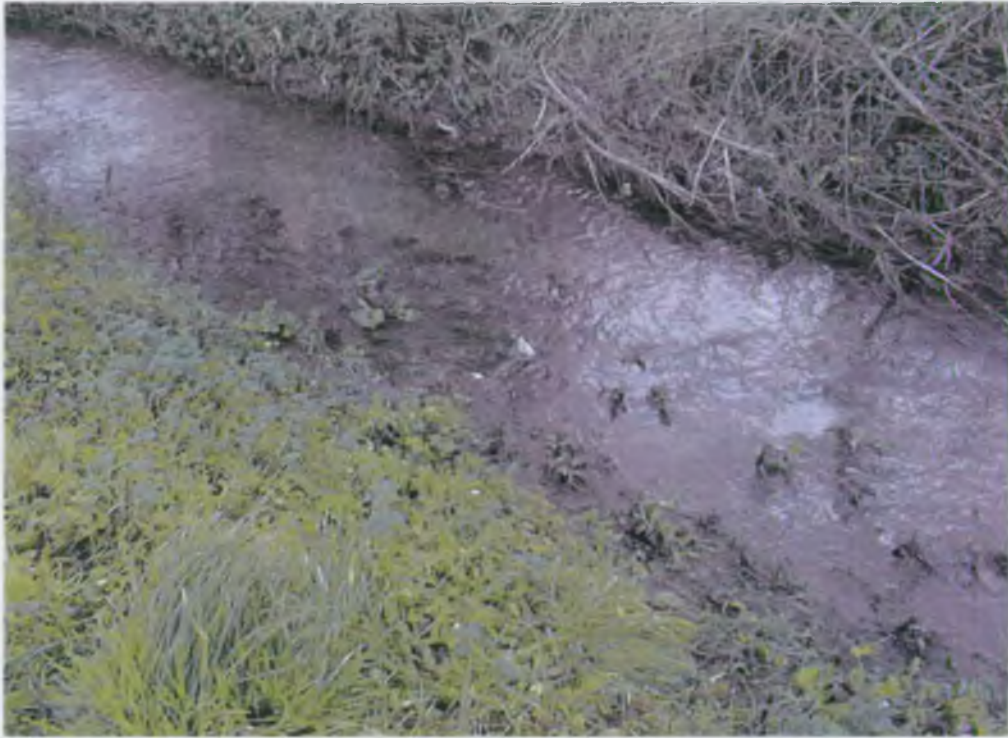
From 2nd January 1999 until 21st January 1999 the Stormlog recorded a continuous discharge of storm effluent. The Stormlog was downloaded during this period (5th January 1999), it was noted that the storm was discharging. Large quantities of sewage derived debris including sanitary towels, condoms and paper was observed in the stream (plate 3) and the copa sac was full (plate 4).

Plate 3. Sewage debris down stream of Ipplepen STW storm sewage discharge point.

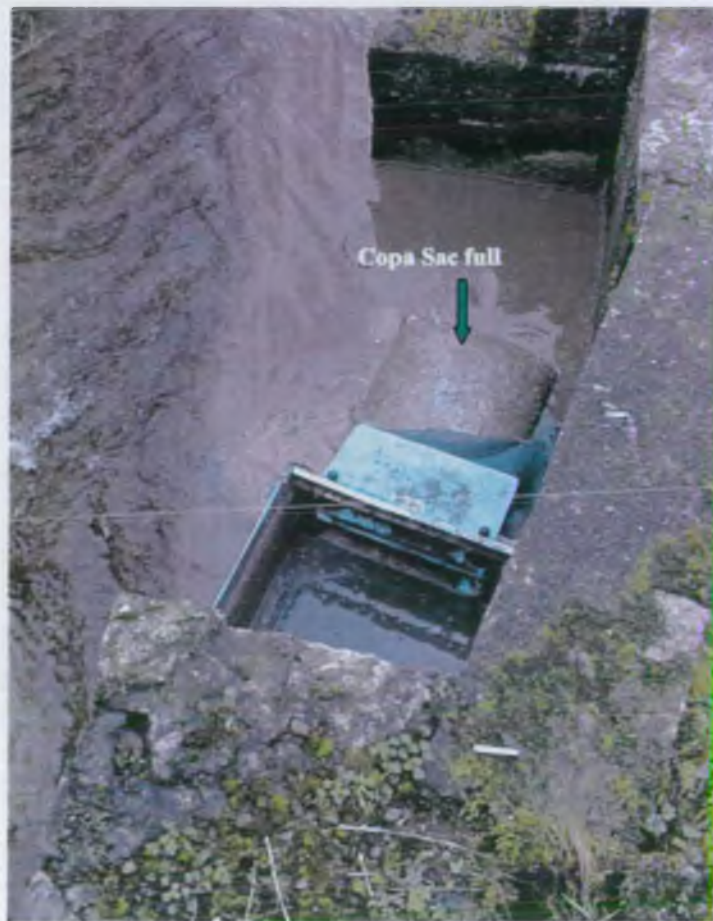
Plate 4. Showing storm sewage discharge at Ipplepen Sewage Treatment Works
