**DEVON AREA  
INTERNAL REPORT**

**INVESTIGATION INTO UPSTREAM  
FAILURES AT PUDDINGTON  
SEWAGE TREATMENT WORKS.**

**MAY 1999  
DEV/EP/10/99  
(CATCHMENT 05J)**

**Author: S. HUNTER  
INVESTIGATIONS OFFICER**

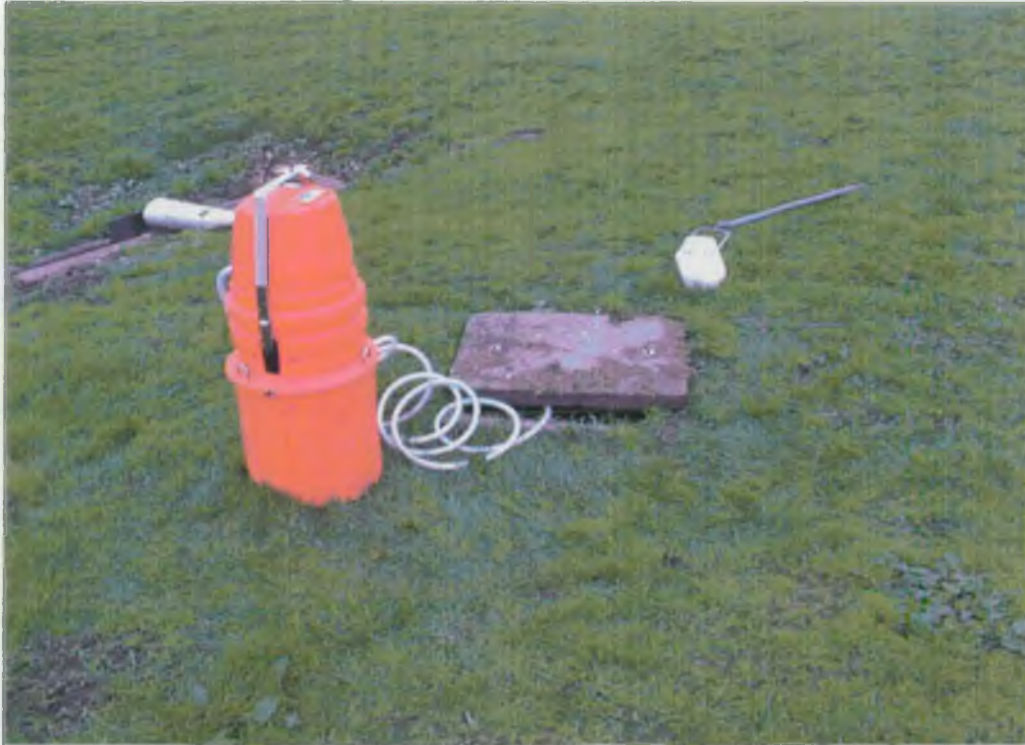
Plate 1

Epic auto-sampler next to manhole at site 7.

On the 1<sup>st</sup> February 1999 the second microbiological survey was undertaken, including two extra sites (fig. 3, sites 13 & 14). Also at 11:45 the percolating filter was dosed with 10ml of *B.globigii* in 1 litre of water. An 'Epic' auto-sampler was used to collect samples from the manhole at sample point 7 (Plates 1 & 2). An 'Epic' sample was taken every 2 hours for 48 hours; the first sample was taken at 13:30.

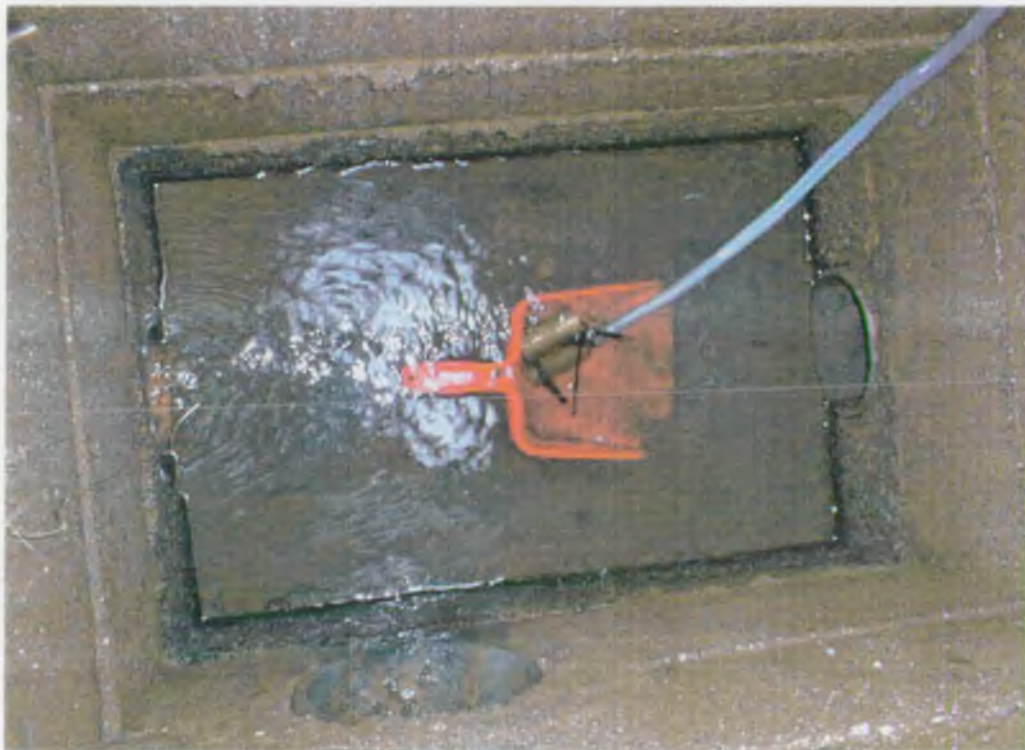
Plate 2

Showing view of sample tube in manhole.

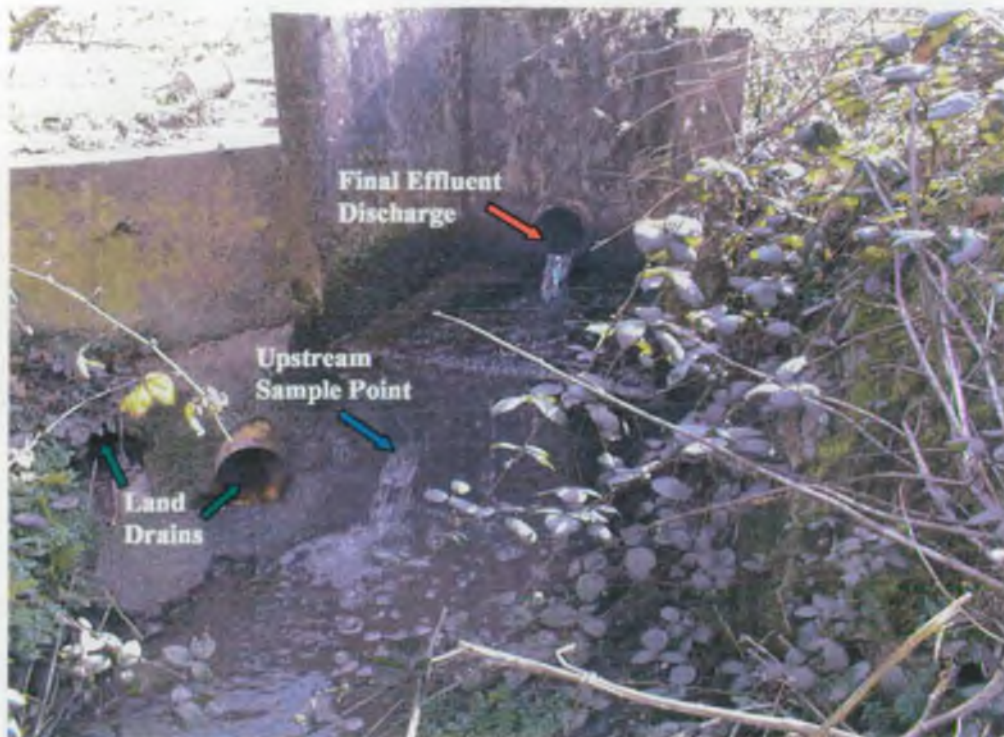
Plate 3

Also the construction of the upstream sample point makes it almost impossible to guarantee an upstream sample is taken without some level of contamination from the final effluent discharge, if it is operating (see plate 3).

The present location of the upstream sample point makes it almost impossible to take a confident sample when the final effluent is discharging.

Showing concrete apron where final effluent and stream discharge

The construction of the final effluent discharge and upstream sample point makes it impossible to take an upstream sample without a high possibility of contamination from the final effluent. Upstream and down stream sampling is not a statutory obligation and could be discontinued; however this would lead to difficulties in determining whether the sewage treatment works is having an impact on the stream. If however upstream and down stream sampling is to continue, work must be undertaken at the point of discharge, to separate the effluent from the stream, and allow uncontaminated stream samples to be collected.

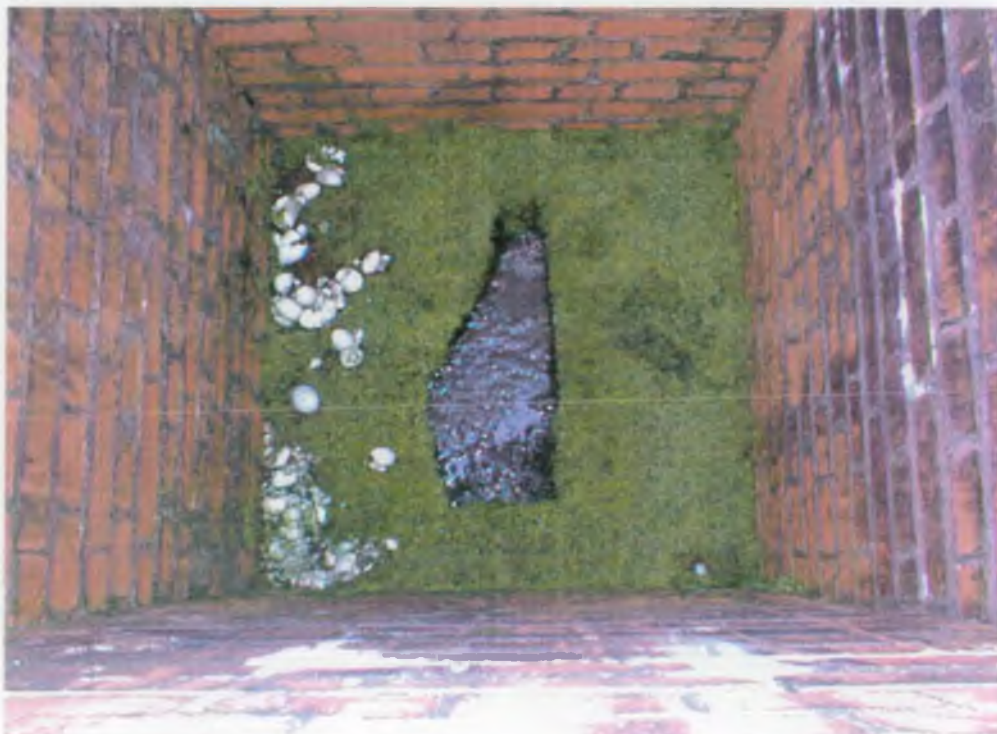
Plate 4

The chamber containing sites 5, 6 and 10 is located near the perimeter fence of the works, adjacent to a paddock and a chicken coup. A number of broken eggs were present in this chamber. The eggs must have been deliberately thrown into it (see plate 4, appendix 1). Although this is not believed to be the cause of the failure, it is obviously bad practice and has a potential to influence the results of samples taken of the stream.

Chamber which stream flows through into which eggs have been thrown.

An attempt should be made to stop the practice of throwing waste eggs into the chamber.
