living with the risk

The floods in Boscastle
and North Cornwall 16 August 2004

Some of the worst floods ever seen in Britain devastated Boscastle and surrounding areas of North Cornwall on 16 August 2004.

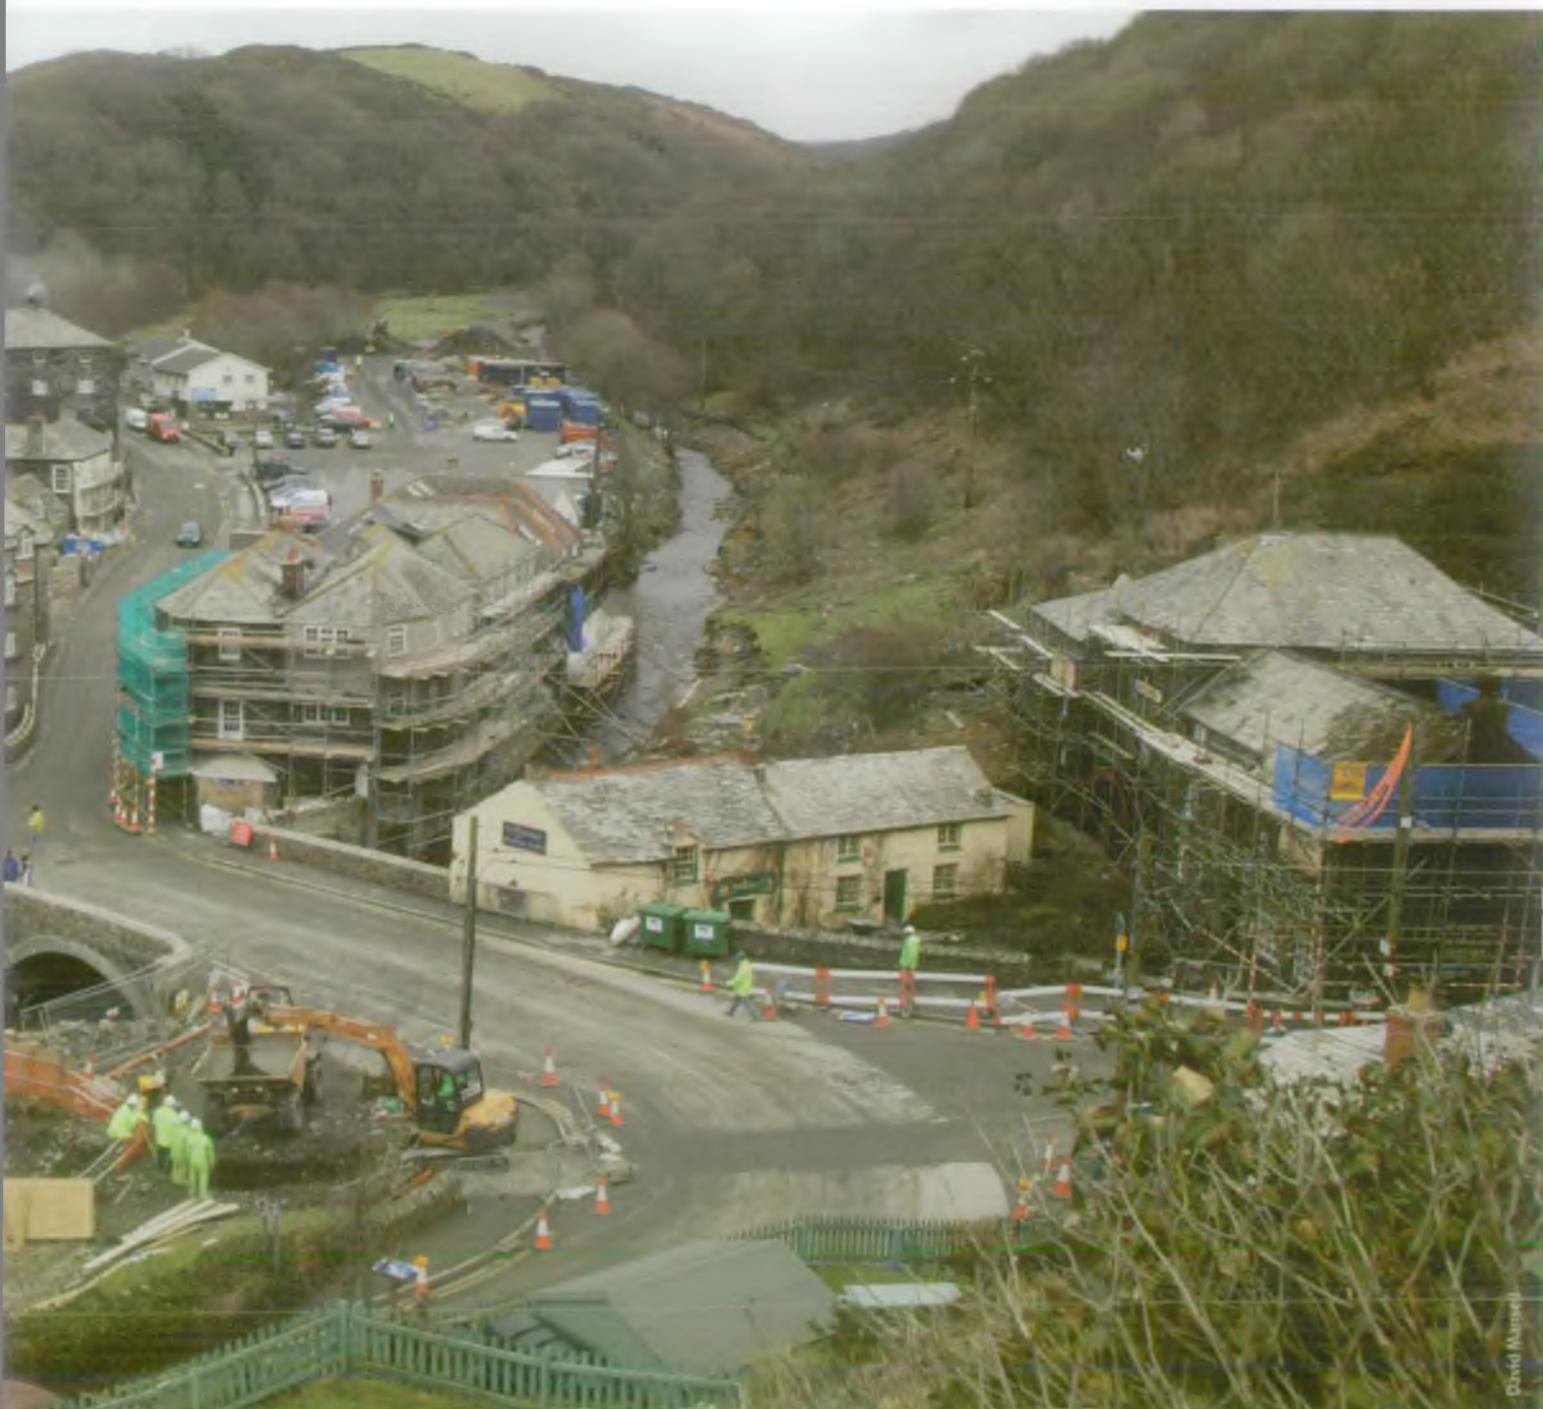
Regeneration: A new culvert is laid alongside the Jordan as rebuilding work continues at Boscastle

The Environment Agency was pleased to participate and to have been able to lend support to the event, which also marked the completion of our new culvert for the River Jordan and the other remedial work.

Our medium-term plan for the flood risk management of the region included improvements on the River Jordan. We decided in May 2004 to improve the existing culvert from above Marine Terrace to where the Jordan meets the Valency. Work on this scheme had been due to start in September 2004, but following the August flood a revised scheme was built (see section *What's happened since*).

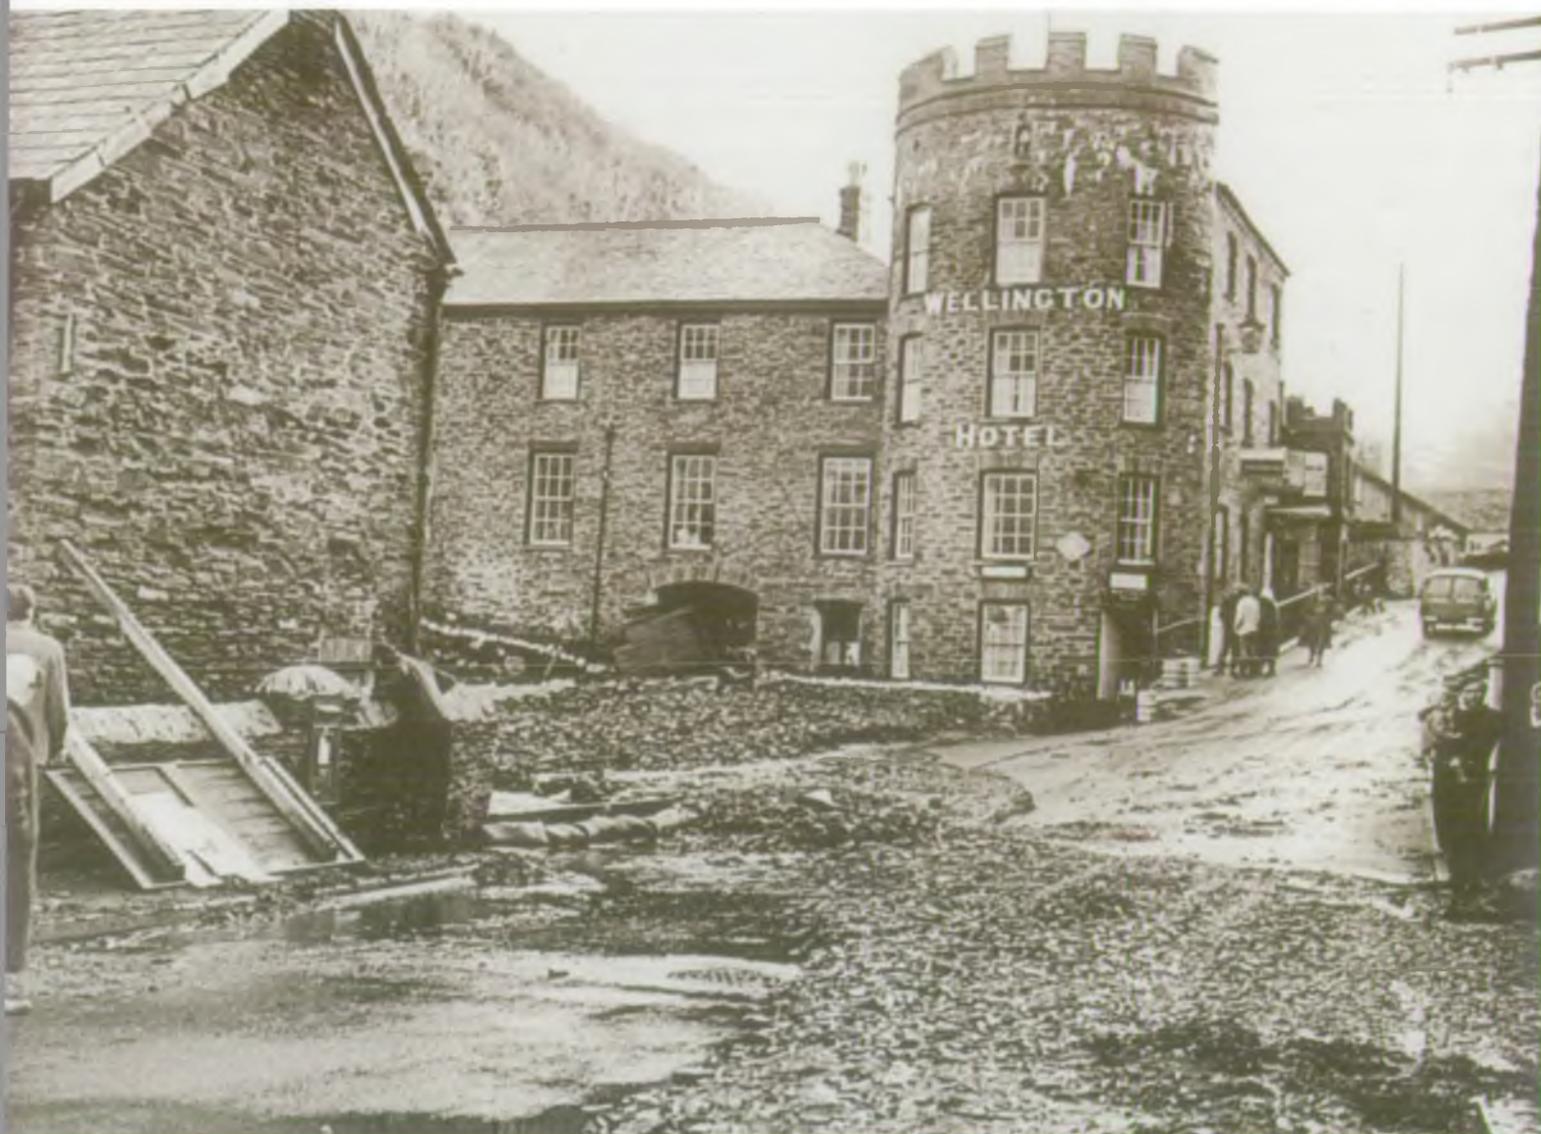
Aftermath: stones carried down by the Jordan in the 1963 flood spill out of the Wellington Hotel

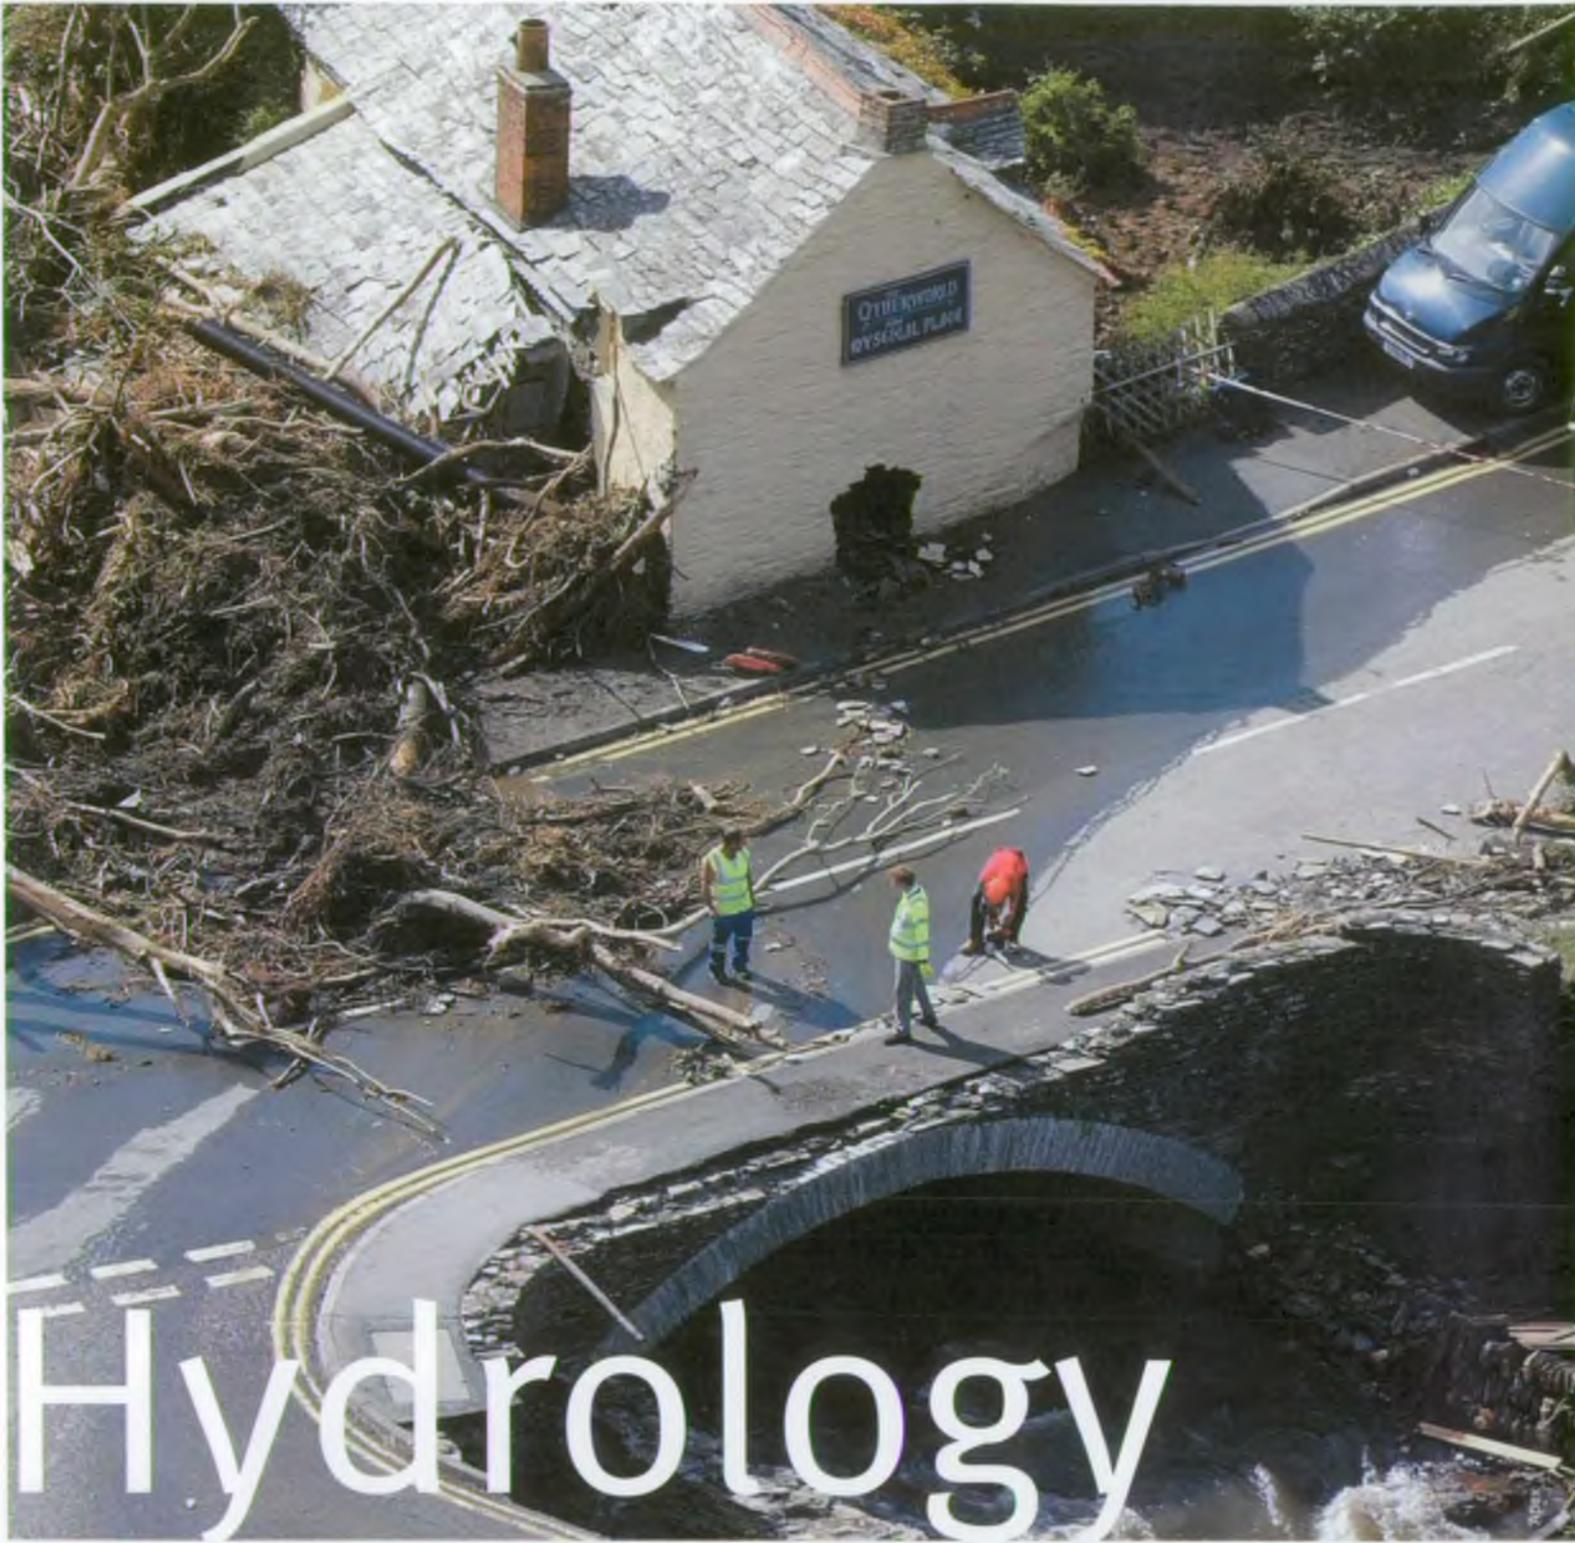
Morning after the storm: Trees block the road bridge in Boscastle as the clean-up begins

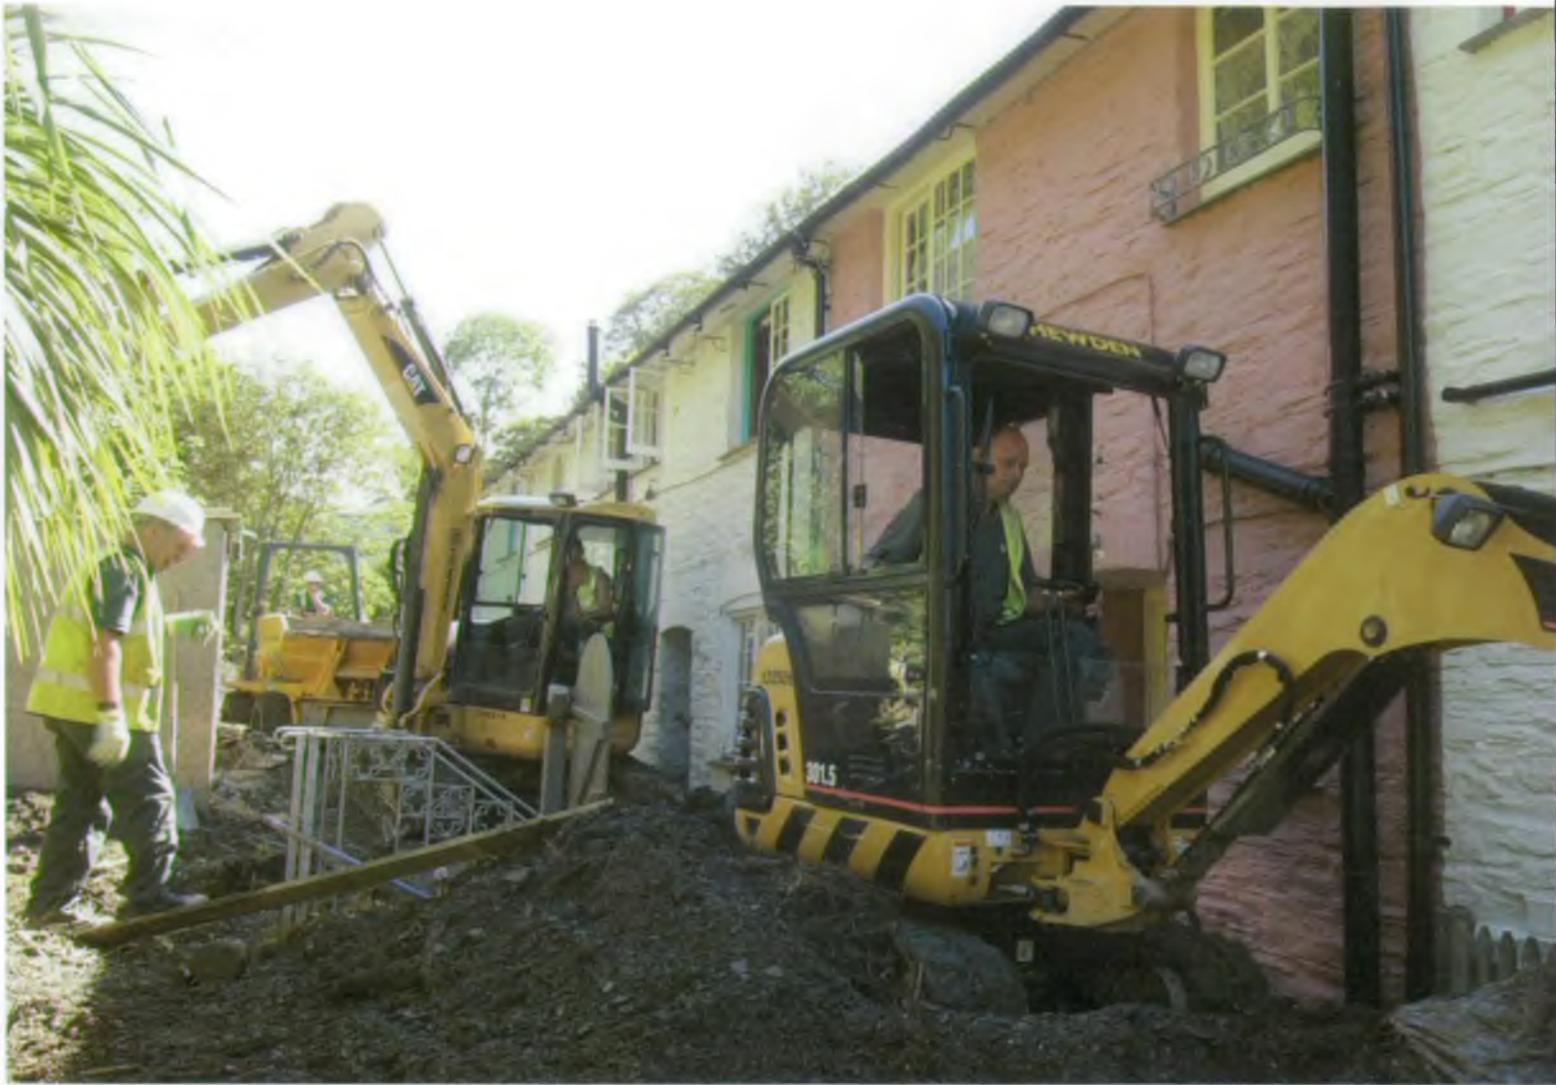
Environment Agency staff clear flood debris behind Marine Terrace in Boscastle

- We helped advise the immediate emergency and rescue response, working with the local authority, emergency services and other organisations.
- We carried out emergency works at Marine Terrace on the River Jordan clearing the culvert and debris.

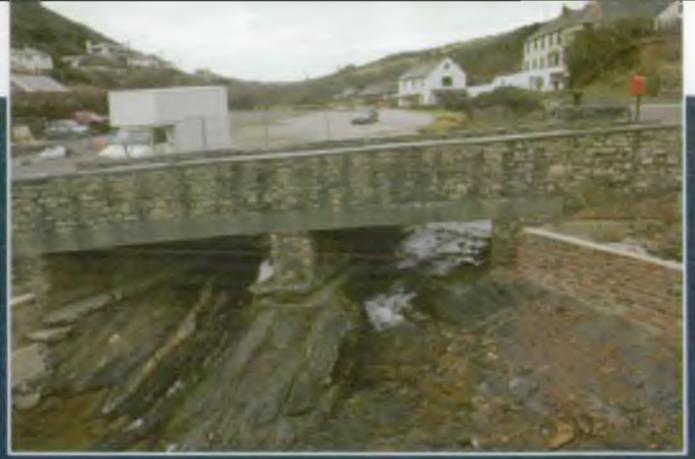
Repaired: The road bridge at Crackington Haven which was badly damaged in the floods

Extremely fast flows in both streams eroded not only the banks but also the bridge over the Pengold Stream and undermined the foundations of the main road bridge.

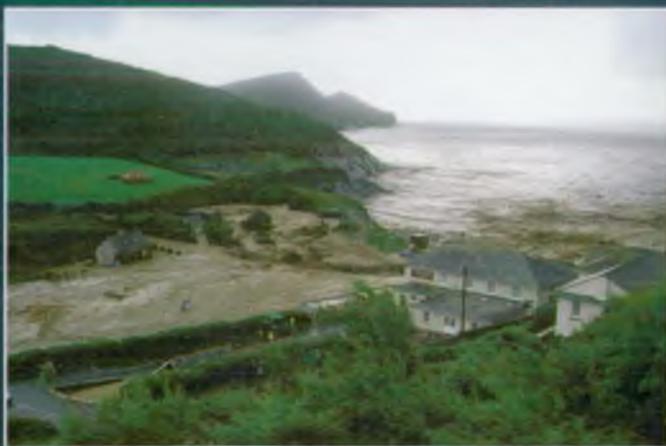
Hydrology consultants HR Wallingford recreated the flood using a computer model. The results suggested that the rapid blocking of the lowest bridge on the Crackington Stream would have made the water level rise rapidly by about 3m (10ft).

Debris washed down the Crackington Stream by floodwaters

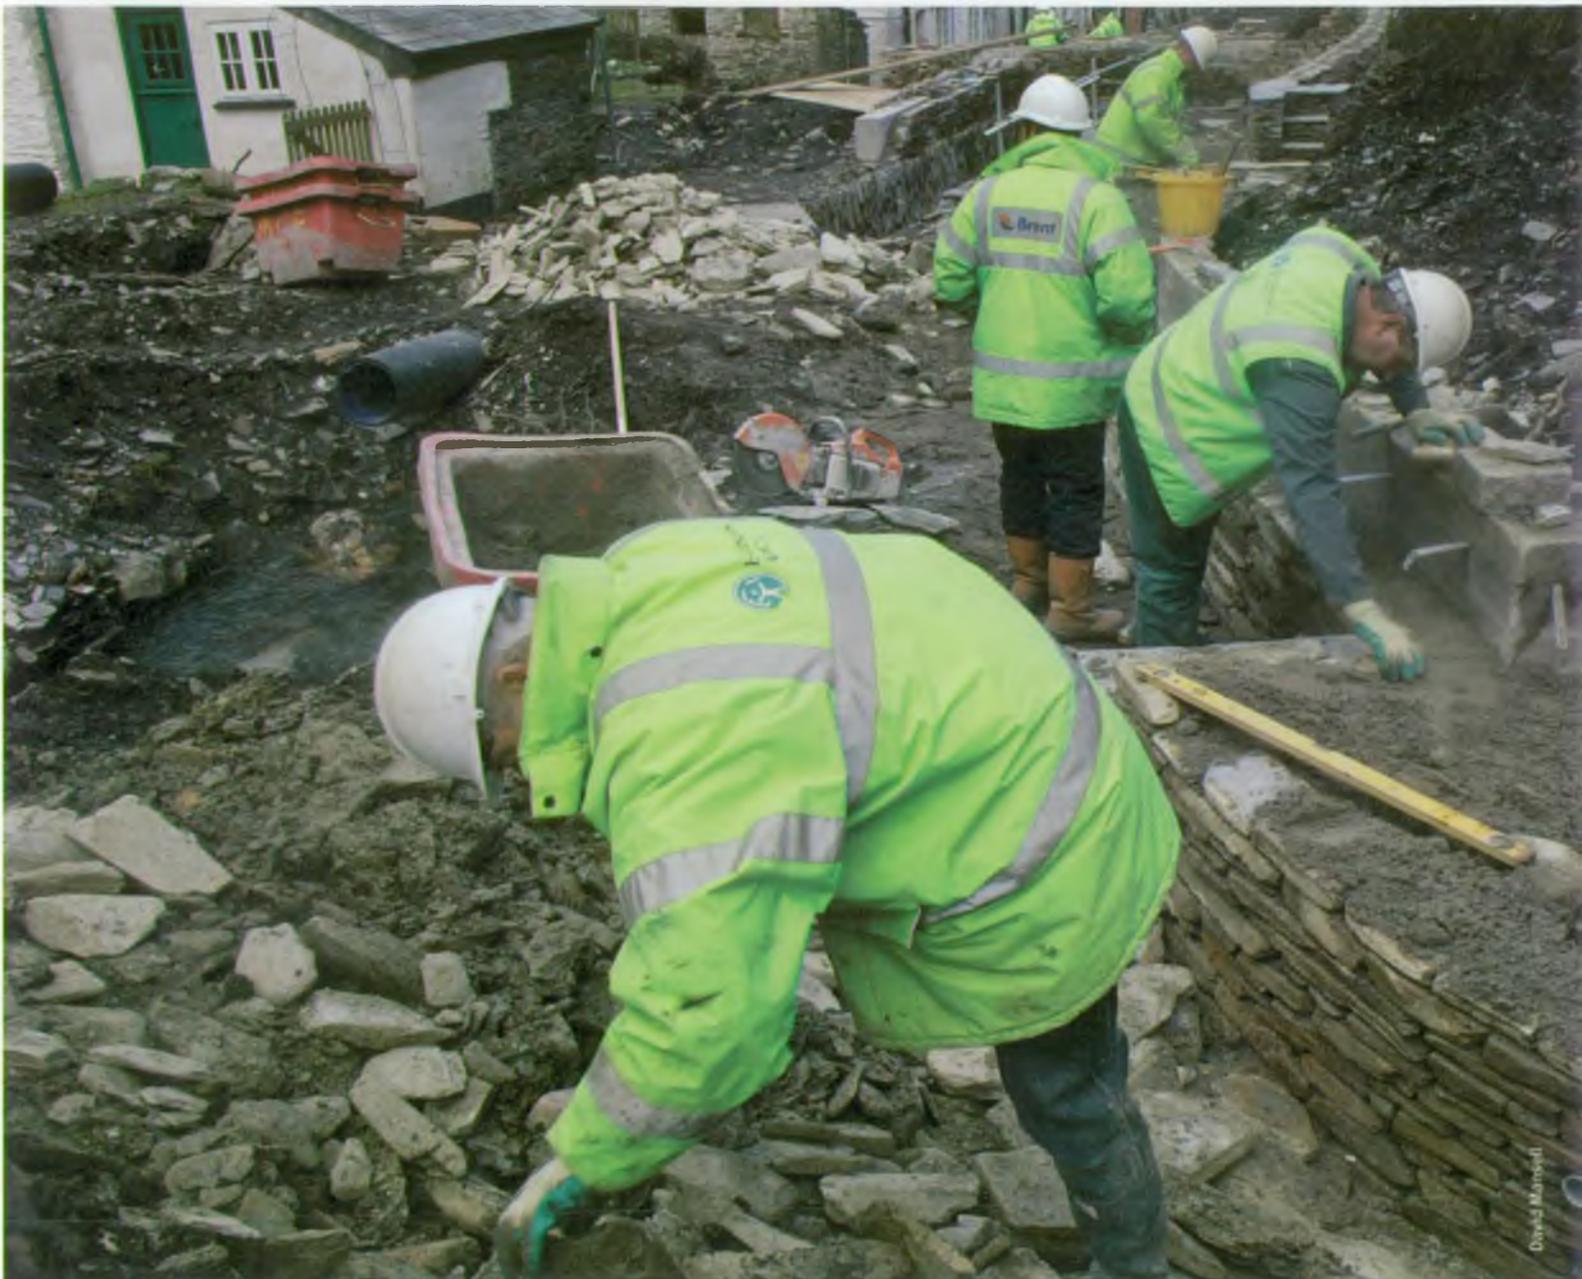
Environment Agency staff help rebuild stone walls above Marine Terrace in Boscastle

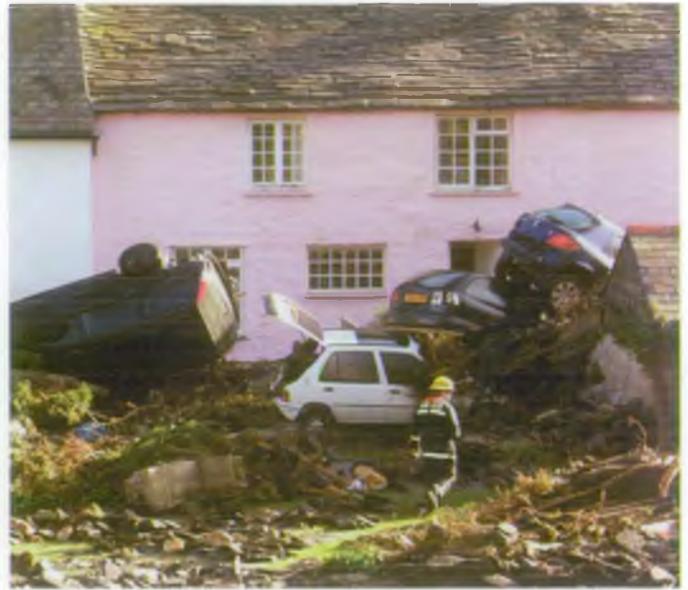
After the flood - cars piled on top of each other
