**RIVER DARWEN**  
**CATCHMENT REVIEW**  
**1984-1995**

**ENVIRONMENT AGENCY**  
**CENTRAL AREA ECOLOGY**  
**NORTH WEST REGION**

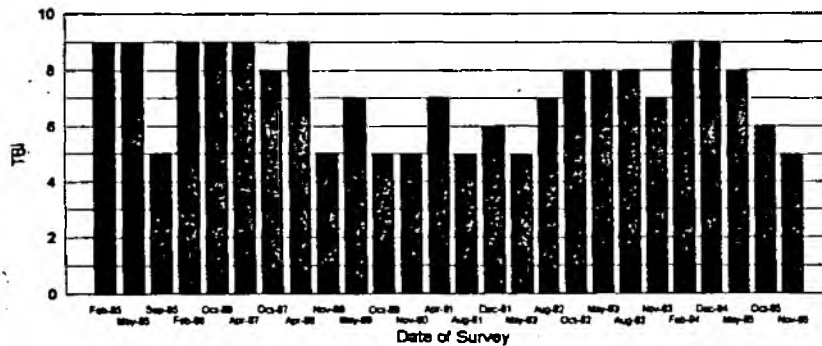
# River Darwen u/s Hardman Way.

This site shows much fluctuation in ASPT, BMWP and TBI. In October 1989 there is indication of a toxic pollution. This had a devastating effect some 20km downstream, with some dead invertebrates being found at Cann Bridge. However, this appeared to have recovered by April 91. In Aug 91 the inferred NWC dropped from class 2 to 3 as a result of organic pollution, recovered and dropped again from a class 1B to 3 in Oct 95 for the same reason. The current survey shows that this site has still not regained its former water quality and is fluctuating between a class 2 and 3.

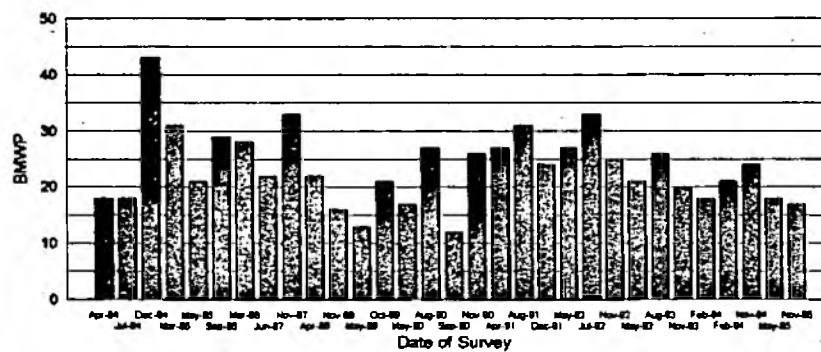
**101.00**

This site appears to follow the same pattern as that found at Site 99. The ASPT and TBI are more steady over time showing that some of the effects of the upstream site may have been buffered by Blackburn STW. However, due to said STW, the site does suffer from organic pollution and sewage fungus problems.

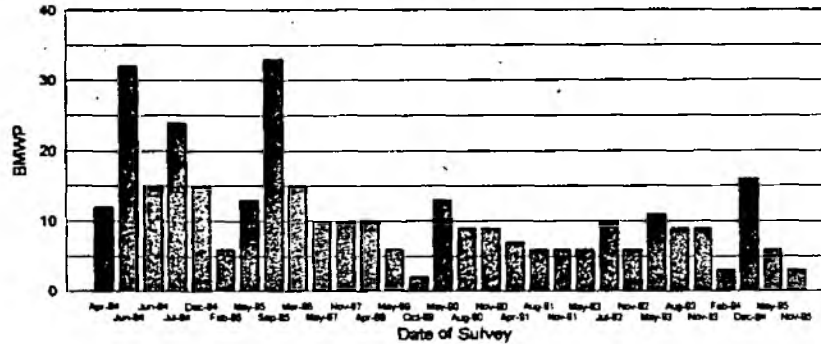
# Hole Brook d/s Blackburn STW

Hole Brook is suffering from continual deterioration in water quality. The trend appears to have started in Feb 85 with ASPT, BMWP and TBI all decreasing significantly. In Nov 95 the class dropped further from 3 to 4 as a result of gross organic pollution. There were massive growths of sewage fungus covering the majority of the bed and trailing vegetation. The Sept 96 survey revealed a class 4 result.

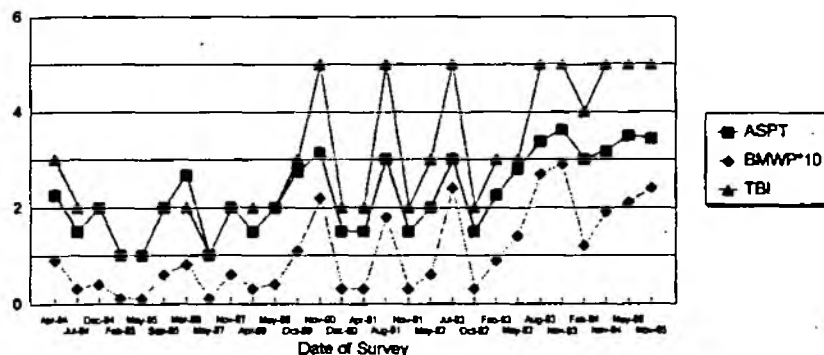
# Hennel Brook ptc R.Darwen

Prior to Feb 93, the ASPT at this site showed much variation and the BMWP was extremely low. This was due to organic pollution from a very active SSO. Since then there has been a marked upward trend and the brook appears to be recovering well. The brook now has a stable class 2 result.

The River Darwen catchment has many problems related to organic pollution. However, where the organic discharges are reduced, e.g. Hennel Brook ptc R. Darwen, a significant (and sustained) improvement has been noted. If this problem was addressed, and the highly urbanised sections of watercourse physically improved habitat wise, the River Darwen catchment should be capable of supporting a stable NWC class 2 invertebrate population.
