W E L M O R E L A K E S L U I C E
R E C O N S T R U C T I O N

ENVIRONMENT AGENCY

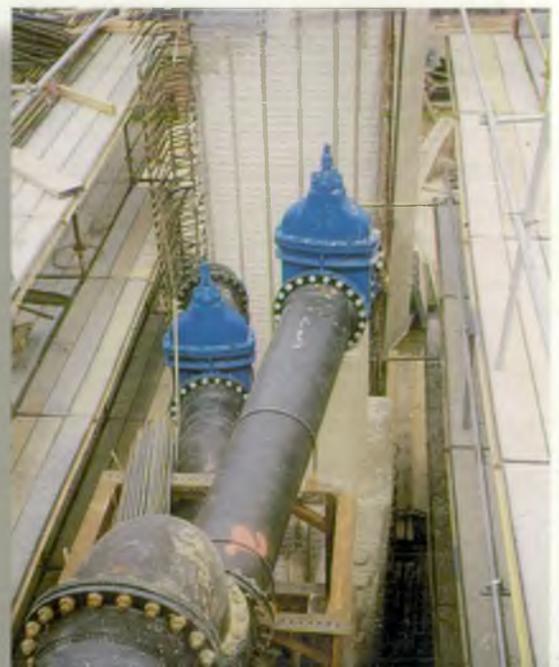
Pipework within the piers of the new sluice for land drainage pumping

- The new sluice incorporates two separate land drainage pumps, used to evacuate the last remaining volume of flood water which cannot be discharged by gravity into the tidal Hundred Foot River. Provided there are no high flood flows during spring and summer, which would cause the flood control sluices at Earith to operate, environmentally beneficial target water levels in the River Delph can be achieved and maintained.
- The permanent pumping facility replaces the temporary one which did not adequately discharge summer floodwater. The new installation, with a total of six discharge points, can also be used to facilitate the dispersal of silt in front of the tidal gates.

The permanent pumping installation utilises two submersible canister type pumps installed in chambers in the upstream end of the piers. Their combined capacity is 1.5 cubic meters per second.

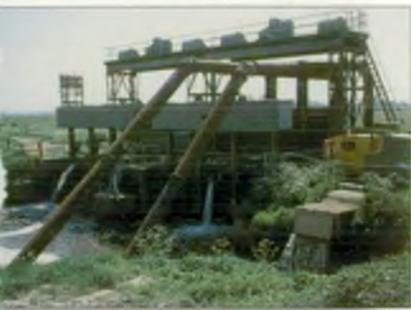
Temporary pumping at the 1933 sluice

Expensive temporary pumping equipment had to be used, particularly in the summer months, when gravity alone is not sufficient to get all the waters through and off the Washes.

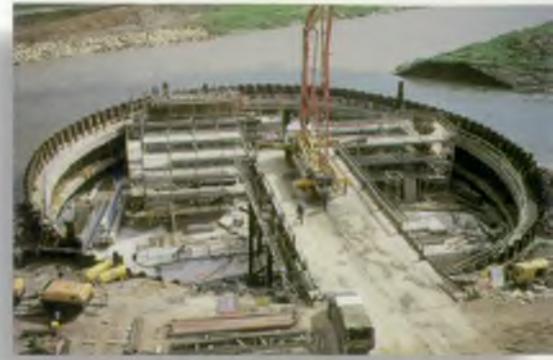
Temporary cofferdam

- Temporary cofferdam. A cofferdam is a watertight structure which allows underwater structures to be built in the dry. The new sluice was built within a temporary cofferdam, 45m in diameter. A length of the south bank of the River Delph was excavated to divert water flow around the cofferdam, thus ensuring continued management of the Washes during the rebuilding of the sluice.
- The sluice has three upstream vertical steel mitre gates, approximately 7.4m wide and 6.7m high, each weighing 25 tonnes.
- The three pairs of mitre gates, made of ekki timber, are 4.7m x 7.0m and each gate weighs 12 tonnes.

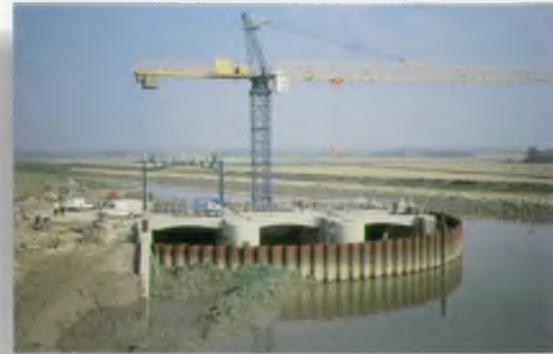
The new structure within the cofferdam

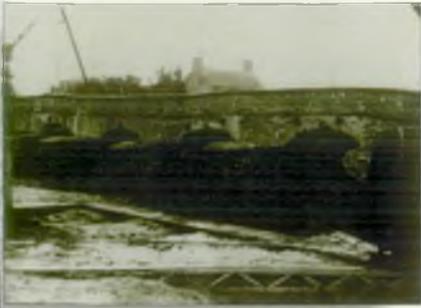
The 1825 sluice

This less than ideal method was used until 1825 when a sluice was first built at Welmore Lake. This was a timber and brick construction with four sluiceways, which lasted over 100 years.

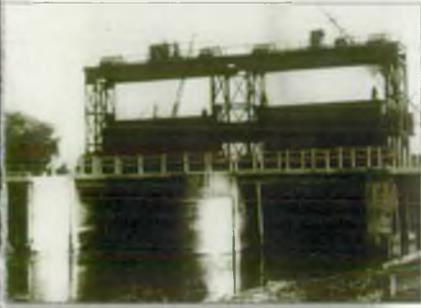
The 1933 sluice

A new sluice constructed from reinforced concrete and steel was completed in 1933. Although this later construction had only two waterway openings, these were bigger and more efficient than the four openings in the earlier construction.

The sluice was built upstream of the original structure to avoid tidal flooding during construction. Although this helped the construction work, it eventually created problems due to a build-up of silt. As the structure was now further away from its outfall into the Tidal River, silt began to build up immediately in front of the tidal flap gates which inhibited the flow of waters and prevented the tidal flap gates from opening when required. This resulted in the need for dredging during the summer period.

Over the years, the tidal flap gates became distorted because of their susceptibility to damage from trapped debris, resulting in inadequate protection against saline and silt incursion.

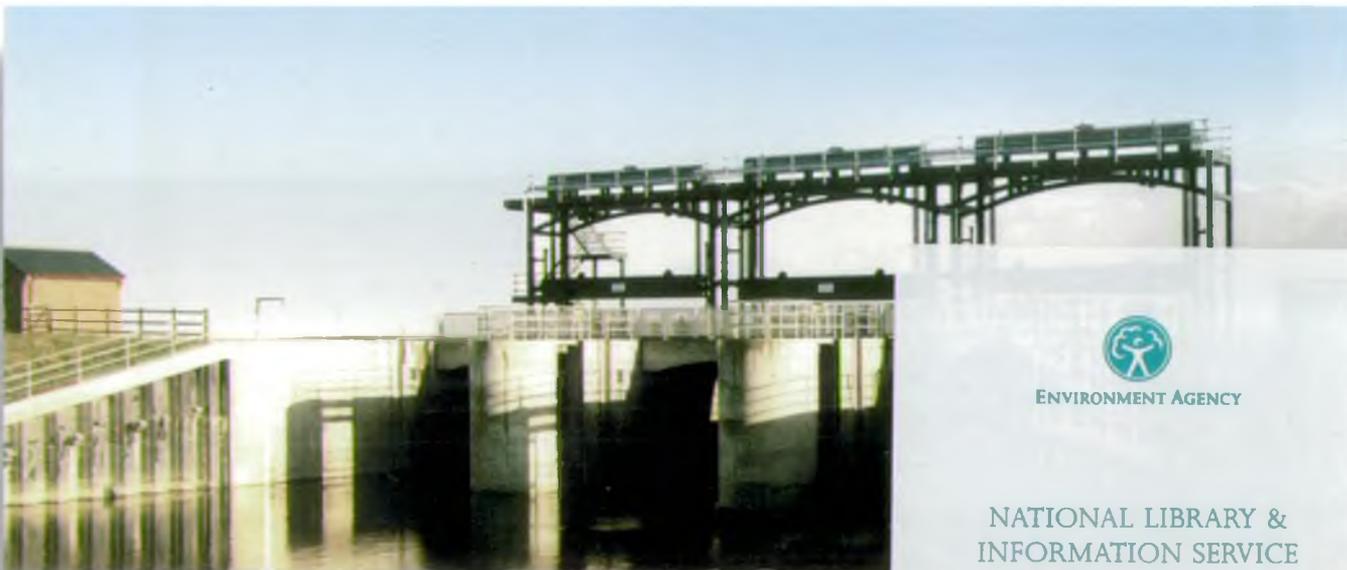
The completed structure - viewed from up stream

The new sluice discharges 50% more water than its predecessor. Its permanent pumping facility will improve the summer drainage of the Washes. Relocation of the structure along with the installation of silt jetting equipment will reduce the consequences of siltation.
