## ROUTINE BIOLOGICAL MONITORING OF RIVER QUALITY 1990

July 1992  
FWS/92/014

*National Rivers Authority  
South West Region*

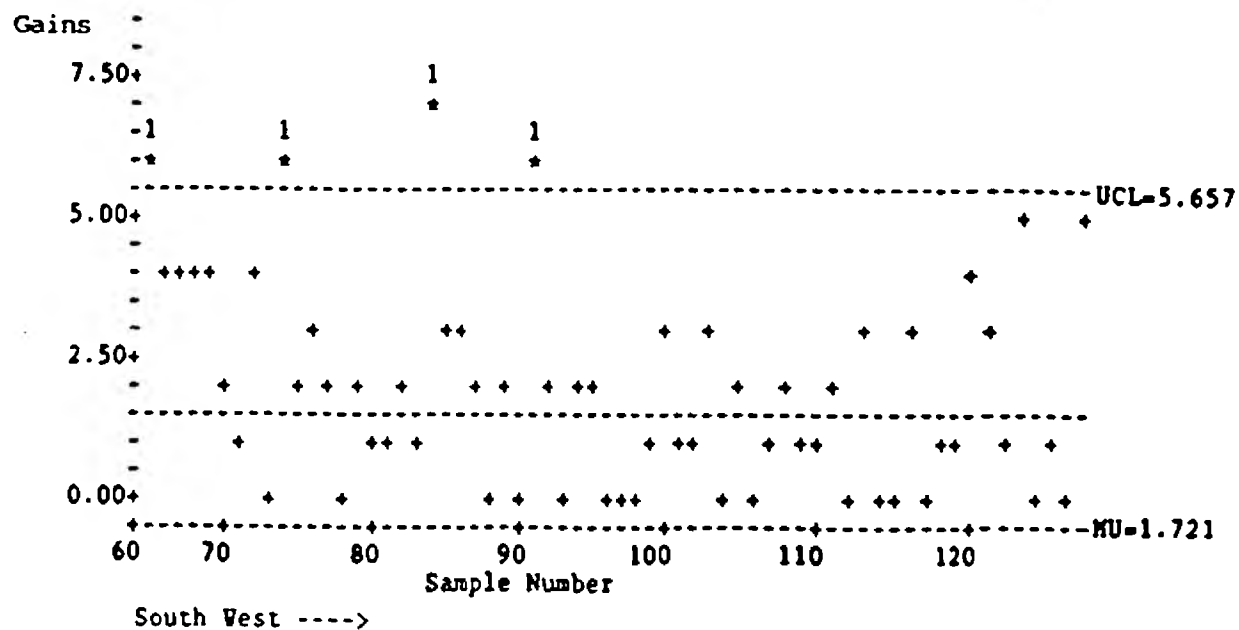
Figure 3.1 shows the variations between consecutive samples that were audited. Poorer results early in the programme reflect the lack of experience and training of staff. Very quickly the results improved as staff gained competence, and this was reflected clearly in the results for individual staff.

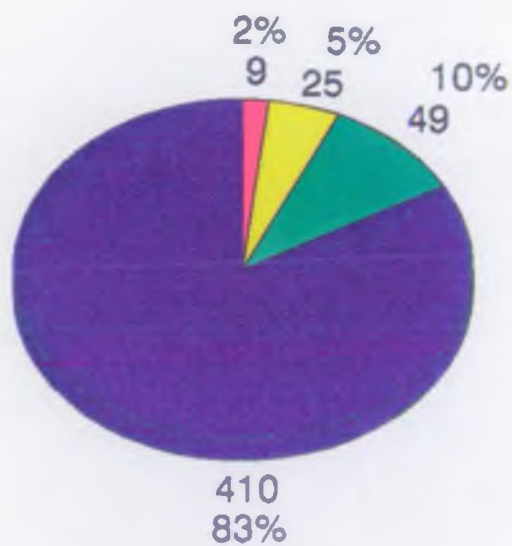
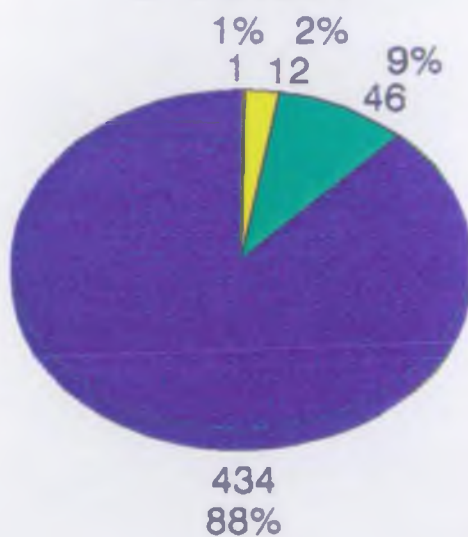
Figure 3.2  
in 1990

The biological quality of streams and rivers in the South West Region, as reflected in their macro-invertebrate communities, was generally good (Figure 3.2). Approximately 88% of the river length classified in 1990 was of good biological quality according to the overall NRA Biological Classification. The high proportion of good quality waters reflected the paucity of heavy industry in the Region, and the fact that most of the larger conurbations were near the coast and their sewage (representing that of approximately 70% of the Region's population) was discharged to the sea. The invertebrate fauna of the Region was particularly rich, which is probably a reflection of the mild maritime climate. Other biological surveys in the Region indicated that taxonomic richness at the family level was not always translated to richness at the species level.

Proportion of sites belonging to different ecological classes

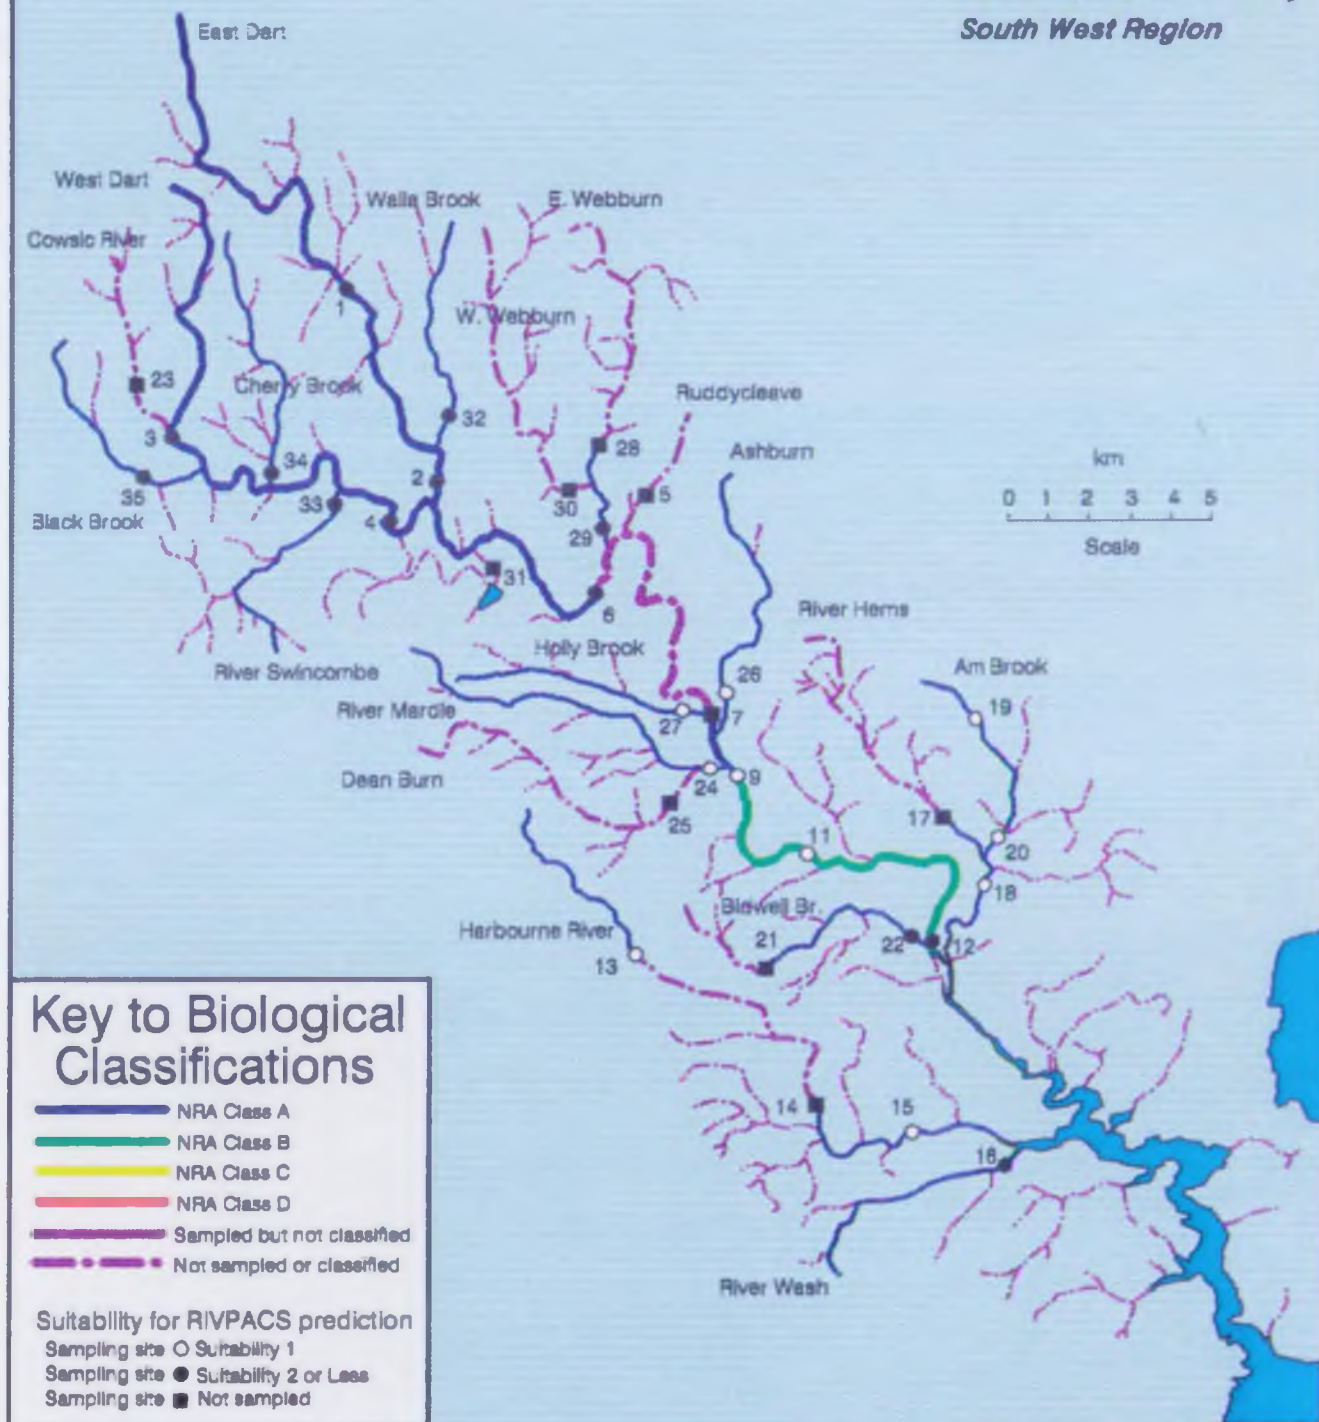
Figure 3.14 Dart Catchment (7) NRA Biological Class - 1990

The whole catchment was of good ecological quality, except for the lower reaches of the River Dart. At Buckfastleigh, the EQI N-fams indicated only moderate quality, though this was not supported by the overall NRA Biological Classification. The site was downstream from a disused metal plating works, which may explain the toxic impact that was apparent there. Poorer than expected taxonomic richness (as reflected in EQI N-fams) was also evident at the next site downstream, at Riverford Bridge, and this was reflected in its overall NRA Biological Classification of moderate ecological quality. The site was downstream from Buckfastleigh STW which discharges pesticides from a wool mill. The biologists reported difficulty sampling at this site, and this may have contributed to the poor taxonomic richness that was recorded there. The most downstream site on the River Dart, at Totnes Weir, was also of moderate quality, but here both the EQI ASPT and EQI N-fams were affected. This reach suffered from eutrophication, which caused algal blooms during the late Summer. This site was deep and was sampled by dredge, which gives more variable samples than the pond-net, which may have affected the results. Moreover, the site had a low RIVPACS suitability (suitability code 4, see Table 2.4), so the classification is of low reliability.

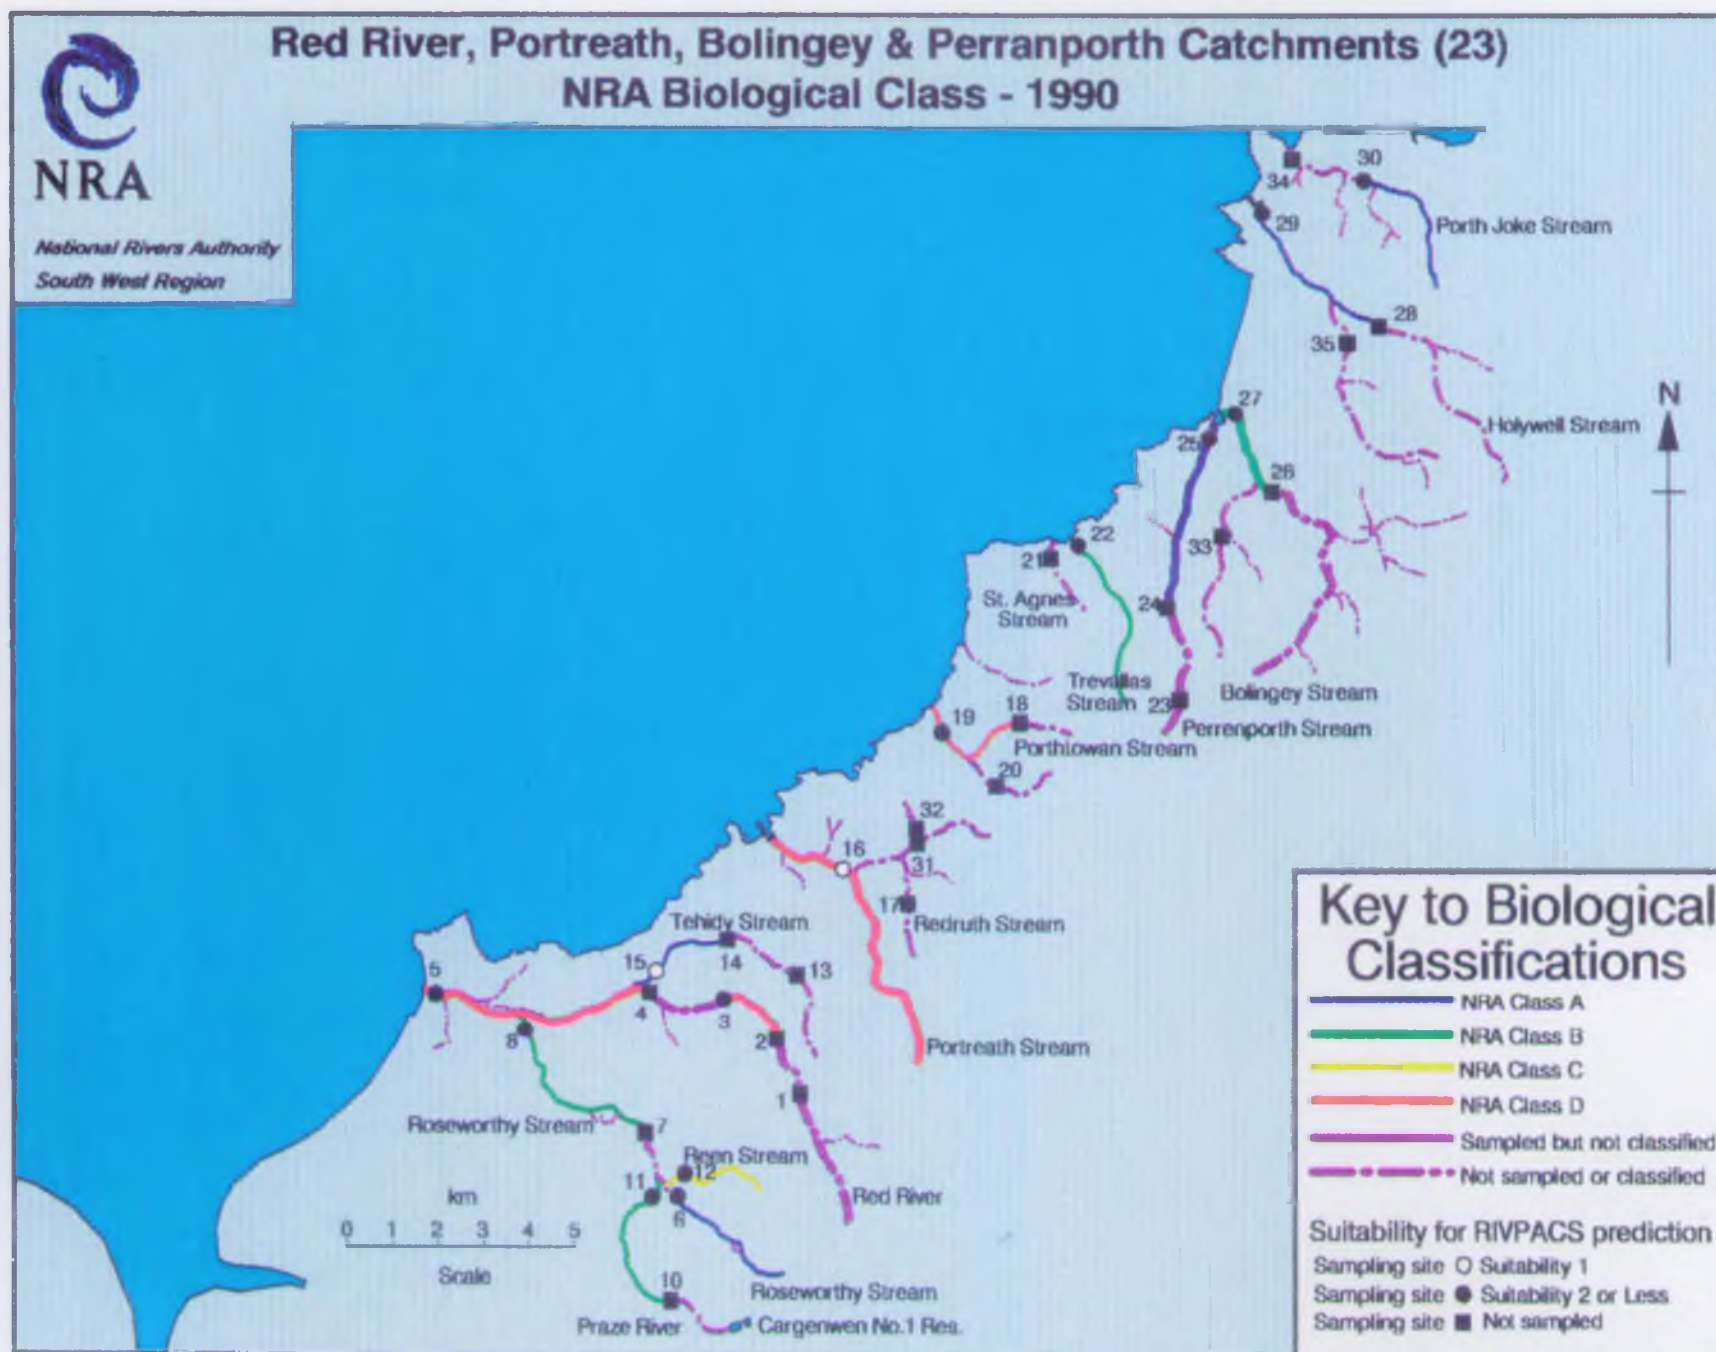
Figure 3.36 Red, Portreath, Bollingey and Perranporth Catchments (23) NRA Biological Class - 1990

This catchment included streams with some of the worst ecological qualities in the South West Region. At both sites on the Red River the overall NRA Biological Classification was very poor. In the upper reach monitored at Rosegroggan Bridge this was the result of mine drainage and storm-water overflows, and in the most downstream reach sampled from Gwithian Towans it was the result of both mining and organic pollution (at this site the very poor ecological quality was due to both EQI N-fams and EQI ASPT). Although it attained an overall NRA Biological Class of good ecological quality, Roseworthy Stream was classed as only of moderate quality on the basis of its EQI N-fams. The site was dredged in Spring 1990. The lower reach of the Praze River was of only moderate overall ecological quality owing to its EQI ASPT, which implicated organic pollution. Reen Stream was of poor overall ecological quality, largely because of poor taxonomic richness which may have been the result of channelisation, though mining influences were implicated in this reach's failure to meet its chemical River Quality Objective. Both the Portreath River and Porthtowan Stream were of very poor ecological quality according to their overall NRA Biological Classifications, largely due to very poor taxonomic richness, though both were also classed as of poor quality by their EQI ASPTs. Both watercourses are known to be affected by metalliferous drainage from disused mines. Trevellas Stream was of only moderate ecological quality owing to historic metal ore mining, the toxic influence of this on the macro-invertebrate fauna being evident in its moderate quality EQI N-fams. Bolingey Stream was of moderate ecological quality, and was subject to a number of influences including the effects of historic mining activity, dredging, and run-off.

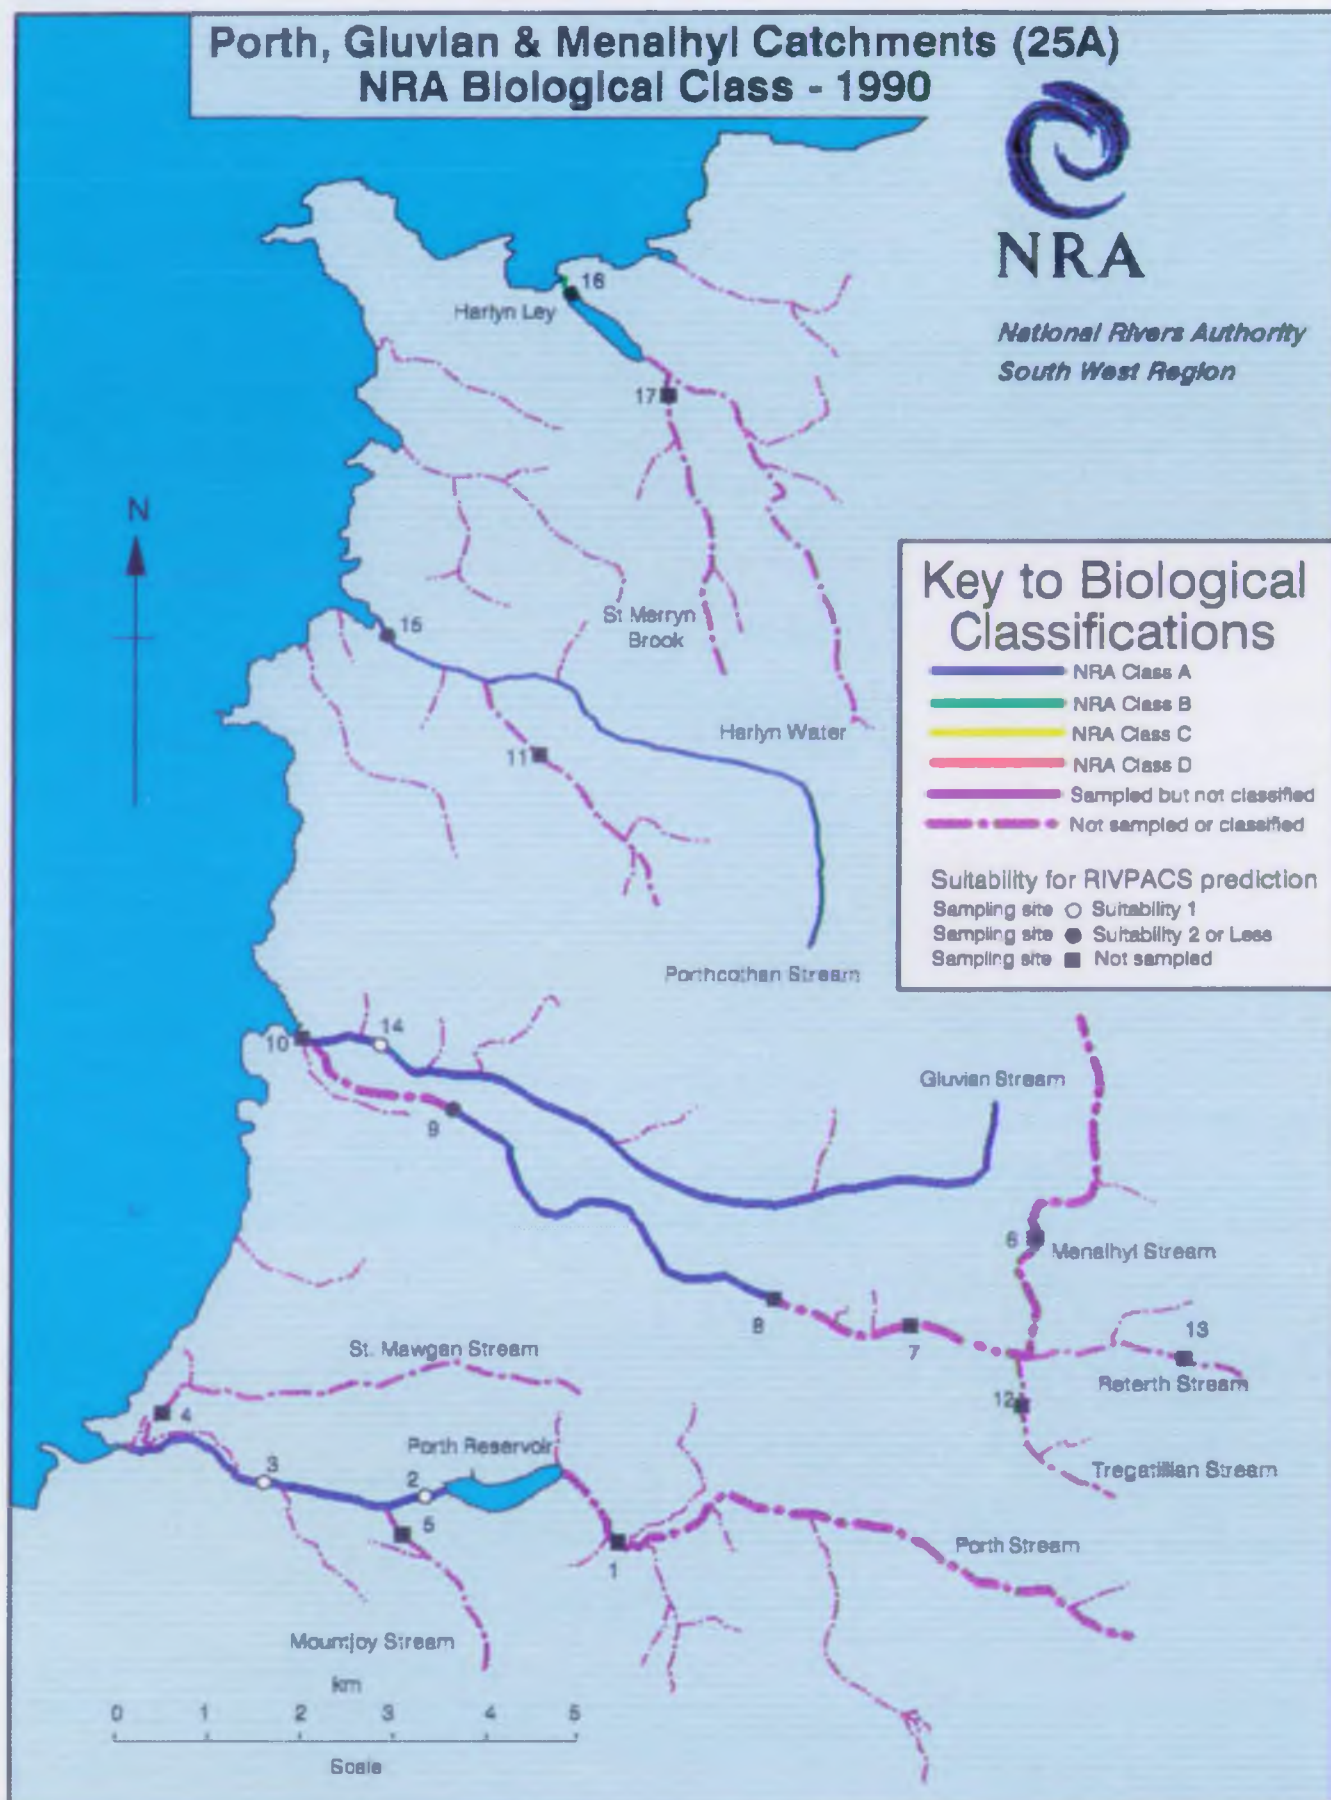
Figure 3.38  
Class - 1990

The watercourses in this catchment were of good ecological quality, except for the most downstream reach on Harlyn Water. This was of moderate quality owing to both its EQI ASPT and EQI N-fams, suggesting that organic enrichment was a problem. The reach was considered to have been affected by the drought, and by effluent from septic tanks. However, the biological monitoring site was in a reed-bed where the water was barely flowing and naturally rich in organic detritus: the site had a low RIVPACS suitability (suitability code 4, see Table 2.4), which would have reduced the accuracy of the classification. A new monitoring site is to be considered upstream from the lake on Harlyn Water.

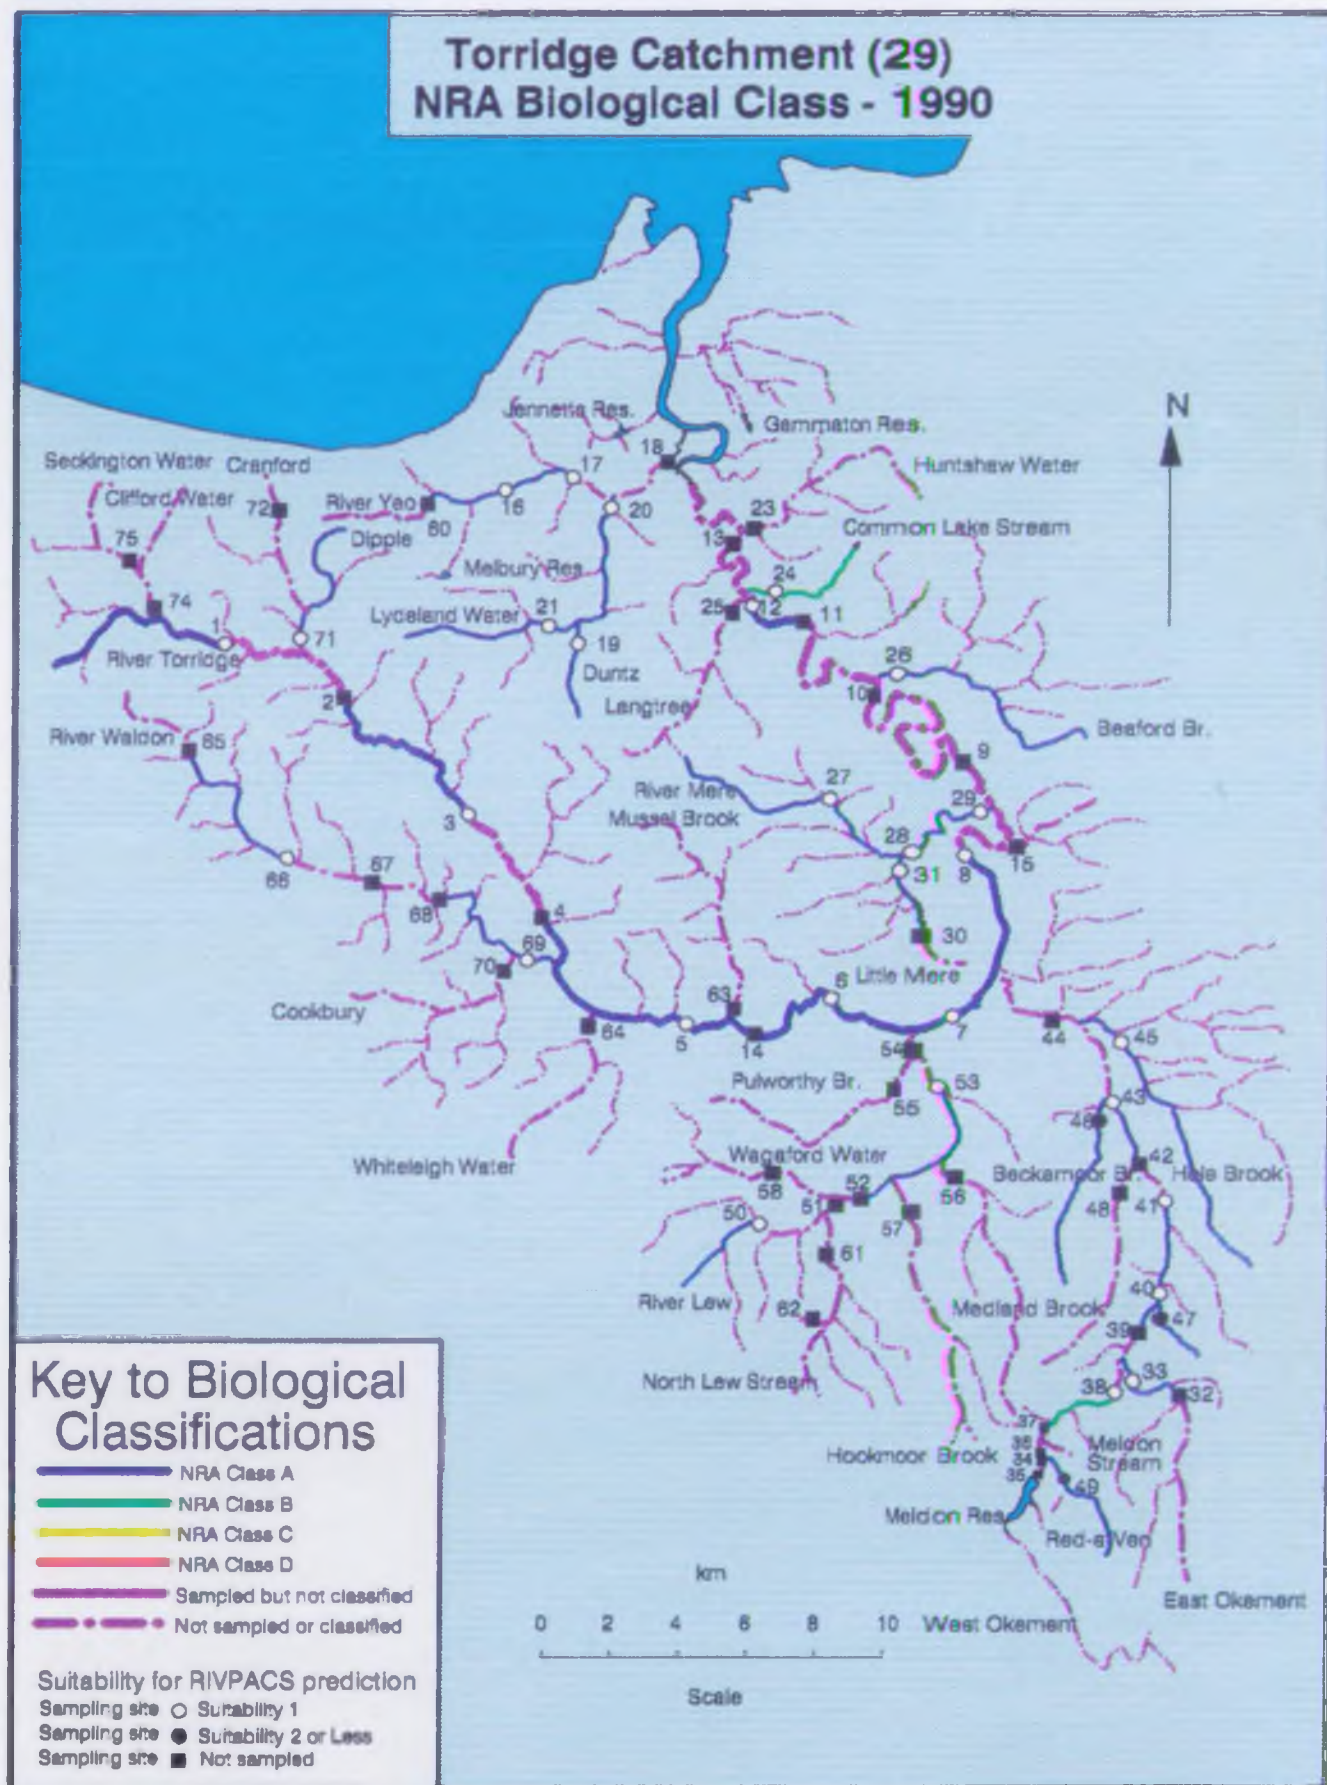
Figure 3.43 Torridge Catchment (29) NRA Biological Class - 1990

Most of the waters in the Torridge catchment were of good ecological quality. Common Lake was of only moderate quality because of organic enrichment from an abattoir. The most upstream reach of Mere Stream, although of good quality according to the overall NRA Biological Classification, was of only moderate quality according to its EQI N-fams. This stream was affected by ball clay mining. The West Okement at Okehampton was of only moderate ecological quality, and both were affected by acidic metalliferous discharges. The moderate quality of this reach of the West Okement was the result of poor taxonomic richness, which is consistent with the toxic effects of acidic and metal-rich waters. The stream bed was covered by ochre and fine sediment. Brightly Stream was of good ecological quality according to the overall NRA Biological Classification, EQI ASPT and EQI N-fams: this was surprising as it was known to be suffering from acidic metal pollution in 1990, particularly in its upper reaches (National Rivers Authority South West Region, 1991b).
