**A Study of the use of Glycol-based de-icers  
at RAF Lyneham and their impact on local  
watercourses during the winter of 1999/2000**

**North Wessex Investigations Team  
NWI/99/178**

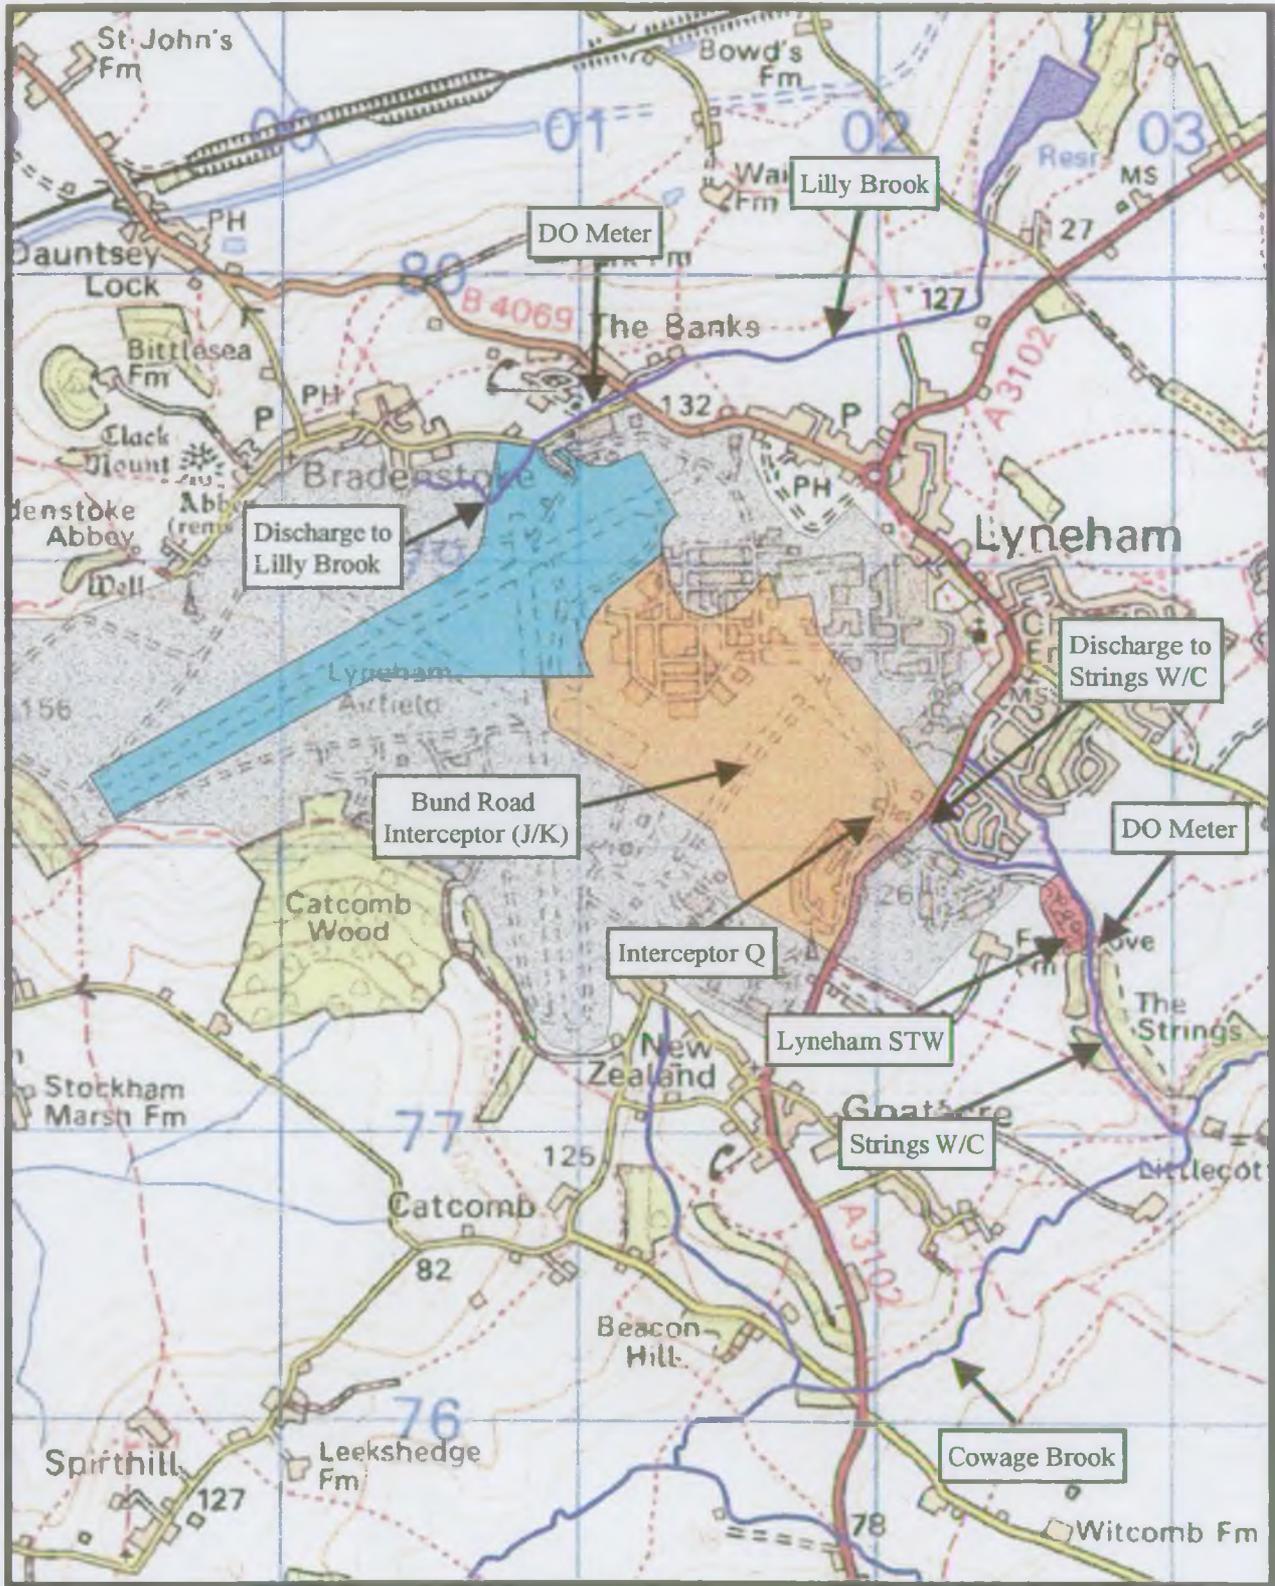
Figure 1 - Map of RAF Lyneham and local watercourses

Area drains to Lilly Brook
  Area drains to Strings W/C
  RAF Lyneham

The majority of the runway area drains to the Lilly Brook, a tributary of the Brinkworth Brook. The hardstanding where aircraft are parked and de-iced drains largely to the Strings Watercourse, a tributary of the Cowage Brook. Most of the discharges from the site pass through oil interceptors.

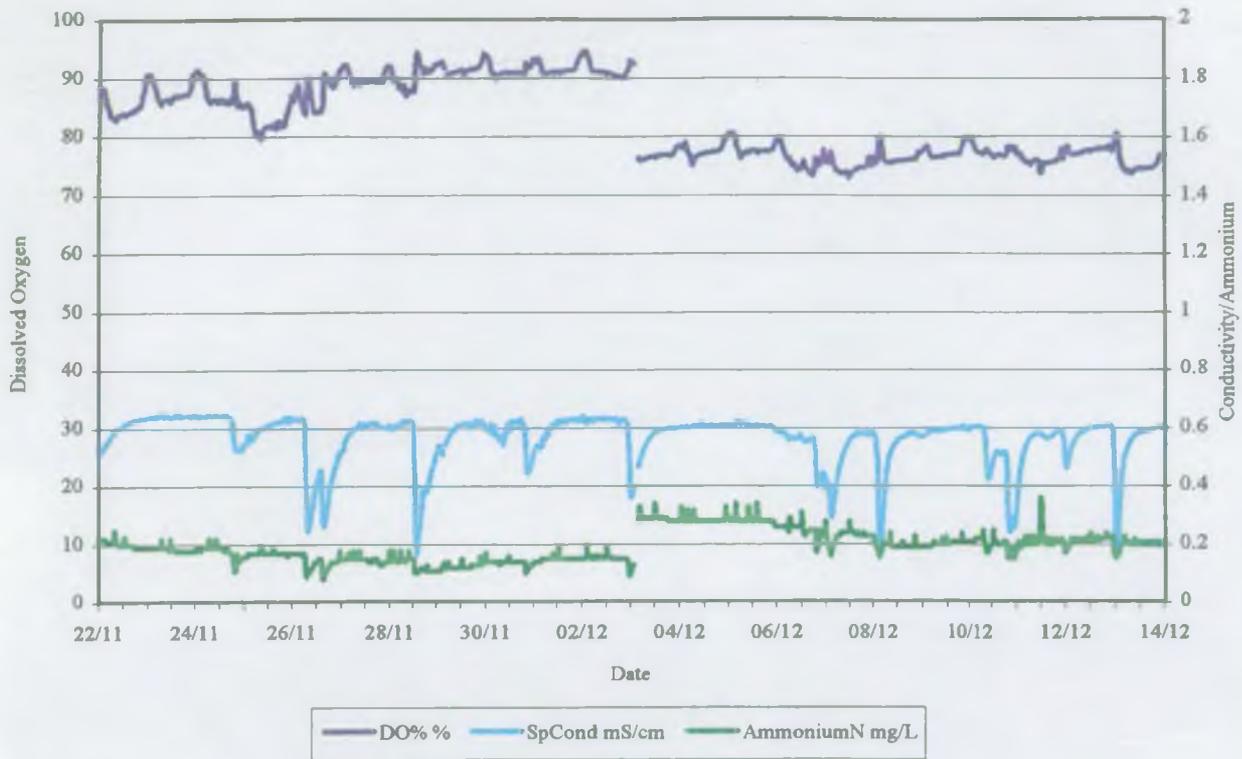
Lilly Brook 1/2 kilometre D/S RAF Lyneham

Figure 2 - Continuous Monitor Results

At both sites, no significant effect was found on the D.O. concentrations despite the use of de-icers during the monitoring period. In particular fairly large quantities of Konsin were used which might have been expected to deplete dissolved oxygen concentrations in the Lilly Brook.

It is possible that the de-icer had not made its way through the drainage system to the brook during the monitoring period or that oxygen demand of the de-icer did not impact on the brook until further downstream. It is likely that the low ambient temperature during this period would suppress the oxygen demand on the stream caused by a discharge of de-icer.

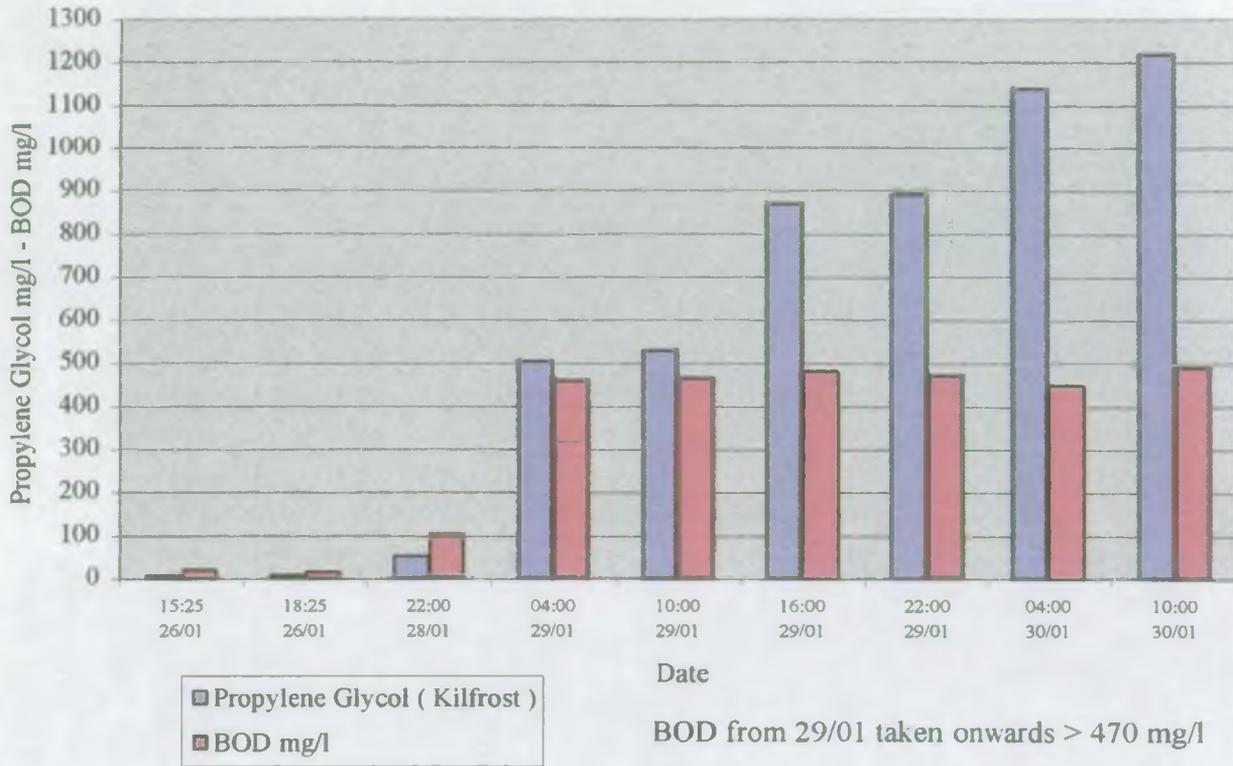
RAF Lyneham - Bund Road Interceptor

Figure 3 - Sample Results

The results of the samples taken from interceptor J/K showed very high concentrations of propylene glycol toward the latter period of sampling. The BOD concentration of the samples increased proportionally with the glycol concentration, but due to the limited number of dilutions that could be made by the lab, several of the results were over-range. The BOD concentrations were, however, very high.

Large quantities of Kilfrost had been used on the morning of 27/01/00 (6150 litres), so it appears that there was a delay of about 48 hours before the Kilfrost reaches interceptor J/K.

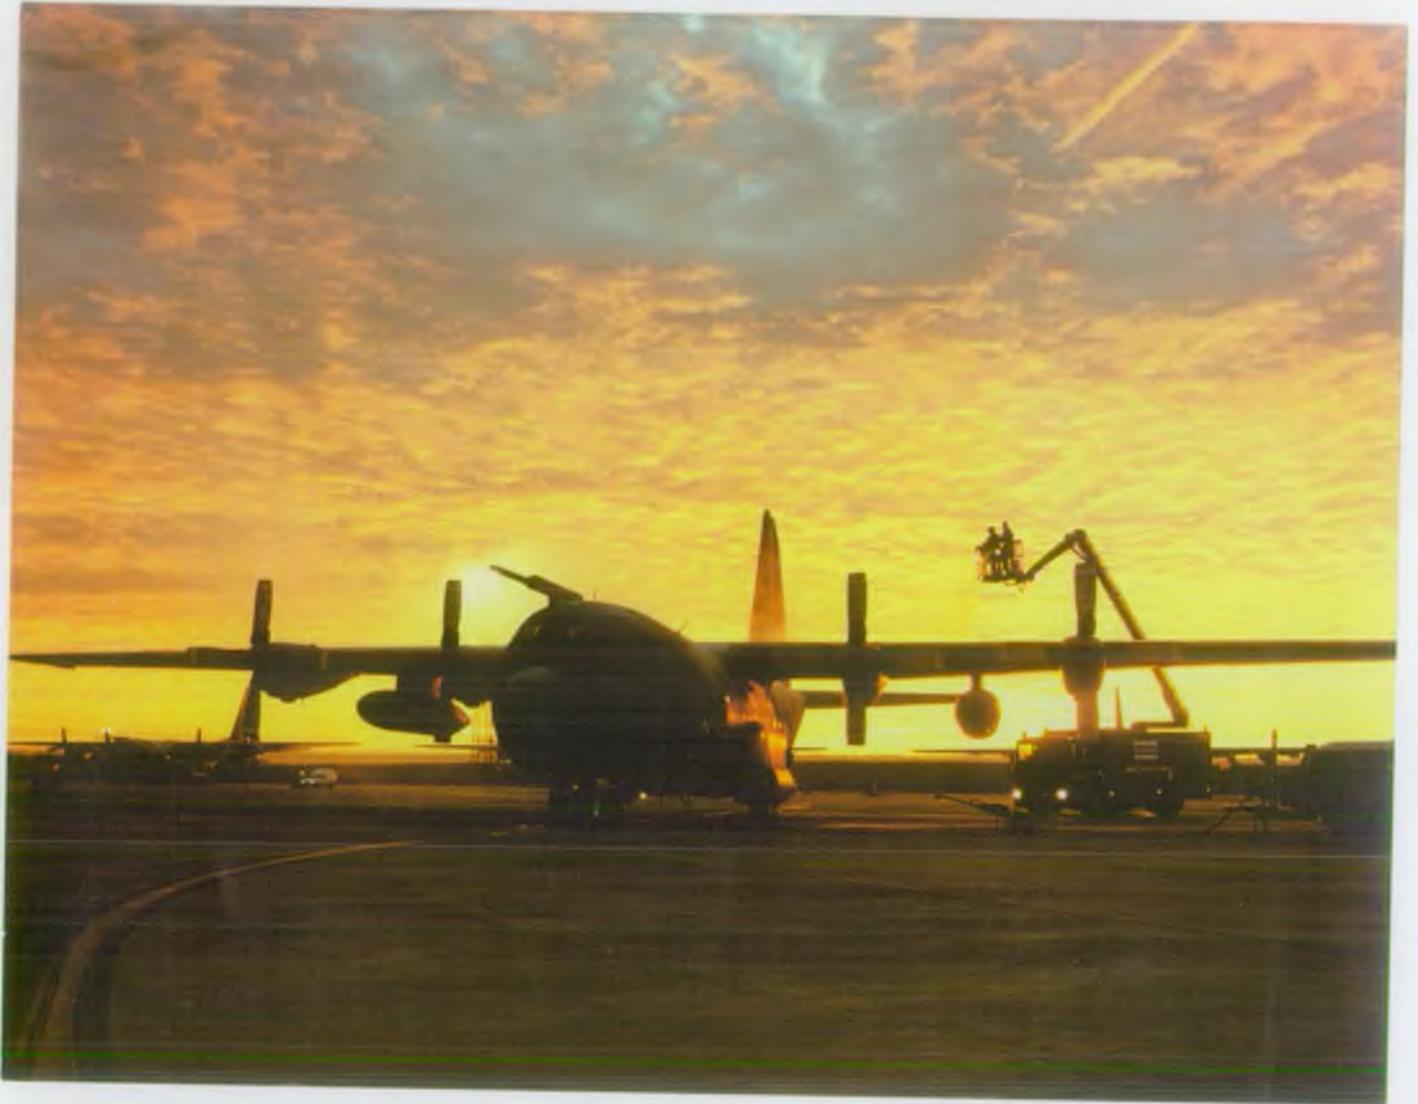
PLATE 1 – De-icing a Hercules Aircraft with Kilfrost at RAF Lyneham
