**River Deben Alleviation
of Low Flows Scheme: An
Environmental Appraisal**

Final Report

May, 1994

Report No 94/3/821

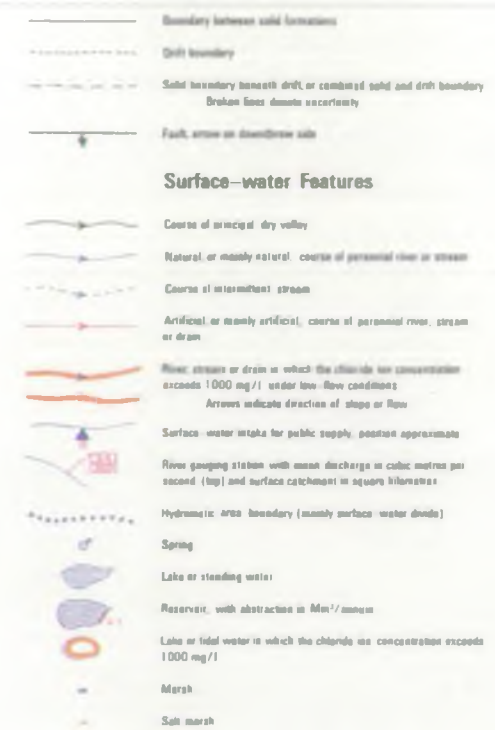
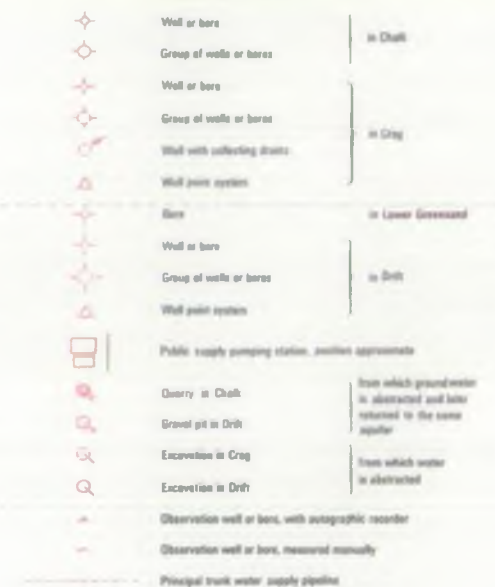
Figure 3.20 Geological and Hydrogeological Map of the River Deben Catchment (Scale 1:50,000)

Reproduced with permission, from BGS hydrogeological map of Southern East Anglia
