NATIONAL RIVERS AUTHORITY

SEPTEMBER 1991

VISIT TO DANISH COASTAL AUTHORITY

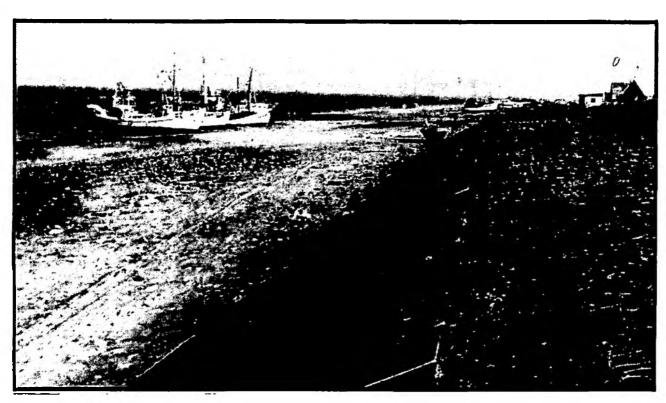
In front of the machinery house the revetment was constructed with a smooth frontslope covered with sand for better operation of the haul system. The remaining part was built with toplevel +5.0 m and frontslope 1:2.

Lild Strand, revetment

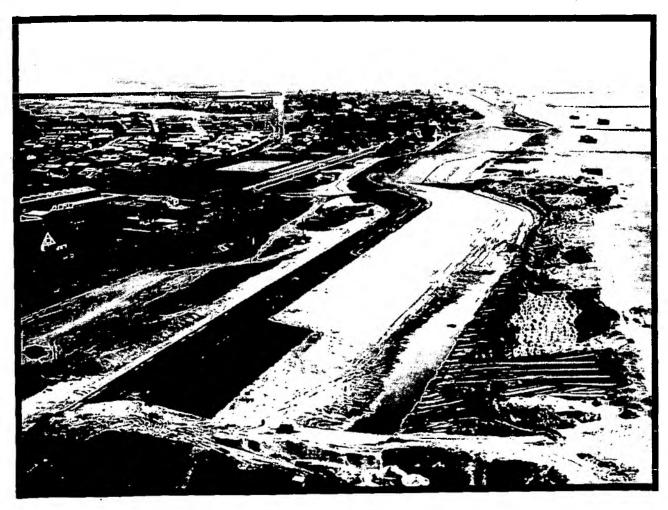
Asphalt coating of sea dike at Thyborøn carried out 1974-75
