NATIONAL RIVERS AUTHORITY

RIVER RAY, OXON

FISHERIES SURVEY

1989

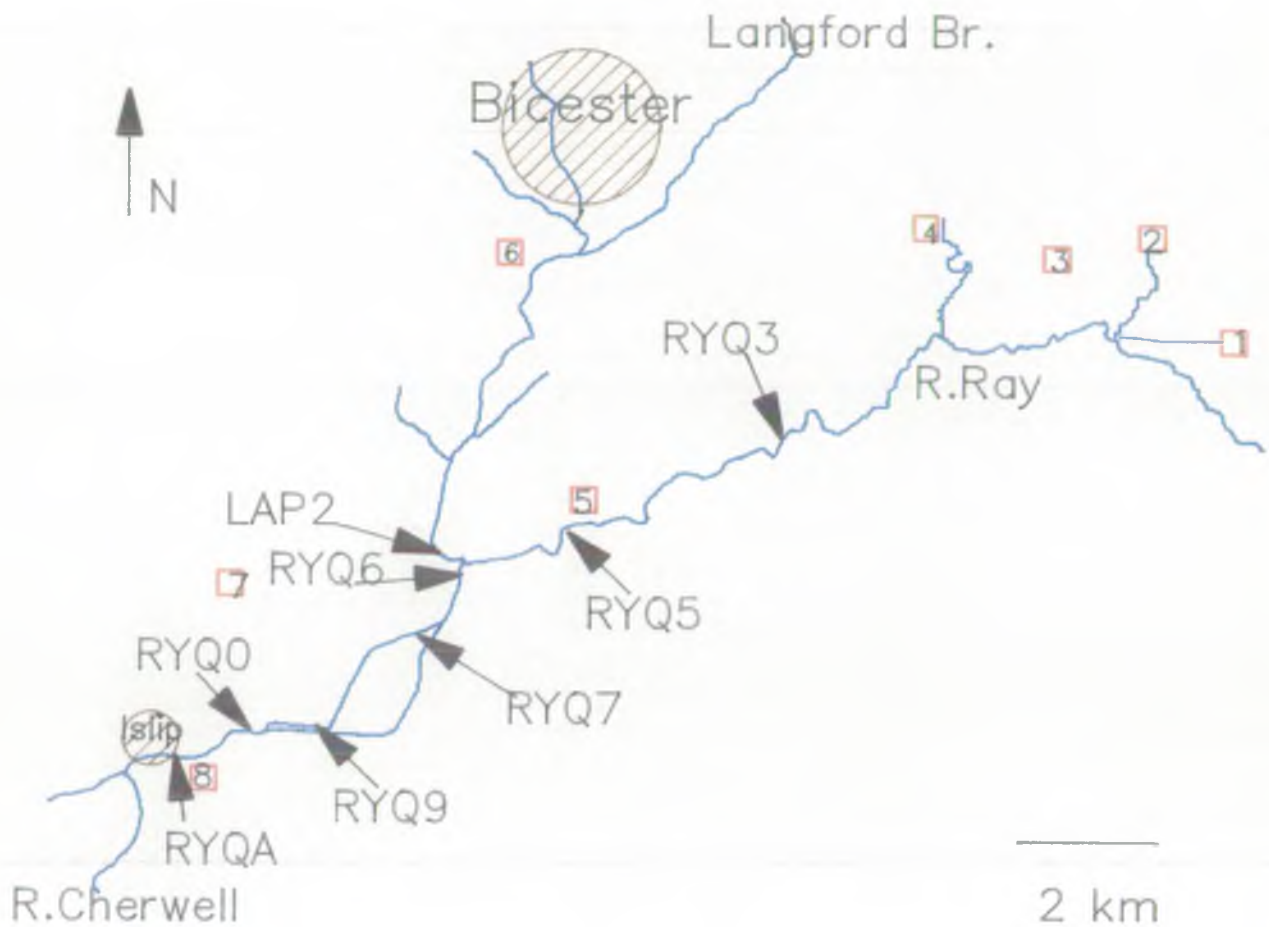
Fig 2.1 Map of River Ray

- – Consented Discharges (> 100 cu.m./day)
- (1) Grendon Underwood STW (2) Charndon STW
 - (3) Marsh Gibbon STW (4) Launton STW
 - (5) Merton STW (6) Bicester STW
 - (7) Weston on the Green STW (8) Islip STW

➔ – Fishery Survey Sites

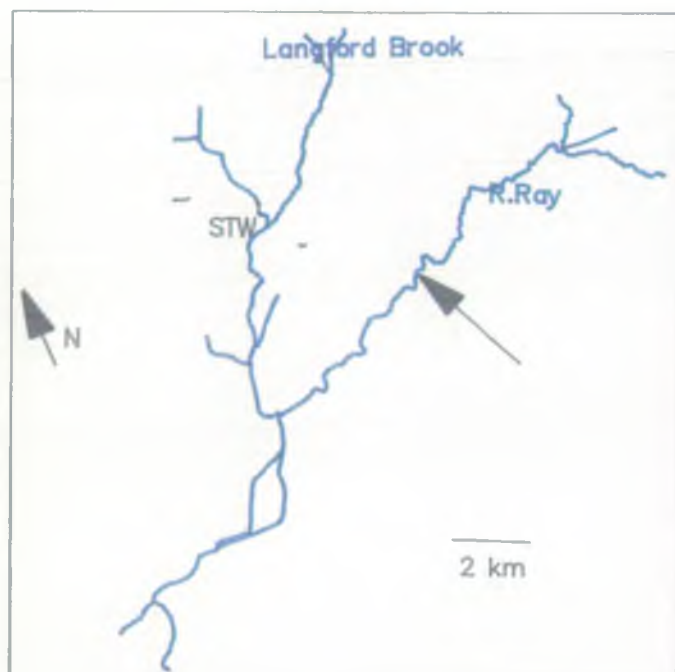
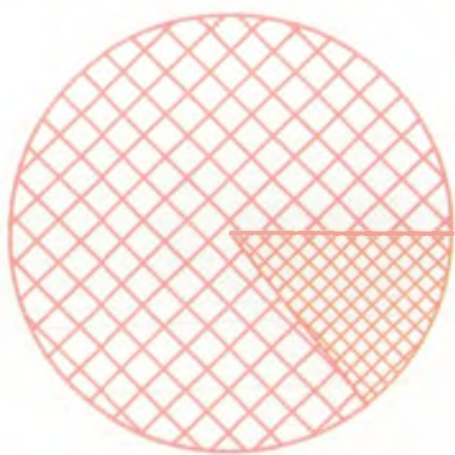
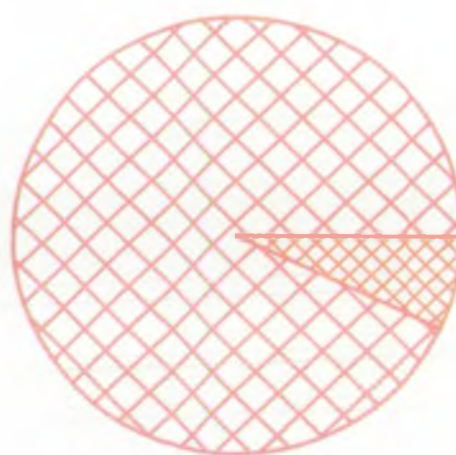
Site RYQ3 (Arncott) Biomass and Density

COMMENTS: No upstream run due to abundant vegetation and overhanging tree branch. Small numbers of cyprinid fry were observed. There was an abundance of invertebrates. The River Ray has been heavily modified for land drainage and the resultant paucity of habitat is probably responsible for the poor biomass of 4.3g/sqm. There is also a lack of diversity with the site being dominated by small pike.

Pike	3.7	0.054

Tench	0.6	0.004
TOTAL	4.3	0.058

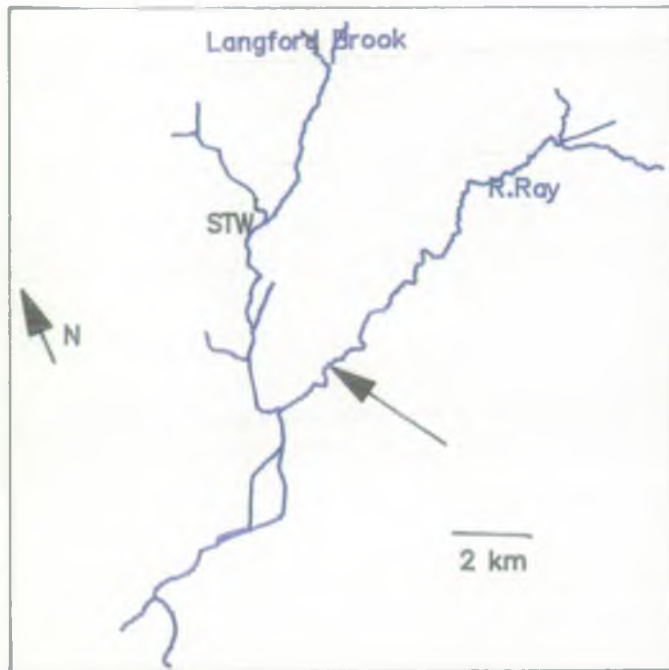
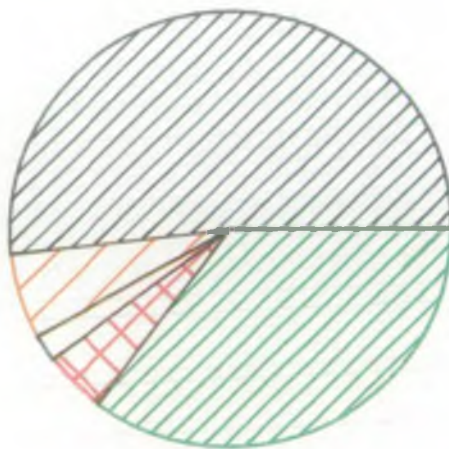
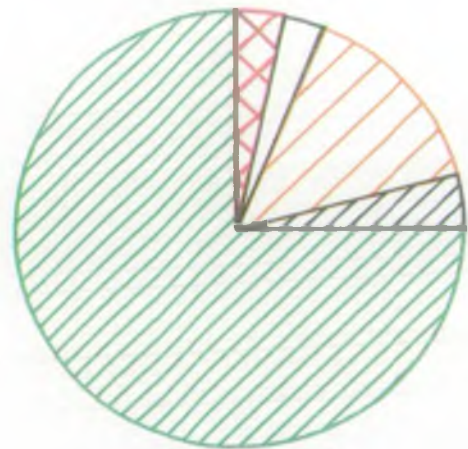
Site RYQ5 (Merton) Biomass and Density

COMMENTS: Minnows present. Masses of fry present especially roach. Some fish had lesions and there was a moderately high infestation of Blackspot. The biomass was extremely high at 91.7g/sqm (not including the huge numbers of fish below 6cm in length). Recruitment is obviously good. The fish were tightly shoaled, and it is likely that sections of river above and below the shoal would have had significantly lower biomasses.

Biomass (gm-2)	Density (nm-2)
  Bleak	0.0	0.001
  Bream	47.5	0.035
  Dace	5.8	0.131
  Gudgeon	0.0	0.001

Perch	1.8	0.025
  Pike	4.3	0.031
  Roach	32.2	0.666
TOTAL	91.6	0.890

The river changes at Merton STW due to the increased size of river and the assured flow. The site below the outfall produced an incredible 91.6g/sqm of fish, the majority of which were caught immediately below the outfall. It is likely that this result is not typical of the section and that further downstream fish populations would be much lower. This phenomenon of high fish density directly below STW outfalls has been observed on previous surveys including the Wiltshire Ray at Swindon STW, the River Wye at High Wycombe, the River Thames at Aylesbury and the River Cherwell at Banbury.

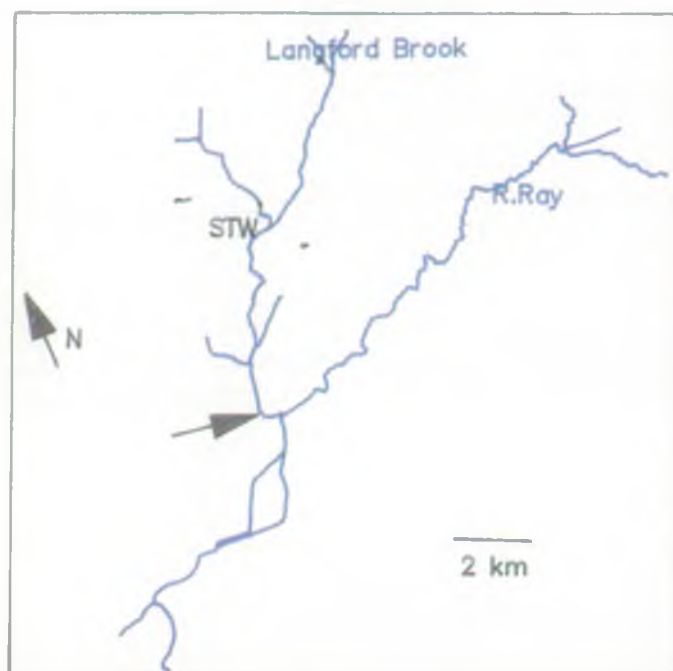
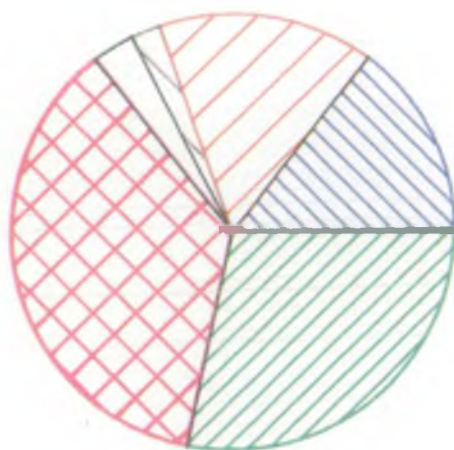
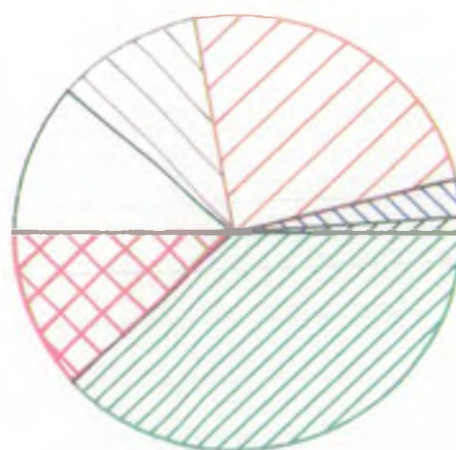
Site LAP2 (Langford Brook) Biomass and Density

COMMENTS: Thousands of 1st year roach fry as well as fry of other species. Stoneloach common. The biomass of fish was 20.4g/sqm, this does not include fish below 6cm long. It appears that this is an excellent spawning/nursery site. The brook receives effluent from Bicester S.T.W. but is able to support a fishery due to the relatively constant flow. Re-aeration is assisted by small weirs and riffles. There is some silt but not as much as in the River Ray below the confluence (site RYP6).

Roach	5.7	0.095
TOTAL	20.4	0.252

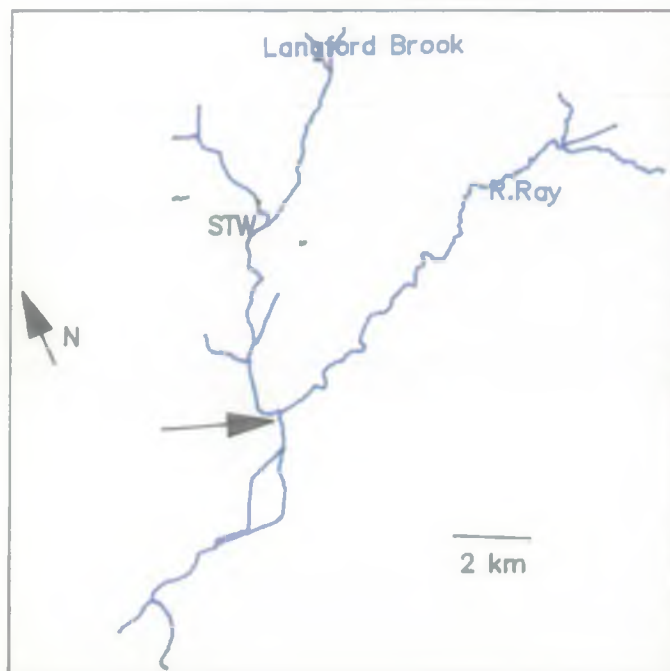
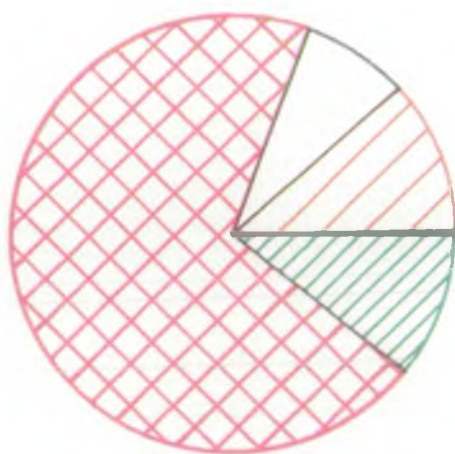
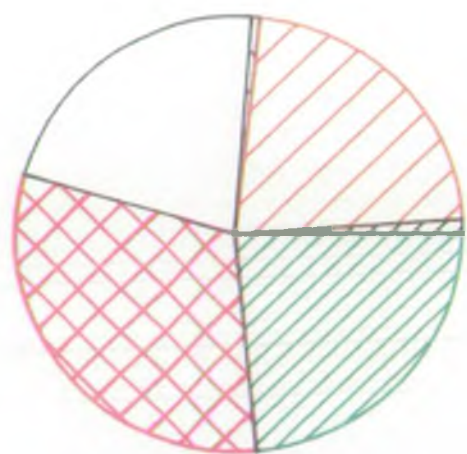
Site RYQ6 (Langford Brook Confluence) Biomass and Density

COMMENTS: Stoneloach were present. Many of the roach had blackspot. There was an abundance of snails. We fished for a short distance upstream and caught a number of quality pike and perch. The habitat was much better above the Langford Brook confluence being narrower with a clean bed and more natural banks.

The survey site biomass was 17.9g/sqm which is lower than the target for cyprinid waters (20g/sqm N.R.A. Thames Region current levels of service). The biomass was composed largely of small pike. The generally poor fish population is probably due to poor habitat and water quality. The water quality is generally poor due to Bicester S.T.W. which discharges to the Langford Brook. The Brook is generally fast flowing and so maintains reasonable oxygen levels. Suspended solids brought down by the Langford Brook are deposited when they reach the slow, overwide River Ray. As a result oxygen levels in the River Ray can fall dramatically in summer. The site also suffered from a farm pollution in June '87 which killed a significant number of fish.

Another factor in 1989 has been the construction of the M40 which crosses the River Ray a short distance upstream of this site. The river has at various times been impounded, abstracted and received polluting discharges without consent, by the Motorway contractors.

Bream	0.1	0.002
  Dace	2.0	0.041
  Gudgeon	0.1	0.001
  Perch	1.4	0.040
  Pike	12.5	0.057
  Roach	1.9	0.043
TOTAL	17.9	0.207

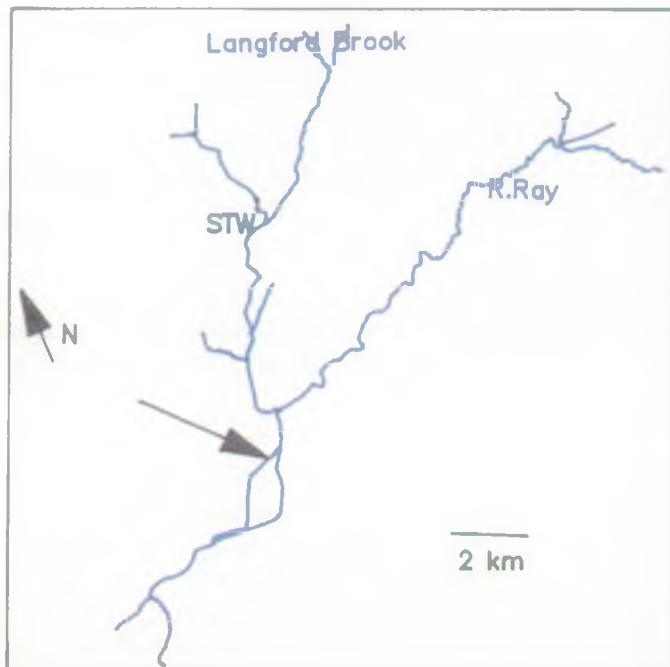
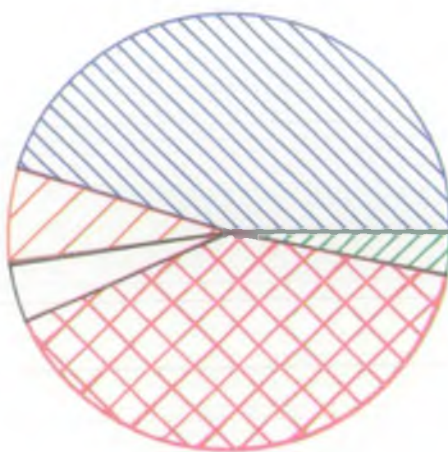
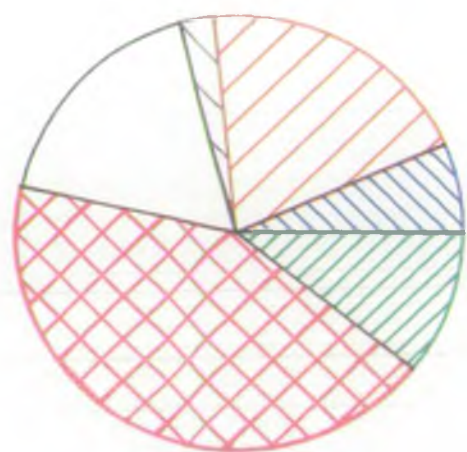
Site RYQ7 (Charlton on Otmoor) Biomass and Density

COMMENTS: Stoneloach present. The habitat in this section is poor with machine-cut 45 degree banks and no bends. The biomass of 8.2g/sqm is low, and well below the target of 20g/sqm for cyprinid sites (NRA-Thames region -current levels of service). The weir does provide aeration, and a much higher biomass would be expected in the summer months when Oxygen levels on the River Ray can be critical. This phenomenon was observed in a previous survey in 1985.

Roach	0.3	0.008
TOTAL	8.2	0.075

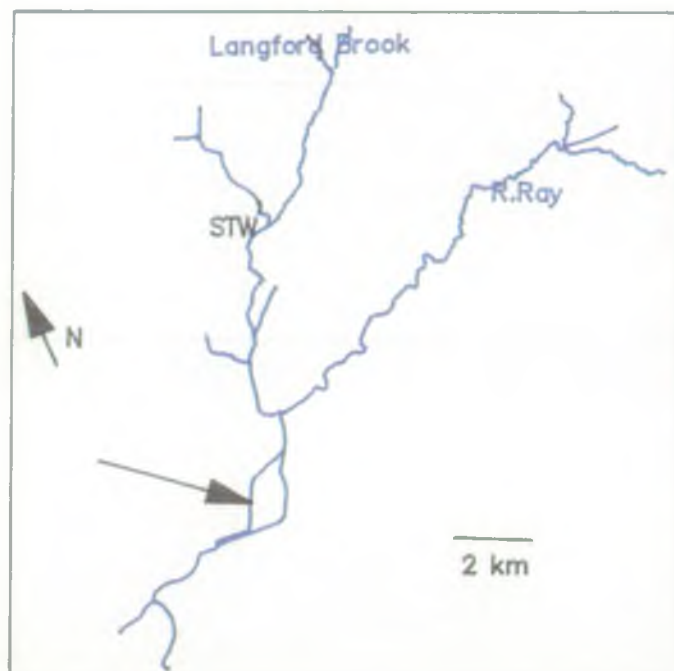
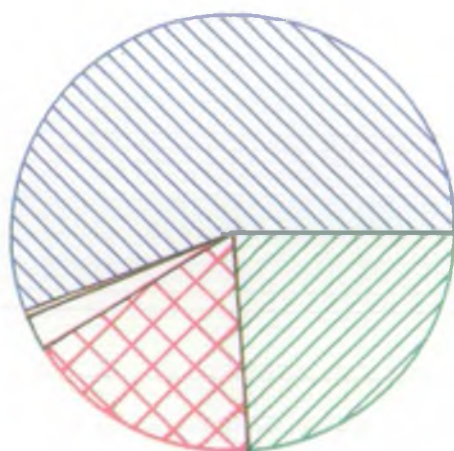
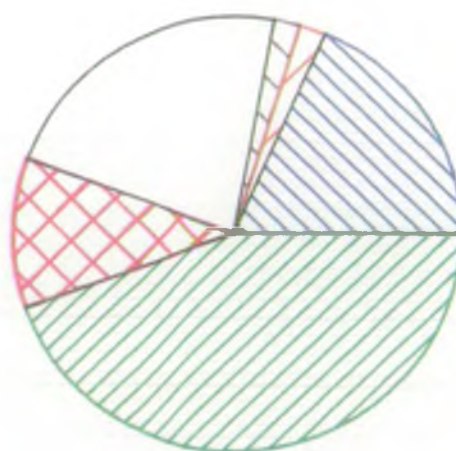
Site RYQ9 (Oddington) Biomass and Density

COMMENTS: An upstream run of 236m by 10.2m produced 7.5kg, (a biomass of 3.1g/sqm). Most of the fish were in one shoal, and we failed to catch a single fish in a 100m section. This emphasises the patchy nature, and the mobility of the fish in the River Ray. The survey site biomass of 17.6g/sqm is below the target of 20g/sqm for a cyprinid site. The upstream run biomass suggests that the survey section result was atypical. Minnows were common, stoneloach and cyprinid fry were present. Many of the roach were nearly ready for spawning and some perch were shedding milt. Fish leaches Piscicola were present on a number of fish.

Biomass (gm-2)	Density (nm-2)
  Chub	9.8	0.010
  Dace	0.1	0.001
  Gudgeon	0.0	0.001
  Perch	0.4	0.012
  Pike	3.1	0.006

Roach	4.2	0.024
TOTAL	17.6	0.054

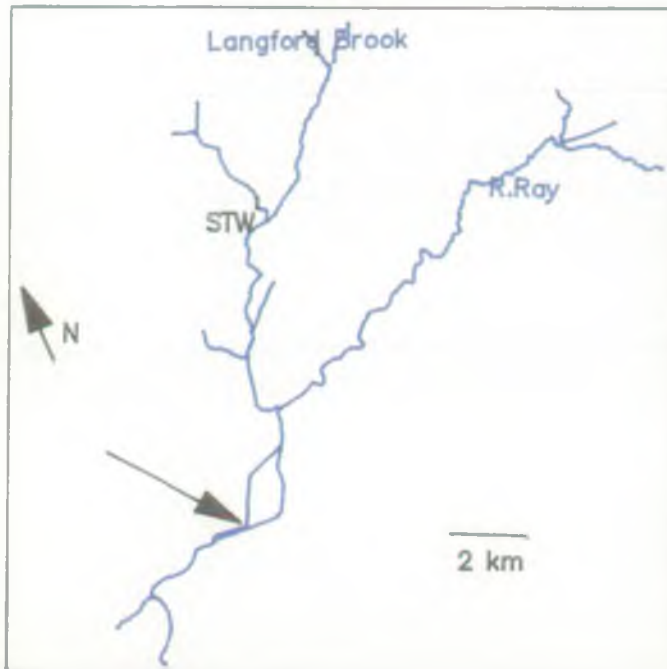
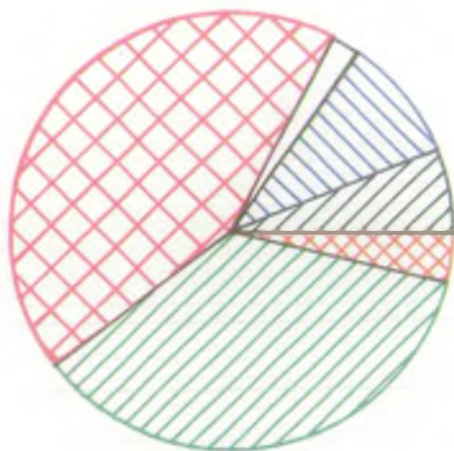
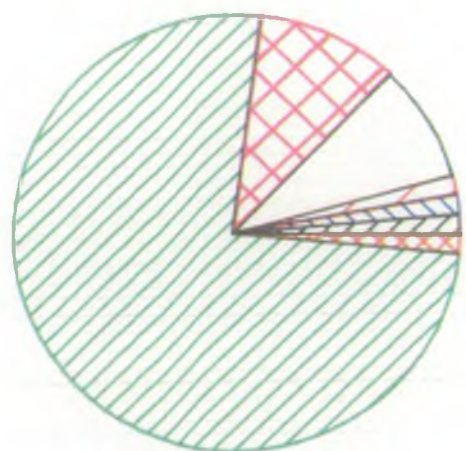
Site RYQ0 (Old River Ray Confluence) Biomass and Density

COMMENTS: Minnows were present and roach fry common. An upstream run of 185m produced 11kg of fish (a biomass of 8.5g/sqm). The upstream section was deeper than the survey section. Allowing for the reduced efficiency would suggest a true upstream biomass of between 15 and 20g/sqm. The survey section had a biomass of 20g/sqm which just meets the target for a cyprinid water. The results are better than those obtained at the next 3 sites upstream. This is probably due to the better habitat, and the improved water quality. (This site is a reasonable distance downstream of Bicester STW)

Tench	0.7	0.001
TOTAL	20.0	0.071

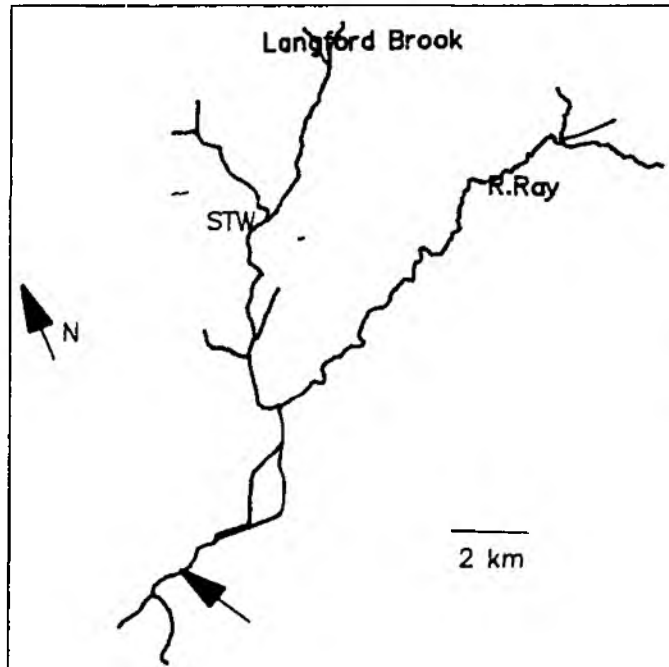
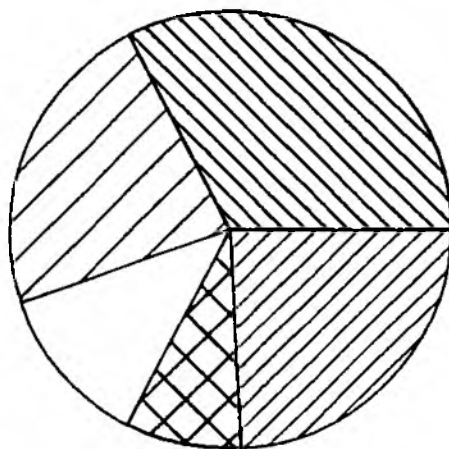
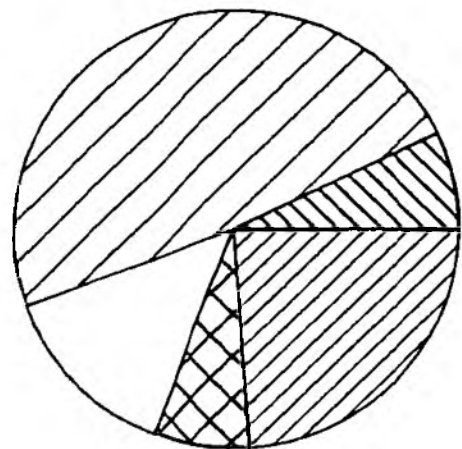
Site RYQA (Islip) Biomass and Density

COMMENTS: An upstream run of 57m produced 12.5kg, mostly
quality roach (a biomass of 54.7g/sqm). In the survey
section, roach and dace fry were common. The biomass of
13.1g/sqm fails to meet the target of 20g/sqm. However
the site is frequently inhabited by a shoal of large
chub, which were not present on the day of the survey. In
addition, the excellent results from the upstream run
indicate that this is a good fishery.

Roach	3.1	0.023
TOTAL	13.1	0.097

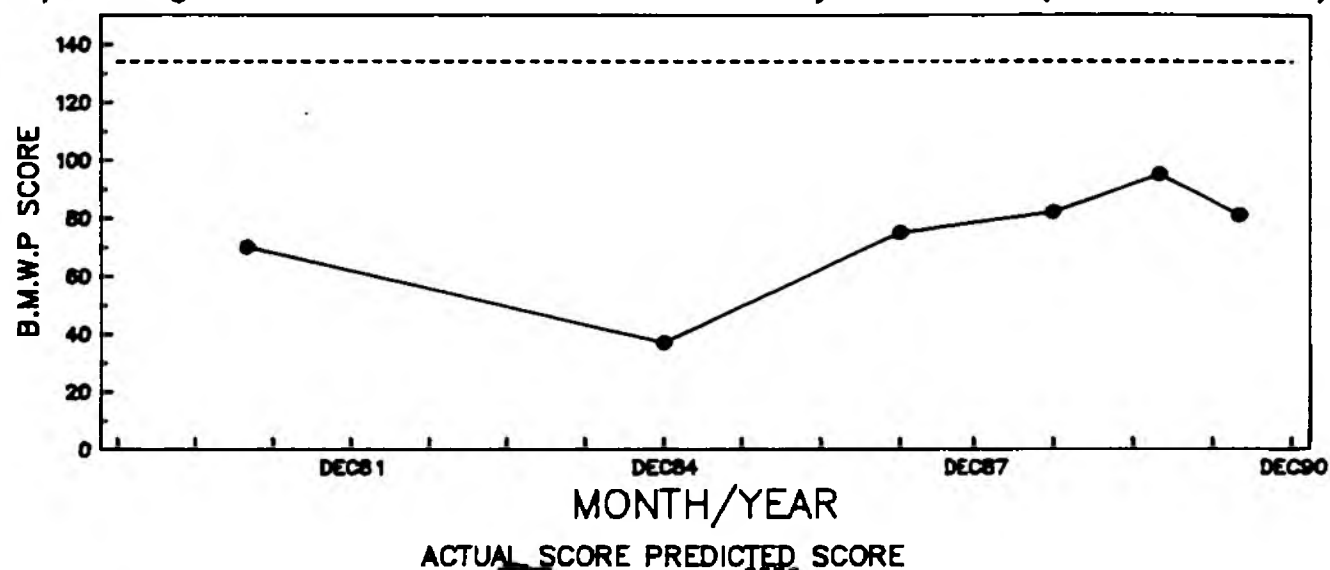
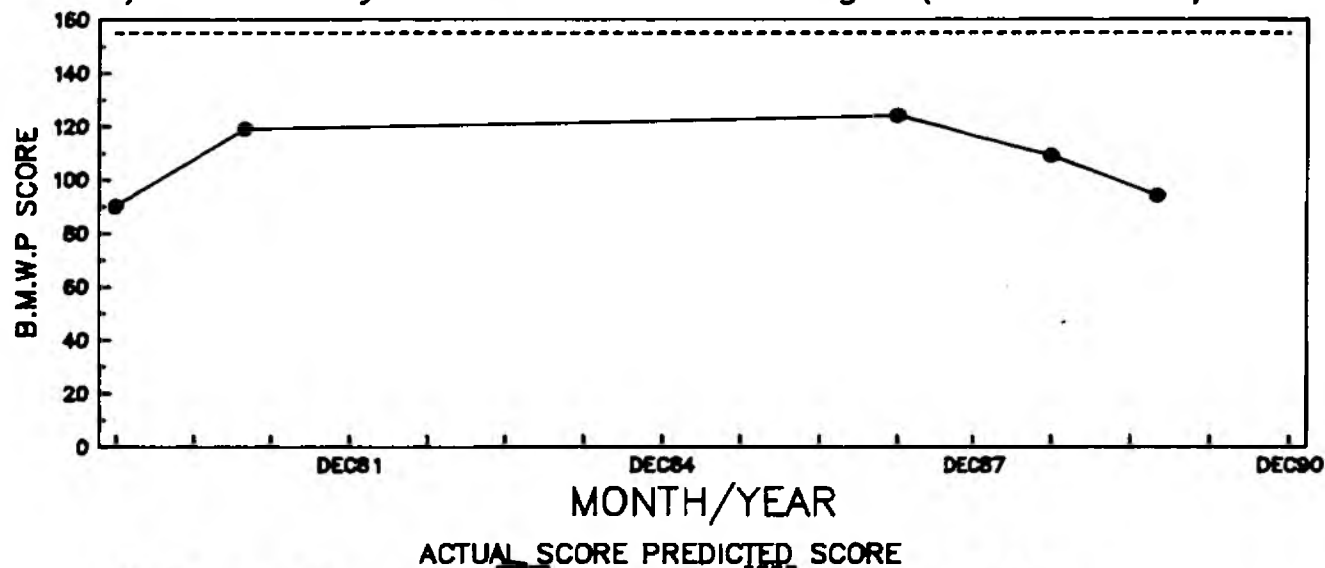
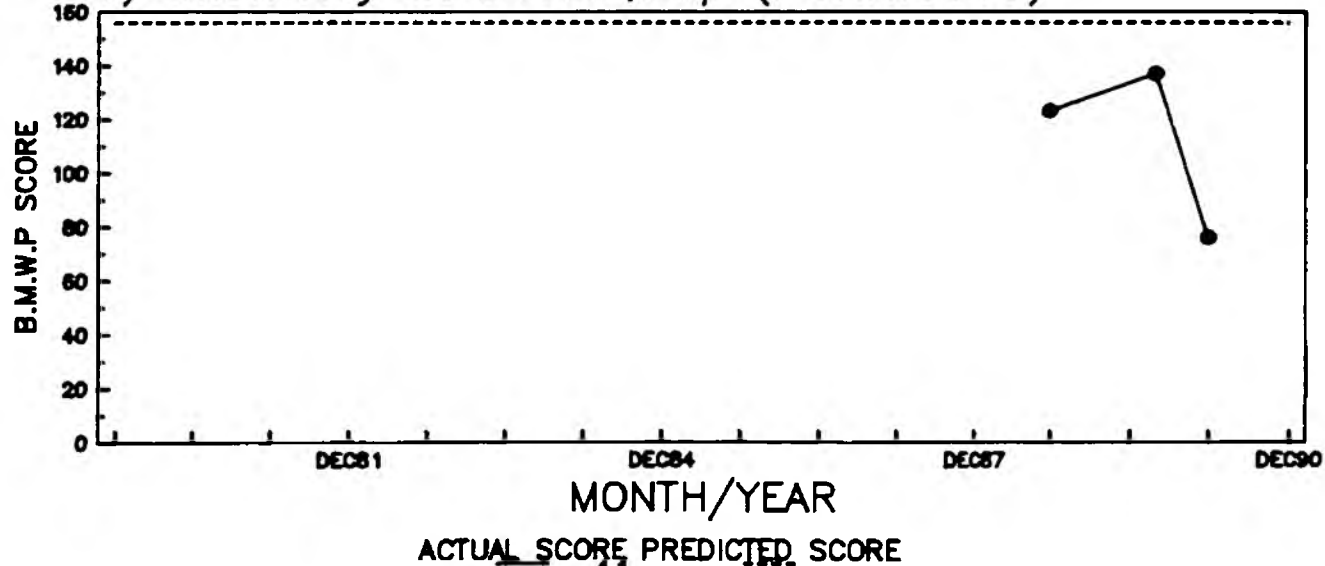
FIG.5.5.1 BIOLOGICAL MONITORING RESULTS 1979-90

Scores are significantly lower than predicted, especially on the Langford Brook. This is presumed to be the result of poor water quality.
