SANDON DOCK WASTEWATER TREATMENT WORKS

OUTFALL SURVEY OCTOBER 1992

Marine and Special Projects  
report MSP-93-07

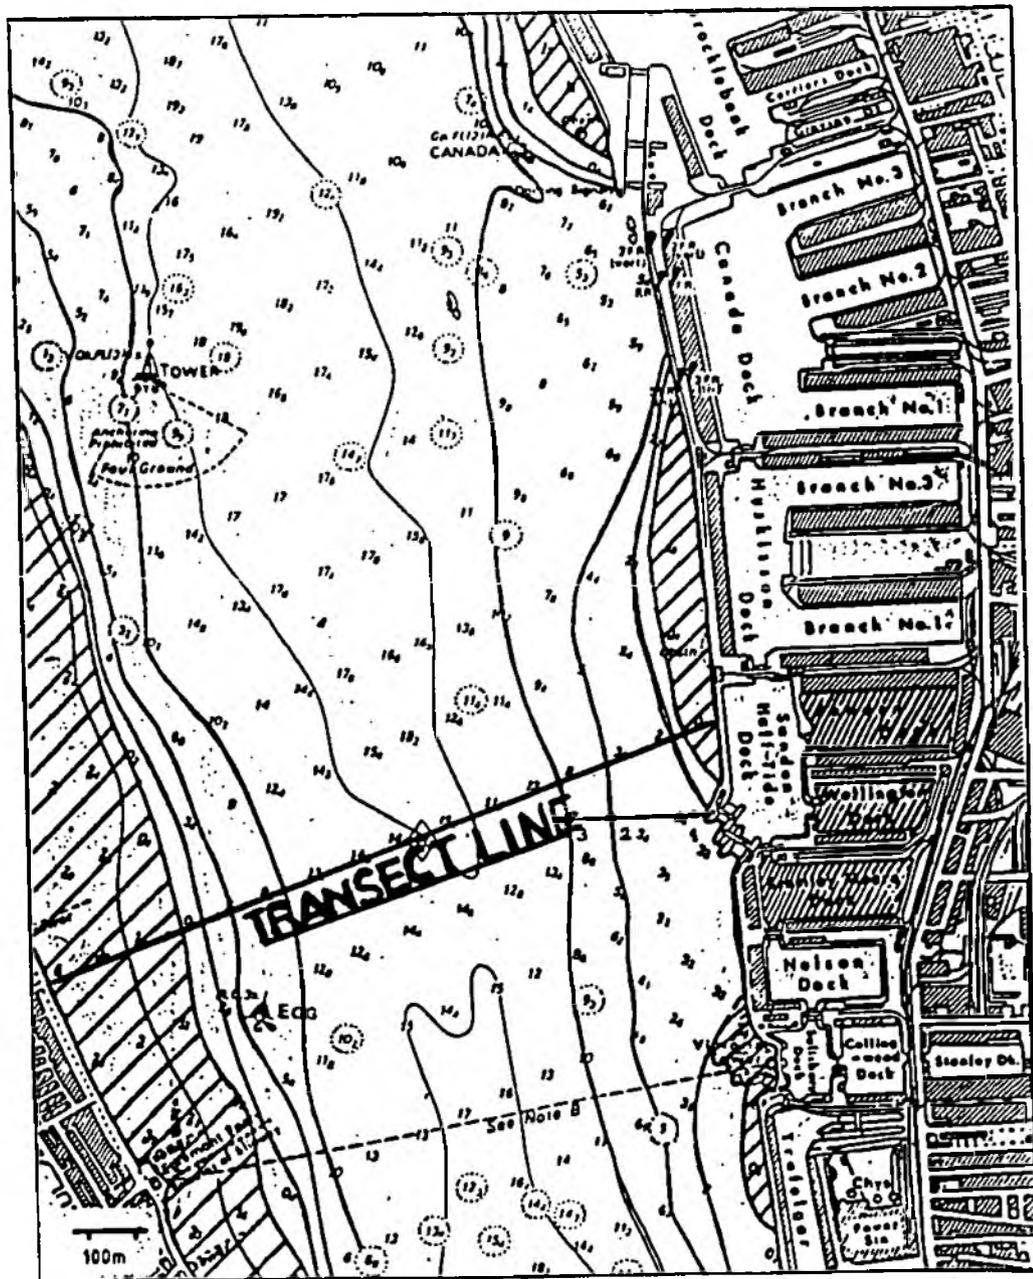
**FIGURE 1 : THE LOCATION OF SANDON DOCK**

Current velocity data from the 24<sup>th</sup> and 25<sup>th</sup> July, 1992, (similar neap tides), are also included. These data were obtained using an RDI Broadband Acoustic Doppler Current Profiler, from the transect line shown in figure 1.

Current velocities, measured on two days in July 1992, along a transect close to the outfall (see figure 1) are presented in Appendix D. The data are from similar tides:

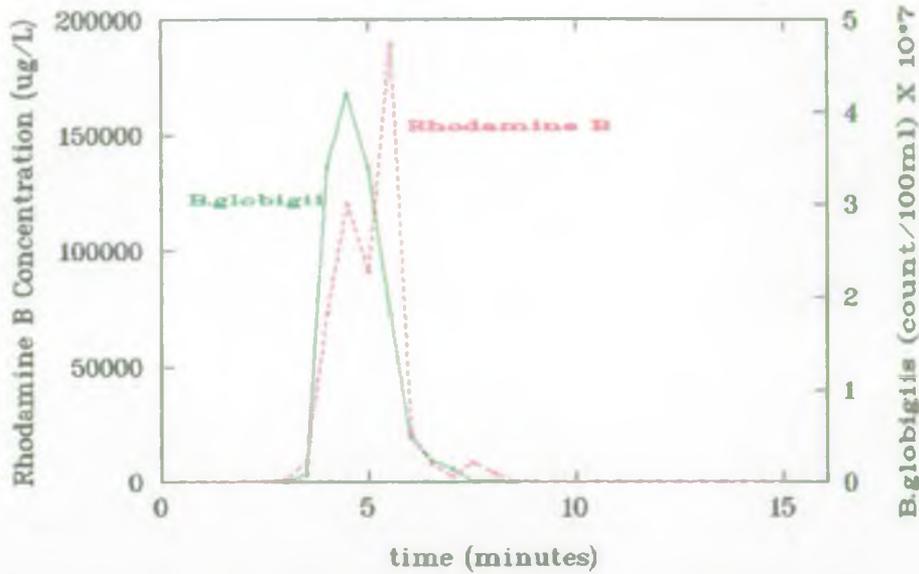
Figure 2 : Rhodamine B and B.globigii concentrations within Sandon WTW

Figure 2 shows the concentrations of Rhodamine B and *B.globigii* from the samples taken within the works.

The main concentration of tracers passed between 13.55 and 14.00. From these samples the maximum values were :

Rhodamine B concentration =  $1.9 \times 10^5 \mu\text{g/L}$

B.globigii =  $42 \times 10^6$  counts per 100ml

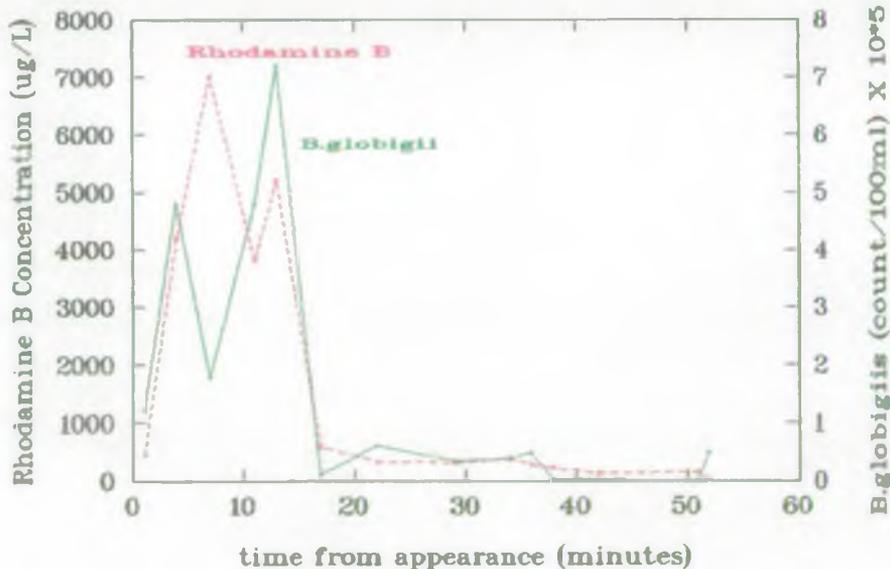
Figure 3 : Rhodamine B and B.globigii concentrations in Estuary

Figure 3 shows the concentrations of Rhodamine B and B.Globigii from the first 20 samples taken from the boil in the estuary.

The maximum values were:

Rhodamine B concentration =  $7 \times 10^3 \mu\text{g/L}$   
B.globigii =  $7.2 \times 10^5$  counts per 100 ml

Rhodamine B = 27:1  
B.globigii = 58:1

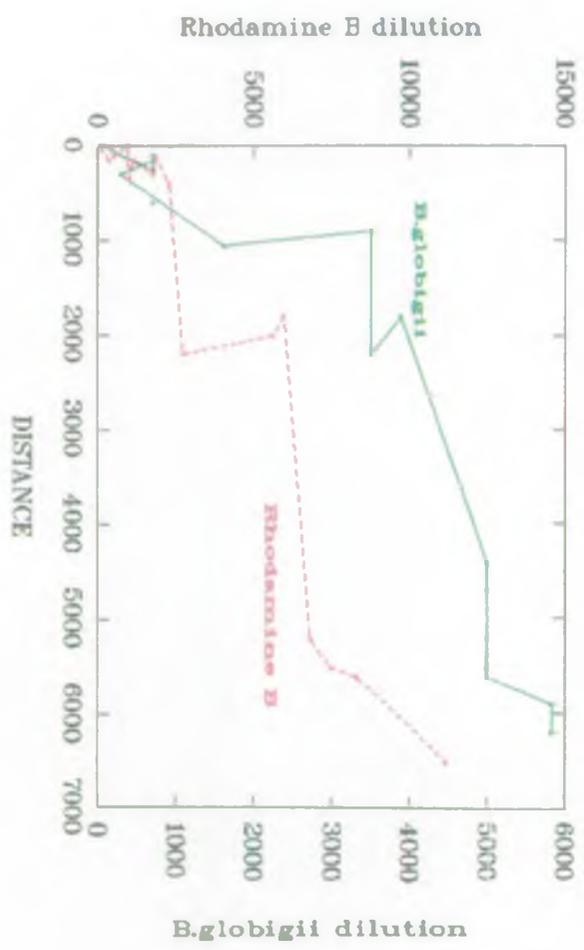
Figure 5 : Rhodamine B and B.globigii dilution in Estuary

Figures 4 and 5 show subsequent dilution as a function of time and distance as the effluent migrated away from the outfall. The values (see Appendix B) comprise the maximum concentration found within the works divided by each subsequent peak concentration.

With respect to time, figure 4 shows how both tracers suggest that rapid dilution does not occur before 16.00, nearly two hours after first emerging. Figure 5 indicates that this occurs after a distance of approximately 1-2 km.

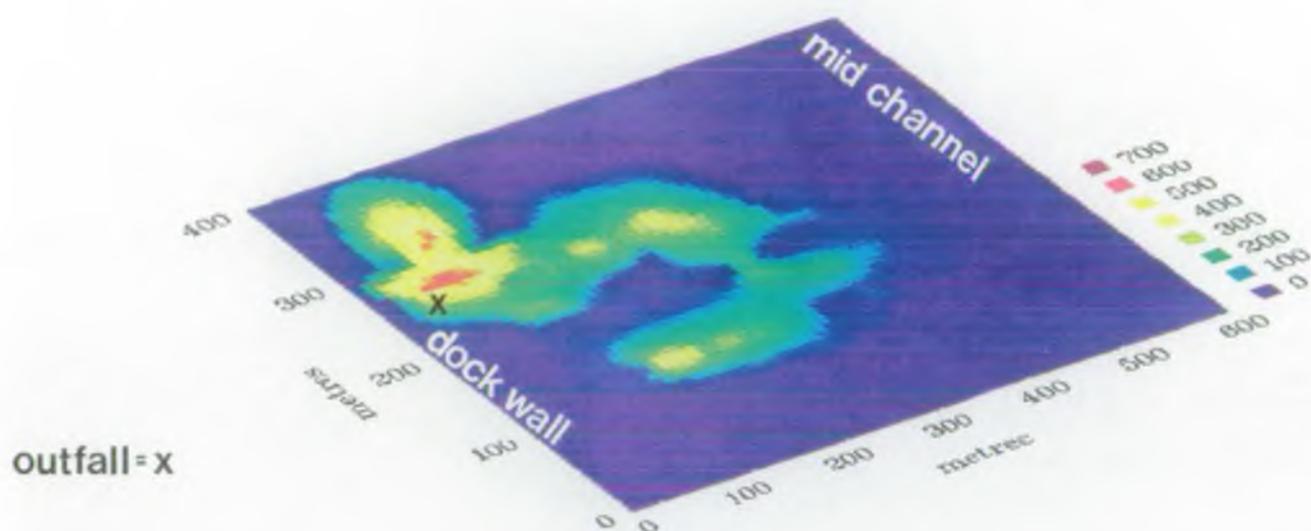
Figure 6: Rhodamine concentrations over the first hour

With the last of the ebb in the subsequent 30 minutes (chart 2), the main patch of dye, still above 400 $\mu\text{g/L}$ , reached approximately 250 metres seaward of the outfall, but remained within 200 metres of the sea wall. Over the first hour, sufficient data in close proximity was logged to allow reasonable contouring of the dye patch as shown in figure 6.

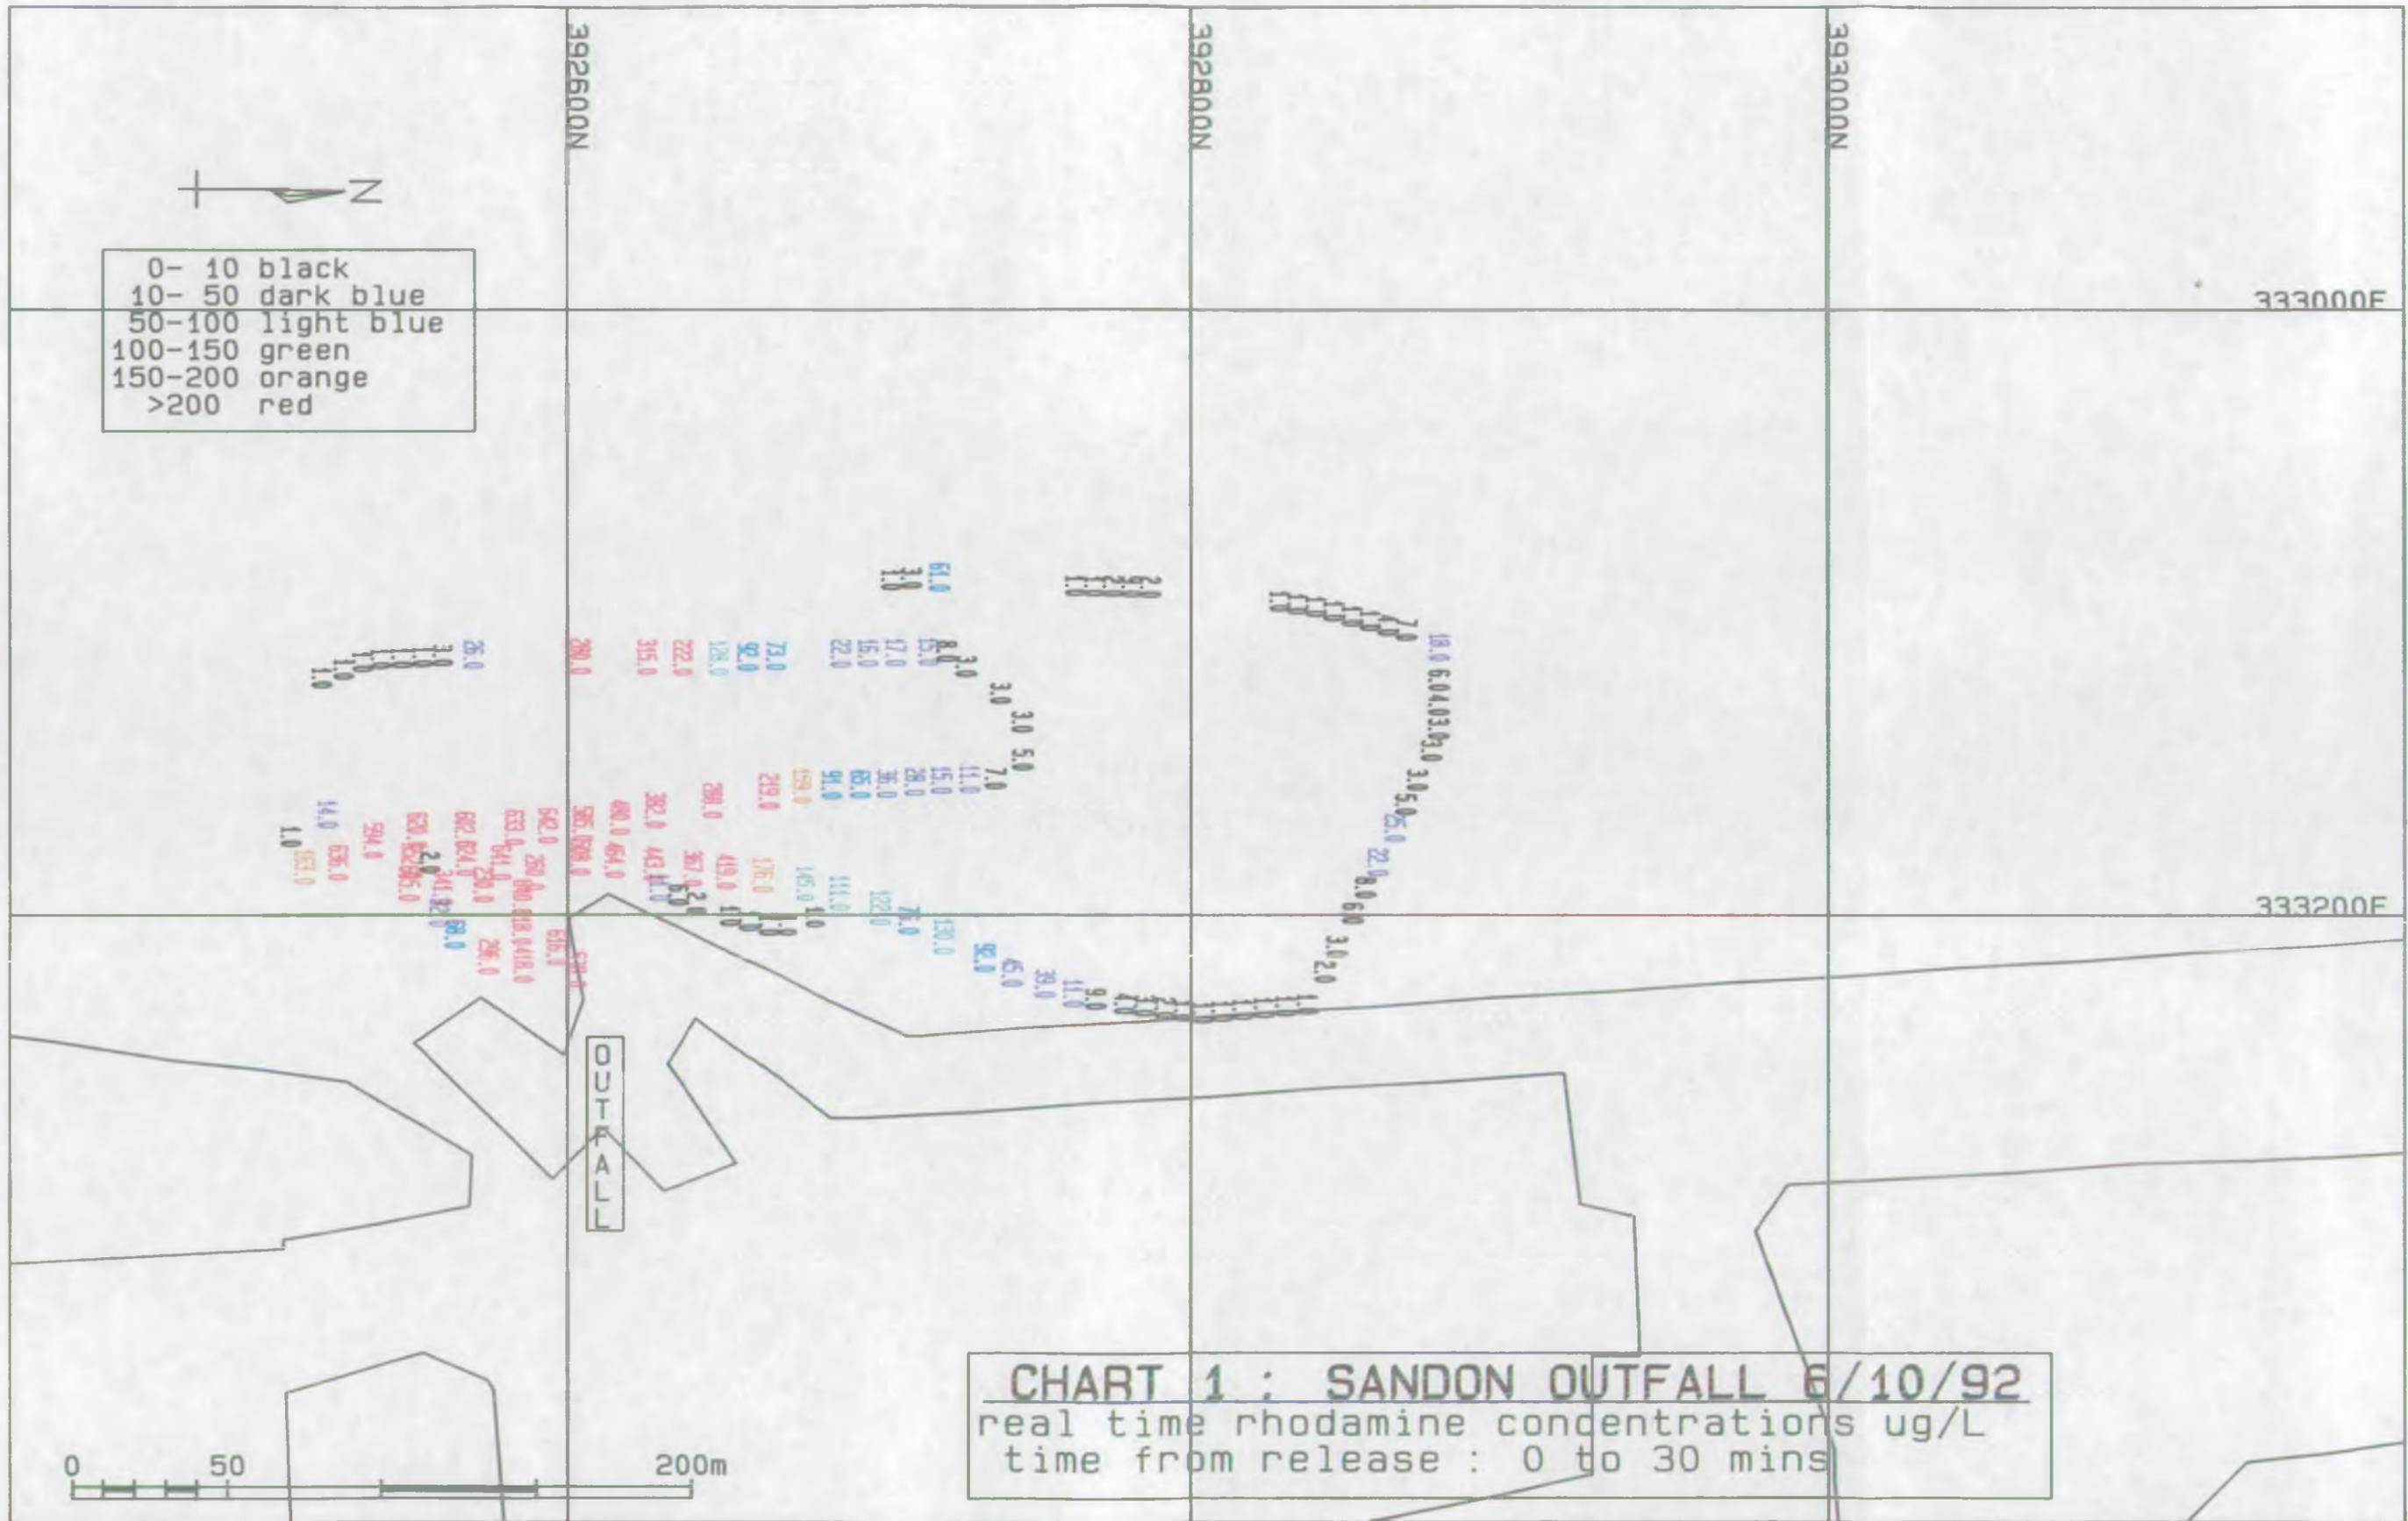
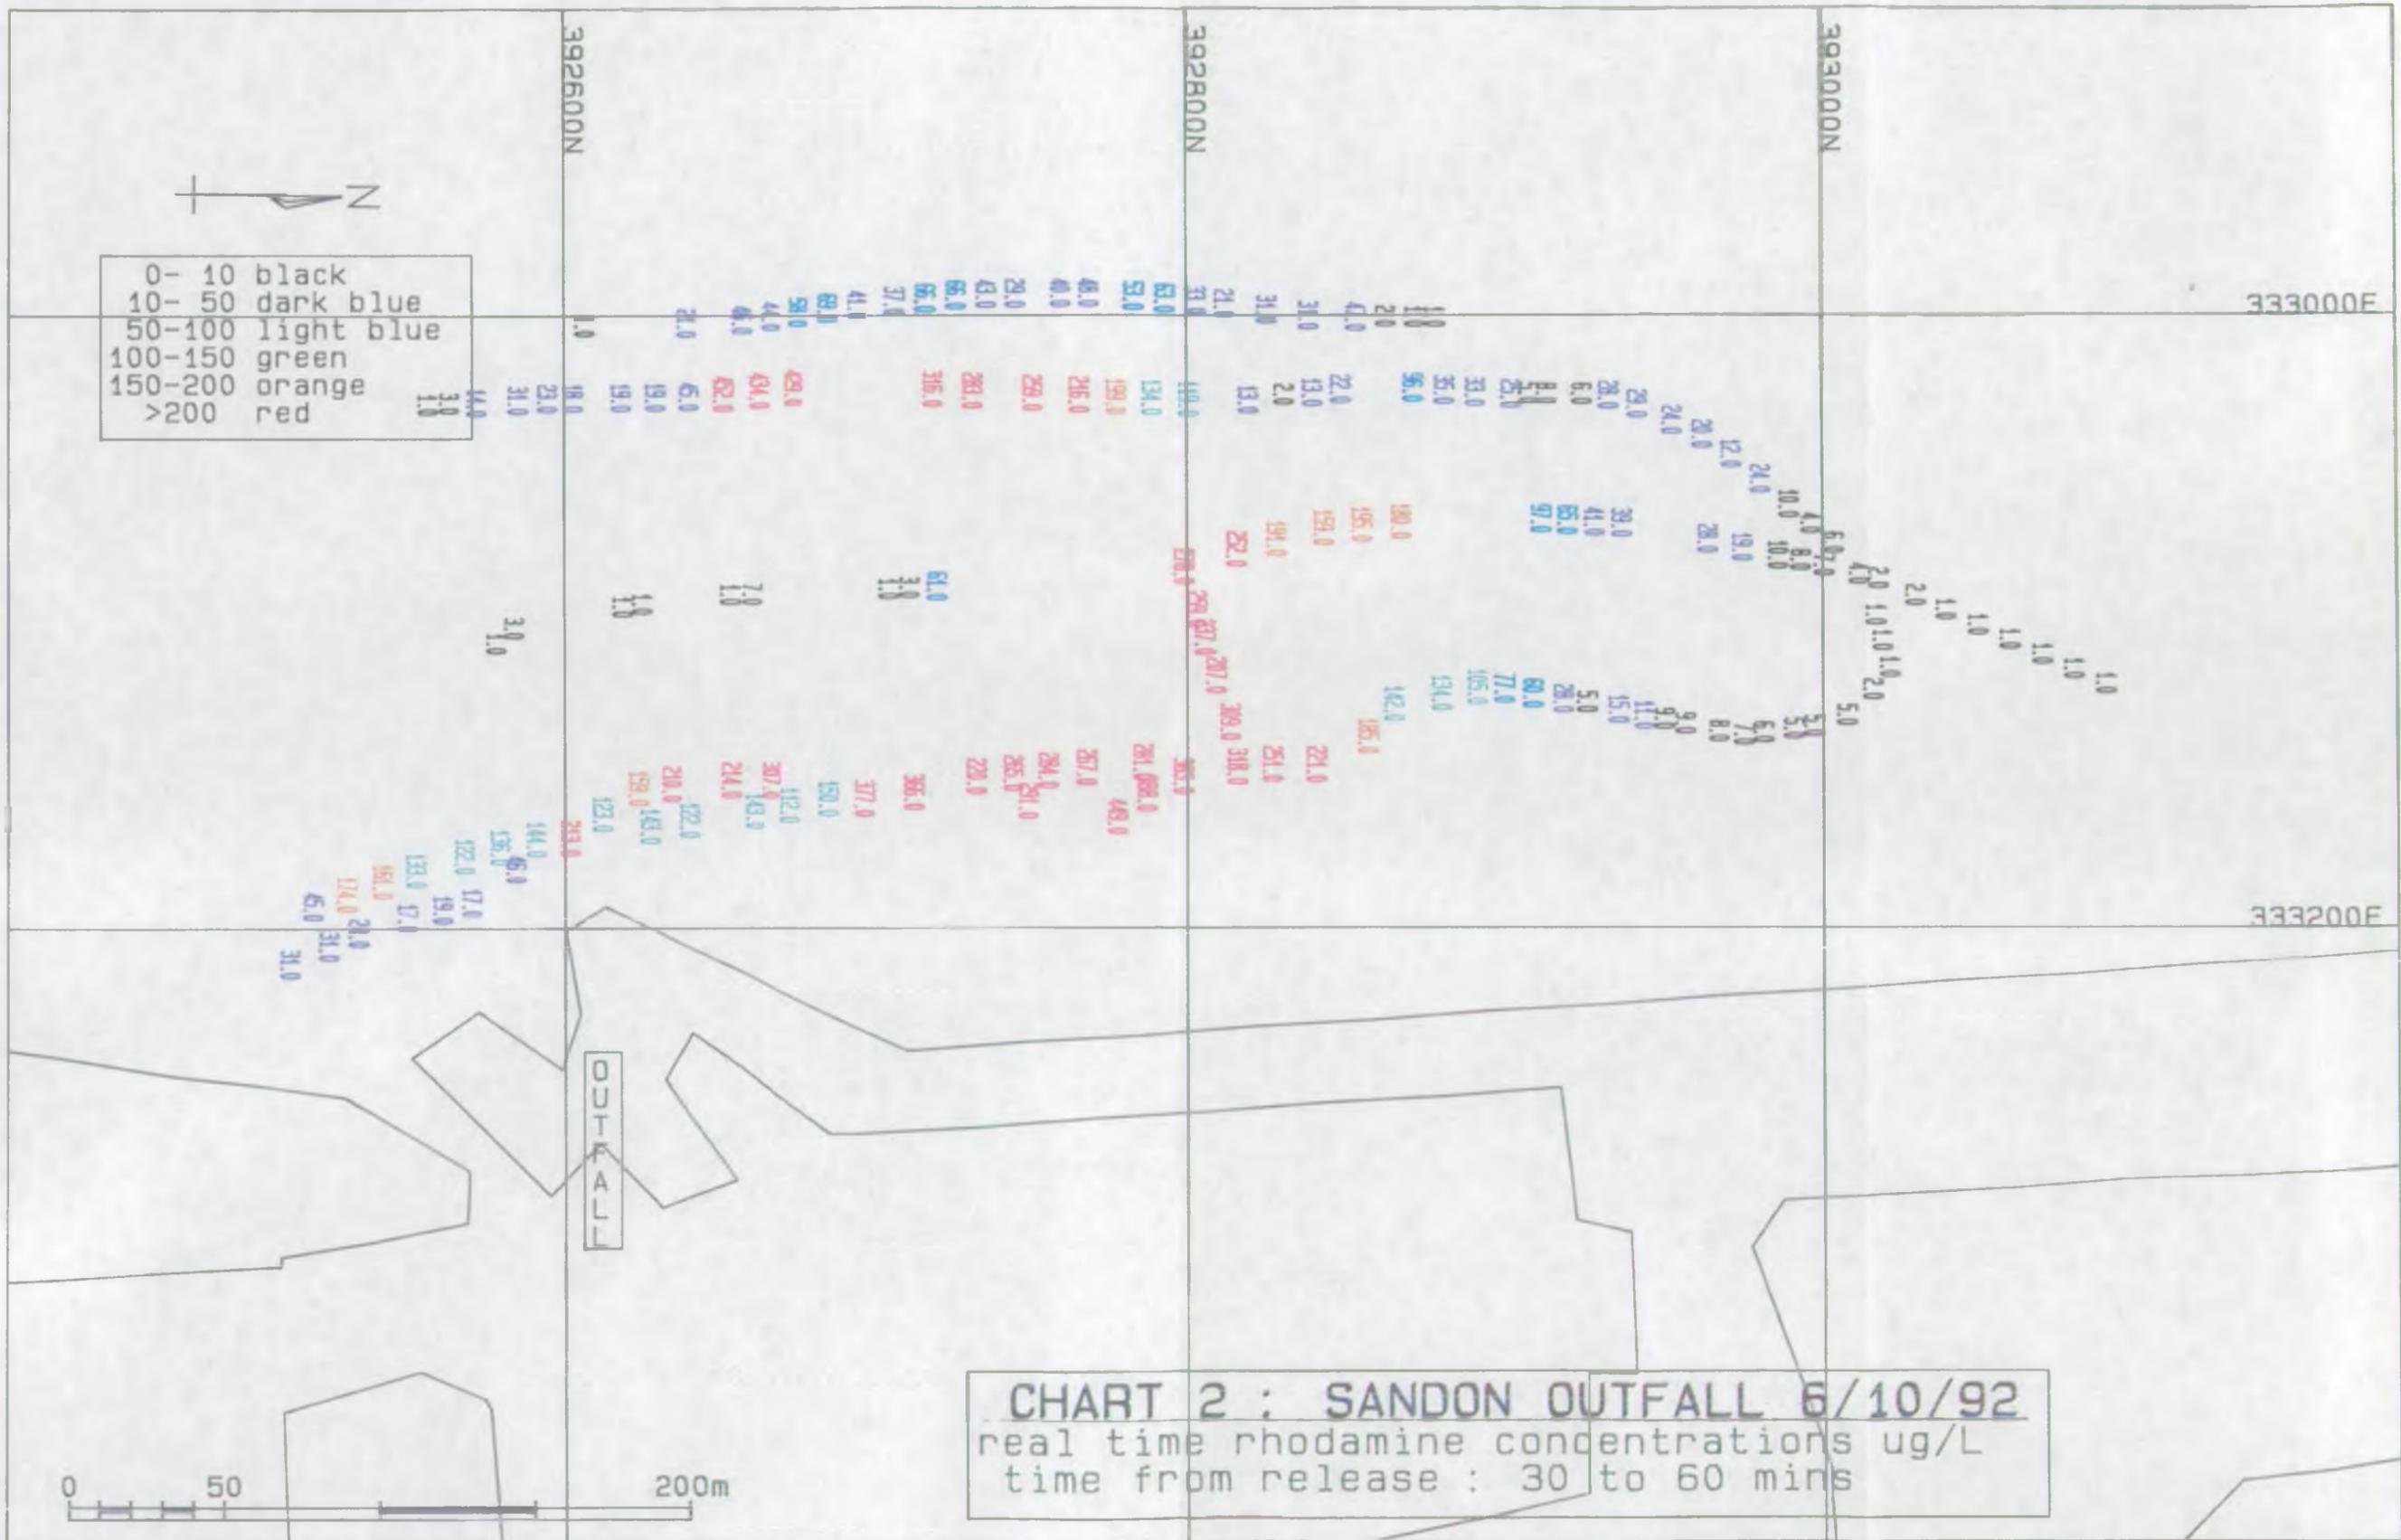
The data were edited such that in the final charts the highest value at any point is displayed, lower values being removed to avoid overwriting. The results are summarised in Appendix C, charts 1 to 6. For the reasons described earlier, the readings are only accurate below 250  $\mu\text{g/L}$ .

Charts 1 to 4 are divided into 1/2 hour time steps from the emergence of the dye in the estuary at 14.14, 35 minutes before predicted low water. Chart 5 is the third hour, and chart 6 is the final hour and a half.

In the first half hour the most concentrated dye (over 400  $\mu\text{g/L}$ ) stayed relatively close to the sea wall and slowly tracked seaward for approximately 100 metres, as shown in chart 1. The delineation of the dye patch was very marked.

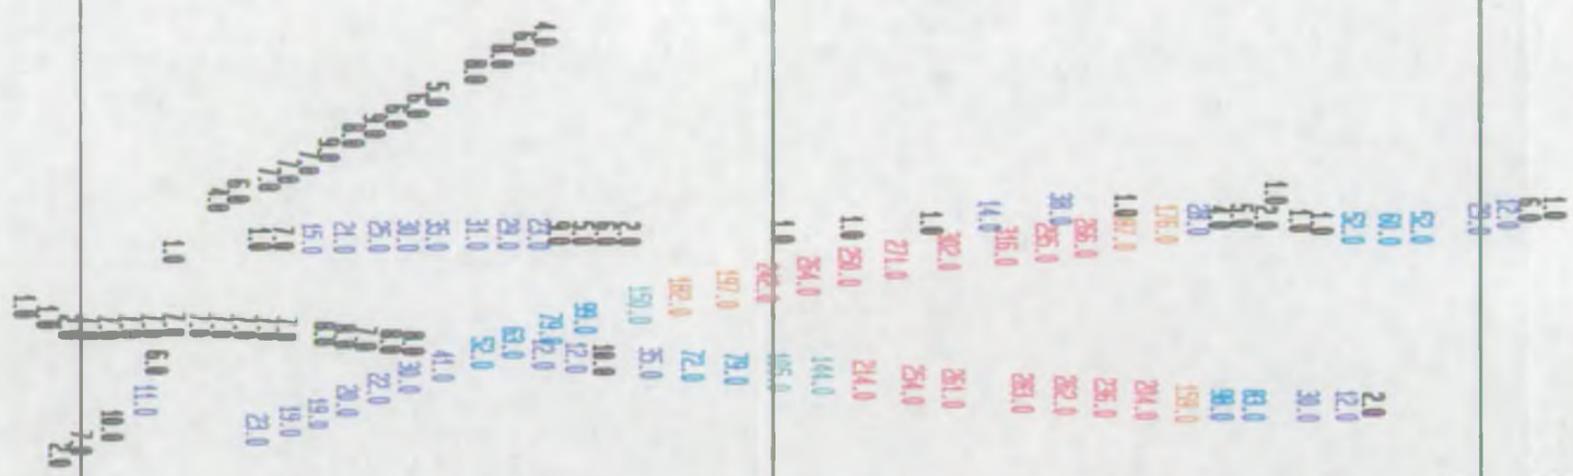
**CHART 3 : SANDON OUTFALL 6/10/92**  
real time rhodamine concentrations ug/L  
time from release : 60 to 90 mins

Between 60 and 90 minutes following discharge (chart 3), the main patch of dye was still in the area just to the north of the outfall, stretching up to 400m seaward, and 200 metres from the sea wall. A very clear demarcation line existed around the concentrated dye patch. There was some evidence that the dye was being pushed back towards the wall with the start of the flood.

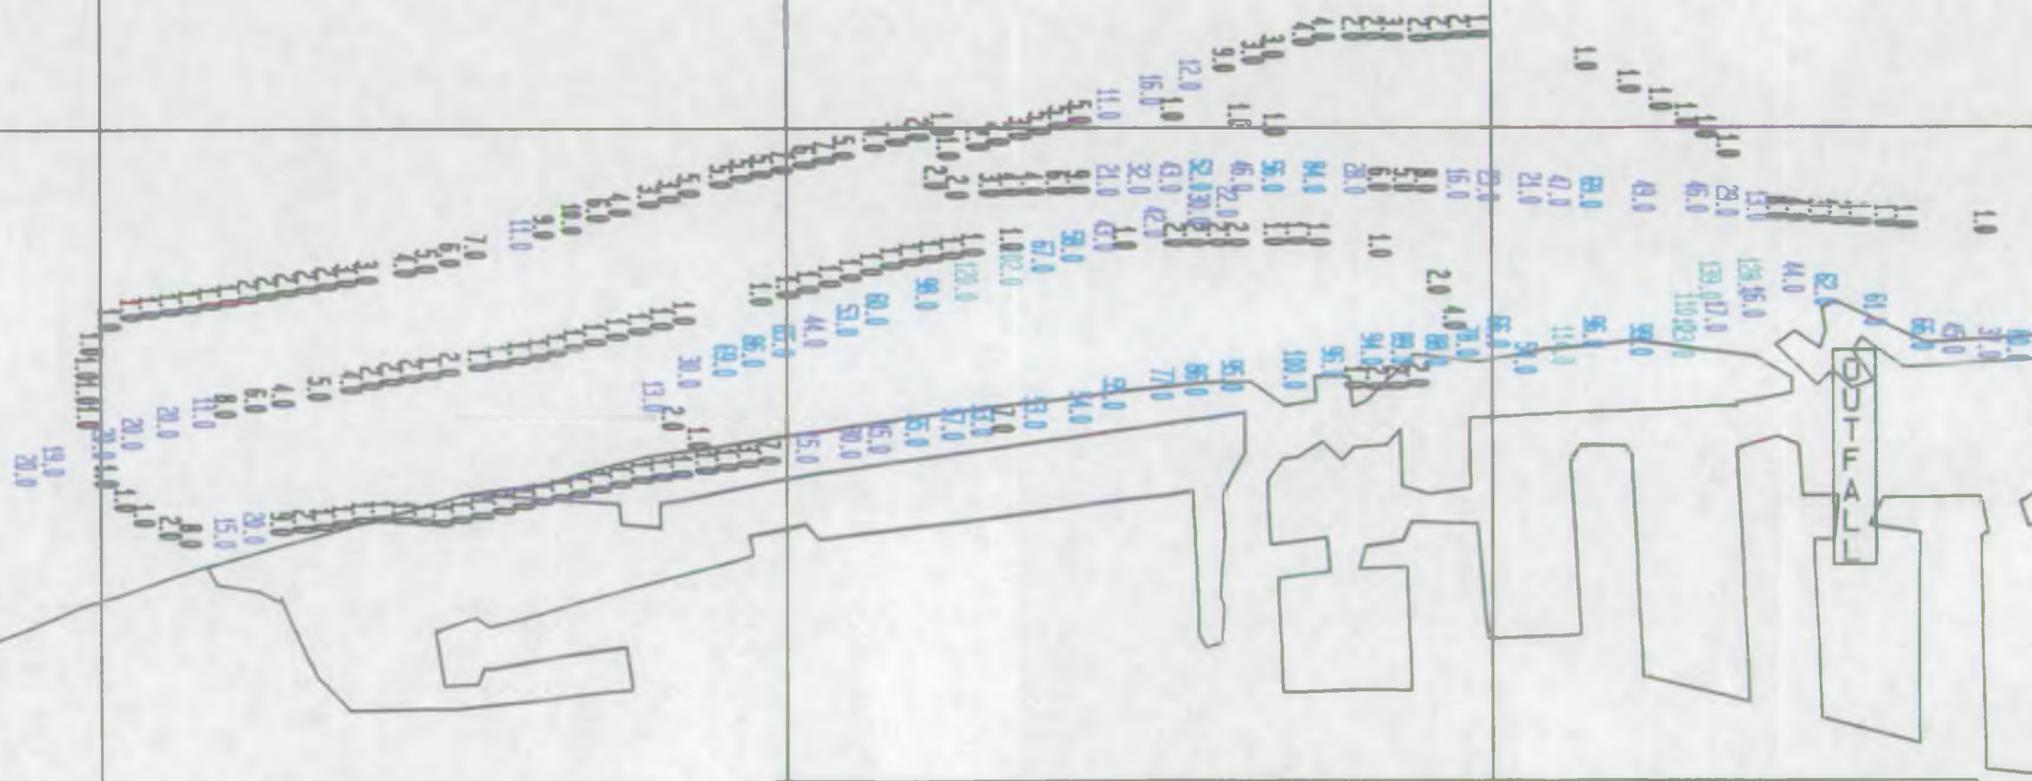
**CHART 5 : SANDON OUTFALL 6/10/92**  
 real time rhodamine concentrations ug/L  
 time from release : 120 to 180 mins

data, although there are some obvious discrepancies, most notably chart 5 where the ships track goes over Sandon wall instead of tight up against it.

In the third hour the dye, now with peak concentrations of around  $100 \mu\text{g/L}$ , extended over a kilometre south of the outfall, but still stayed within 200 metres of the sea-wall (chart 5).

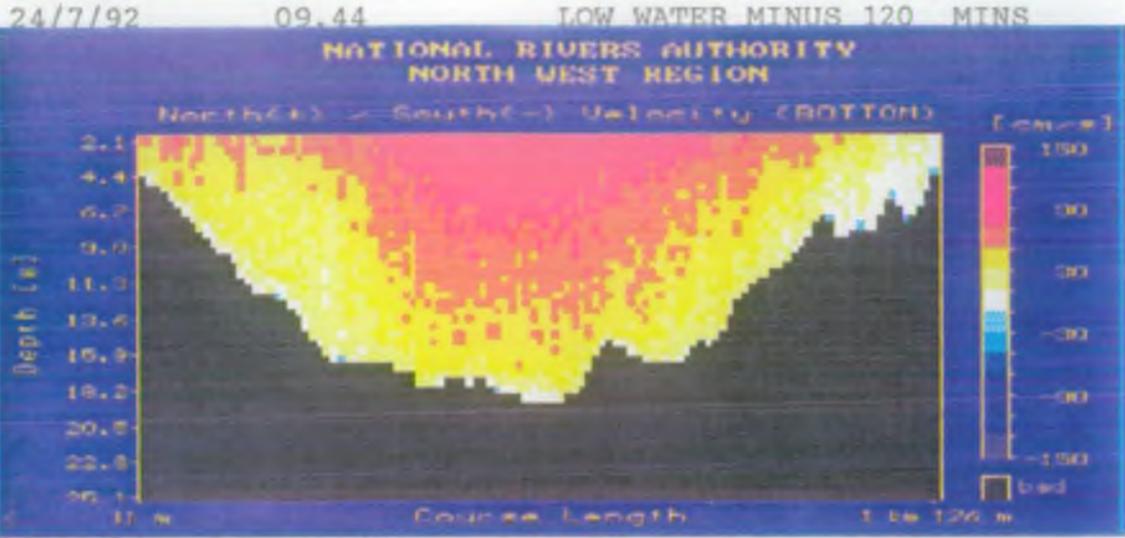
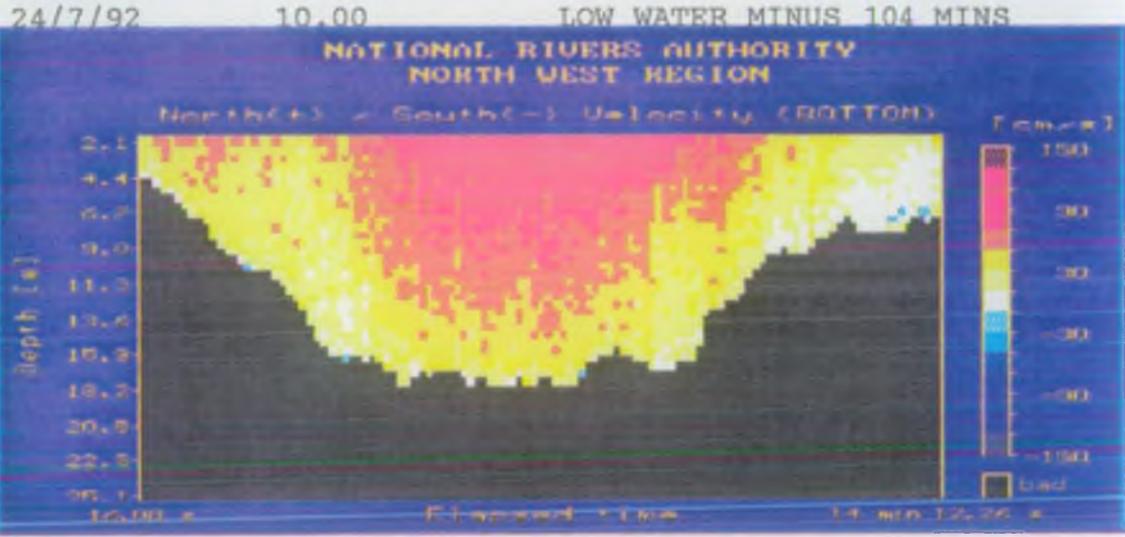
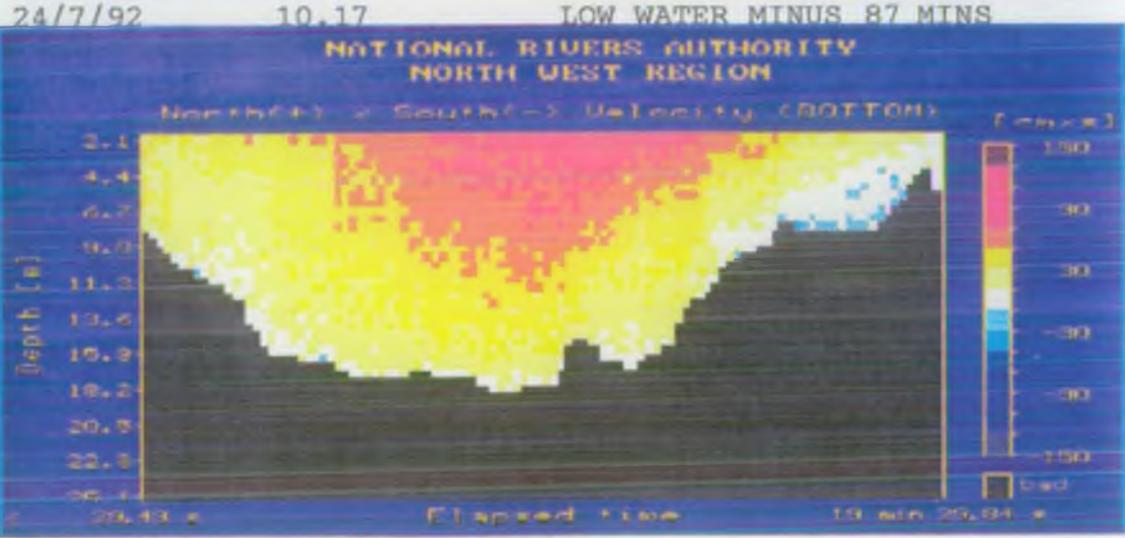
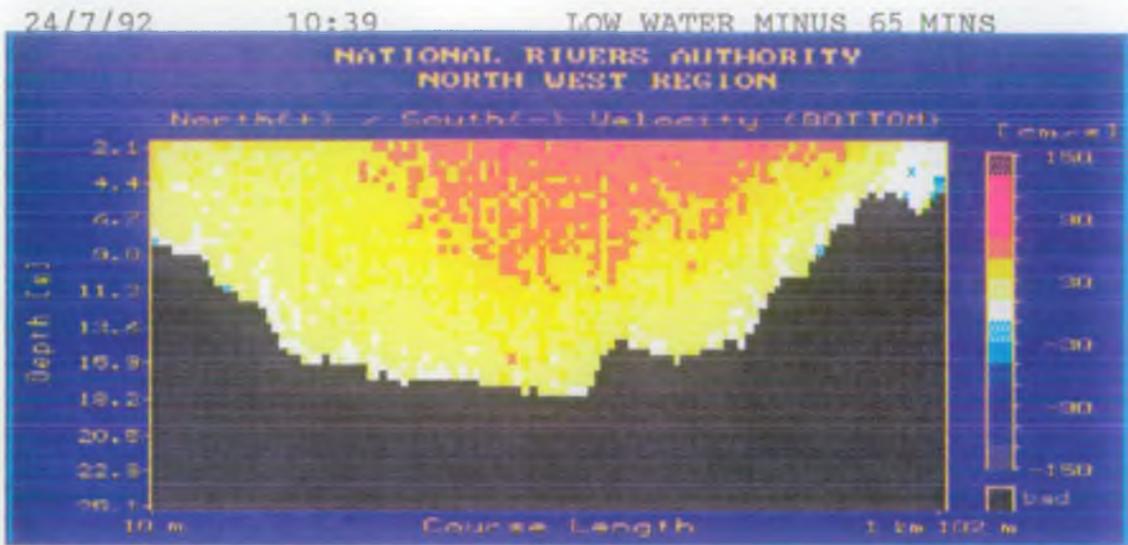
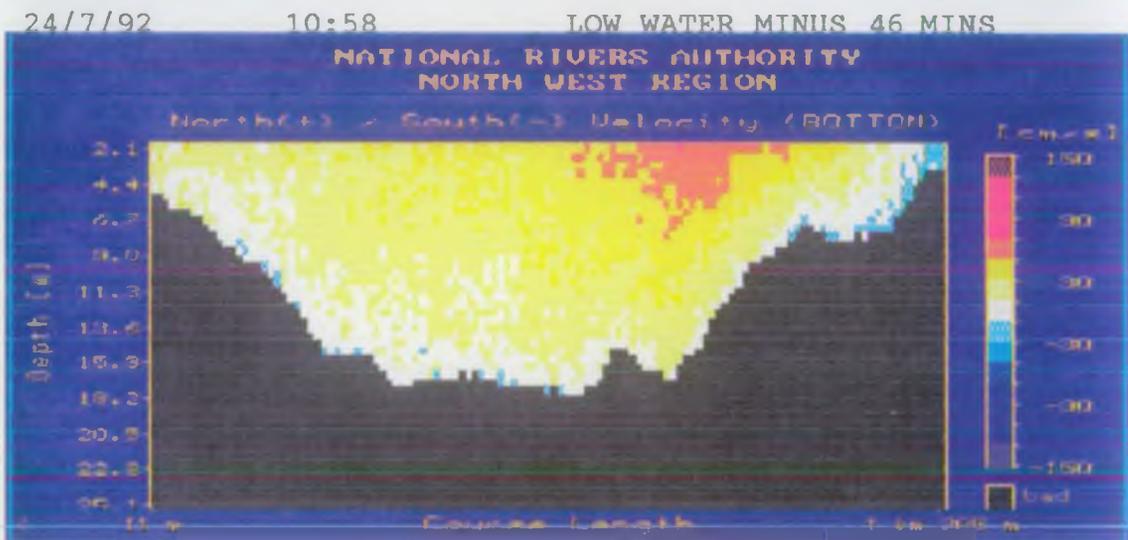
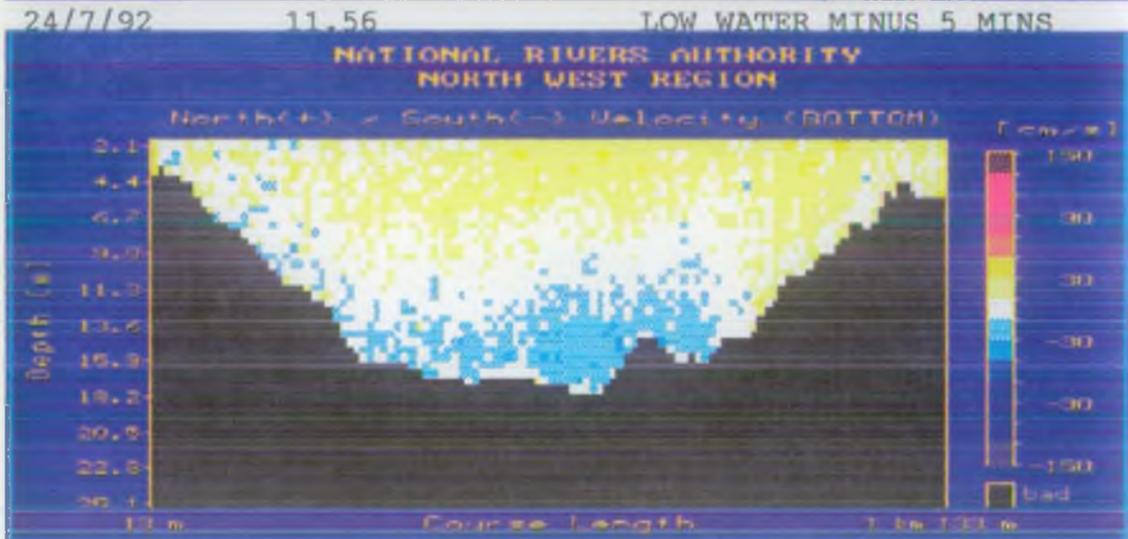
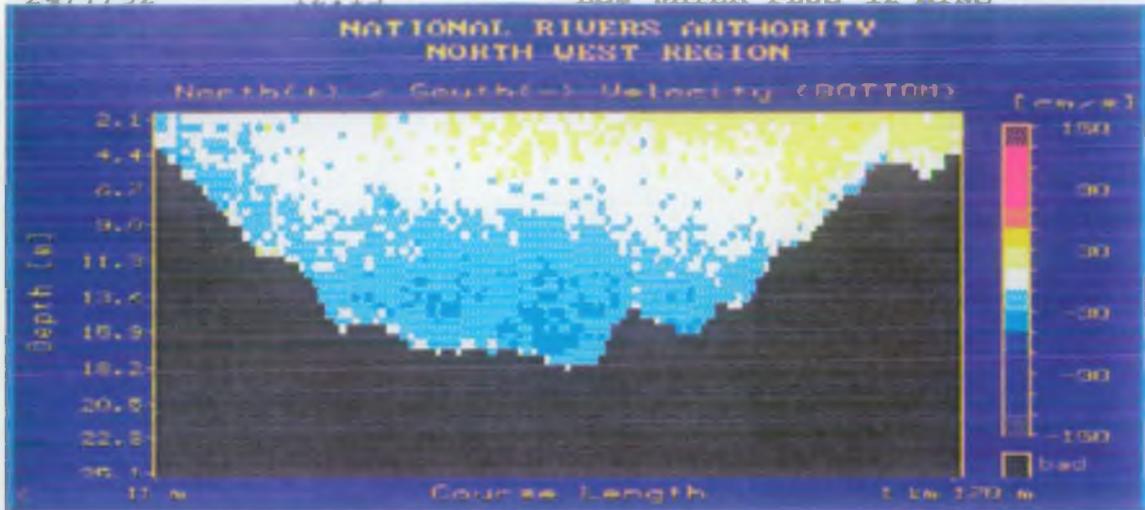
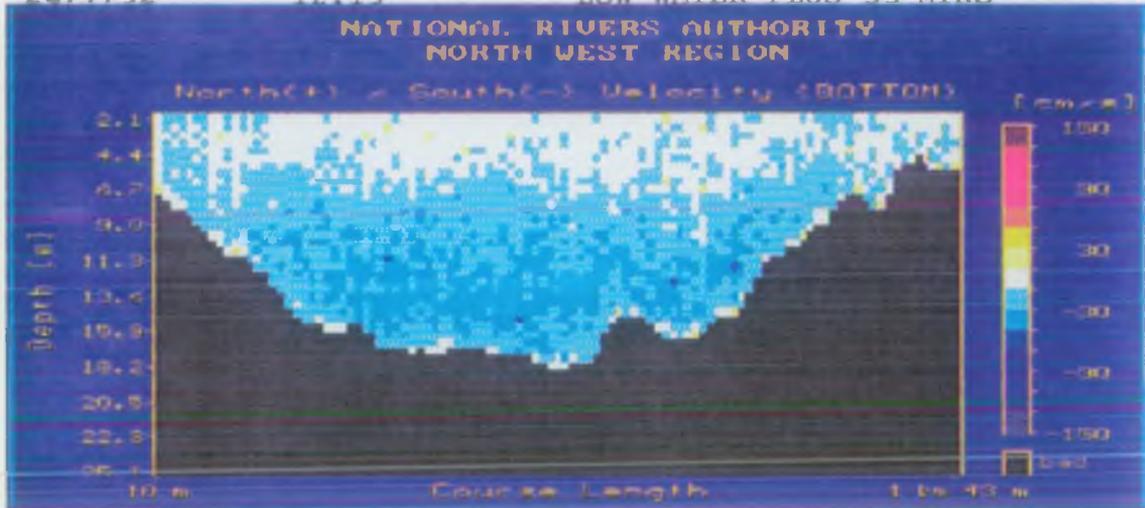
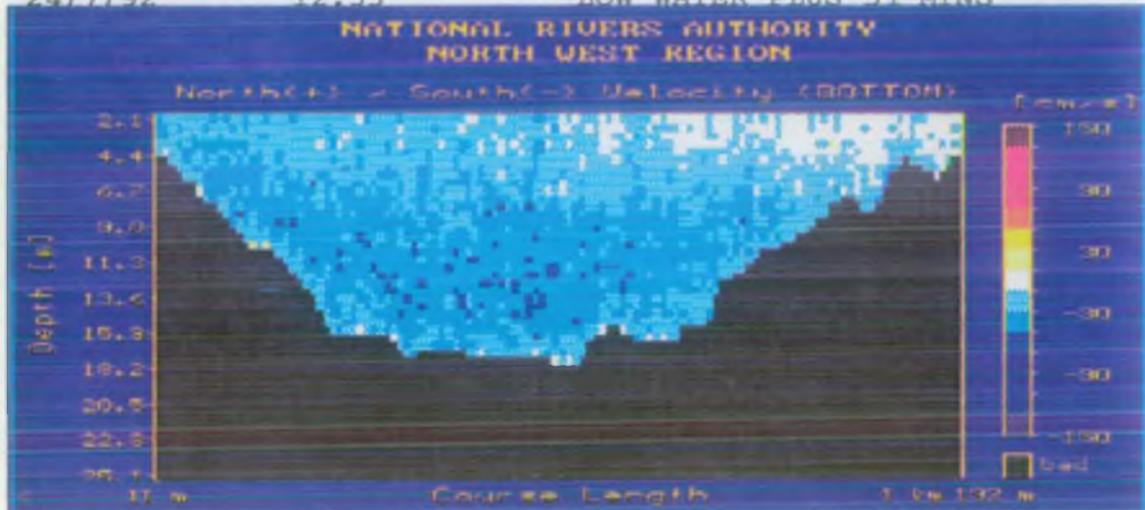
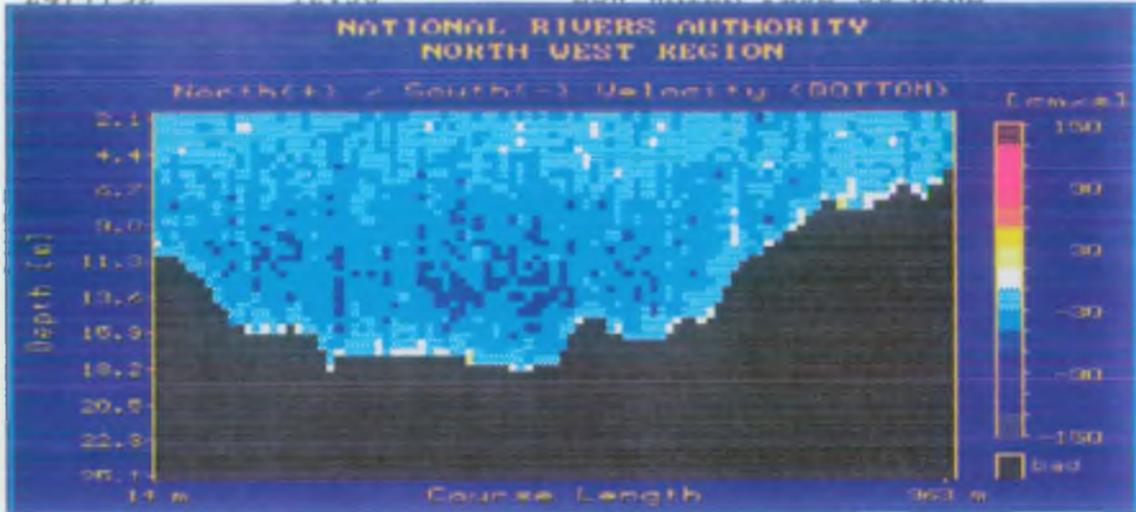
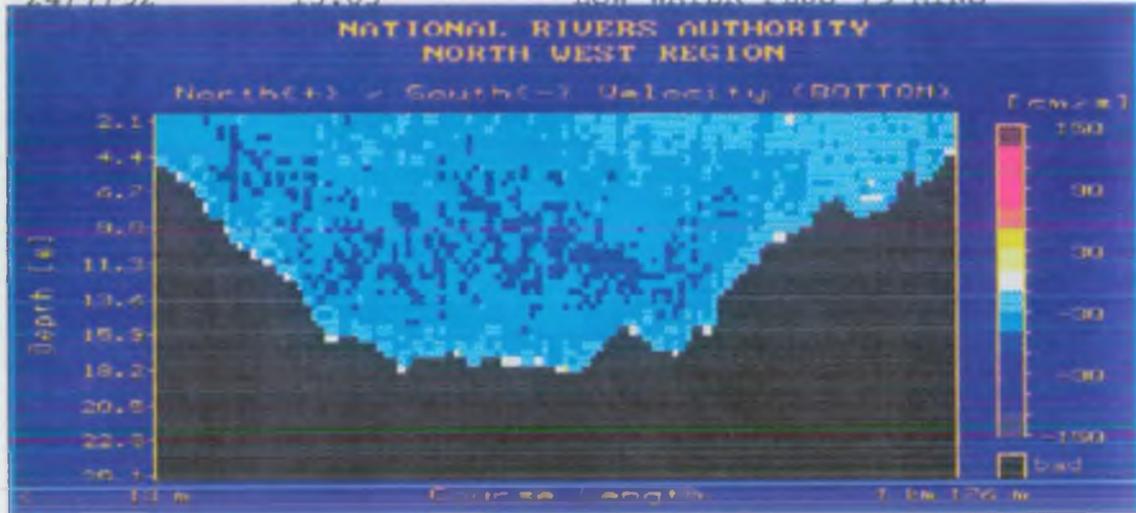
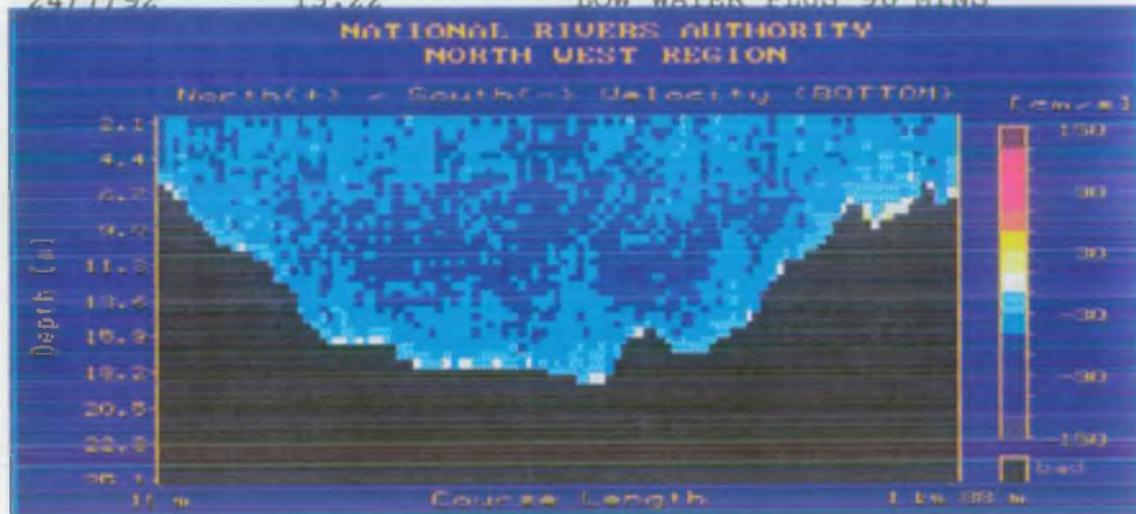
APPENDIX D : CURRENT MEASUREMENTS

The cross sections show Egremont to the left and Liverpool to the right, therefore the 'view' is effectively out to sea. Positive values (reds and yellows) are the tide ebbing, while negative values (blues) are the flood tide. The black area represents the river bed.

Each transect took approximately 15 minutes to complete. The time given for each is that of the mid point of each transect.

Both days data show a similar pattern of current flows.

Two hours before low water the tide was ebbing at up to 100 cm/s over much of the channel but was noticeably slacker near to the Sandon wall.

An hour before low water the tide is still ebbing strongly over a large area in the middle of the channel. However, near to the Sandon side, the water is barely moving and there is evidence that in the region up to 150 metres from the dock wall there is a flow in the opposite direction.

Approximately 45 minutes before low water the ebb tide, although slowed considerably, is still flowing at more than 50 cm/s over a considerable area on the Liverpool side of the channel. Near the Sandon wall the counter current is now more pronounced with flows of up to 30 cm/s.

At low water this gyre has disappeared. The initial flood of denser saline water near the channel bed is evident, with the fresher water nearer the surface still ebbing.

In the hour after low water the water is still slack towards Sandon. In the second hour following low water the currents are still significantly smaller near the Sandon side of the channel.

These findings are totally in accord with previous surveys in this vicinity (Rivers division, 1984; John Taylor & Sons, 1987). Features such as the pronounced counter current during the ebb tide (which starts approximately 90 minutes after high water) and the density circulation giving rise to the tide flooding earlier at the river bed are clearly shown in the ADCP plots.

The current velocity data shows that ambient flows close to the dock wall are very small for protracted periods before and after low water. Evidence of a counter current for long periods before low water was found, as observed on many previous occasions.
