**REPORT ON THE MANAGEMENT
OF THE DRAINAGE REGIME WITHIN
EXMINSTER MARSHES**

NRA

South Western Region

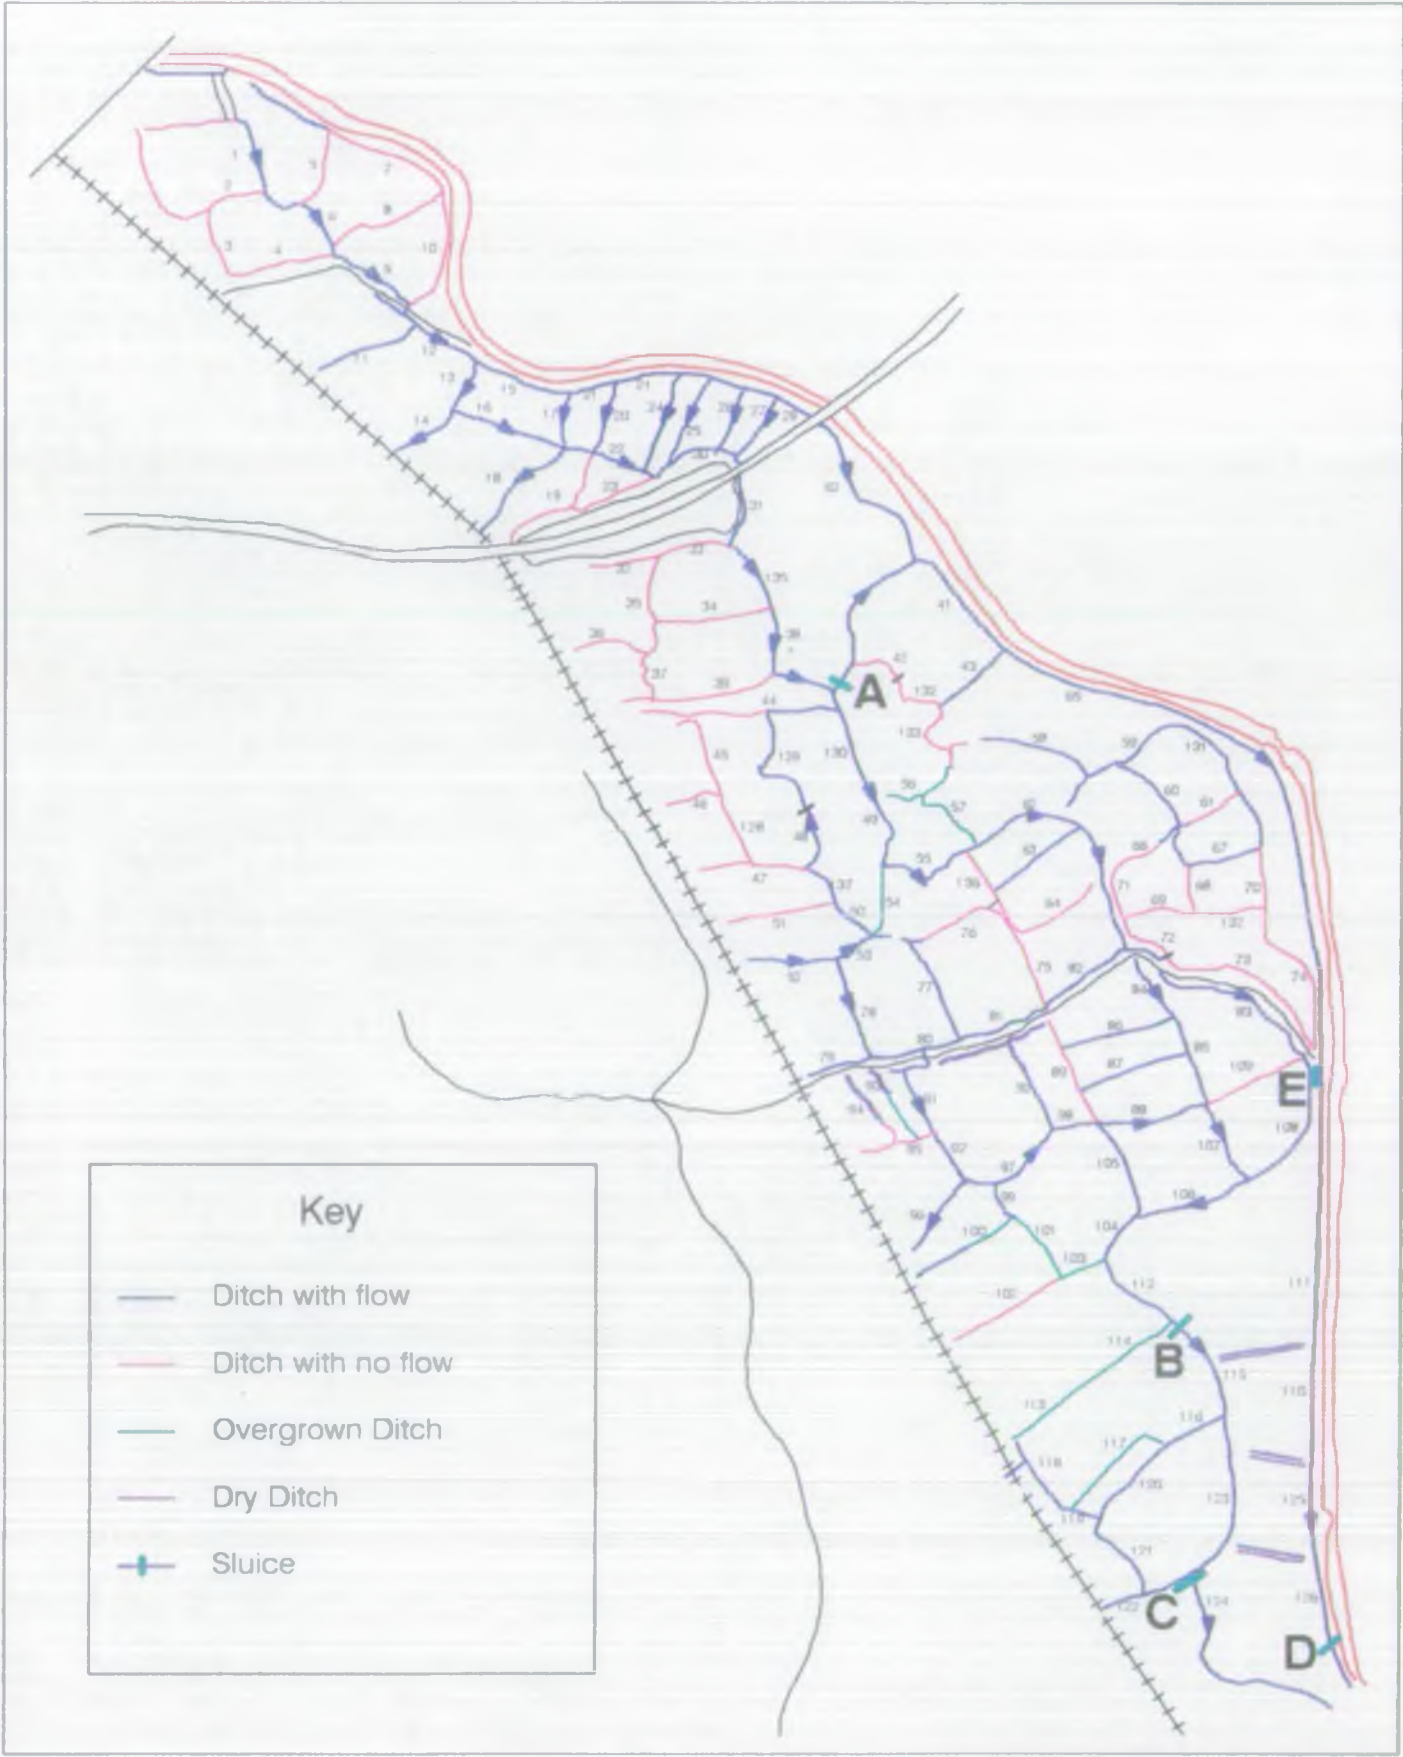
Figure 3 - Observed flow directions within the ditches and positions of sluices

The flow direction of many of the ditches was assessed and it was possible to get an appreciation of the main flow pattern through the marshes (fig. 3). In some cases ditches were too heavily vegetated to measure flow direction and in others the ditches were completely dry or appeared to have no flow. It should be recognised that fig.3 does not represent a definitive flow pattern which will apply under any circumstances, it is a snapshot situation during a dry summer. It is likely that the flow regime is subject to considerable variation depending on the amount of water entering the marshes and the state of vegetation growth within individual ditches.

The water level differences associated with the sluices (fig 3) are presented in appendix 1 together with any general observations. All but one of the sluices was shown to maintain a water difference (sluices A, B, D, E).

Despite local variations in flow and flow direction there was found to be a clear, and not unexpected fall of water through the ditches from Alphin Brook to Turf Lock. The survey can provide little more than a snapshot of the flows as changing states of vegetation growth will influence flow direction. It would

appear that ditch flow during low flows is concentrated into two major parallel systems running down the marsh. The ditch closest to the canal being the more significant of the two. Exminster Brook has a minor role to play at times of low flow in providing water to the west side of the marshes. Fig.3 shows that certain areas of the marshes are isolated from the through flow. The presence of these "back waters" has been recognised by the maintenance engineers who have installed sluices to direct flow towards areas identified as needing water. Additionally they serve to increase the travel time of water passing through the middle and upper sections of the marshes maintaining water levels. Of the five sluices only B and E maintained a significant difference of water level. Sluice B held back some 0.6m of water and its removal would most certainly detrimentally effect water levels in the ditches upstream, as would the removal of sluice E. Sluice C probably has little influence since it is not much more than a pipe and sluice A although it may not influence water levels dramatically may be partly responsible for the lack of a measurable flow in ditch 42.

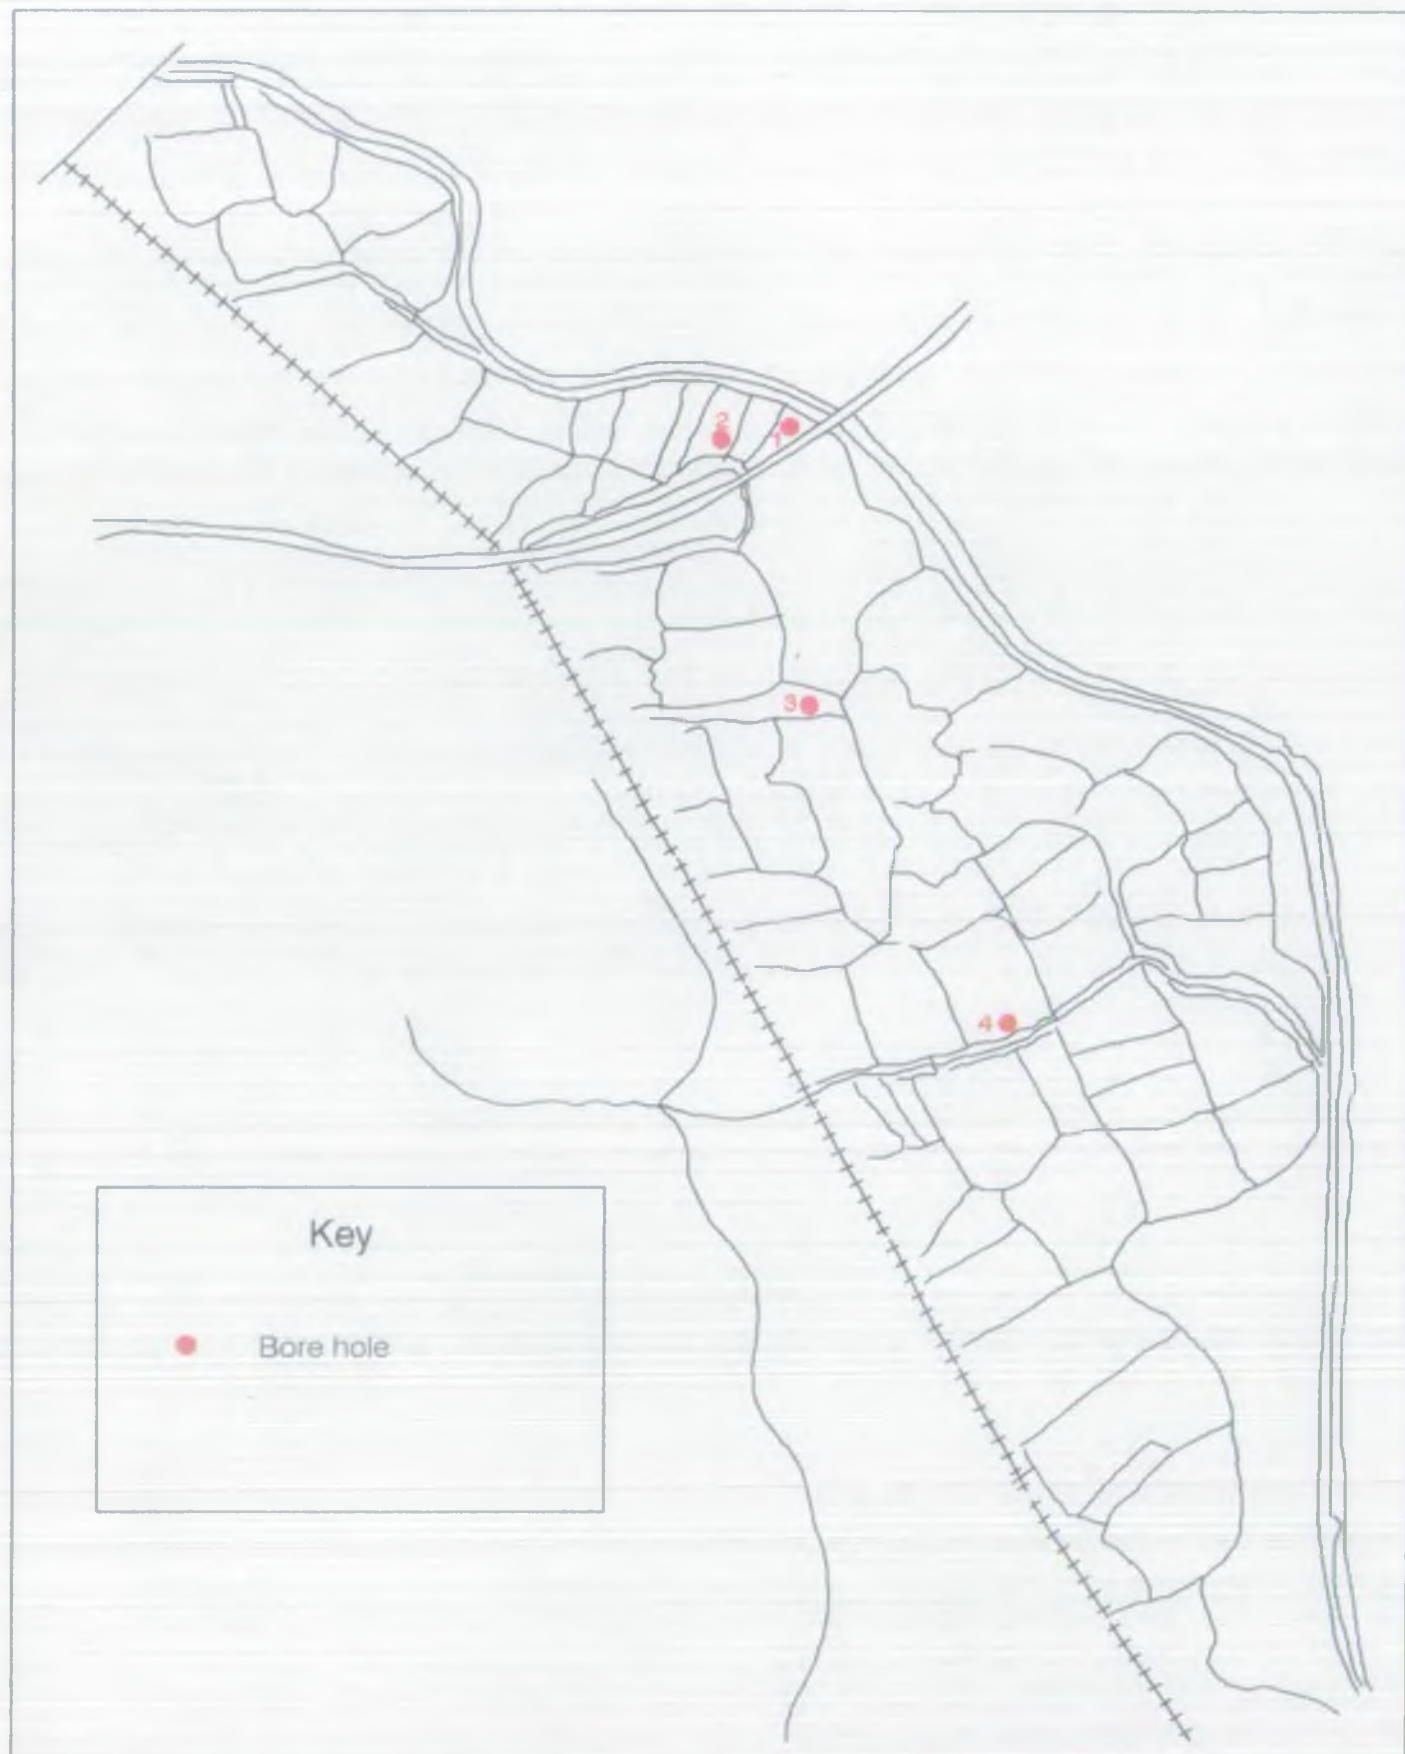
Figure 5 - Bore hole data indicating underlying geology

Historic borehole investigations (Appendix 1) show a thick layer of clay beneath a layer of estuarine alluvium and alluvial gravel.

Bore hole data indicating underlying geology.
