INVESTIGATION INTO THE STORM OVERFLOW DISCHARGE REGIME OF HILL BARTON S.T.W. - OKEHAMPTON.

MARCH 1996 DEV/E/10/96

National Rivers Authority South Western Region

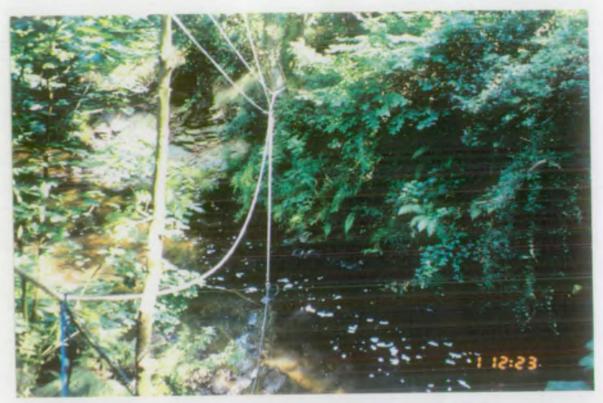
A DMP mk IV water logger measuring dissolved oxygen, pH, turbidity, ammonia, temperature, and conductivity was installed approximately 10 metres downstream of the final effluent discharge (Appendix 3). This was then connected to a meteorburst telemetry system (Appendix 3), to allow real time results to be displayed on a computer terminal, situated in the communications room at Manley House.

Photogragh showing DMP Mk IV deployed approx. 10 metres d/s of final effluent.

Due to proximity of the storm discharge and the final effluent it was impossible to monitor each effect separately. Also the topography of the area (steep sided gorge, and solid bed rock) makes it very difficult to place a monitor in an acceptable location. The DMP mk IV water quality monitor was installed on a suspended rope structure, so that the probe was in the centre of the river approximately 10 meters downstream of the final effluent discharge. A meteor burst telemetry system was installed to display and collect data at the communications room at Manley House (Appendix 3).

This allowed for data collection within the mixing zone, but all measurements would be of the combined effect of both storm and final discharges.

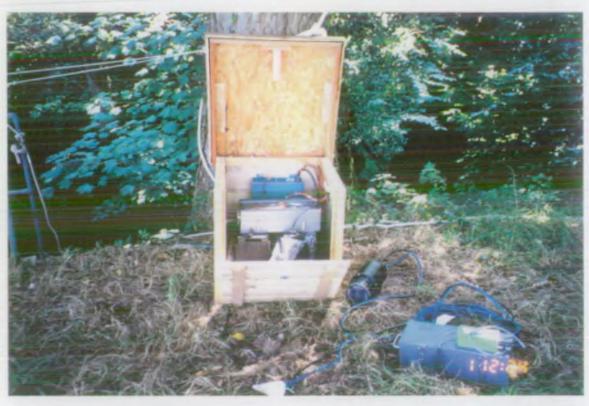
Photograph of Meteorburst telemetry unit.
