## AYLESBURY FLOOD ALLEVIATION SCHEME

Aylesbury a rapidly expanding town has a history of flooding, most significantly in 1947 and most recently in 1987, when large parts of the town were flooded, particularly around the Stocklake area.

Following extensive research and the preparation of a computer model, a flood relief scheme was prepared to cater for future development and provides protection from a 1 in 100 flood event.

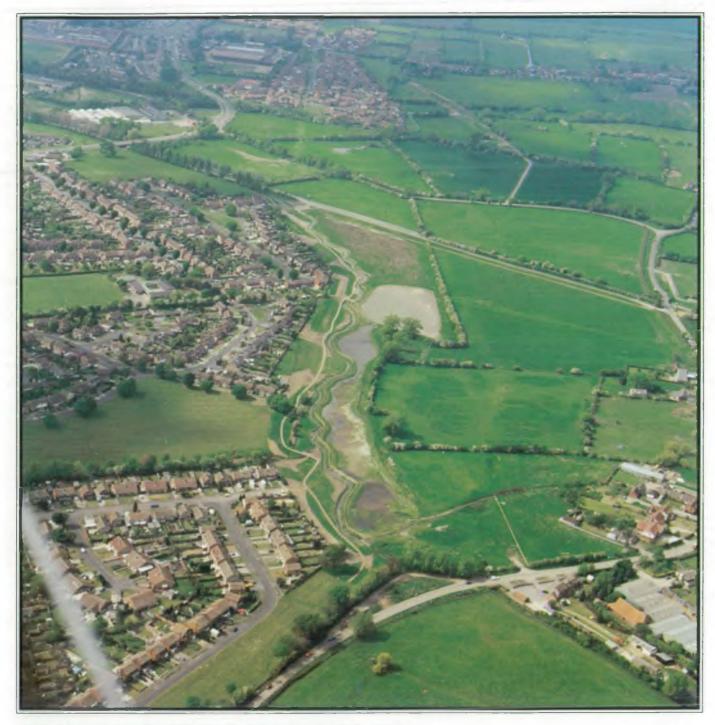
Aerial photograph taken May 1995. Bear Brook flood storage area in centre

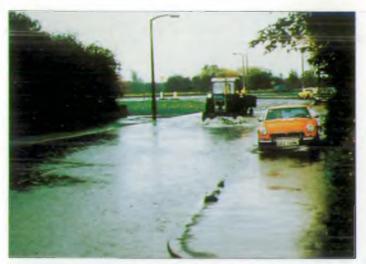
#### Typical flooding in Aylesbury prior to works

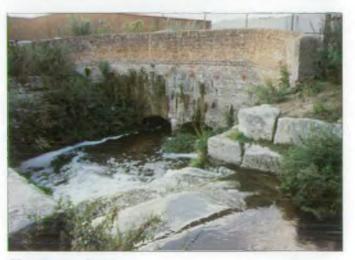
Upstream Inlet

Problems had long been encountered where the Bear Brook passes under the Aylesbury Arm of the Grand Union Canal. Known as the Bear Brook syphon and permanently submerged, the syphon (or culverts) were difficult to inspect and prone to blockage with a build up of flood debris preventing the watercourse flowing freely.

The work involved constructing a new Portland stone overfall upstream of the structure which, in combination with the Bear Brook regrading, provides for clear passage of water. The opportunity was taken to fully refurbish the syphon and the approach and exit channels. This is believed to be for the first time since the canal was built.
