## PILOT ENVIRONMENTAL AUDIT

# LEIGH, TONBRIDGE, DISTRICT OFFICE

## SOUTHERN REGION

DATE OF AUDIT 14/15 March 1995.

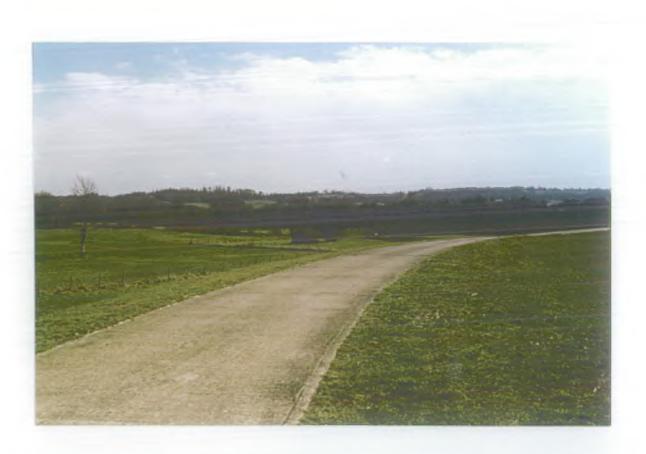
The appearance of the barrier is stark; there is no tree planting to obscure and soften the visual impact of the barrier. (Picture 1) The meadow land was reported to be grazed by sheep during the summer and we observed it was closely cropped. The manager of the adjoining country park had noted that the grass on the barrier did seem to be kept short, but understood that there were operational reasons for this. There is a tree planting scheme in progress at the northern end of the barrier with an area of trees being grown on prior to possible transplantation. (Picture 2)

In view of the cramped nature of the main site there is little prospect of enhancement to the visual and aesthetic appearance of the site. However, we recommend that:

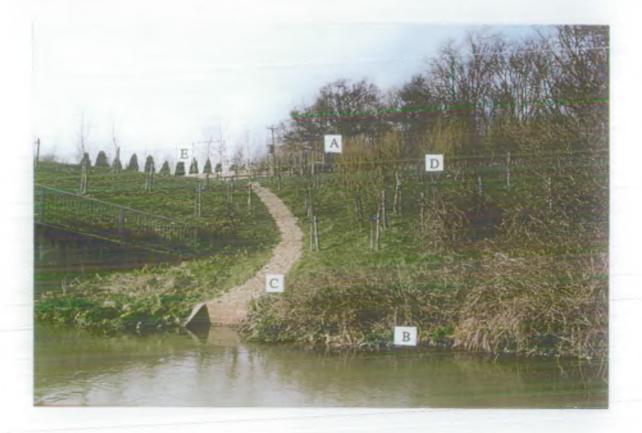
Picture 2 Leigh Office and barrier with Powder Mill Stream in foreground. A - sewage treatment plant; B - sewage outfall; C - land drain; D - tree planting scheme; E - Leigh Office.

The treatment plant is a small biological "off-the-shelf" package unit or "Bioclere" which is designed to produce a treated effluent acceptable for discharge to a watercourse. No information is available on the quality of the effluent discharged and we found no monitoring programme in place. Similarly there is no information on plant maintenance.

There is no evidence to suggest an oil separator is installed in the surface water system. In view of the vehicle movements, and in particular the variety of oils moved around the site we believe one is required. There is one air conditioning unit on site and the condensate from this is vented to the ground.

- An accurate drainage plan is produced. The drainage plan supplied indicated that surface water is directed to soakaway but there is also a suggestion that some may pass to the river.
- The colour coding system is extended to all inspection chamber' covers on site as recommended in the NRA Pollution Prevention Guideline No. 18 "Pollution Prevention Measures for the Control of Spillages and Fire Fighting Run-Off," section 4b, and the "Pollution Prevention Pays" video.

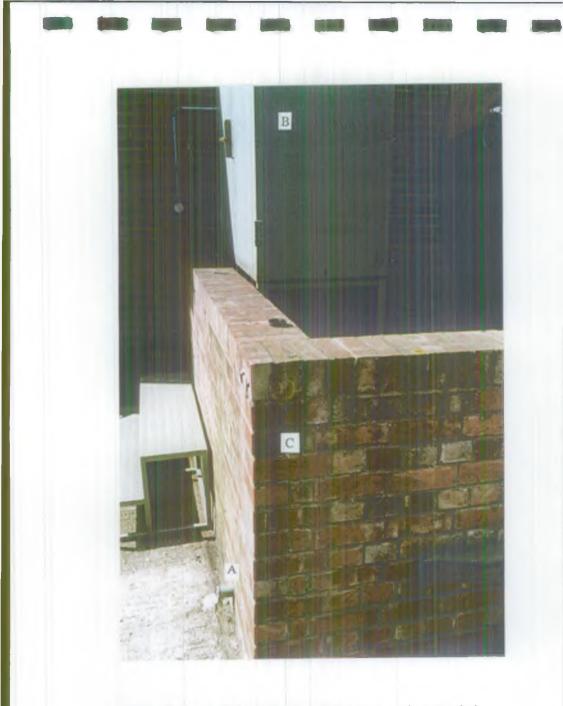
Picture 3 Leigh Office bulk oil tank bund. A - rain water drain through bund wall; B - fuel dispensing cabinet; C - bund wall.

- A contingency plan for the site is put in place to deal with any hazardous substance release. (See also Section 4.6)
- All forms of storage comply with the requirements of our own pollution prevention guidelines, including securing all polluting liquid storage facilities, and especially improving drum storage facilities.

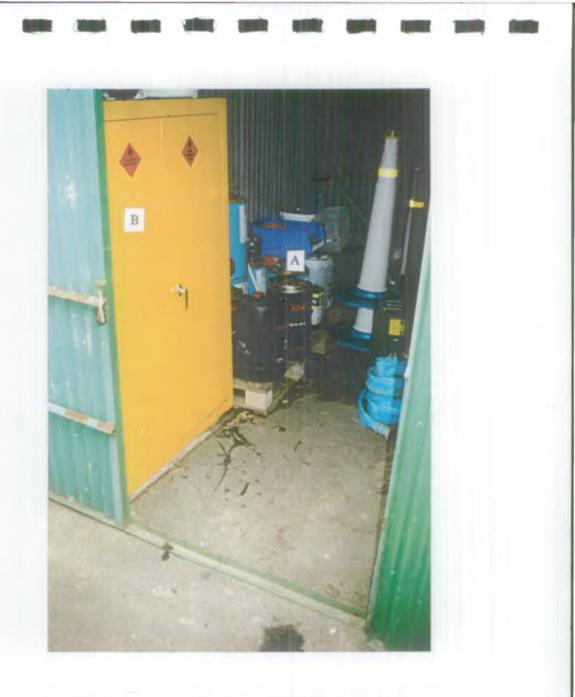
Picture 4 Leigh Office storage hut placed directly on tar macadamed surface. A - drums of oil; B - hazardous chemical store.

flood defence workforce for storage of all types of equipment. There are several 25 litre drums of various oils kept within these stores without any form of protection. Additionally, lead/acid batteries are also stored on the floor in vulnerable positions. Although these stores are kept locked when not in use, any spillage within the stores would be difficult to contain and could contaminate nearby surface water gullies. (Picture 4)

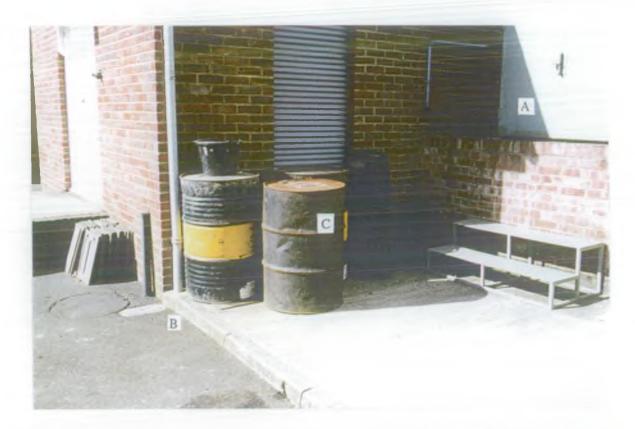
Picture 5 Leigh Office fuel dispensing area and drums stored alongside bulk oil tank. A - fuel dispensing point; B - unsealed rain water downpipe; C - oil drums.

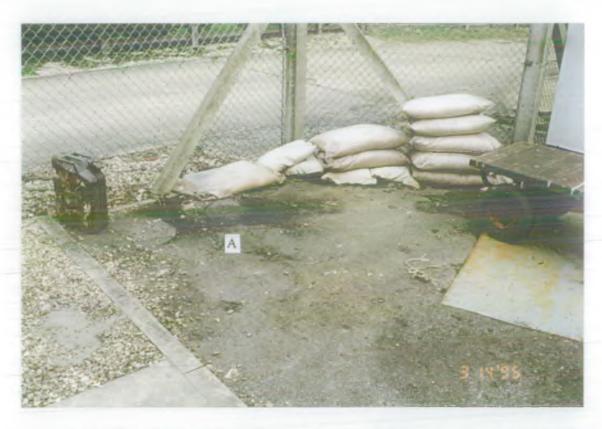
Picture 6 Leigh Office unbunded store area alongside Portastore building. A - marks due to oil spillage and drums.

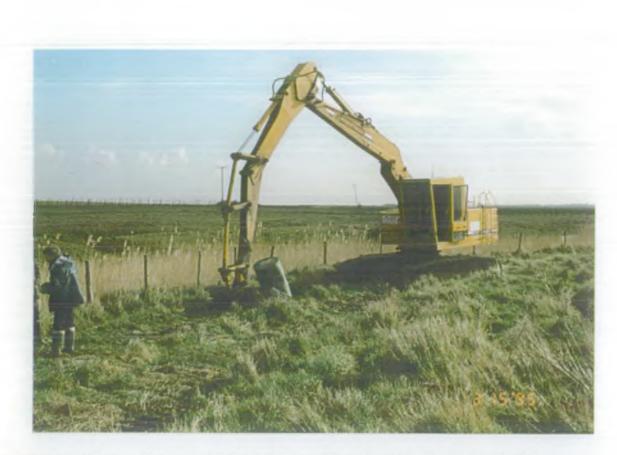
Spillage - Refuelling Plant was not present during the audit but was recently used. Operatives reported that fuel is moved in a trailer or the rear of a truck but did not state if it was contained. Drums are left on site and there is a potential problem with escapes caused by vandalism. Jerricans are used to fill small plant with the risk of small spills, estimated by staff at a maximum of a pint. No absorbents are kept and no spill procedures are available.

Picture 7 Dredging at Yantlet Creek. Note the fuel oil drum carried in the excavator bucket.

- Fuel is transported to sites by bowser or bunded pallets in all but the most exceptional conditions.
- The fuel drums on the dredger are secured and adequately bunded, and spill absorbents are carried.

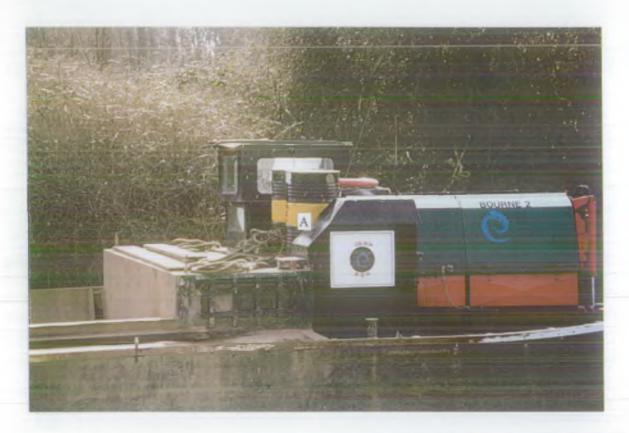
Picture 8 Dredger "Bourne 2" on the river Medway below Oak Weir. A - fuel oil drums carried, unsecured and unbunded.

**Refuelling** The Medway dredger "Bourne 2" is refuelled from two yellow and black 45 gallon drums mounted on decking just by the wheelhouse. There is no protection around the storage area should a spillage occur, and the drums were not secured; finally, although specified in the contract document,

oil absorbents were not seen to be kept on the vessel. (Picture 8)

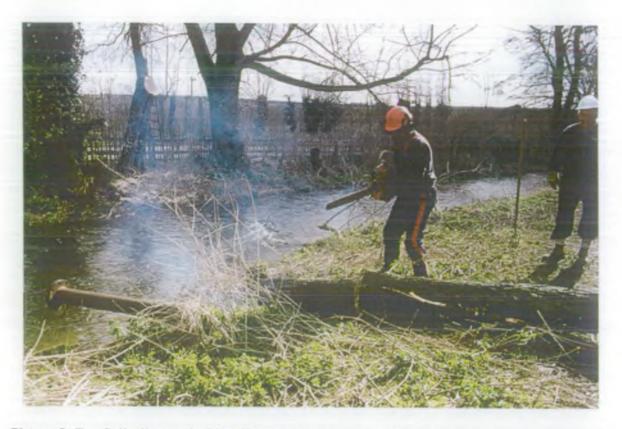
Statutory Nuisance The occasional use of a chain saw (noise and smoke) and the burning of brush in a particular area is unlikely to cause a Statutory Nuisance. The use of bow-saws for cutting small branches can achieve a reduction in the environmental impact. This is more convenient, comfortable and less noisy to the operatives and neighbourhood than the tendency to always use 'easy' mechanical means. (Picture 9)

**Spillage - Chain Oils** The experienced supervisor identified the oils from their differing viscosities. It was not always apparent from the container. The operatives did not know whether the chain saw oil was biodegradable. Sawing was taking place over and immediately adjacent to the river.

Picture 9 Tree Pollarding on the River Darent at Horton Kirby. Use of chain saw in immediate vicinity of river.

- Rapidly biodegradable hydraulic fluids are used in NRA plant, subject to the findings of the project in Northumbria and Yorkshire.
- The use of biodegradable oils for chain saws is adopted.

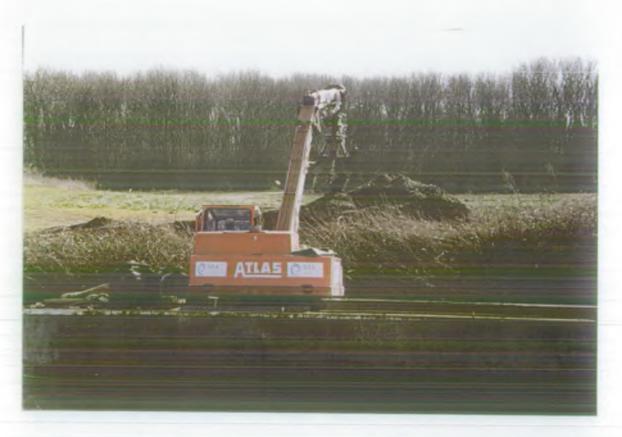
Waste Disposal At the Medway dredging site excavated spoil is stockpiled on the adjacent river bank prior to some of the material's use to improve local farmland and roads. At other sites where deposit on the bank is not possible we were told that the material is stored within the dredger and then barged to a disposal site. On occasions spoil from the hold was deposited at a gravel pit. We could not clarify the status with respect to the application of the Duty of Care for the Disposal of Waste. (Picture 10)

Picture 10 Dredging from "Bourne 2" on the medway below Oak Weir. Spoil is deposited on the river bank.
