PILOT
ENVIRONMENTAL AUDIT

NRA
DARLINGTON
DISTRICT OFFICE

NORTHUMBRIA AND YORKSHIRE REGION

DATE OF AUDIT 26/27 July 1995.

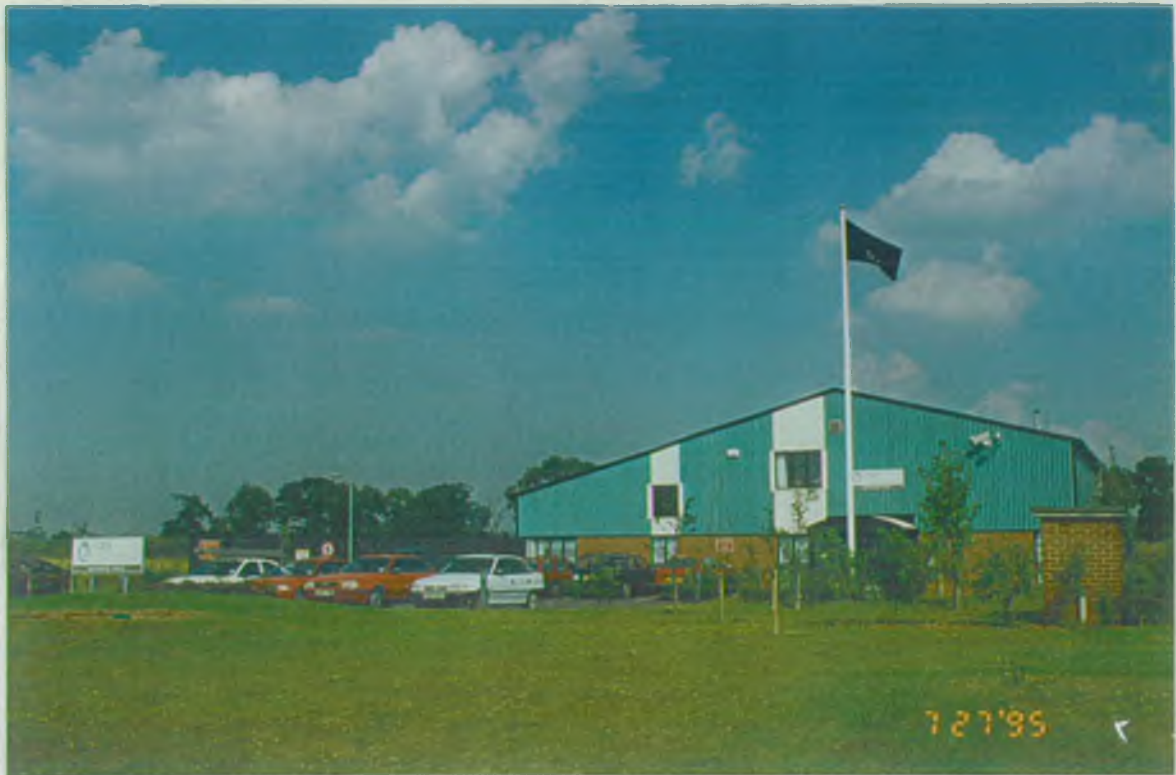
Photograph 1 A general view of the Darlington Office. The growth of trees in the foreground, planted when the site was developed, has been patchy.

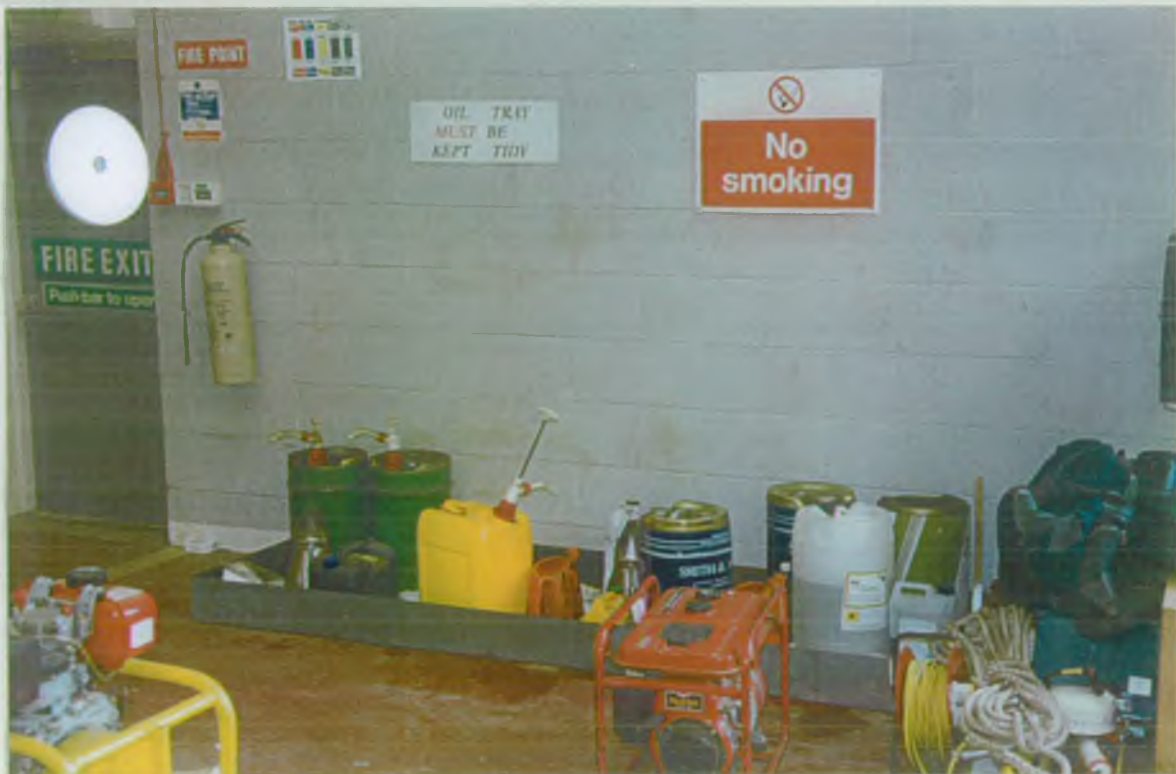
Photograph 2 The storage and dispensing area within the garage/workshop. Containers are held within a galvanised metal tray.

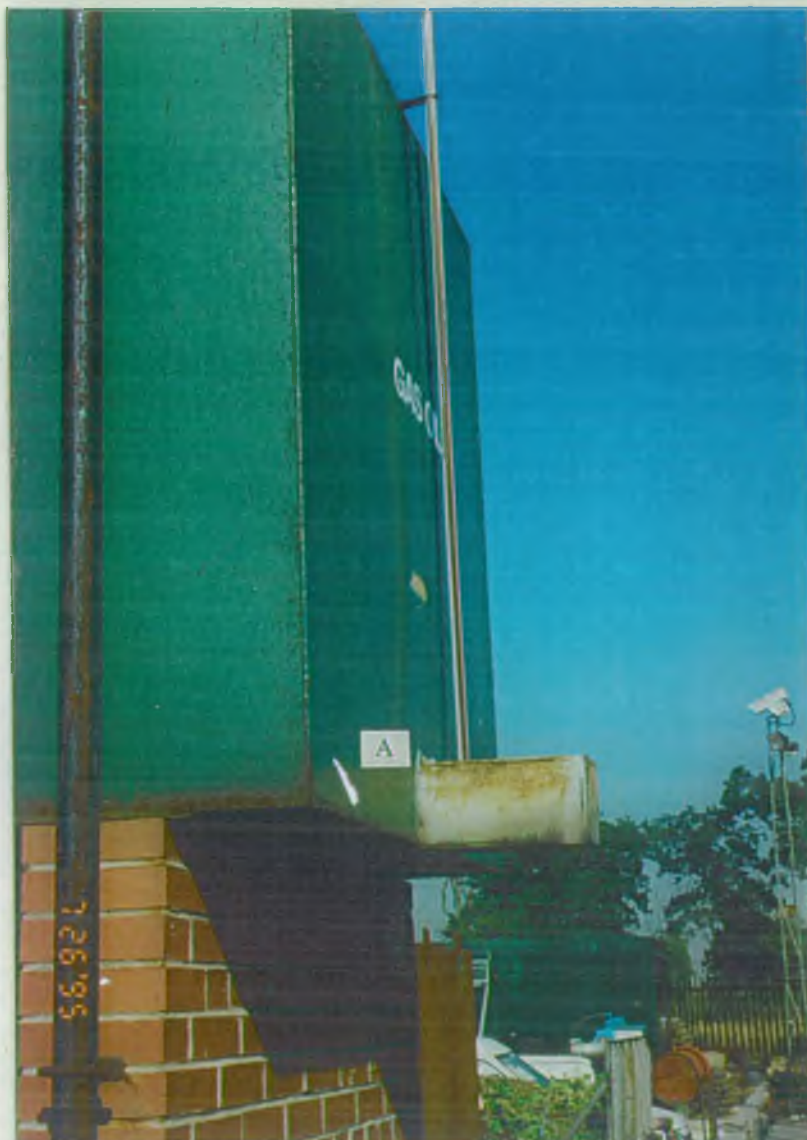
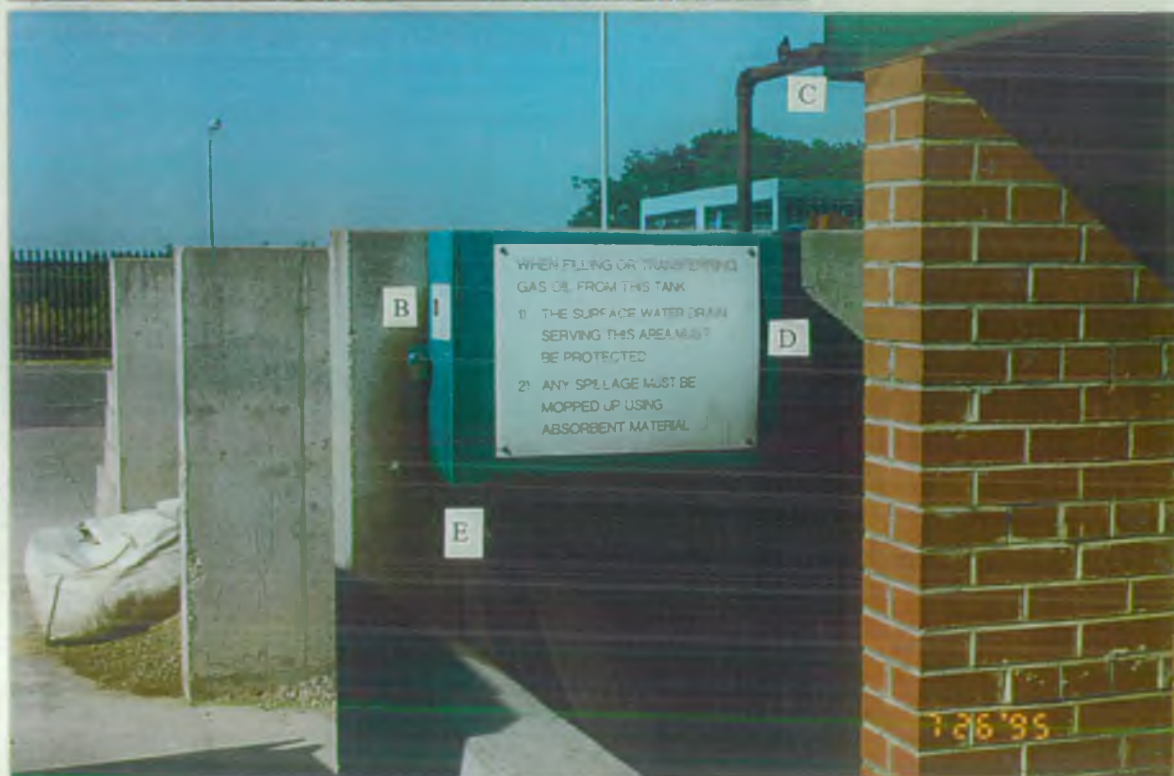
The sight gauge is affixed to the tank at the end adjacent to the perimeter fence and is vulnerable to interference from outside the site; a public footpath runs through the adjacent land. Additionally the outlet from the tank and its associated valve is encased within a metal box welded to the tank and would be extremely difficult to access on the occasion of damage to the sight tube. (Photograph 3).

- **Bund Compound** There is no sump within the compound to allow the removal of accumulated rainwater and there is no pump permanently mounted to allow rainwater to be decanted off. We were advised that rainwater is removed regularly by means of a portable pump, however, markings on the inside of the bund wall indicated that the level may be allowed to rise too far on occasions. Also located within the bund compound is a metal cabinet containing the refuelling pipe and fuel meter which are served by gravity feed. At the time of inspection the cabinet was padlocked but the valves controlling the gravity feed were not. The cabinet is sited close to the front containment wall, and, although there is a sign affixed to the door warning users of the dangers of spillage (Photograph 4), there could be a risk of leakage from the pipe-work falling outside the bund. There is also evidence of heavy oil staining, which appears to have seeped through the concrete, on the wall adjacent to the cabinet.

Photographs 3 & 4 The bulk oil storage tank; showing sight gauge valve enclosed within a welded box (A), locked refuelling cabinet (B), unlocked feed valve (C), spill refuelling notice (D) and oil staining to the wall (E).

- the oil tank installation complies with all the requirements of PPG 2, including full labelling (including the Oil Care sticker) improvement of the sight gauge arrangements, and identifying the extent of corrosion;
- all forms of storage comply with the requirements of our own pollution prevention guidelines, including securing **all** polluting liquid storage facilities, and bunding all external oil drum storage;
- the fuel delivery cabinet is moved further into the compound; and
- a seal should be available to protect the surface water gully near to the refuelling point.

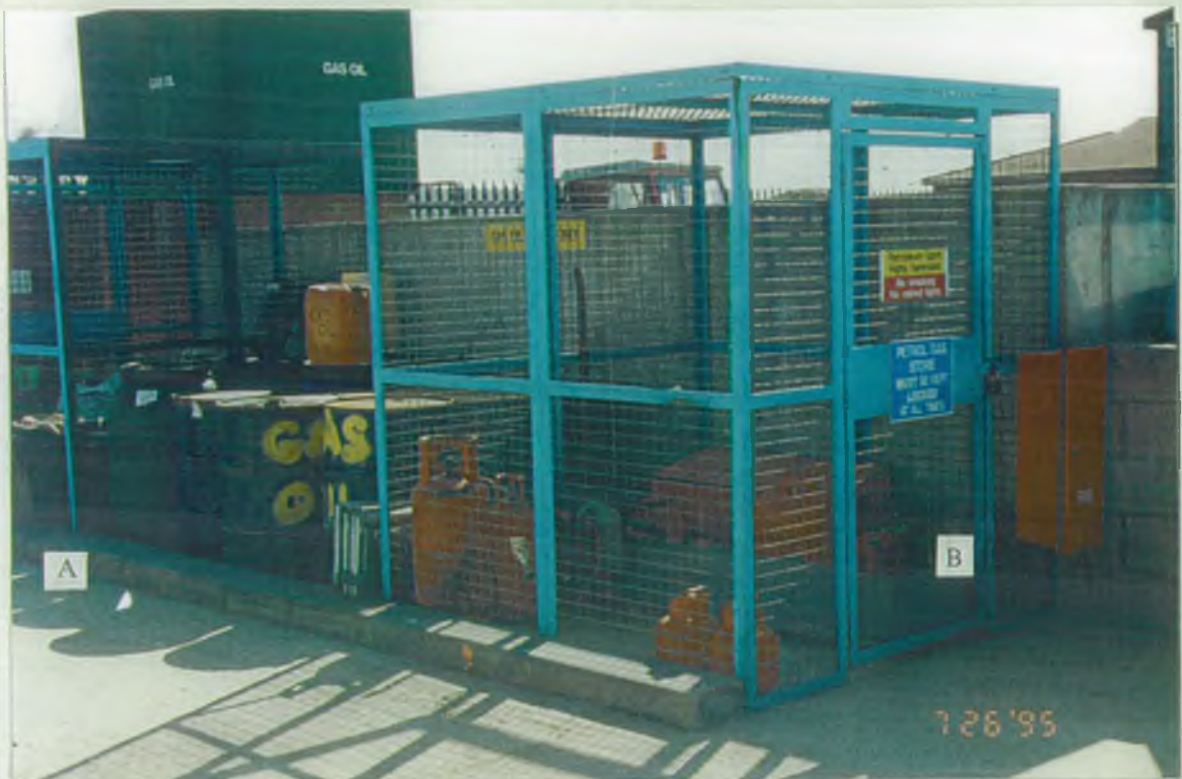
procedures available there is a surface water gully nearby which is vulnerable to spillages both from these activities and deliveries to the main tank. A small metal tray is available for use when refuelling small containers. Although the drums are contained within a kerbed area this is not bunded. Adjacent to this kerbed area is a locked cage which contains various small fuel containers within a metal bund for use with various items of small plant stored within the garage area. (Photograph 5).

Photograph 5 A storage area in the rear yard. Drums are stored kerbed but unbunded (A). Small petrol containers are bundled in a locked cage (B).

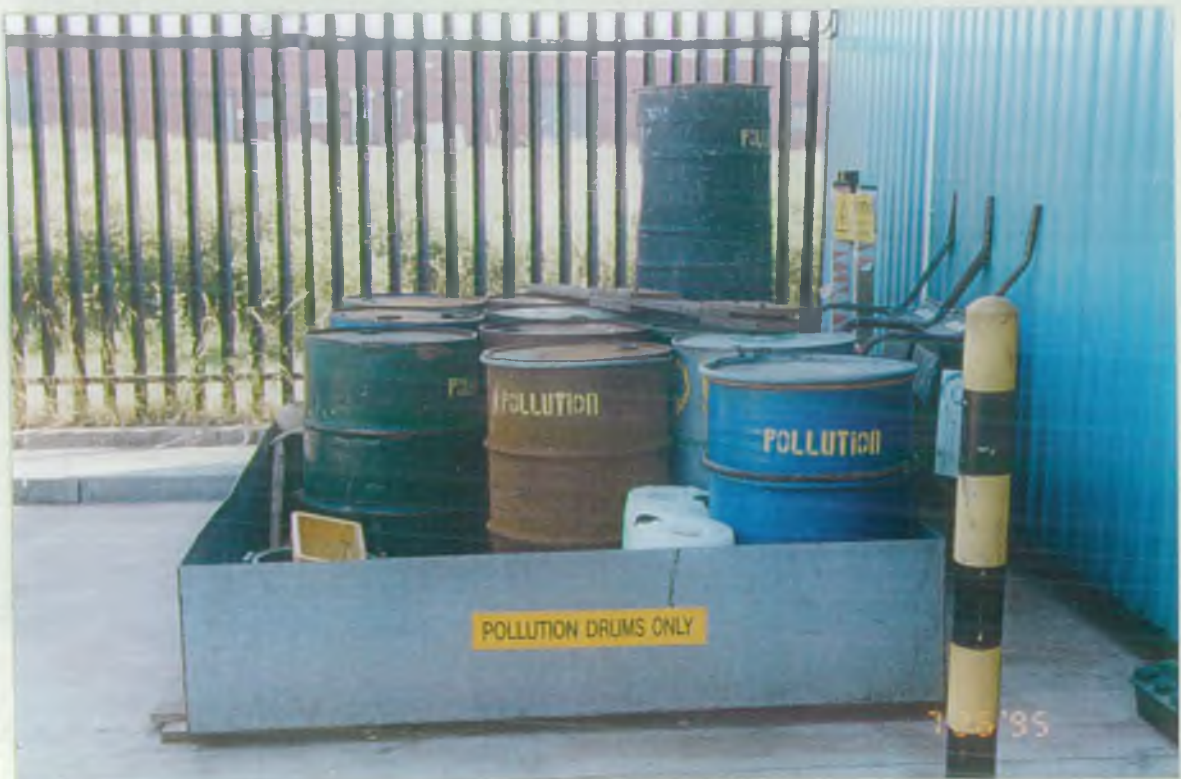
Just outside the rear of the building also against the southern perimeter fence is a galvanised metal compound used for the storage of waste oil in labelled 45 gallon drums and various other oil contaminated items. (Photograph 6). These materials are stored here pending removal by an approved waste disposal contractor. Unfortunately the oil is not recycled due to difficulties associated with the quality and variety of waste oils.

Photograph 6 Waste oil drums (labelled pollution) stored in the open in the yard in a labelled galvanised metal tray.

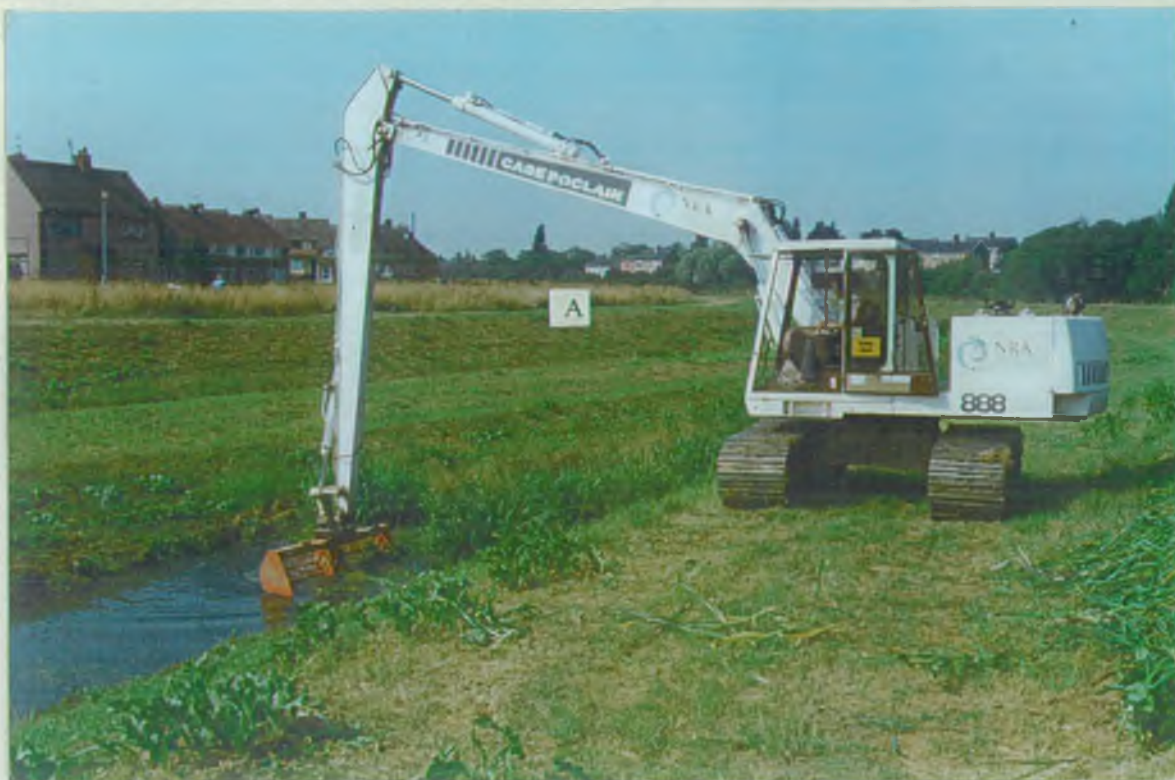
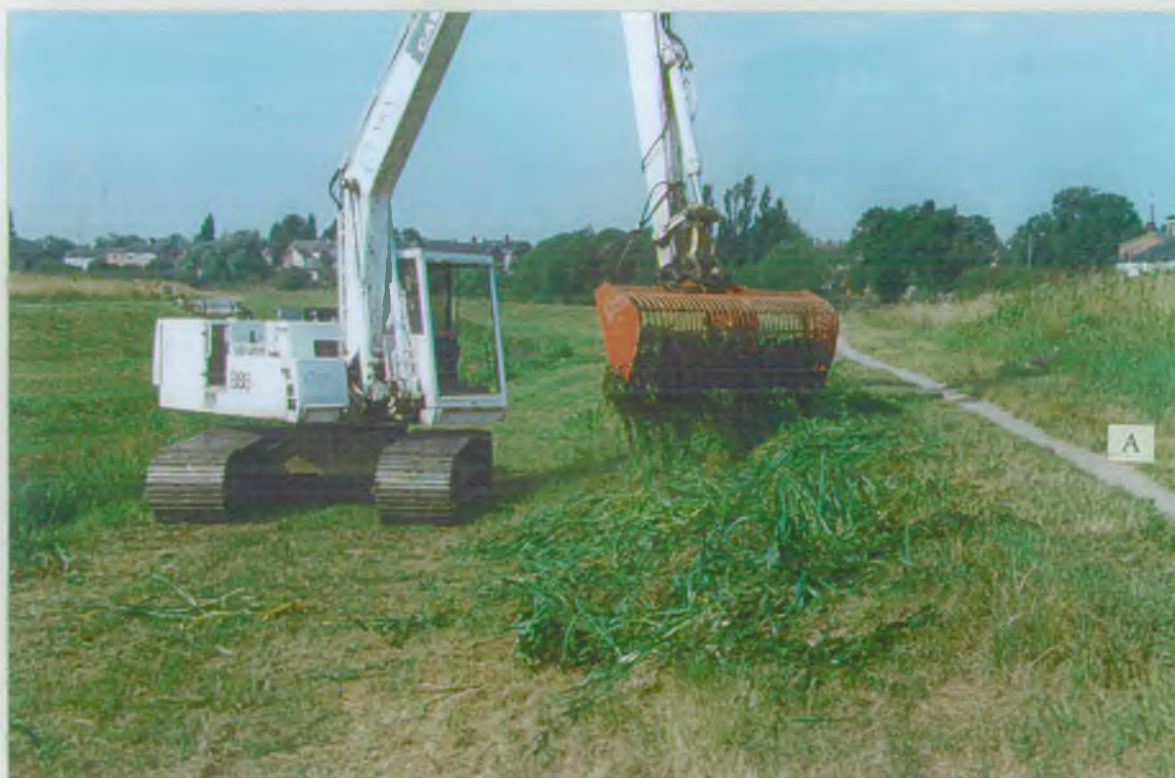
- **Waste Disposal** There were two types of cutting operations in use; 1) manual cutting using a scythe; 2) machine cutting using a Case Poclain tracked vehicle equipped with a long arm and hydraulic cutter. With both techniques the cut weed is removed from the stream and left to lie on the bank. (Photographs 7 & 8). This spoil is exempt from control as 'Directive Waste' by the Waste Management Licensing Regulations, 1994. Any large object retrieved is removed for later disposal.

Photographs 7 & 8 Weed cutting on the Lustrum Beck, Stockton. The site is in a developed area with adjacent paths (A) on the engineered bank top. Weed is deposited within the reach of the excavator on the side of the bank.

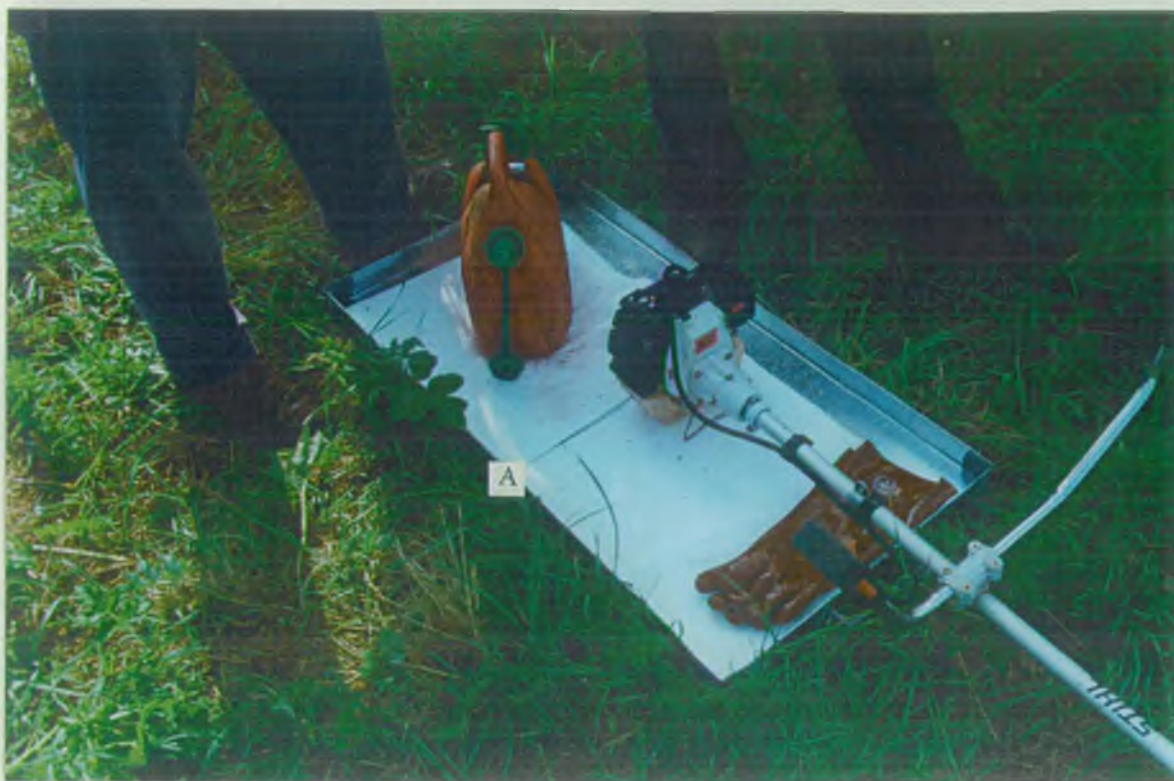
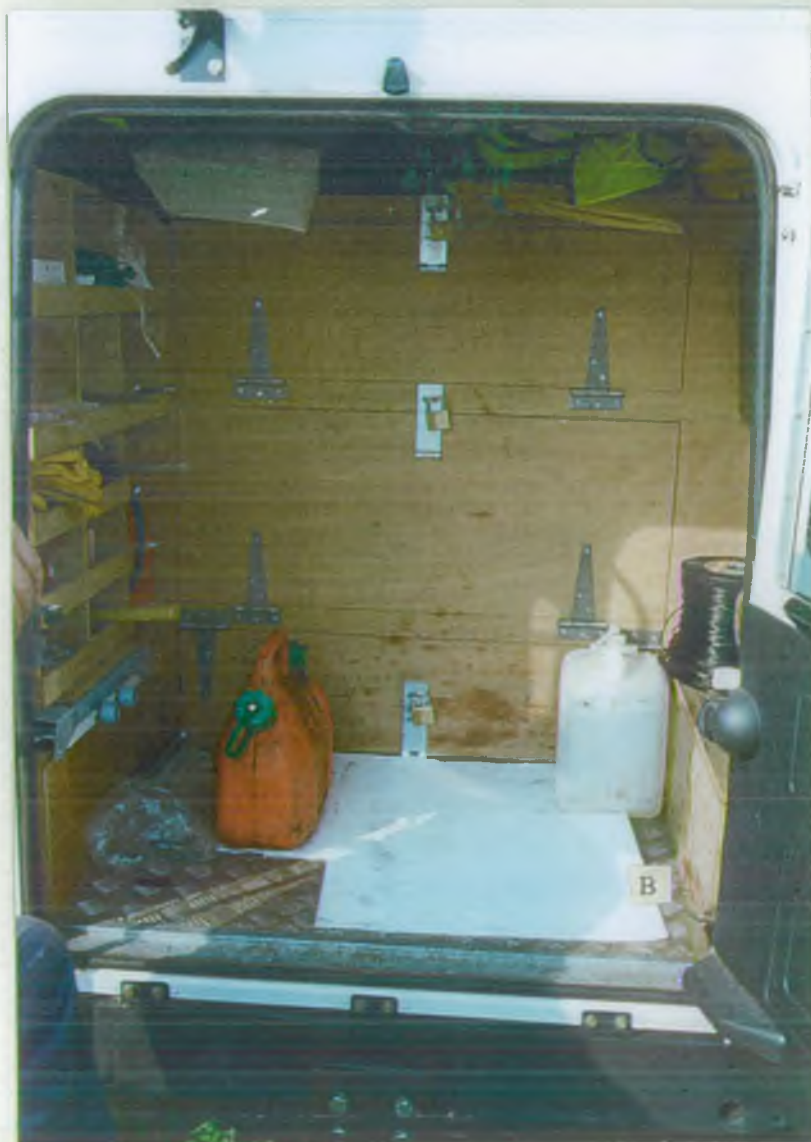
Photographs 9 & 10
Refuelling equipment in use
near the Eller Beck,
Stokesley. Portable metal tray
(A) with absorbent mats, and
absorbent mats inside a Land
Rover (B).

- fuel is transported to sites by bowser or within a protective bund in all but the most exceptional conditions;
- spill procedures are produced, briefed to staff, and displayed in plant and vehicles where practicable; and
- spill absorbents are carried on all large plant that refuel on site.
