ENVIRONMENT
AGENCY

**Brown Trout Habitat Assessment on the
River Bela Catchment (As Recommended
by the Strategic Fisheries Stock Assessment
Task Group 1995)**

**E.P.K. Watson
& D.J.F. McCubbing, 1997**

EA/NW/FTR/97/7

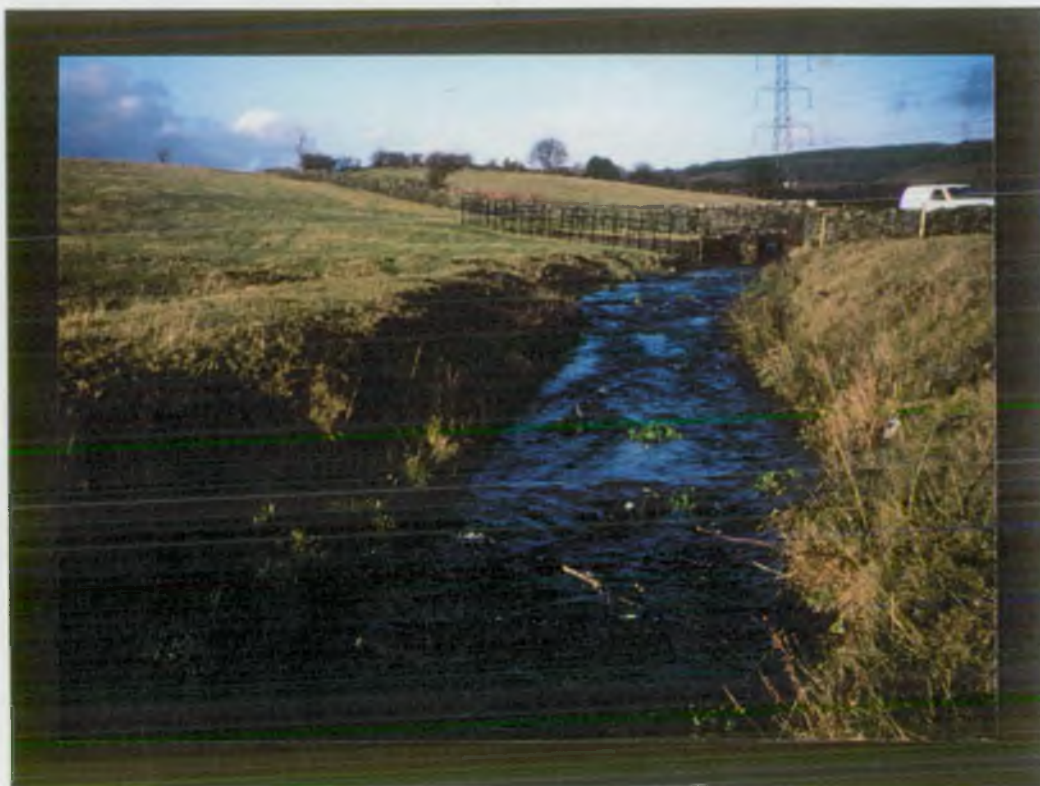
Plate 1, Site No 214, Raw Head Farm, St Sundays Beck, (SD 569 920)

Site No 214, Raw Head Farm, St Sundays Beck, (Plate 1)

A drop in relative score (from class a in 1992 to class c in 1995) has occurred, the relative class e for parr is low, and has remained stable since 1992. Total production score 5 and priority rating 2.5 were calculated.

An HQS score of 4, could be better. Flow is complementary to the requirements of fry, with 85% shallow riffle and 15% shallow glide. Cover is minimal, weed comprising of 2% (seasonal), and a small amount of overhanging vegetation giving an extra 1%.

The substrate is predominantly cobble (75%), with boulders and rocks (embedded) 10% and gravel at 10%, the remainder being made up of sand and silt. Land use is 100% pastoral, with a fairly steep gradient on one side of the beck. A land drainage pipe flows into the beck approximately half way down the site. Bank erosion is widespread (caused by farm stock), with six sites totalling 12m of eroded bank. There is no shading present.

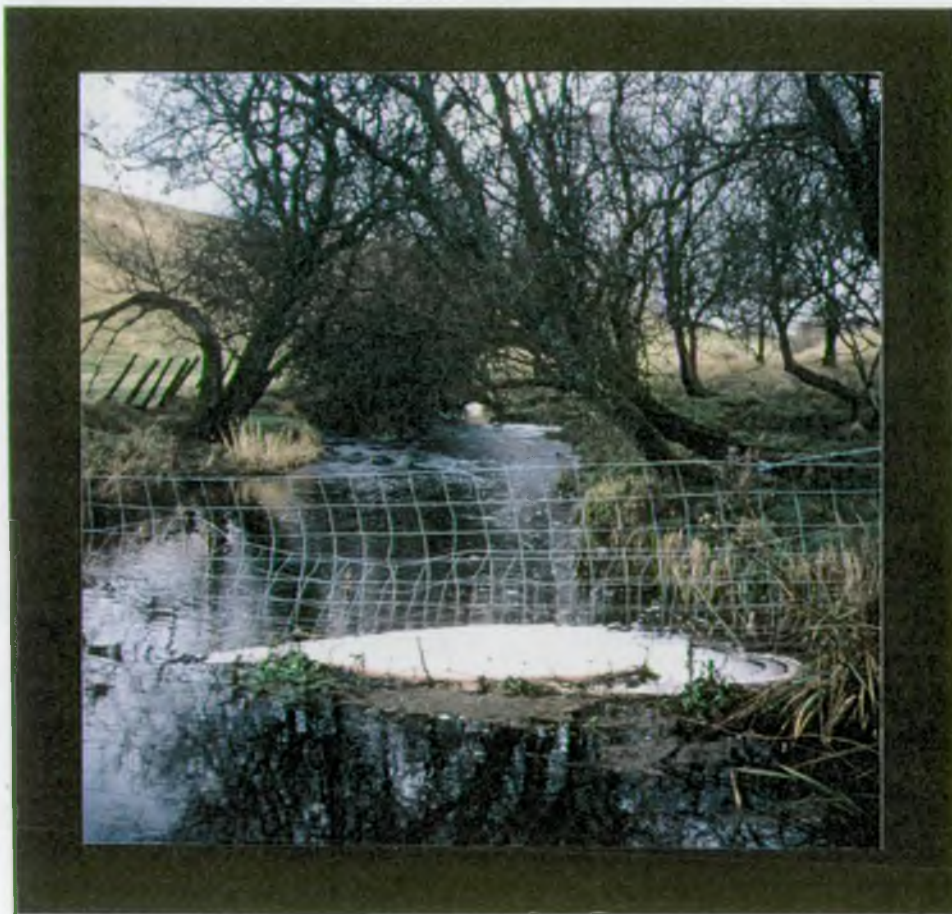
Plate 2. Peasey Beck (SD 584 899, Unsurveyed). Organic Enrichment

The substrate is mainly cobble, boulders and rocks. Sand and silt exist to a lesser extent and there are small amounts of gravel present, although on parts of the beck (especially the upper reaches on unsurveyed stretches) there are areas of detritus (allochthonous material, quite possibly washed down from Killington reservoir) fouling what could be excellent spawning substrate. These areas exhibited signs of organic enrichment, with the beck running a deep red/brown colour (plate 2).

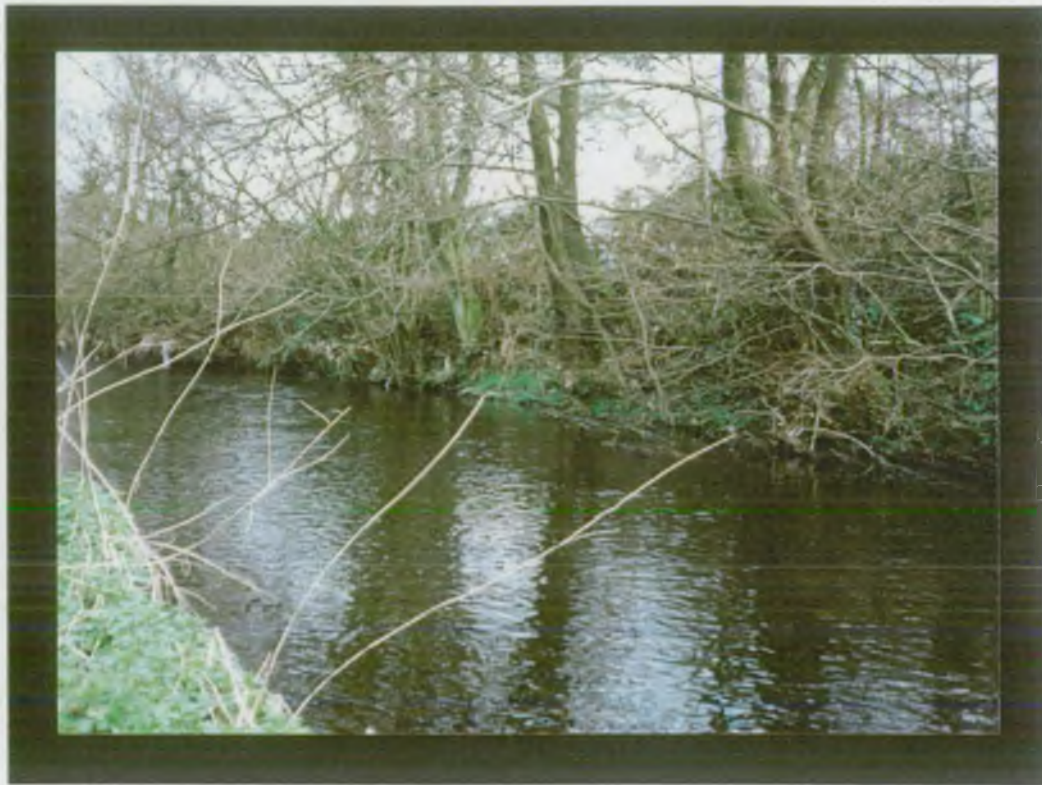
Plate 3. Site No 218, Crooklands, Peasey Beck, (SD 535 835)

The low HQS of 1, is brought about by the poor flow characteristics of the site (95% deep glide). Cover availability levels however were good, with tree roots, overhanging vegetation and undercut banks (plate 3), providing the majority of the 5% score.

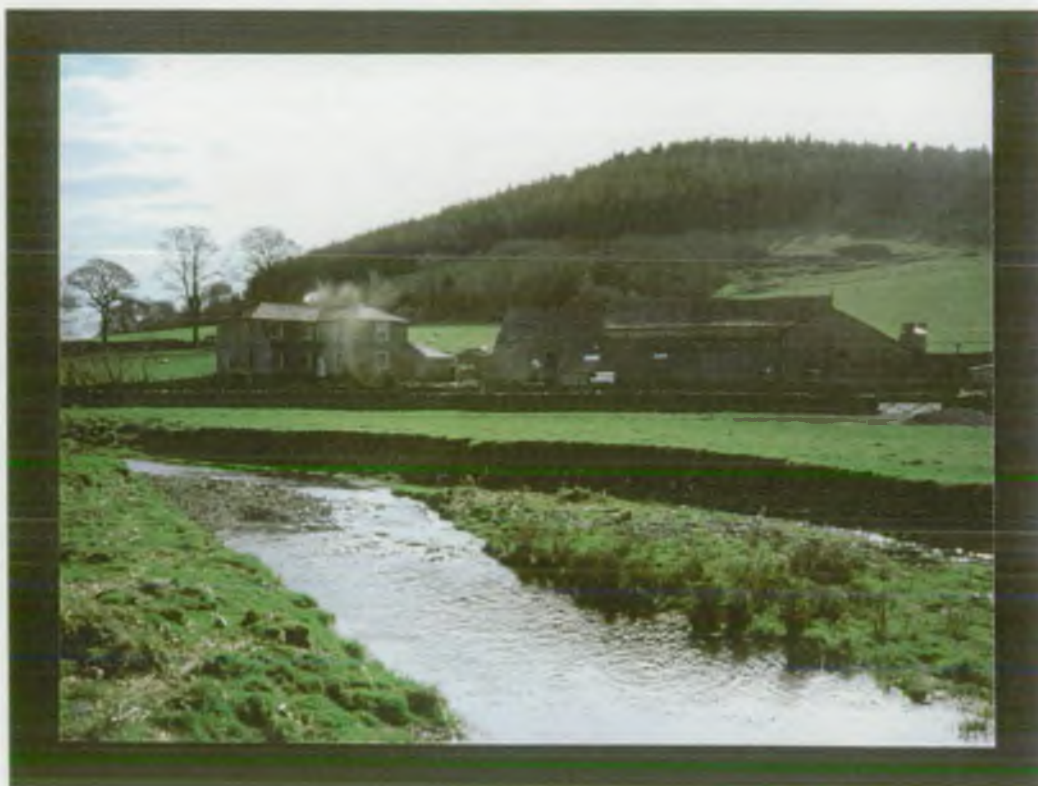
Site No 232, Spittle Bridge, Lupton/ Beck, SD 581 807

An increase in fry relative score has occurred since 1992 (D to C), with a decrease in parr (D to E). Total production score is 6, and a priority rating of 1.04 having been attributed.

The substrate holds 10% sand and silt, 60% cobble and 30% gravel. Land use is 100% improved pasture (no fencing), with severe bank erosion caused by farm stock (9 sites totalling 30m in length), with large lumps of the banks present on the substrate. One site of braiding (approx 11m), is thought to run dry in the summer, leaving two distinct channels. There is no shading present. 8 redds were reported in this stretch (4/12/96), it was observed that cattle were present in the beck, opening a threat of redd trampling and disturbance.

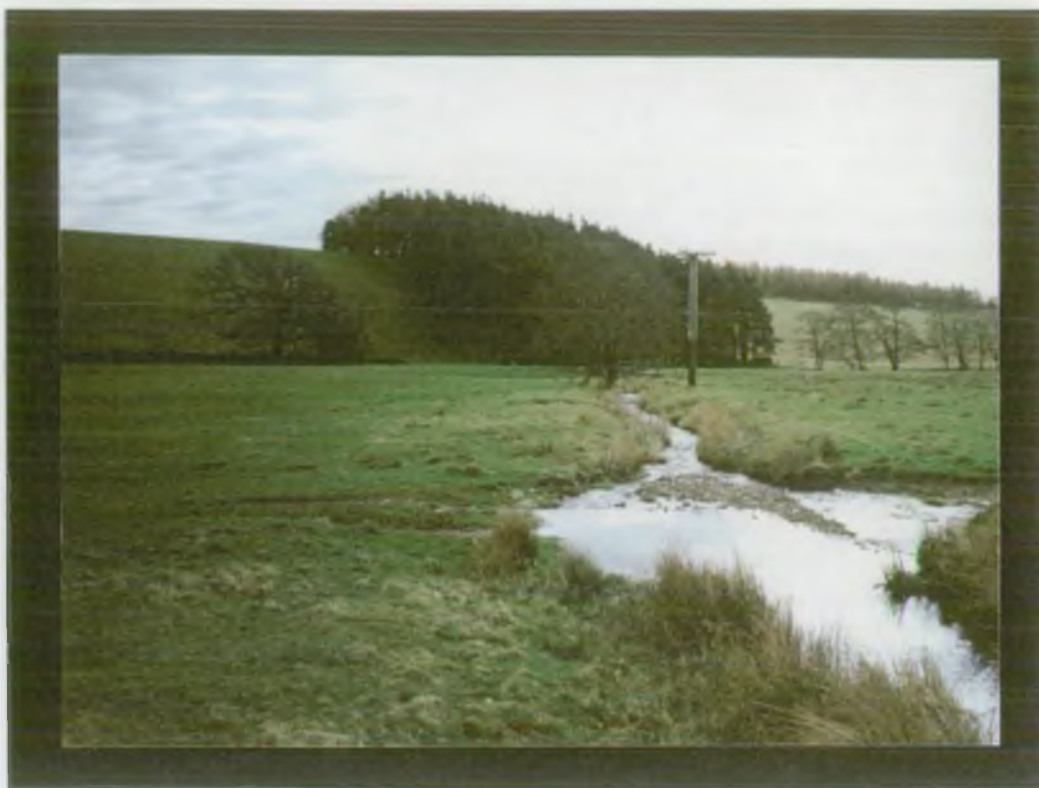
Plate 5, Barkin Beck, u/s site 236, (SD 586 831). Severe bank erosion.

The substrate is largely cobble (85%), with gravel forming the remainder. Land use is improved pasture, with severe bank erosion (6 sites measuring a total of 65m) having been caused by grazing. The site is 20% shaded by large trees.

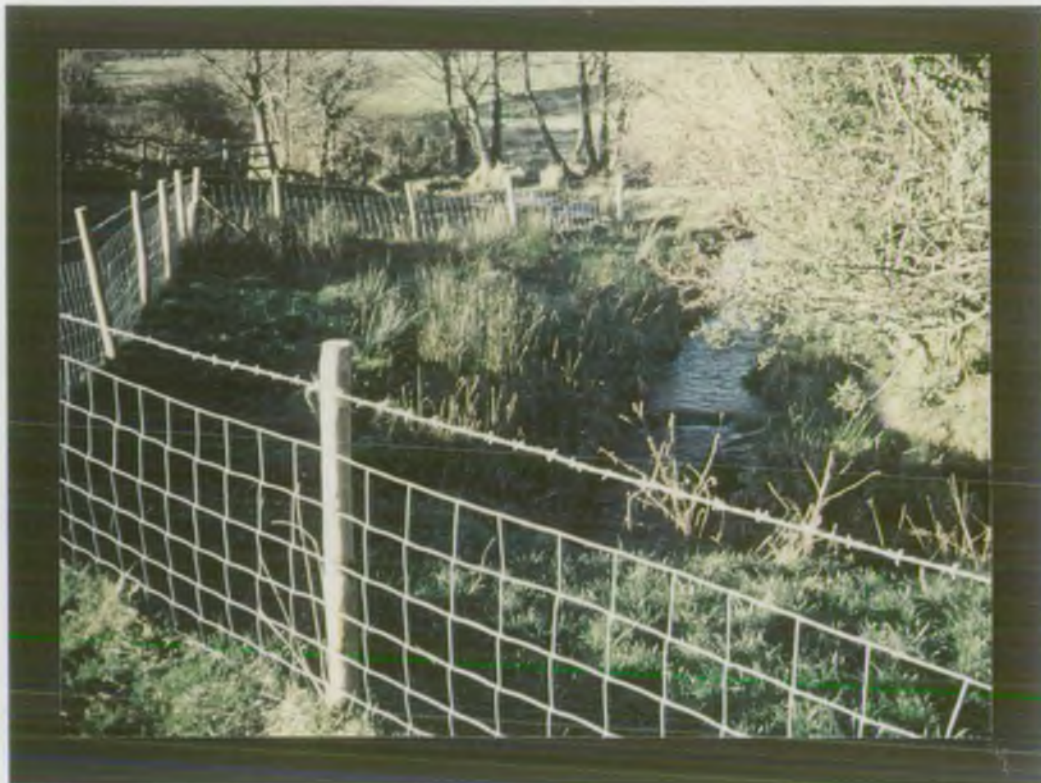
Plate 6. The creation of a buffer zone to encourage riparian growth

The creation of a buffer through fencing would encourage the growth of overhanging vegetation, giving rise to increased cover availability for both fry and parr (example, plate 6)

The introduction of fencing along the entire length of the beck would be an answer to improving fry and parr numbers. Cattle poaching is causing prolific bank erosion. As well as destroying redds, widening the becks and reducing flow velocities, (which will eventually lead to siltation, and loss of spawning habitat), establishment of bank side vegetation is inhibited.

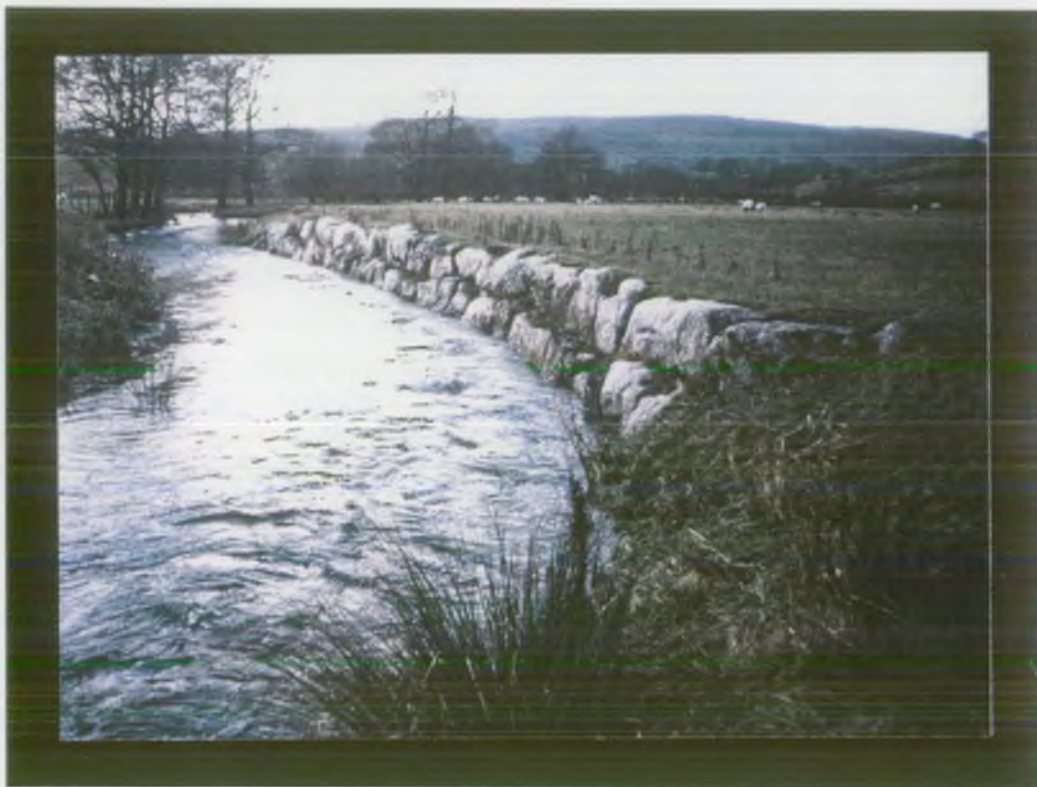
Plate 7, Rock revetment repairs against bank erosion, d/s Spittle Bridge, Farleton Beck, (SD 575 800)

The primary cause of the decrease in parr densities, is probably lack of suitable cover. Growth of overhanging stream side vegetation will be encouraged by the establishment of a buffer zone. Bank erosion was most prominent on this reach. Areas in dire need of repair exist, for example the site directly above Spittle Bridge is widening to such an extent, that in low flow conditions sediment deposition will occur, fouling what is, but soon won't be, suitable spawning habitat. If fencing is to be introduced, rock revetment repairs (plate 7), should be carried out in conjunction with fencing in order to prevent further widening, on certain sites.
