**DEVON AREA
INTERNAL REPORT**

**Investigation into the 1999 Failure
of the European Community
Bathing Waters Directive at Beer
Beach**

**July 2001
DEV/EP/07/01
(CATCHMENT 02A)**

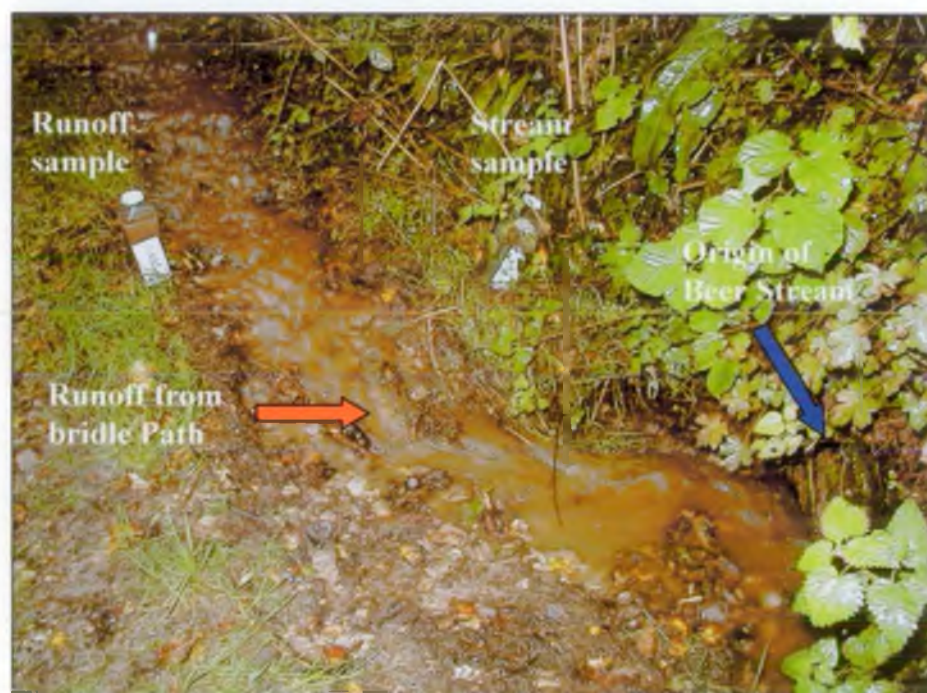
Plate 2, Showing runoff from Bovey Lane bridle path that combines with Beer Stream at source.

- Runoff from Bovey Lane Bridle Path contaminated with faecal pollution. The path is popular with dog walkers and large amounts of faeces have been observed on the path. The runoff mixes with Beer Stream and discharges into the bathing water.
- Runoff from pig ranching in the Beer Stream catchment poses a threat to the bathing water quality at Beer.

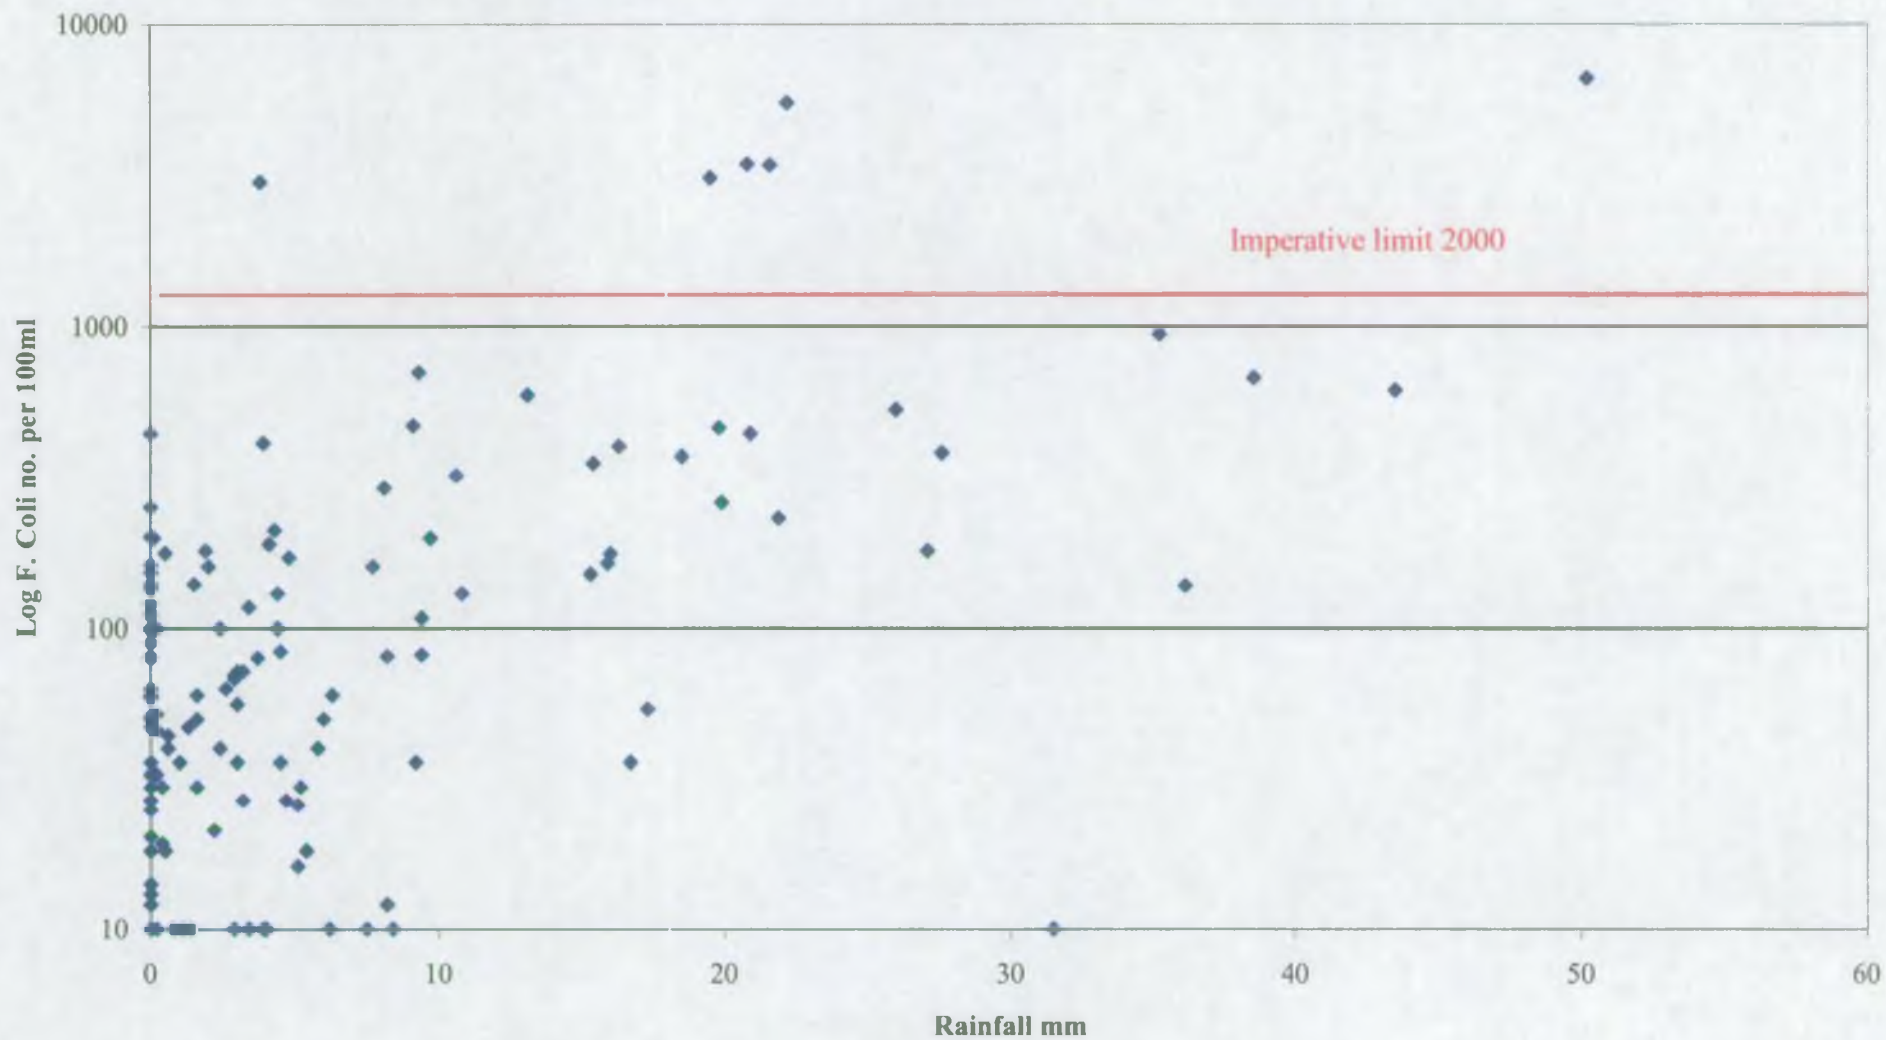
All the results for FC counts over the period 1990 – 1999 were correlated against rainfall on the day of the sample and the previous day. A positive correlation was found between rainfall in the catchment and faecal coliform concentrations. Figure 5 shows the chart, whilst there is a lot of scatter there is clear trend for higher concentrations at higher rainfall.

Beer Beach Faecal Coliform with Culmative Rainfall on Day of Sample and Previous Day 1990 to 1999

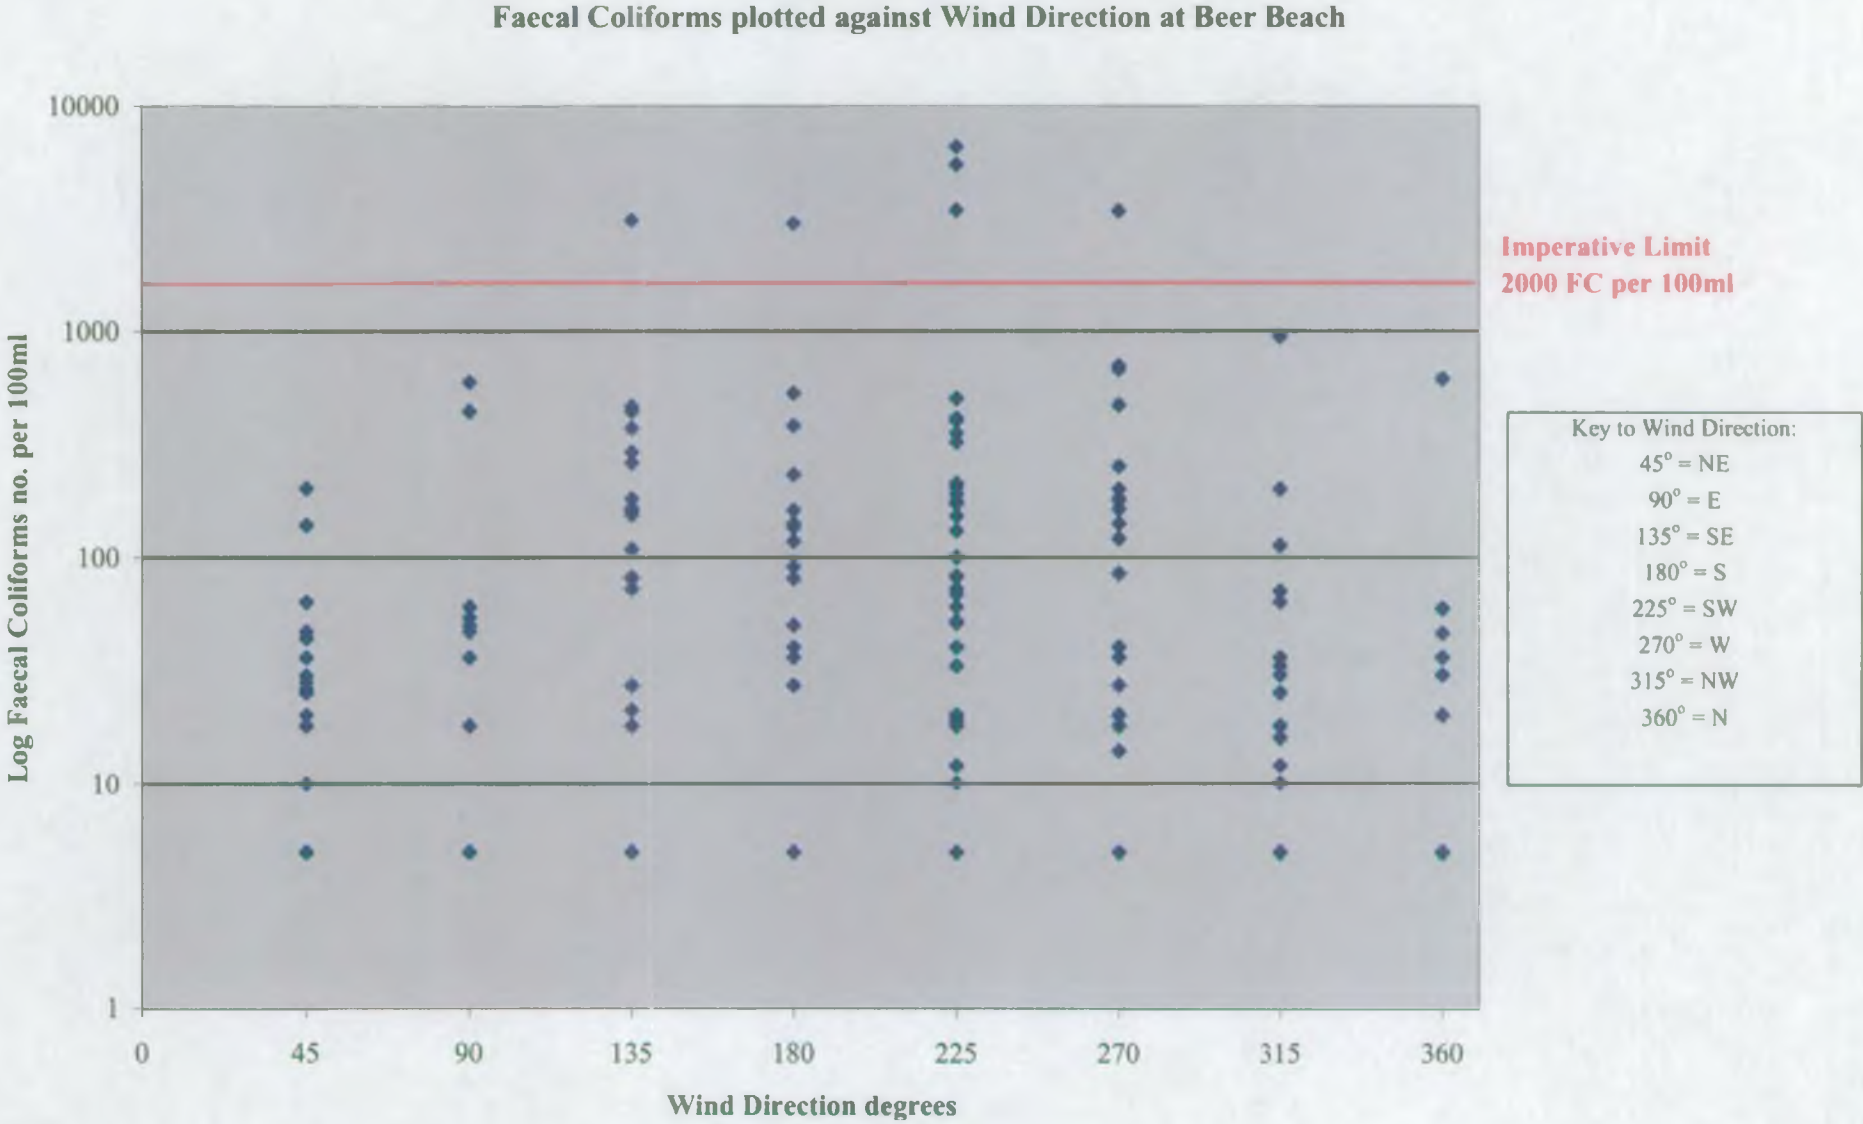
Figure 6

At the time of the six imperative exceedences, wind directions were from the south-east, south, south-west (3 samples) and west. Wind speeds ranged from 0 to 5 on the Beaufort scale. On the date of the greatest exceeded value (FC 6600 no/100ml on 08 September 1999) the wind direction was south-west with a wind speed of 2. A chart showing log FC numbers from 1990 to 1999 plotted against wind direction can be seen in figure 6.

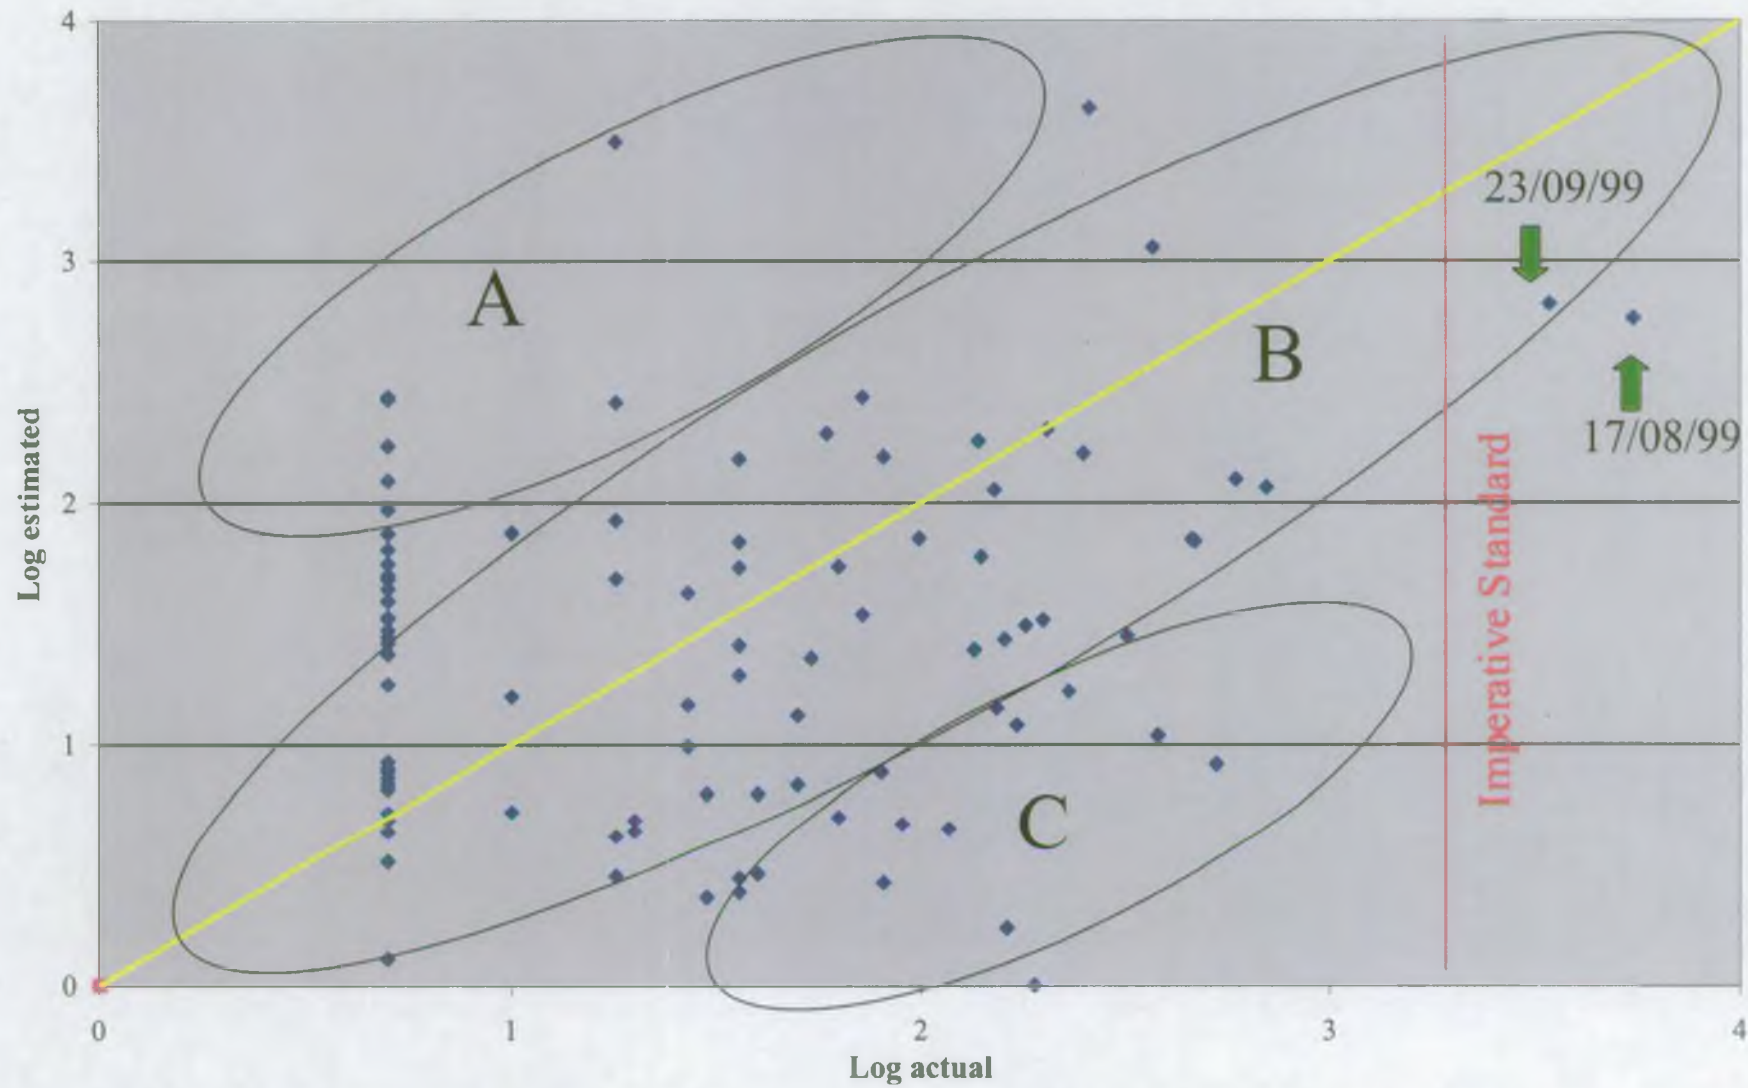
An indication of the origin of faecal coliform contamination can be made by plotting predicted FC concentrations at the bathing water site against the actual concentration in the bathing water samples. This is done using FC and salinity results from Beer Stream samples and the actual bathing water sample results. Figure 8 shows the predicted (or estimated) faecal coliform concentration. On the chart:

Area A represents samples whose FC concentrations were substantially lower than we would have predicted, this may be due to bacterial decay in the bathing water which will move points above the yellow line.

Area B represents samples whose FC concentrations that were of a similar order to those we would have predicted and indicate that Beer Stream was determining water quality at the beach site.

Area C represents samples whose FC concentrations were higher than those predicted and indicate that other sources were responsible, possibly a marine source.

The two points highlighted with the date, to the right of the vertical line are the exceedences. Both points are near to area B and are considered to be due to contamination by Beer Stream.

Actual vs Estimated F.Coliforms, Beer Beach.

Beer Stream was first sampled with the bathing water in 1995. The only two imperative exceedences since then were in 1999. These two samples fall in the area on the chart where the actual sample results were found to be slightly higher than the predicted result from the Beer Stream sample.
