**THE ENVIRONMENTAL IMPACT
OF SEWAGE DISCHARGES TO
THE SALCOMBE ESTUARY,
SOUTH DEVON, FROM
ANCHOR WATCH, CLIFF ROAD,
SALCOMBE**

**November 2001
DEV/EP/10/01
(CATCHMENT 08A)**

**Author: R. PEARSON.
ENVIRONMENT PROTECTION
INVESTIGATIONS OFFICER**

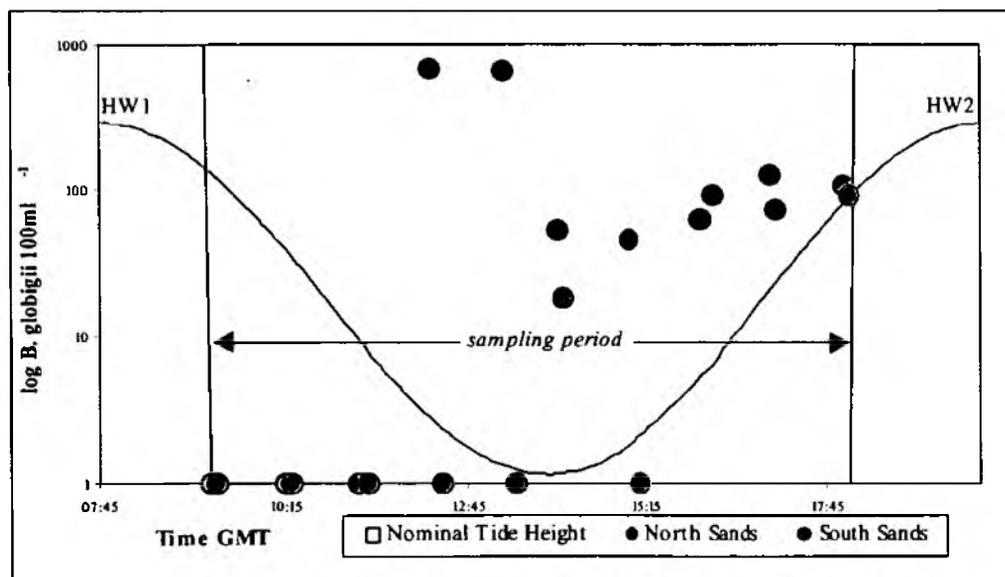
FIGURE 13. Principal Survey: *B. globigii* concentration and tide state at North and South Sands.

Figure 13. shows the relationship between tide state and *B. globigii* concentration at North and South Sands throughout the survey. *B. globigii* was first detected at North Sands at HW1+04:30 and at South Sands at HW2-05:49. The greatest impact at North Sands was 67 faecal coliform equivalent (at HW1+ 04:30) whilst at South Sands the value was 9 faecal coliform equivalent (between HW2-03: 49 and HW2-01:53). A sample was taken at both beaches the following day and these showed faecal coliform equivalent concentrations of $3 \text{ } 100\text{ml}^{-1}$ in each case.

The impacts identified under survey conditions, therefore, were insufficient to cause beaches to fail. However, the *Anchor Watch* discharge may serve to augment other sources of bacteria.

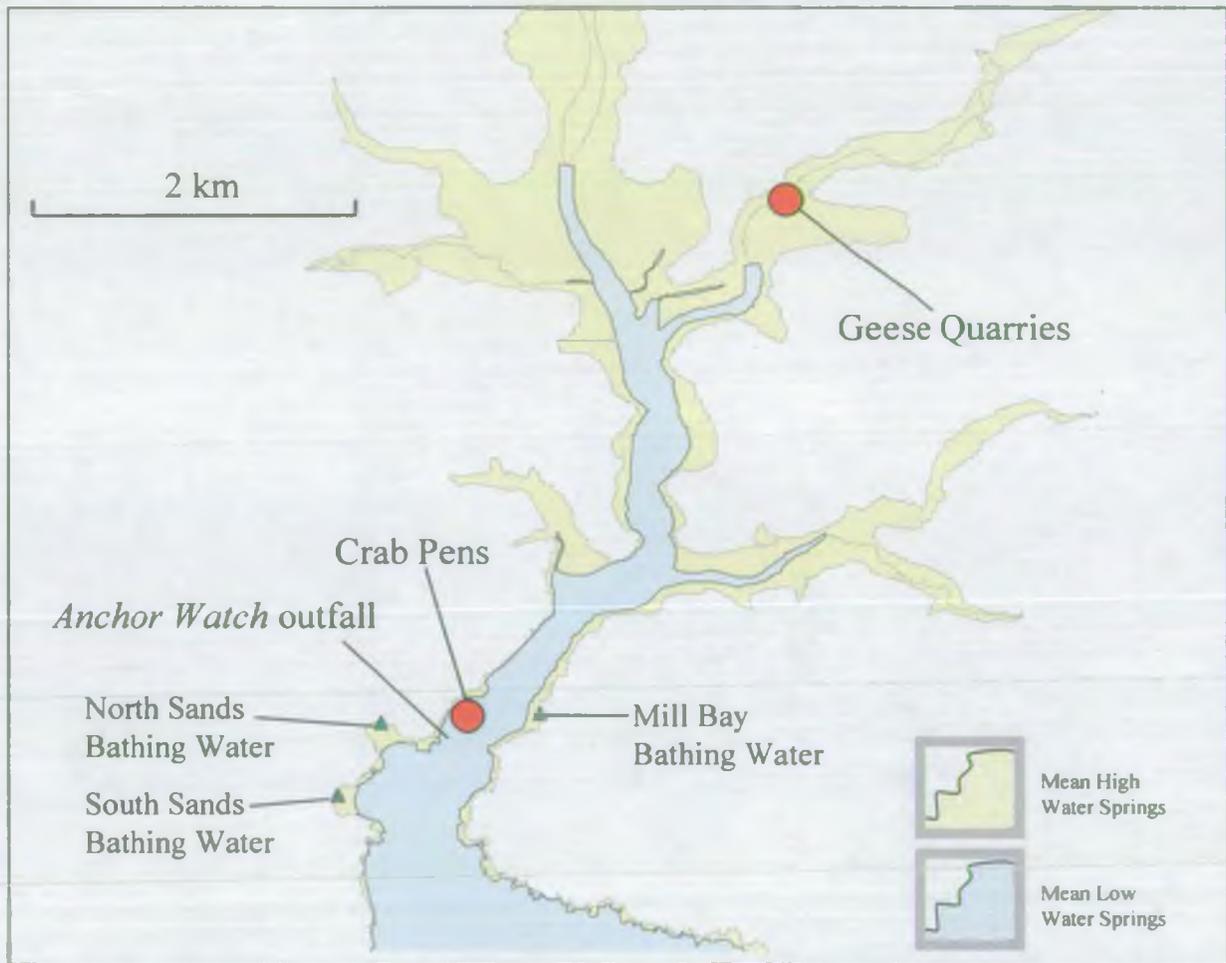
FIGURE 1. SALCOMBE ESTUARY

The principal impact from the discharge will be bacteriological and in order to quantify it's magnitude we need to use some sort of standard against which we can assess water quality. The most appropriate bacteriological standards are those already used by the Agency in this area to determine (i) bathing water quality at North and South Sands (Bathing Water Directive) (**Reference 1.**) and (ii) water quality in relation to the trial shellfishery at Geese Quarry (Shellfish Directive) (**References 2 and 3 and Figure 1.**).

In addition to the sites above there are 4 floating crab pens some 150m from the outfall (**Figure 1**). The effect of the discharge on these will also be considered.

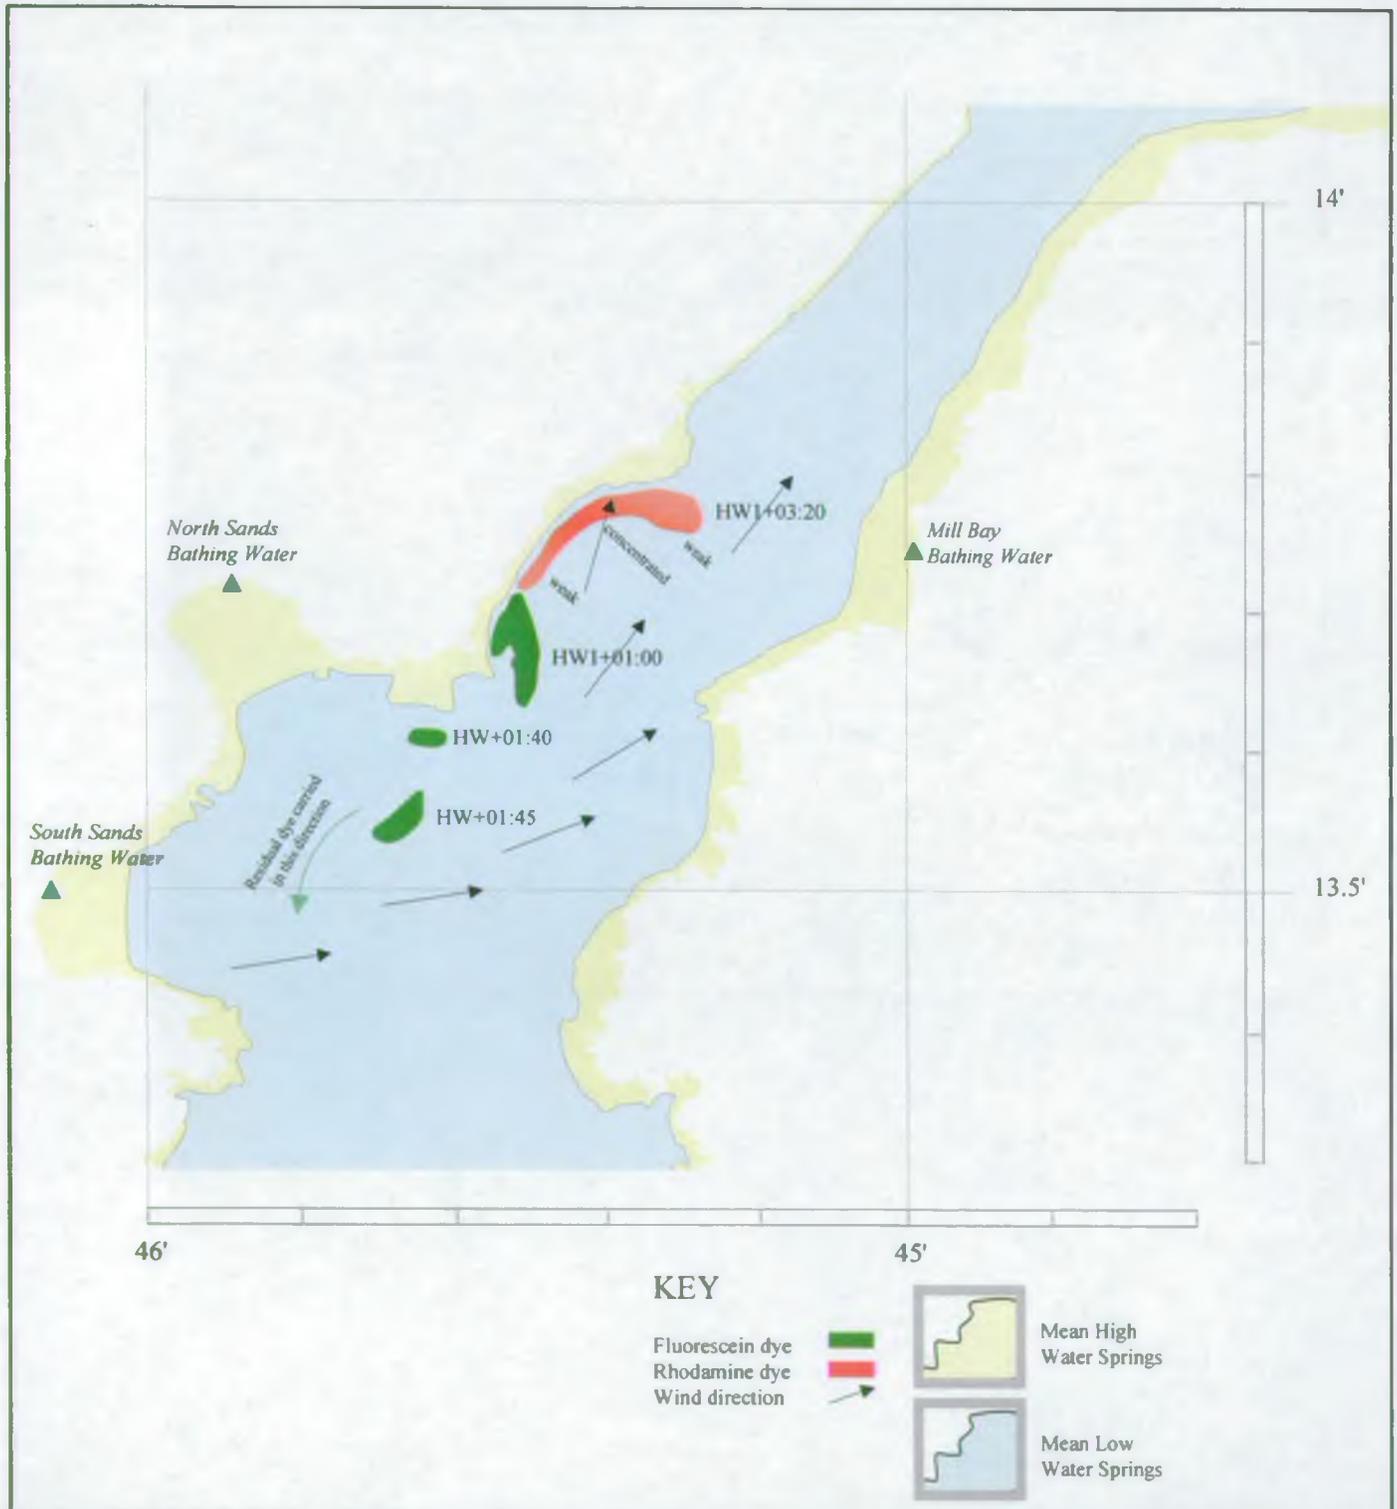
FIGURE 2. PRELIMINARY DYE STUDY 23/07/01: PLUME BEHAVIOUR WITH REFERENCE TO TIDE STATE

The study was carried out on 23/07/01 when the times of high water were 07:43 (HW1) and 19:58 (HW2). Low water was at 13:56. The weather was dry with a light to moderate W to SW wind. Dye was introduced to the discharge between High Water and 1 hour 20 minutes following High Water (HW1 to HW1+01:20). Movement of the discharge is shown in **Figure 2**.

Over the first half of the ebb tide (HW1 to HW1+03:00 approx.) dye moved towards the estuary mouth (**Figure 2** and **Photograph 4**). The maximum rate of travel was >300 m in 30 minutes ($>0.16 \text{ ms}^{-1}$)(08:45 to 09:15). Within approx. 400m of the discharge point the plume had largely dispersed and dye was difficult to discern. No visible impact at the Bathing Beaches was observed.

During the second half of the ebb the dye tended to pond around the outfall and then to move in a NE direction along the shore of Woodville Bay. This latter movement may have been the result of a clockwise eddy set up within Woodville Bay by the ebb current in the main channel.

From HW1 + 02:00 to HW1 + 06:10 the plume was impacting at the crab pens. At LW1 dye at the northernmost point of Woodville Bay was being carried round the small headland and on up the estuary (**Photograph 3**).

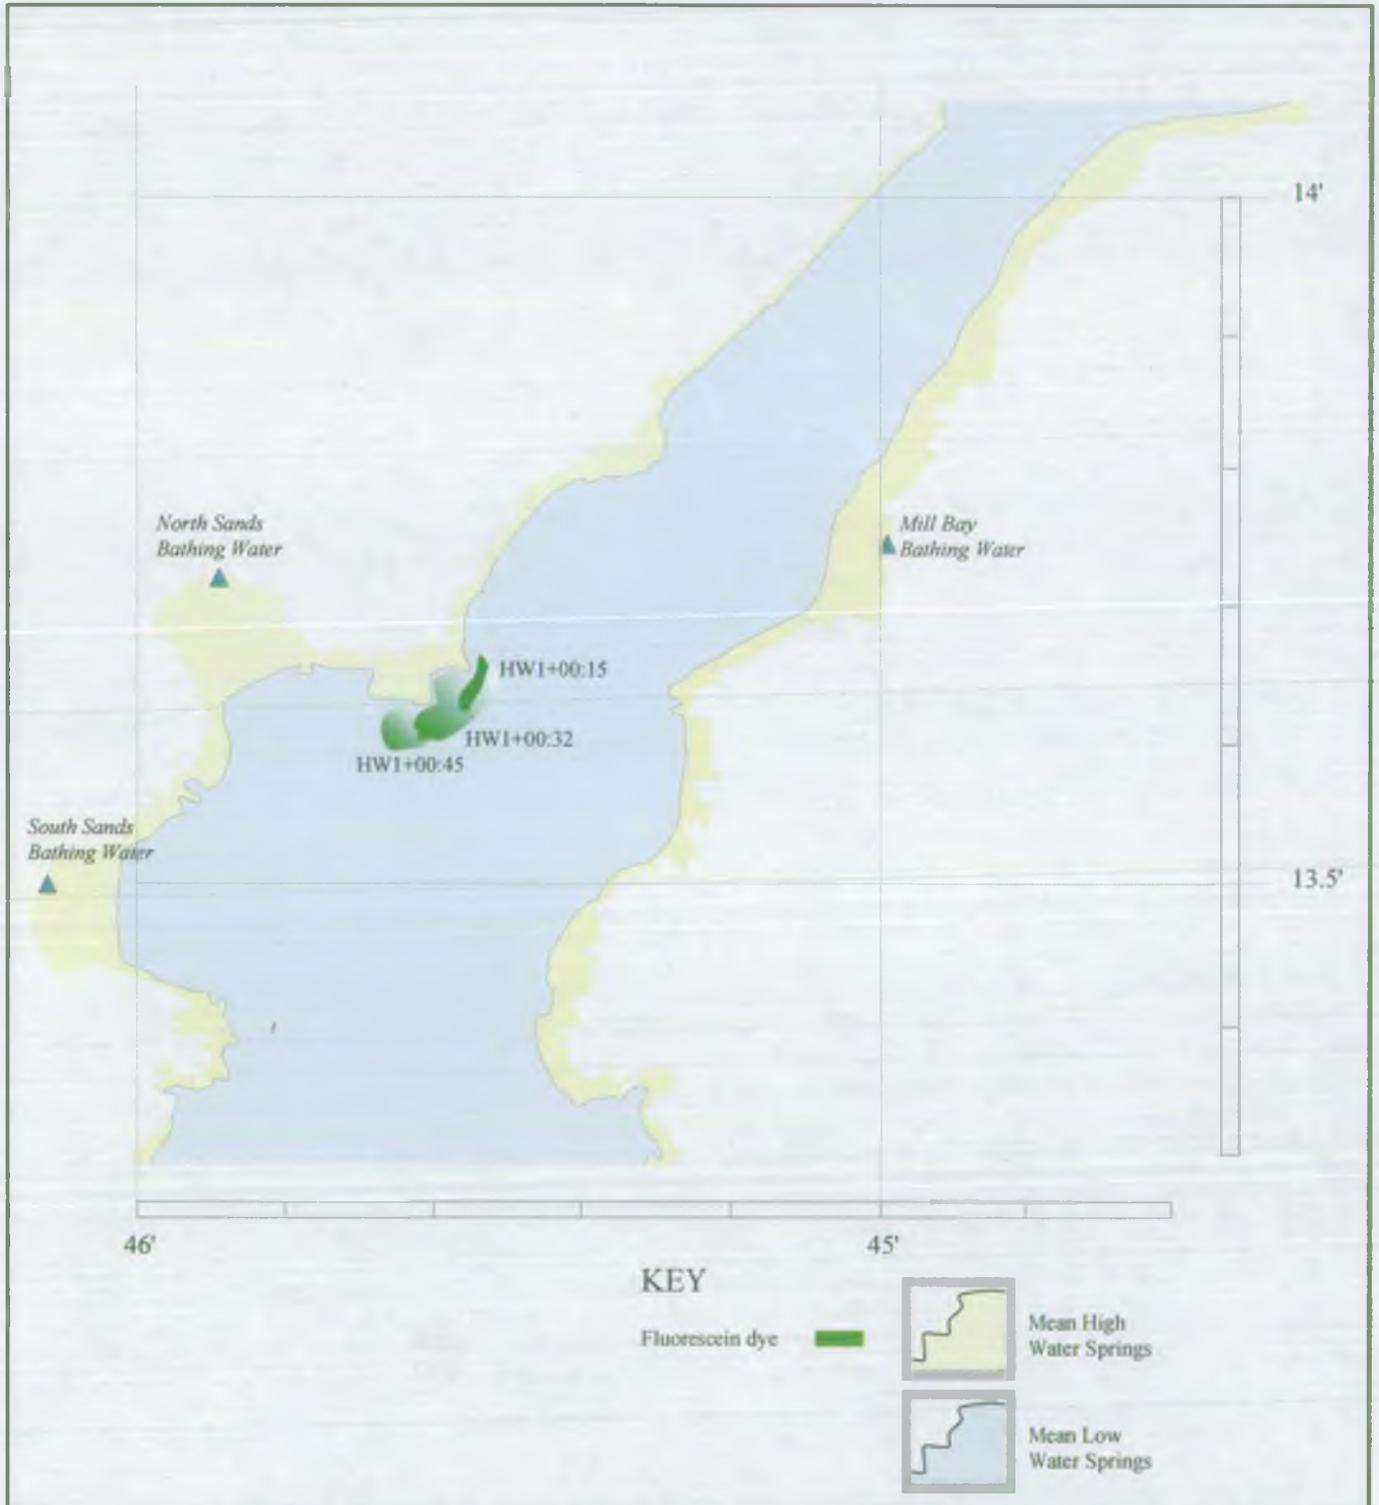
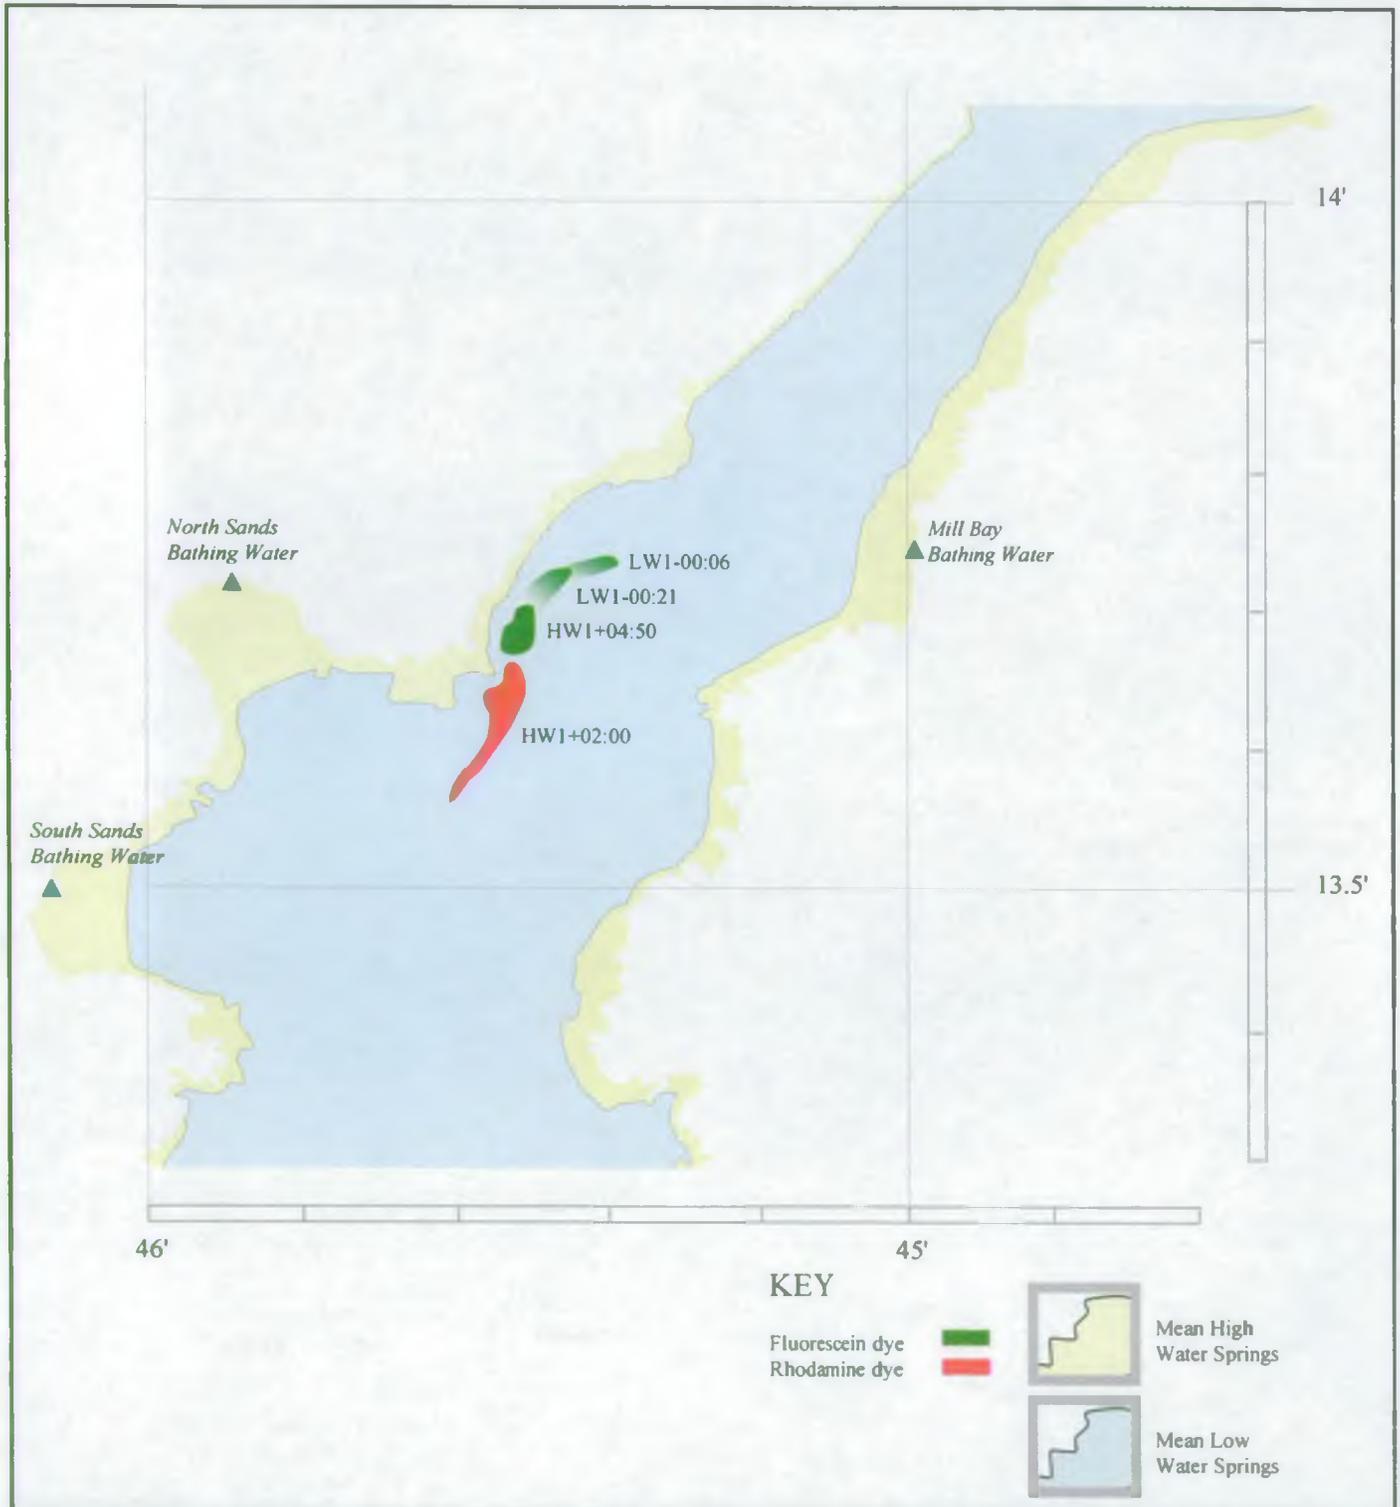
FIGURE 3. PRINCIPAL SURVEY 06/09/01: PLUME BEHAVIOUR WITH REFERENCE TO TIDE STATE

Results of sample analysis are given in **Table 1** and the movement of dye is shown in **Figures 3 and 4**. **Figure 5** shows the behaviour of the surface drogue. Discharge and globigii dosing rates are given in **Appendix 2**.

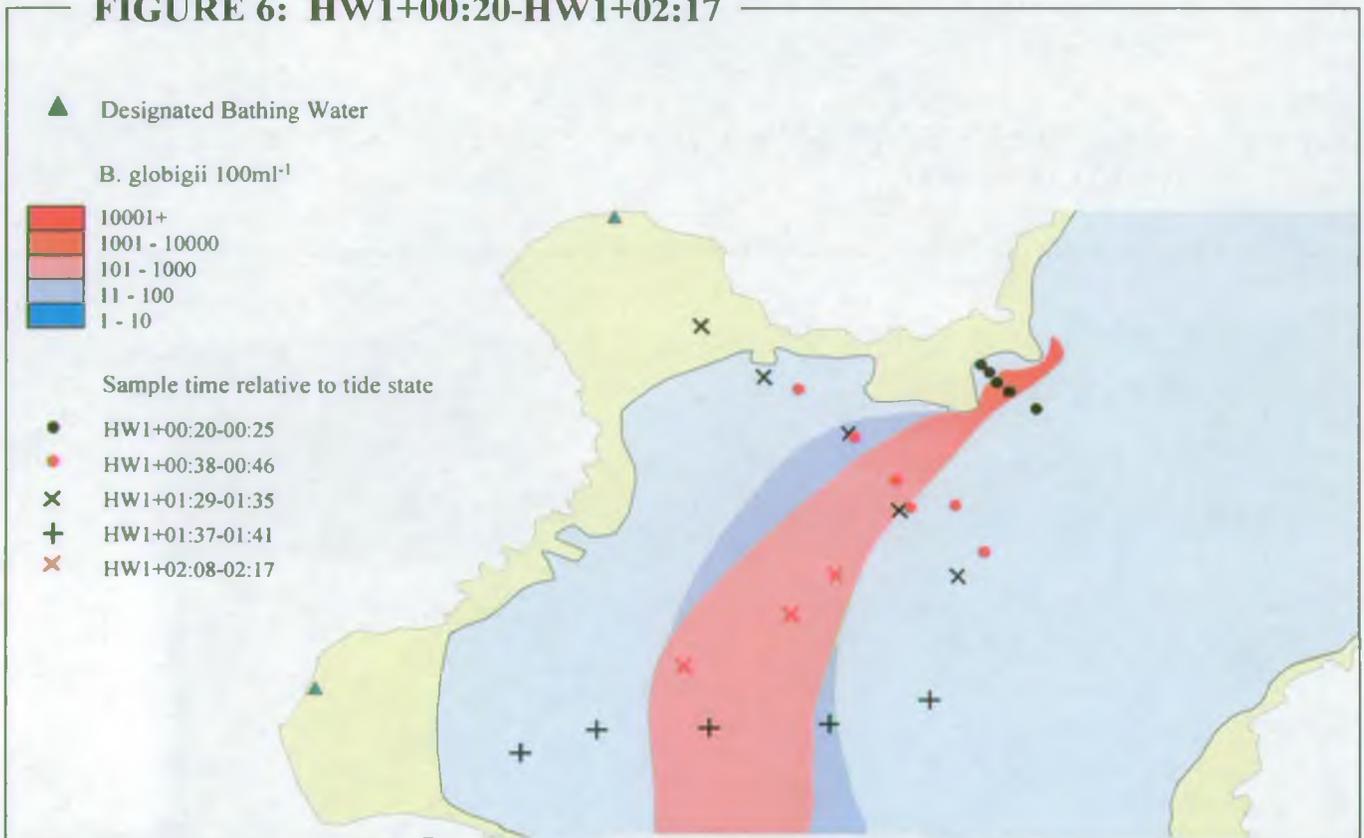
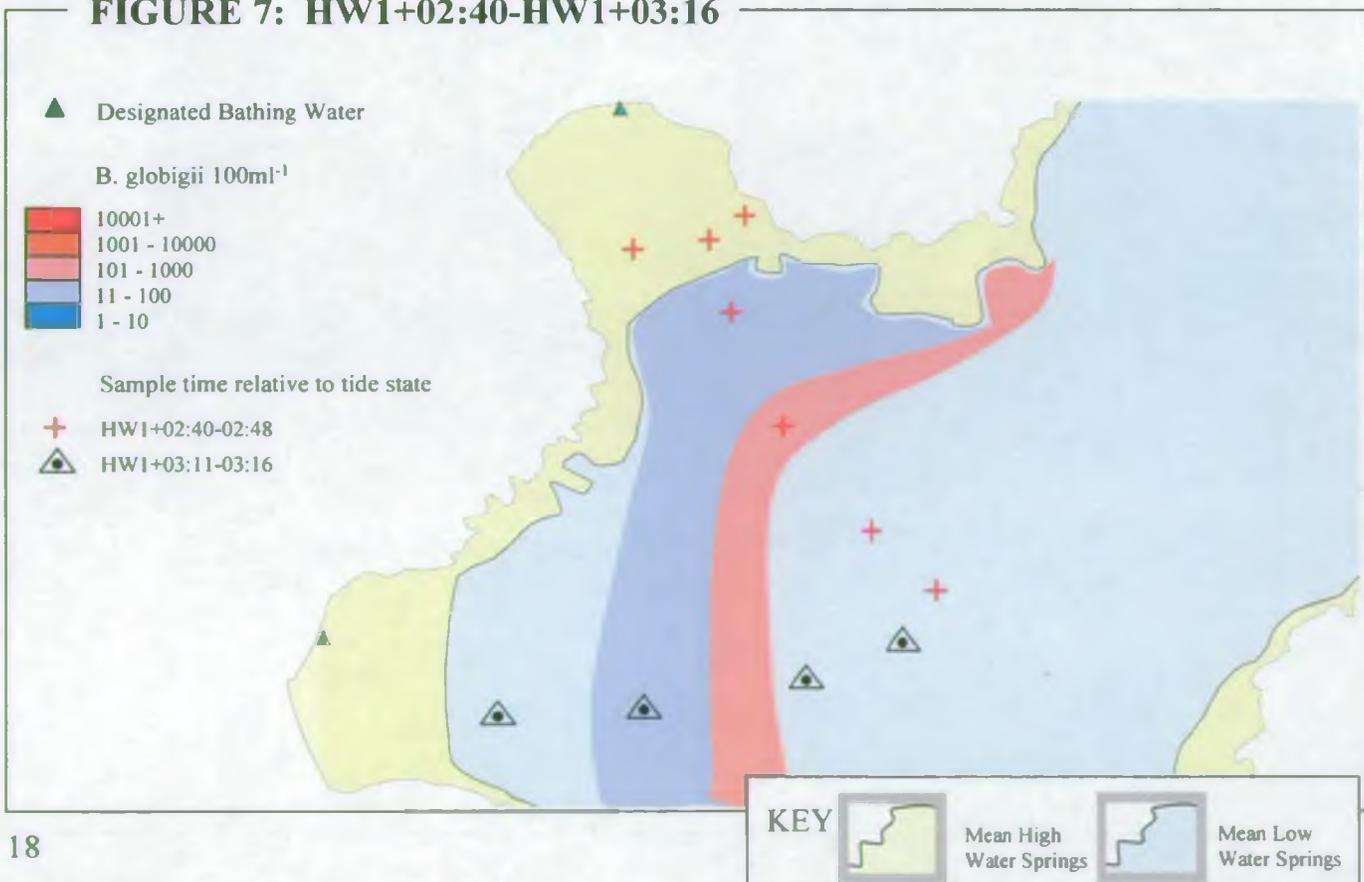
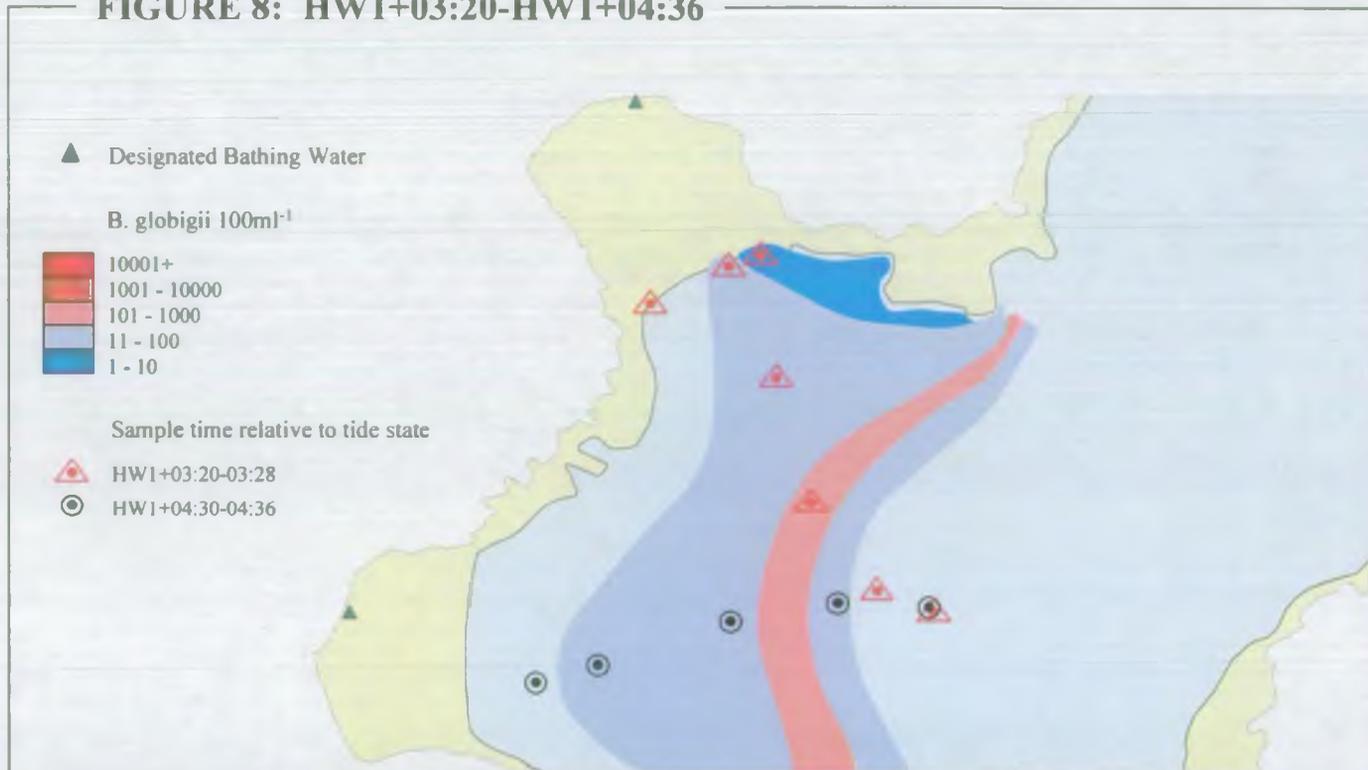
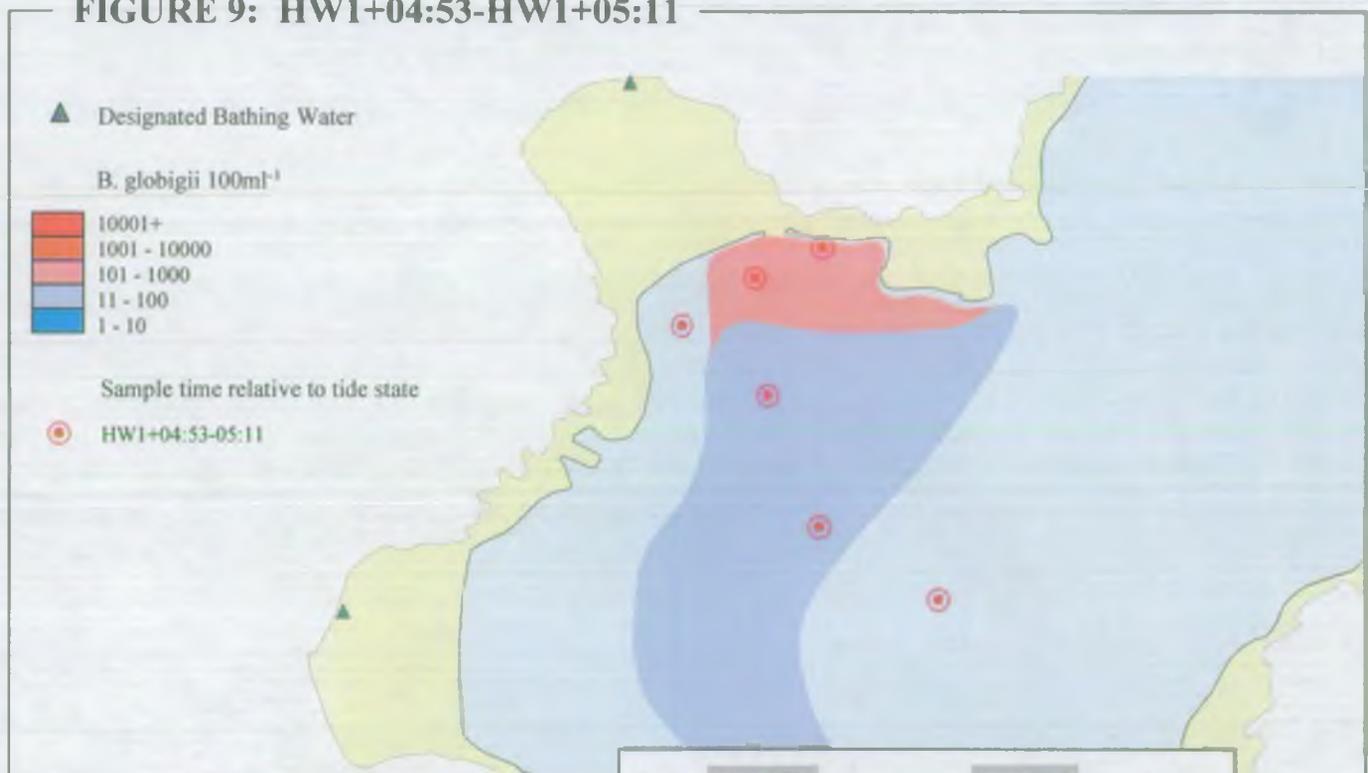
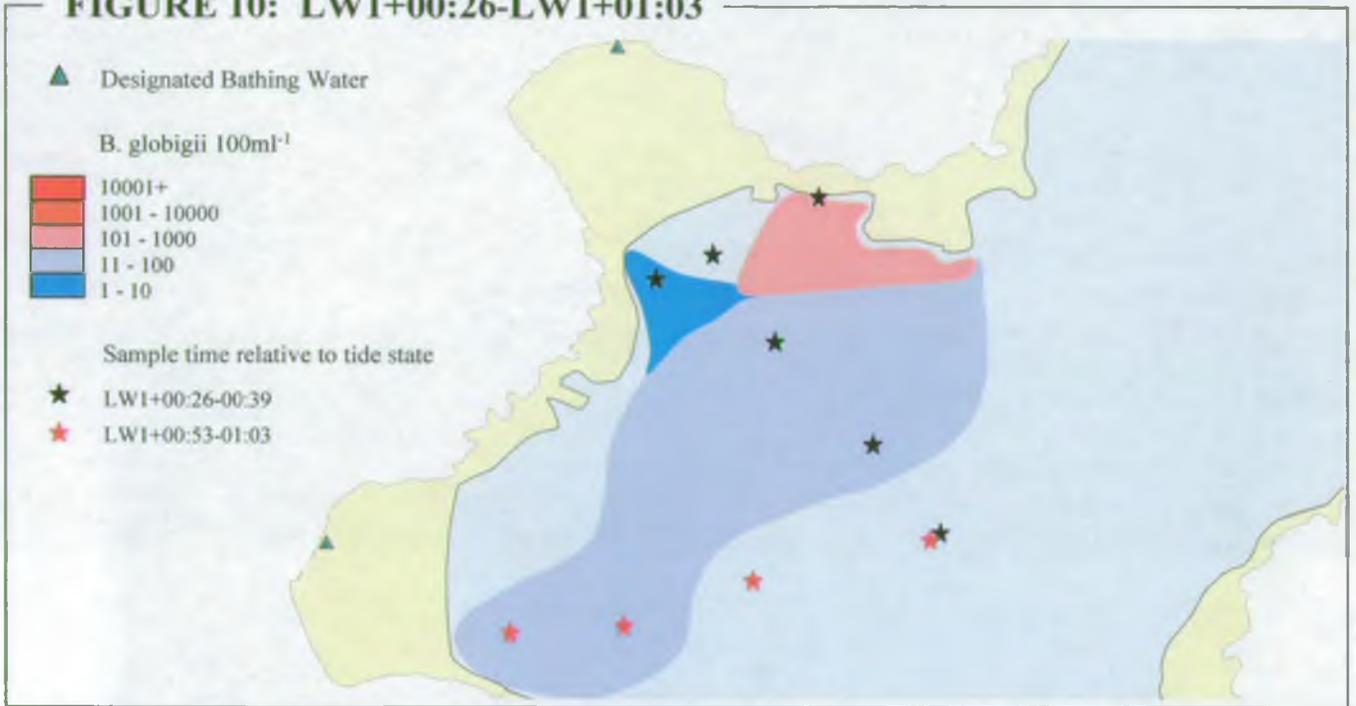
In **Figures 6-12** sample globigii concentrations have been combined with observed dye movement to produce possible synopses for plume behaviour (it should be noted when interpreting these Figures that each covers a time frame and so does not represent a 'snapshot' of the situation at a specific time).

Dye and tracer work indicated that the effluent plume tended to follow the main channel towards the estuary mouth throughout the ebb. From HW1+02:40 to 05:11 the plume was also carried into North Sands but it was not until LW1+01:00 approx. before an impact at South Sands was found (**Figures 6-10**).

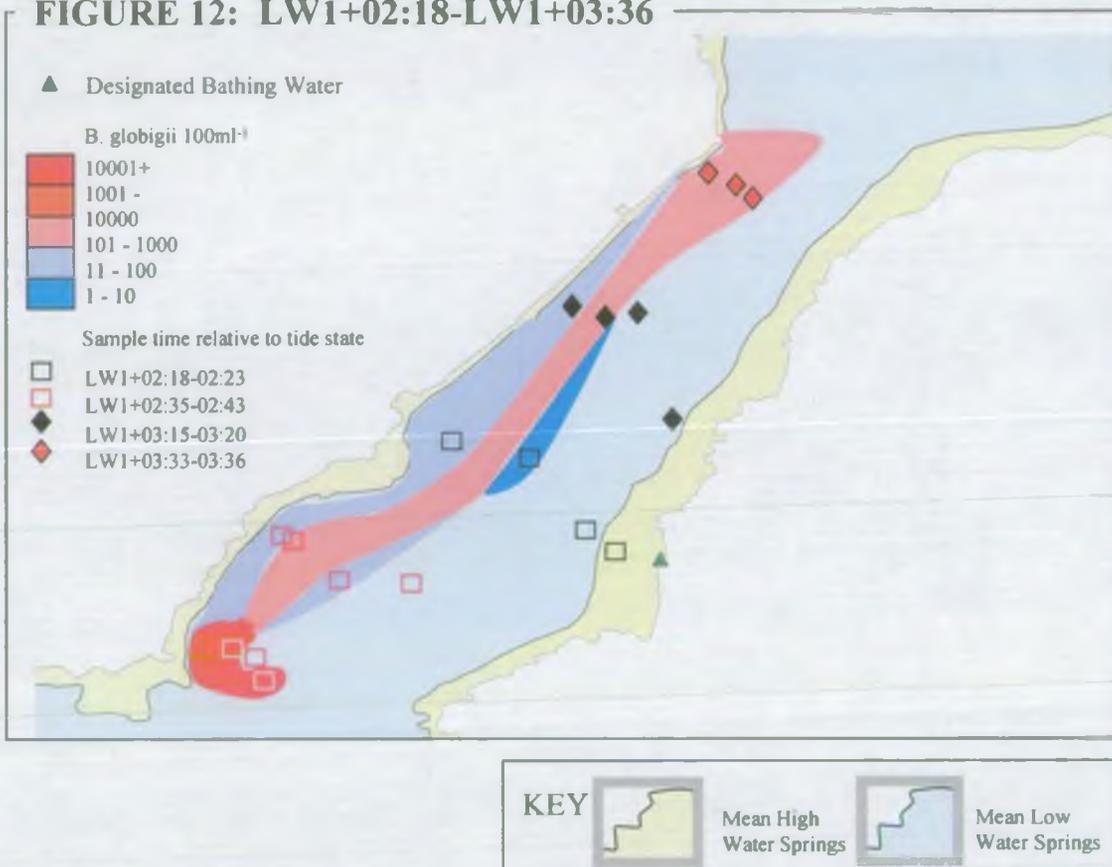
FIGURE 12: LW1+02:18-LW1+03:36

No impact was found at Mill Bay bathing water (Figure 12.).

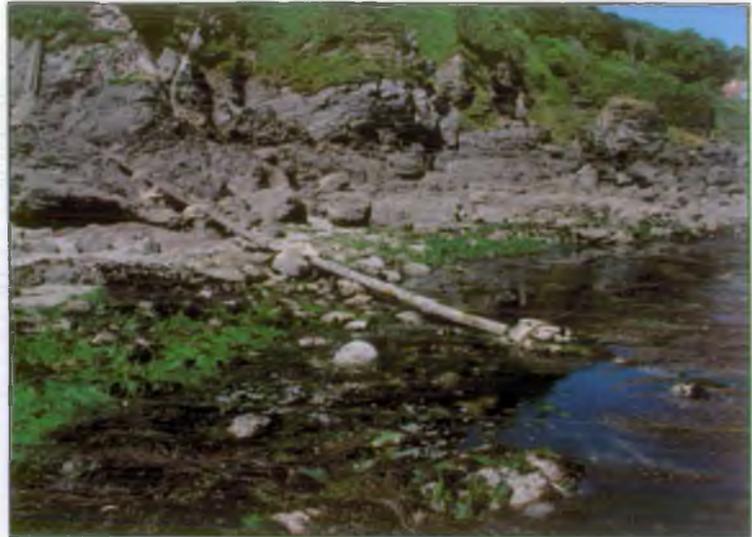
Photograph 1

The initial visit, made on 22/06/01, showed that sewage from the property seems to receive no treatment and that discharges are made via a metal pipe running down the cliff and across the foreshore (**Photograph 1**). The original metal pipe, which ends just below MLWS, appears to have been extended with the addition of a 5m approx. white plastic section.

Anchor Watch outfall pipe
(22/06/01)

- 3.5.2** Untreated discharges to the estuary are undesirable. If this discharge cannot be treated or connected to the main an extension to the outfall pipe is recommended (when repairs to the faulty joint would also be required). The surveys suggest that a 70m extension laid in a south-easterly direction would enable dispersion to main channel flows at all states of the tide.

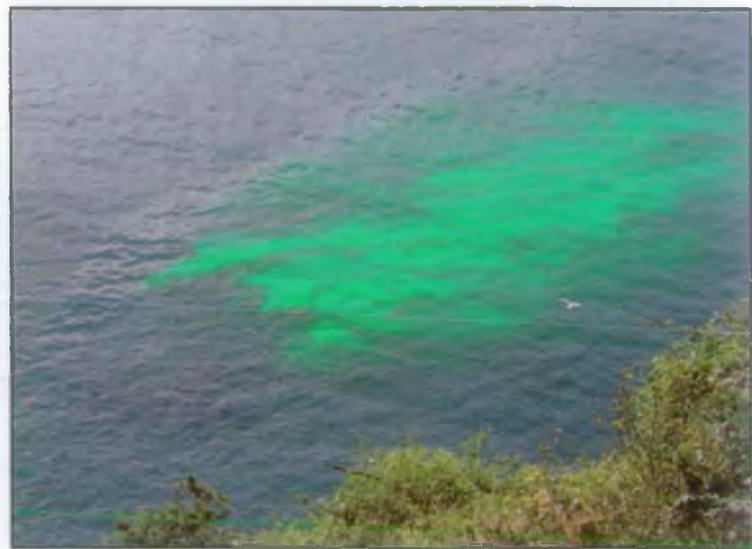
Photograph 2

Dye was seen to issue from both the intended outfall position and from the joint between the metal and plastic pipes (**Photograph 2**).

Dye issuing from two points
in outfall during Preliminary Dye
Study (HW+00:48)
(23/07/01)

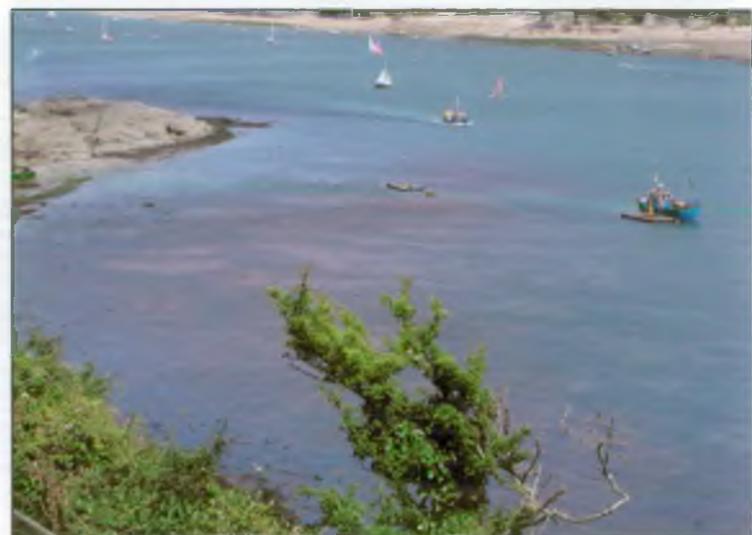
Photograph 3

Impact at crab pens using
rhodamine (red) dye (crabs being
put into pens from boat at right of
picture). Also visible is transport of
dye around 'Woodville Point' at
top of picture (HW1+06:10)
Preliminary Dye Study.
(23/07/01)

- 3.5.1** The appropriate Environmental Health Office is made aware of the potential bacteria concentrations at the crab pens in order that they can further advise the crab fishermen if required.

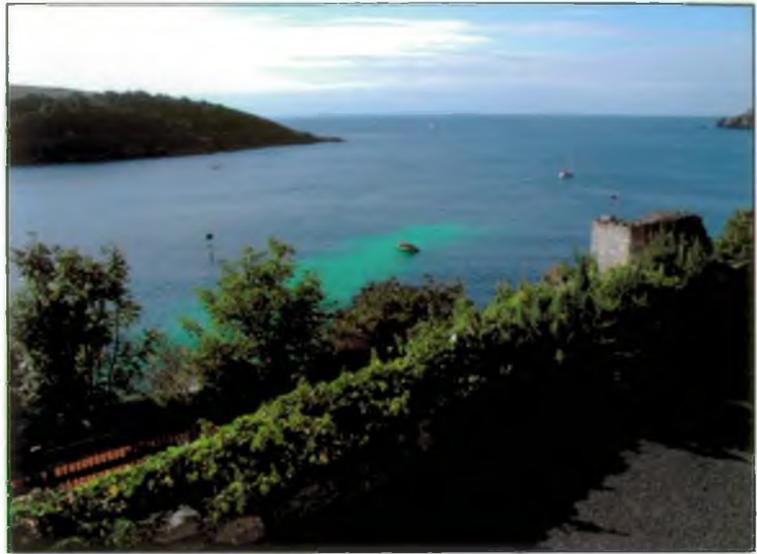
Photograph 4

Plume transport towards estuary mouth on ebb tide. Outfall is outside photograph to bottom left (HW1+00:19).

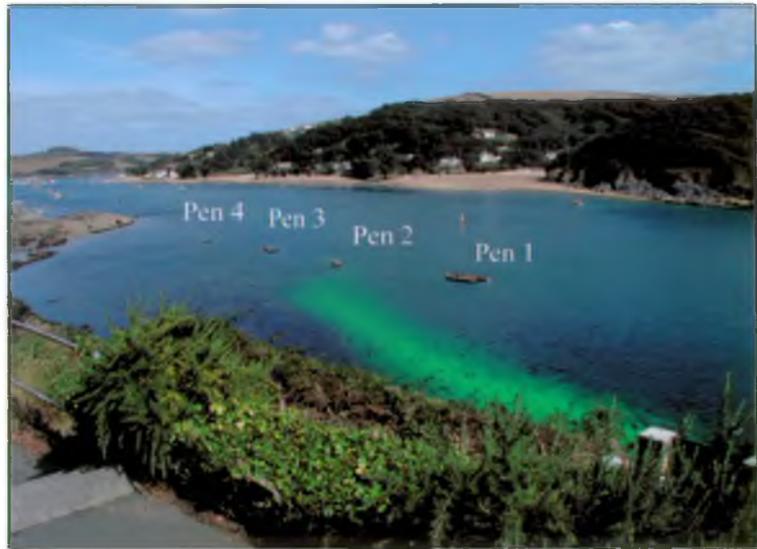
Photograph 5

Transport of plume across 'Woodville Bay' towards crab pens (HW1+05:02)

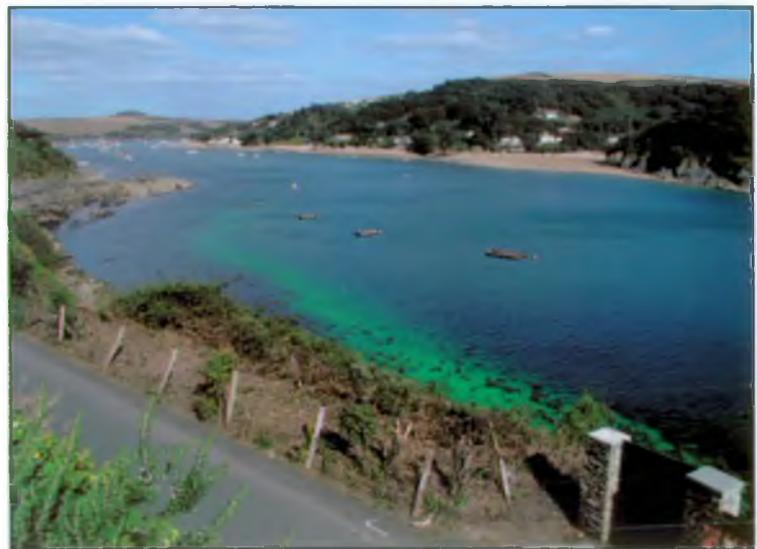
Photograph 6

Transport of plume across 'Woodville Bay' towards crab pens (LW1+00:42)
