FEASIBILITY STUDY & APPRAISAL REPORT

PART 2 : ALTERNATIVE SCHEME OPTIONS

STANMOOR BANK

G7655

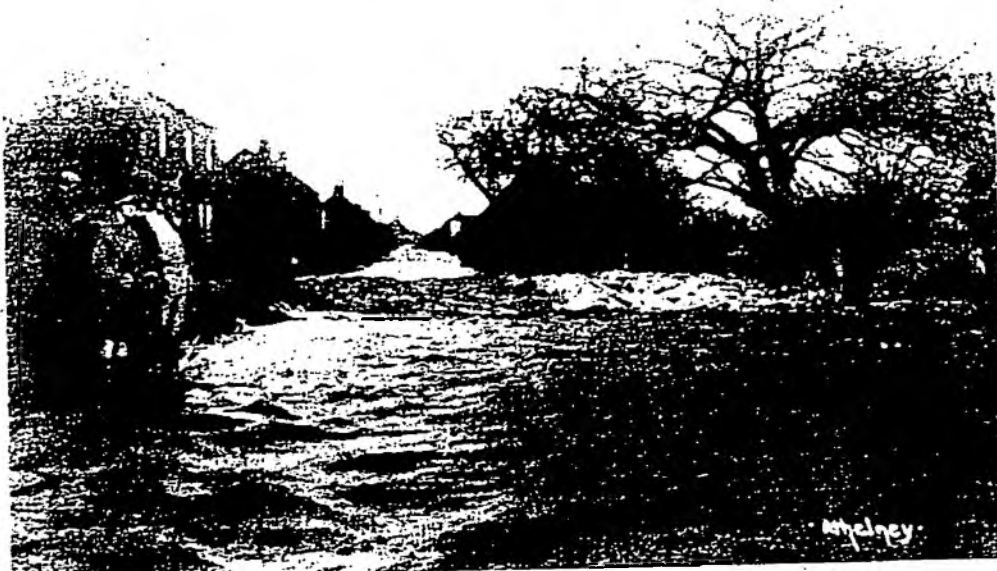
Water flowing across Stanmoor Road.

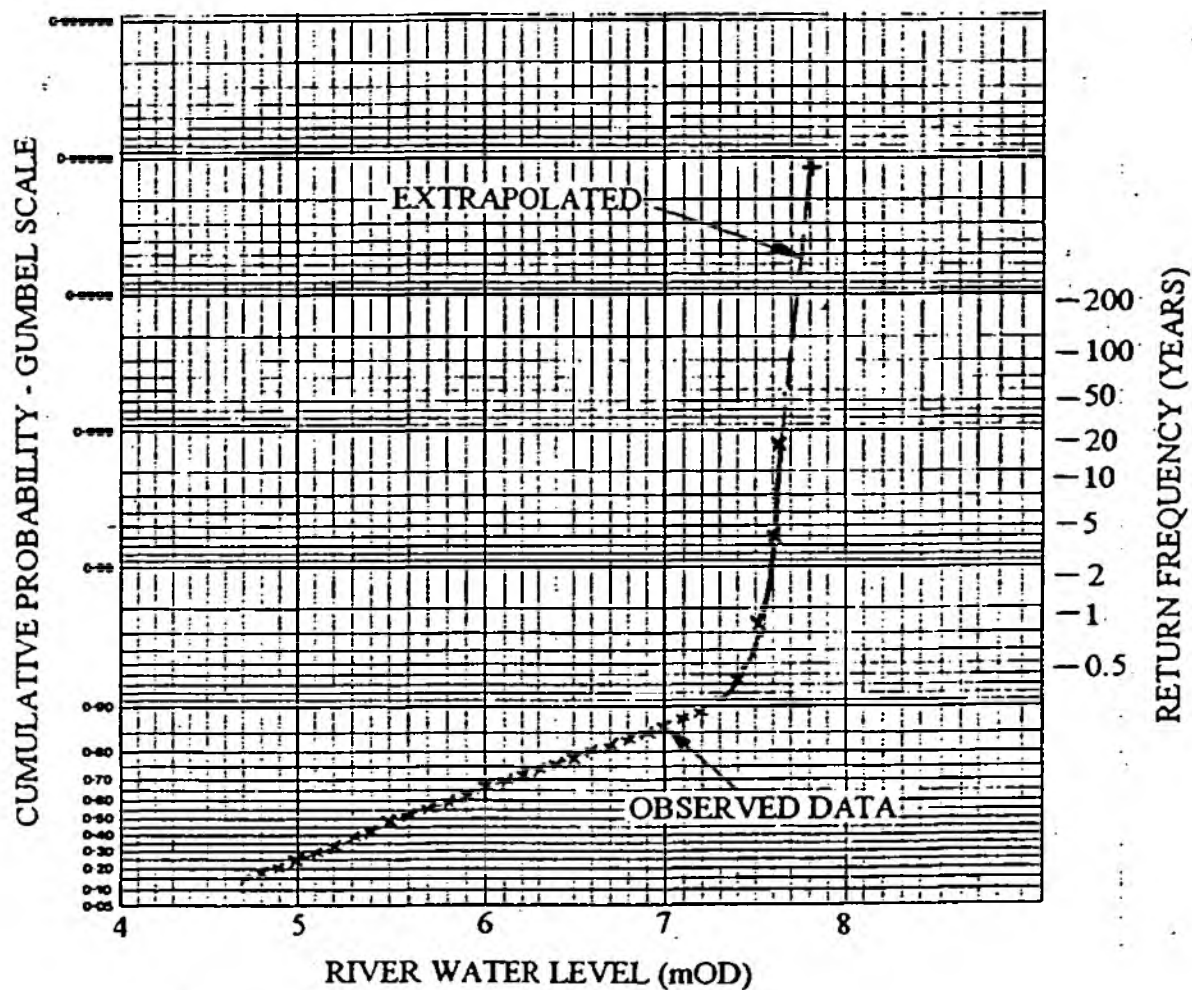
PROJECT STANMOOR BANK FEASIBILITY STUDY AND APPRAISAL REPORT	TITLE RIVER TONE AT CURRYMOOR P.S WATER LEVEL FREQUENCY	POSFORD DUVIVIER CONSULTING ENGINEERS	DATE MAR 98 DRAWN MJM	SCALE CHKD DAW
FIGURE E4

FROM ENVIRONMENT AGENCY WATER LEVEL RECORDS, 1991 - 1996.

Model results for water levels in the River Tone past Stan Moor Bank were further calibrated against recorded levels in the river at Currymoor pumping station outfall. The records used encompassed a period of 5 years, although with some data gaps, and included the flood event of early 1995 which is considered to be of about 1 in 25 years return period. A plot of water level vs. return period is given in *Figure E4*. It is seen that there is a relatively small rise in water level with increasing return period beyond events of 1 in 1 year frequency. This effect is due to the controlling influence of the spillways in the river system over which floodwater in excess of near bank-full capacity is diverted to storage on the Moors. Model results for the Rivers as existing (which can be seen in *Table E10*) were calibrated to accord with the observations at low return period (1 in 5 years) and high return period (1 in 200 years).
