A STUDY TO  
INVESTIGATE AND PROPOSE  
REMEDIES FOR  
RIVER QUALITY PROBLEMS  
IN THE  
MADFORD CATCHMENT

MARCH 1990

FWI/90/008

**R. Smith  
Freshwater Investigations Team  
Environmental Protection  
NRA South West Region  
Manley House  
EXETER**

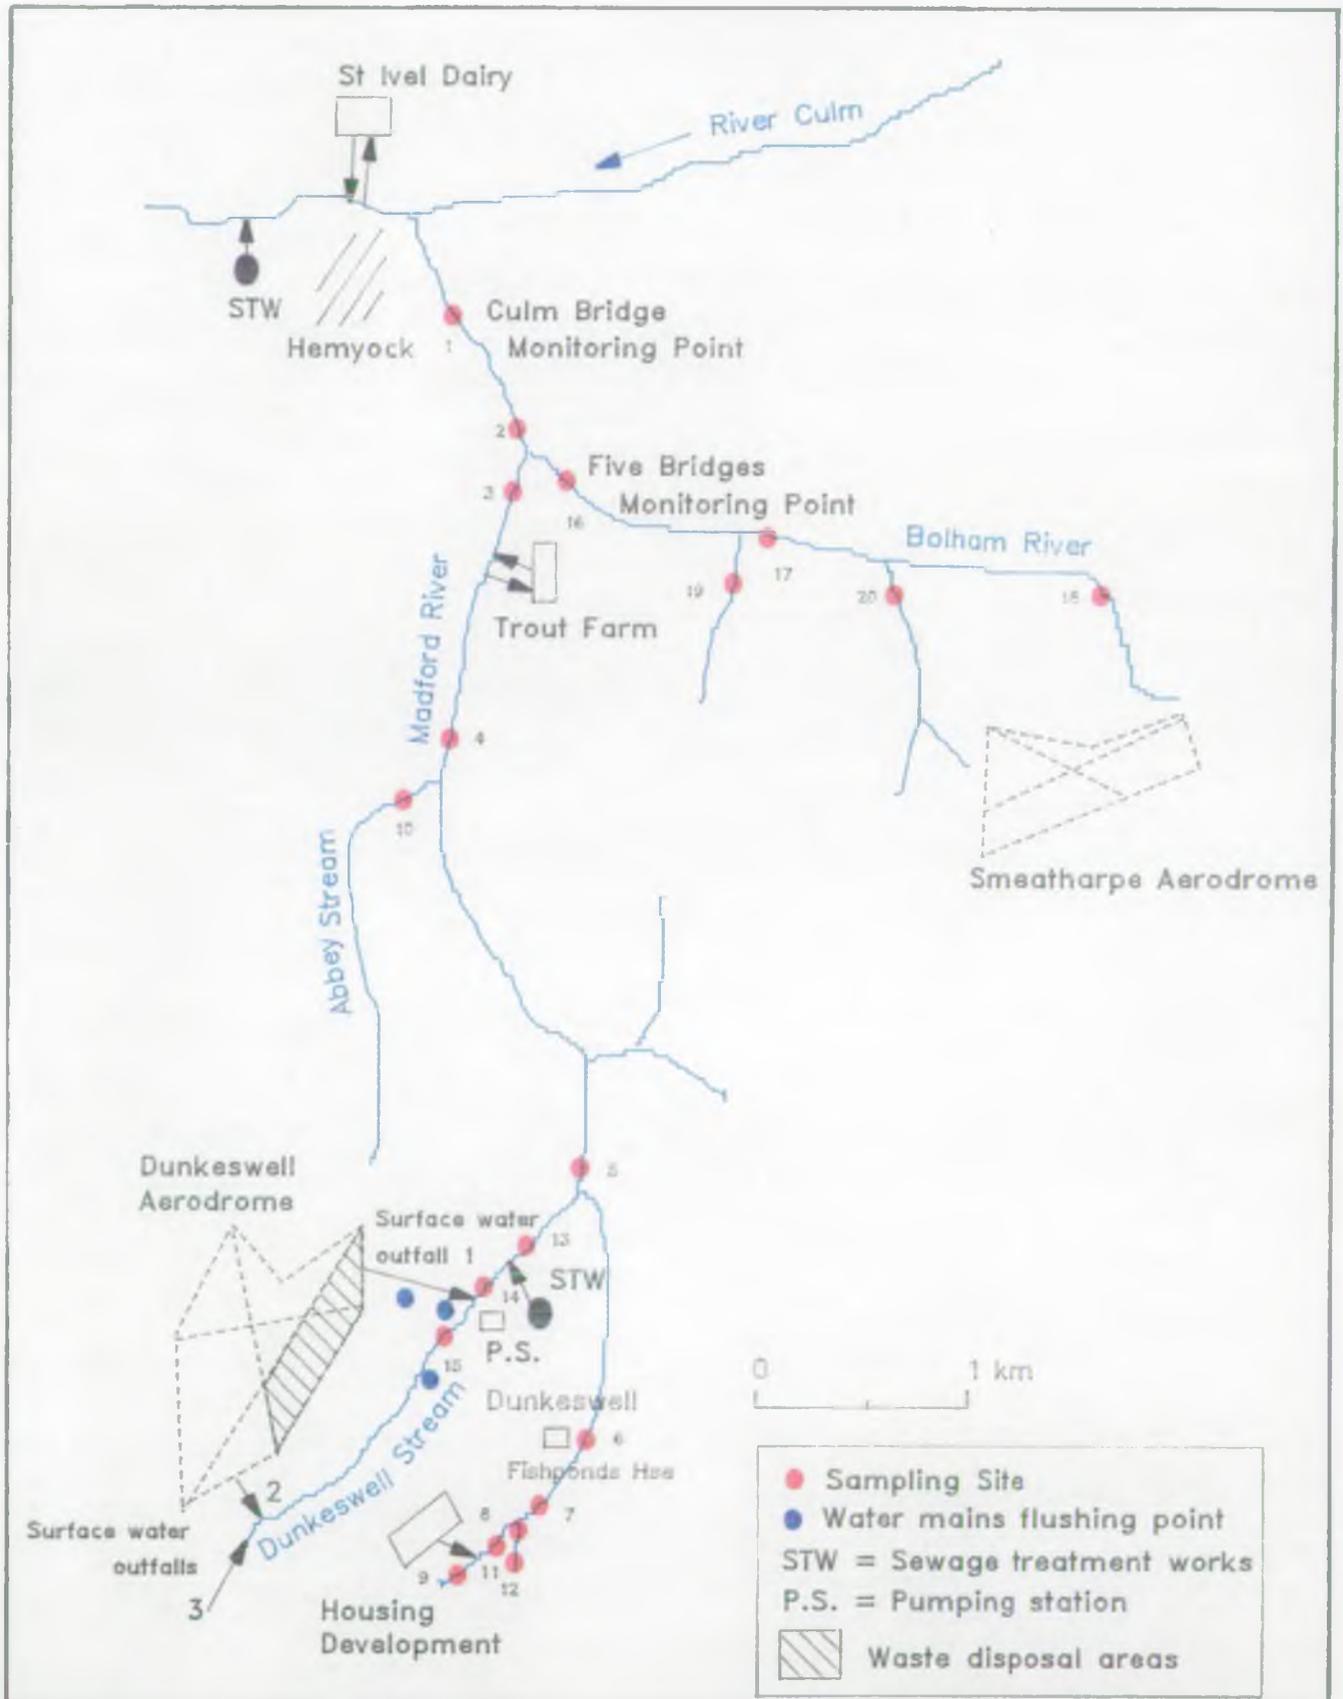
Fig. 1. Map of the Madford River Catchment

Surface water drainage from the estate is connected to a surface water sewer that runs through Bluehayes Farm and discharges to the Dunkeswell Stream at ST 143078 (outfall 1 - Fig 1). This sewer belongs to the Ministry of Defence and is not consented.

Surface water from the aerodrome principally enters the Dunkeswell Stream at Bluehayes Farm (see section 2). There are two other outfalls at ST 131069 (outfalls 2 & 3 - Fig. 1) draining land around Southayes Farm. These were not considered because waste disposal has stopped in this area.
