AN INVESTIGATION  
INTO THE INCIDENCE OF  
SPURTING FROM  
WEEPING WALL SLURRY STORES

Author: PIERS O'NEILL  
HND. Rural Resource Management  
Seale-Hayne Faculty  
University of Plymouth  
August 1992

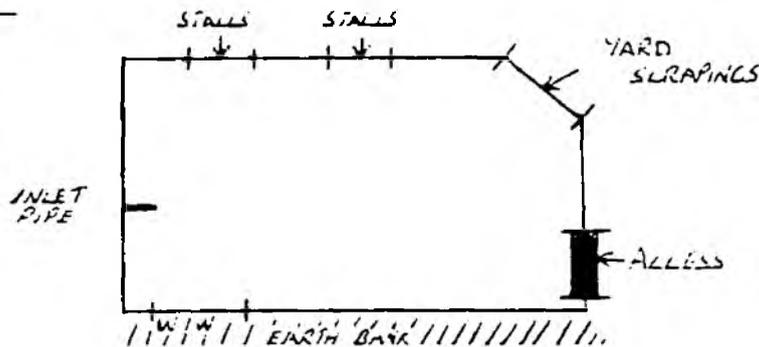
\*DIAGRAM

Weeping wall is relatively small (width approx.3m),however it is faced with a steep earth bank along the entirety of the wall which would deflect and contain any spurts.The weeping wall seems to be working quite well.The sleepers in the store appear to be weeping as well.It is important to note that due to the position of the pipe in the wall,the slurry store may only be filled to a depth of one metre (approximately).

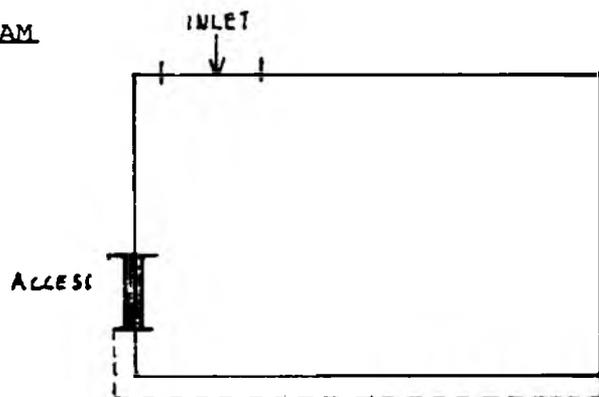
\*DIAGRAM

No yard water goes into store. Only water to enter store is rain water. Important to note the size of the store which is relatively small. There is a 0.5m high retaining wall on the other side of the effluent channel.

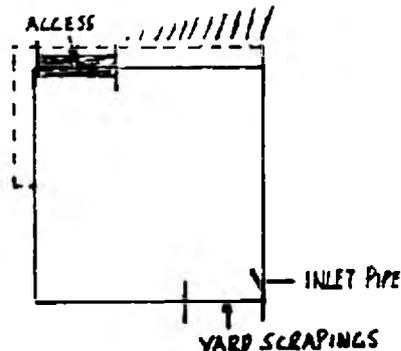
\*DIAGRAM

Concrete panels used to form walls are the same as those used to build silage stores, therefore the ends of each panel are of a tongue and groove nature. This would probably make it impossible to rod the store, but may also serve to deflect any possible spurts (see below).

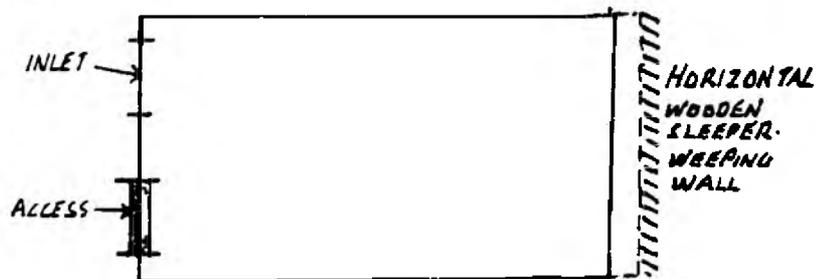
\*DIAGRAM

Store slopes down hill towards weeping wall end. Weeping wall appears to be functioning quite well, and Mr. Rundle reports to have had no problems with spurting.

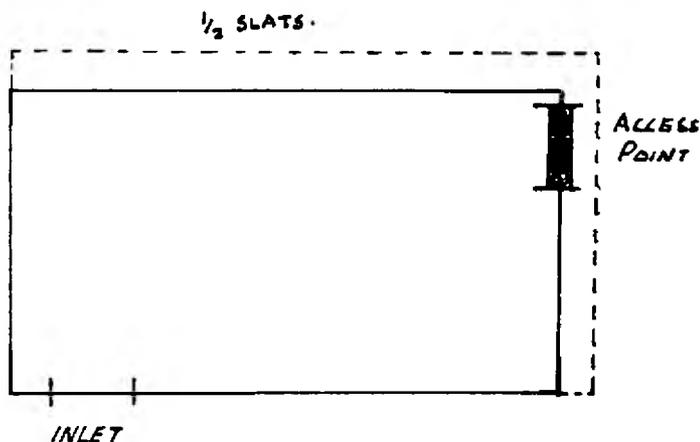
Pages Engineering store with half slats.Only one inlet point into store. Mr.Martin reports to have had no problems with the store and spurting,but was however advised by Pages to rod the store on a regular basis.

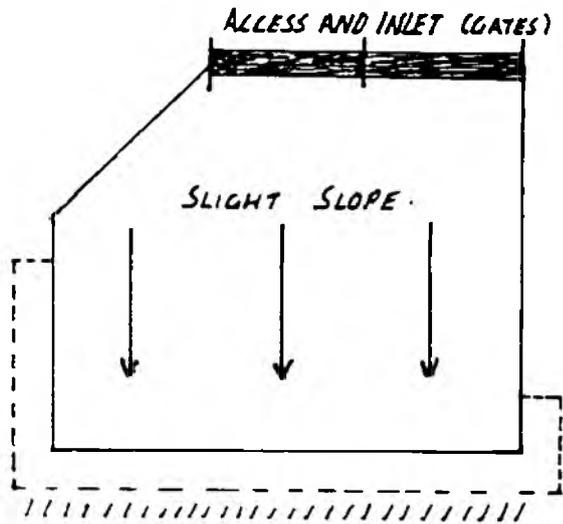
\*DIAGRAM

Store is on a slight slope towards weeping wall.Store was quite empty on visit,but appears to be functioning relatively well.Only one inlet into store.

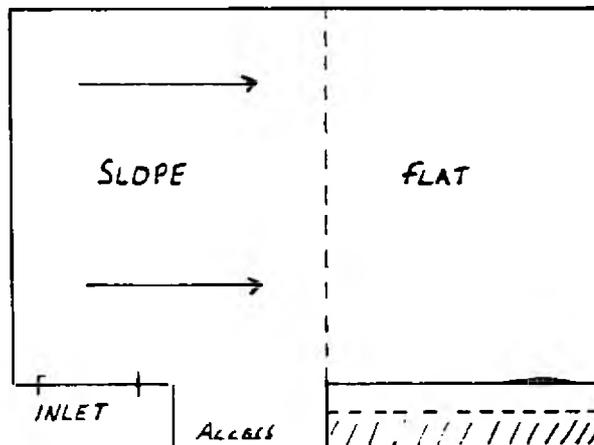
\*DIAGRAM

Unusual designed store with inlet part of store sloping downwards towards weeping wall area.No trouble with spurting in the past but Mr.Hookway has not allowed the store to fill above 2 feet deep.

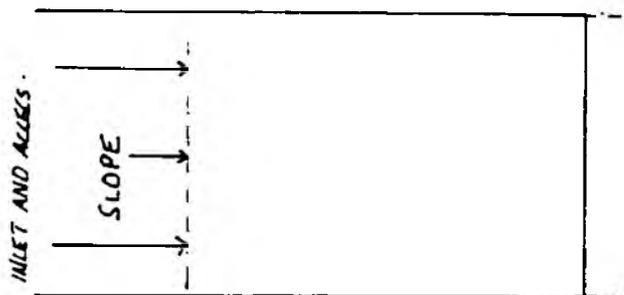
Quite a small store,appears to be functioning quite well.Very wide channel with retaining wall which may restrict any low pressure spurts.

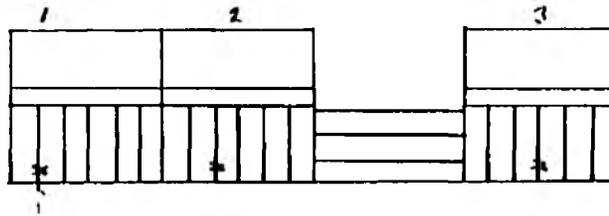
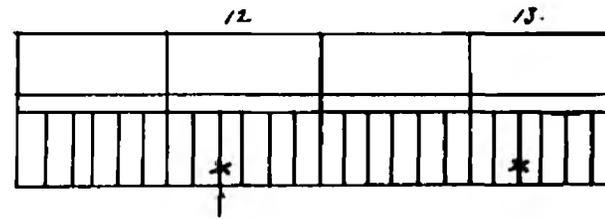
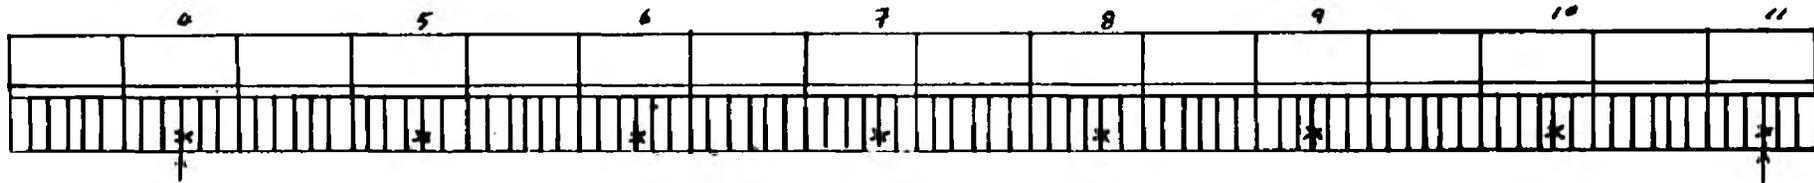
WEEK ONE RESULTS.

Strong wind blowing rain and hail into the access face of the store. The surface of the slurry appeared to be weeping very heavily, especially in the corner with the back inlet wall. When rod number one was inserted into the store it appeared that a pocket of liquid was pierced, and a large spurt then followed. However, this spurt could not be channelled through the pipe. This discharge lasted for about twenty minutes. No further pockets of liquid were found with rods two and three.

11. Both corks removed, effluent emerged with low s.s. under considerable pressure.
12. Both corks removed, effluent emerged with low s.s. under considerable pressure.

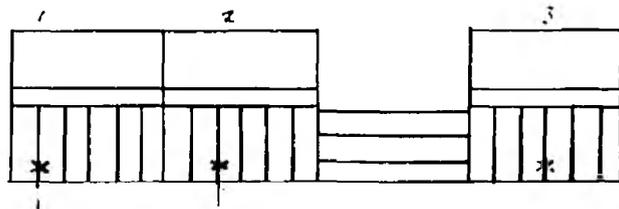
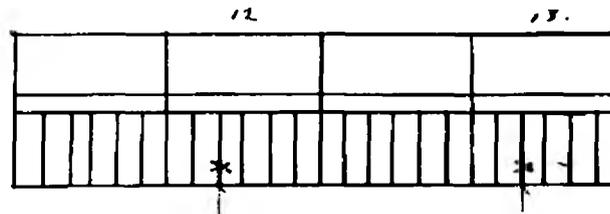
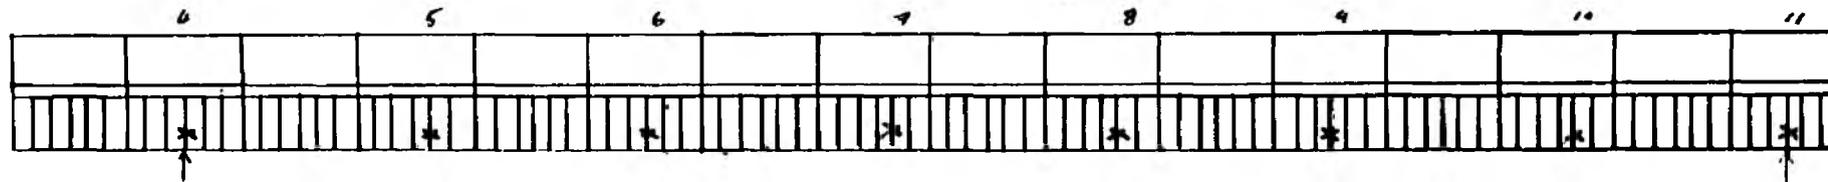
WEEK TWO RESULTS.

There was a moderate wind blowing directly into the access face of the store which appeared to drying out the surface of the slurry being exposed in the slats of the weeping wall. Once this surface crust was broken or disturbed by moving the rods slightly (especially rods one and two) liquid did start squirting out under considerable pressure.

4. Very large amount of liquid apparent - cork removed, rapidly followed by a heavy gush of watery effluent. Cork replaced immediately to stop flow.
5. No apparent build up of liquid - cork opened no effluent emerged, pipe not rodded through.

12. Very large build up of liquid apparent - cork was not removed.
13. Very large build up of liquid apparent - cork was not removed.

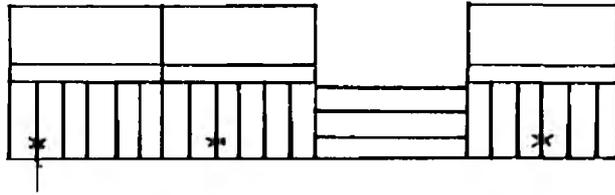
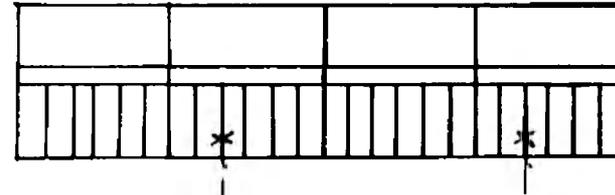
1. Cork opened - very small amount of effluent emerged
2. Cork opened - no effluent emerged
3. Cork opened - no effluent emerged
4. Cork opened - very large amount of effluent emerged. Discharge lasted for approximately 2 hours.
5. Cork opened - no effluent emerged
6. Cork opened - no effluent emerged
7. Cork opened - no effluent emerged
8. Cork opened - no effluent emerged
9. Cork opened - no effluent emerged
10. Cork opened - no effluent emerged
11. Cork opened - very large amount of effluent emerged. Discharge lasted for approximately 2 hours.
12. Cork opened - very small amount of effluent emerged.
13. Cork opened - very small amount of effluent emerged.

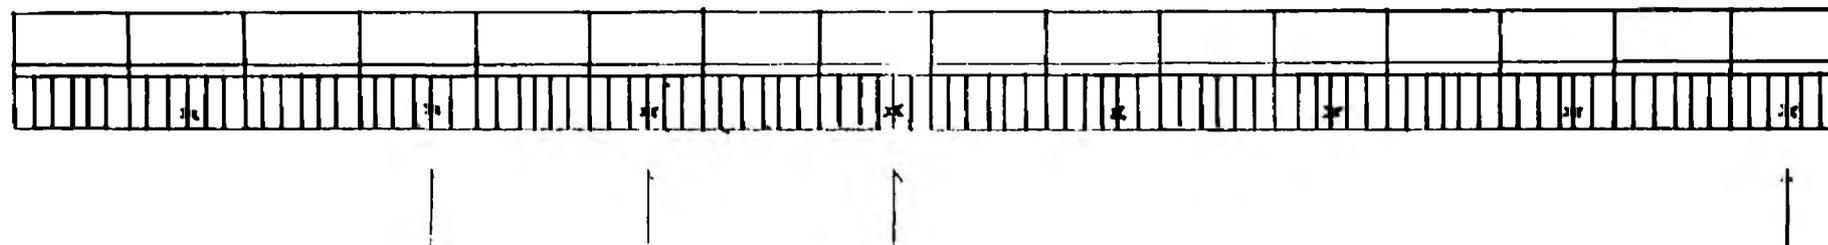
WEEK FOUR RESULTS

- 1: Cork was removed and a small amount of high S.S. effluent emerged.
- 2: Cork was removed and no effluent emerged.
- 3: Cork was removed and a large amount of effluent emerged, cork replaced. Slurry around the pipe then fractured and a spurt then followed, the duration of which was 1 hour 5 minutes.
