DEVON AREA  
INTERNAL REPORT

ENVIRONMENT  
AGENCY

**INVESTIGATION INTO  
THE CAUSE OF HIGH  
PHENOLS IN BUDLEIGH  
BROOK**

**FEBRUARY 1998  
DEV/EP/04/98  
(CATCHMENT 04A)**

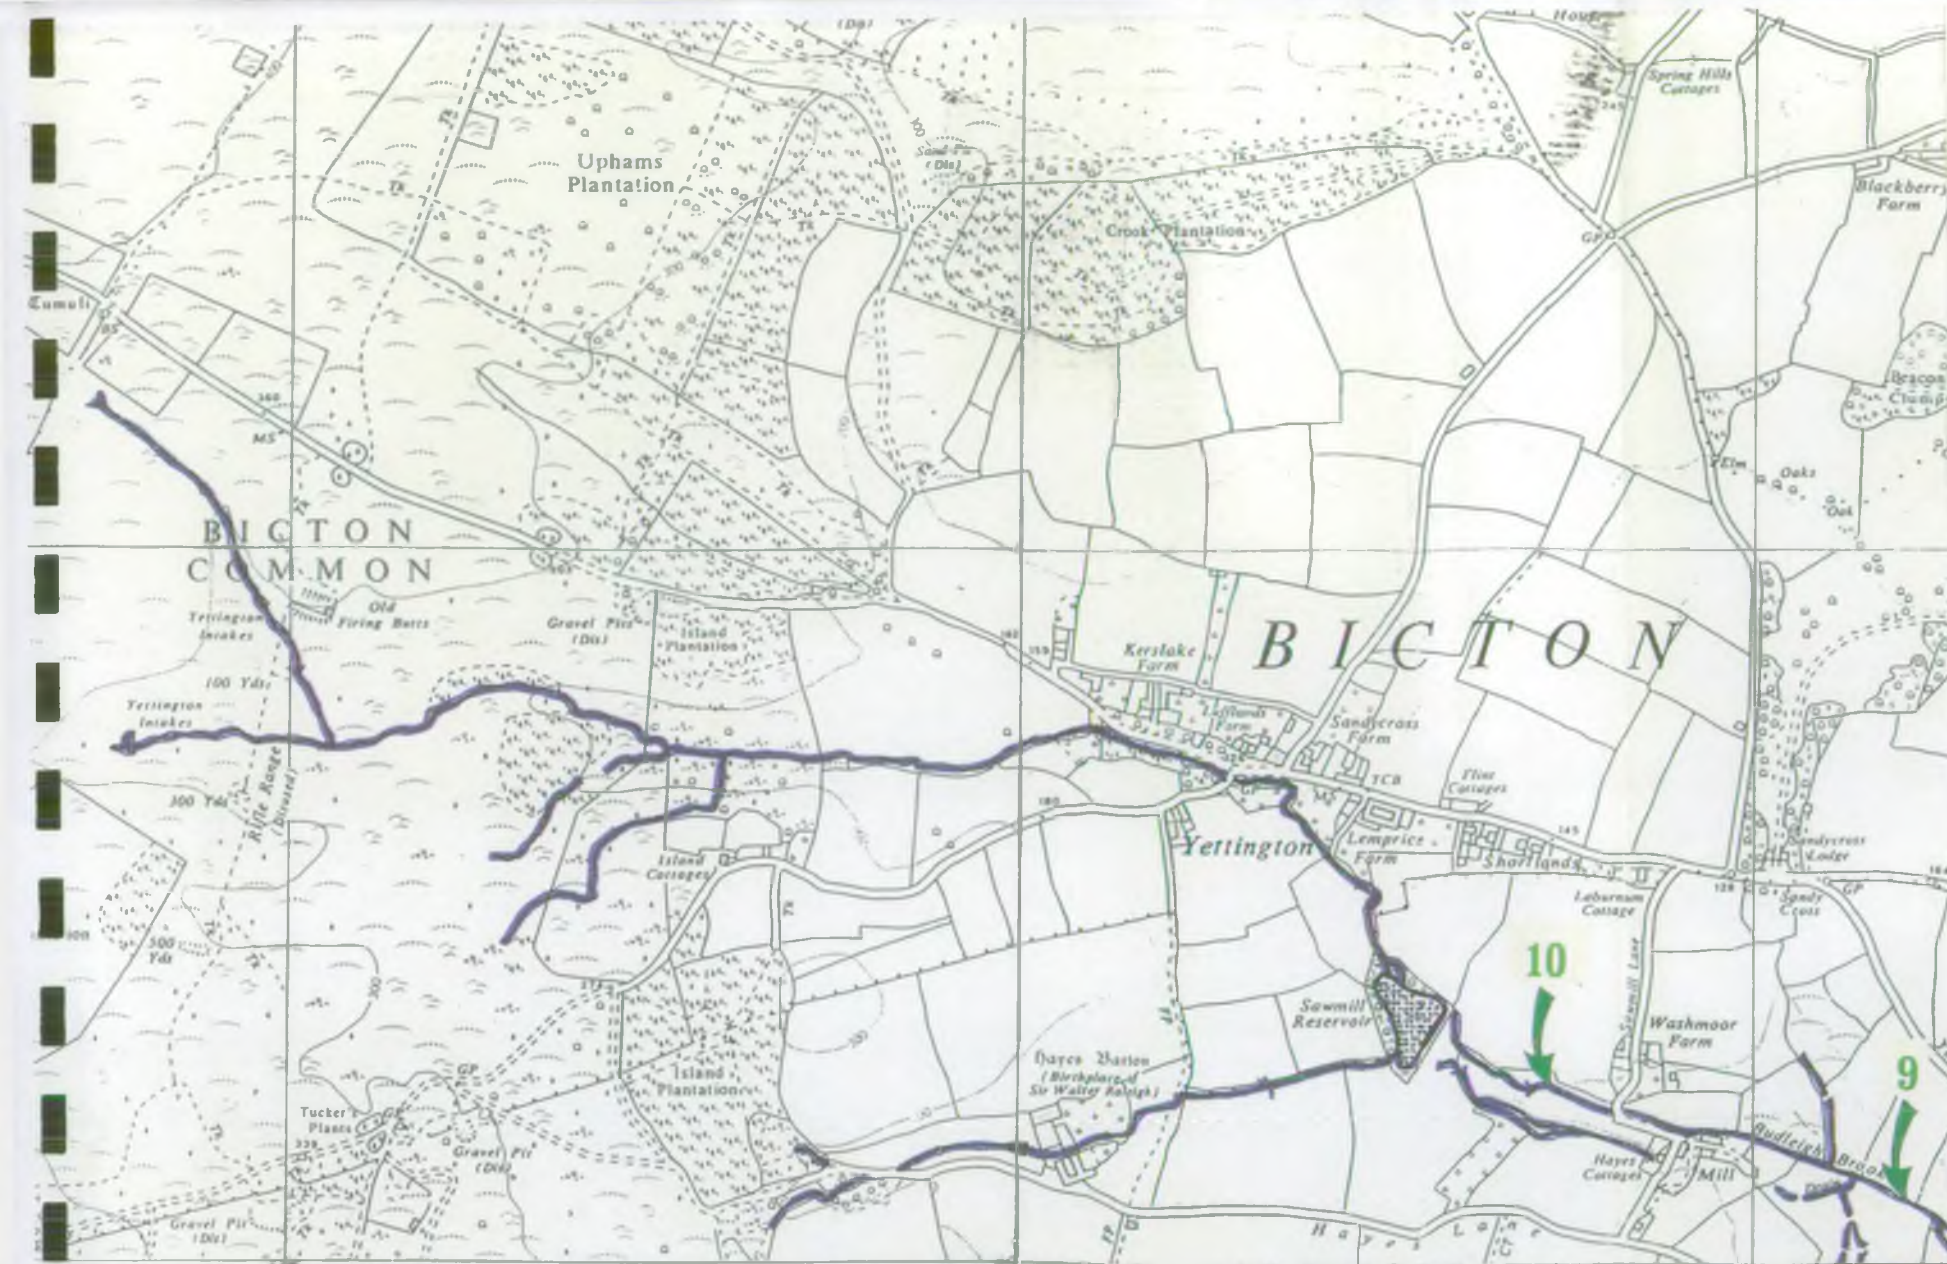
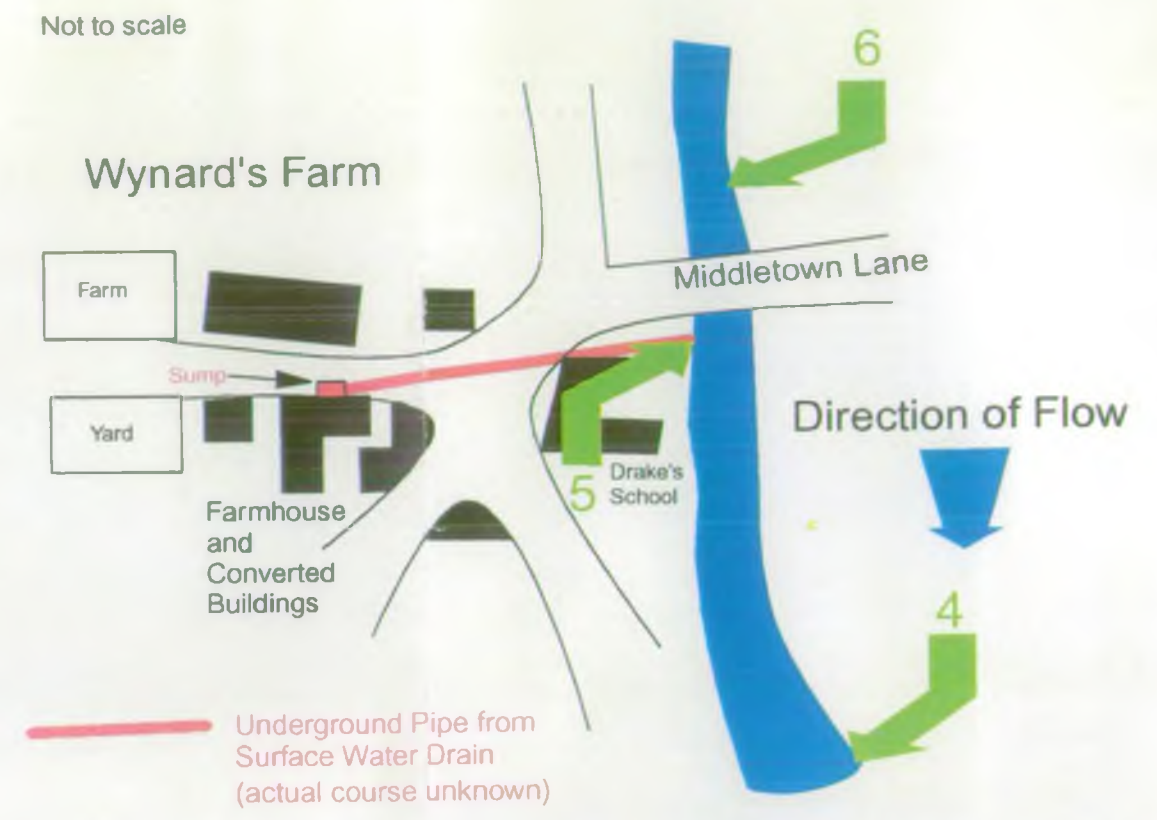
Figure 1. Sampling Point Locations on Budleigh Brook

Sampling site locations are shown on Figure 1.

Sites 8 and 5 are surface water drains which discharge into the watercourse. Site 8 is located near Hill Farm, site 5 is the outfall pipe from a surface water drain which collects in the area at the top of Middletown Lane near Wynard's Farm (see Figure 1).
