**WATER QUALITY SECTION
CORNWALL AREA**

FINAL DRAFT REPORT

**RIVER TAMAR
EC FRESHWATER FISH
DIRECTIVE FAILURE 1994**

**June 1996
COR/96/005
Author: Phil Luxton
Water Quality Officer**

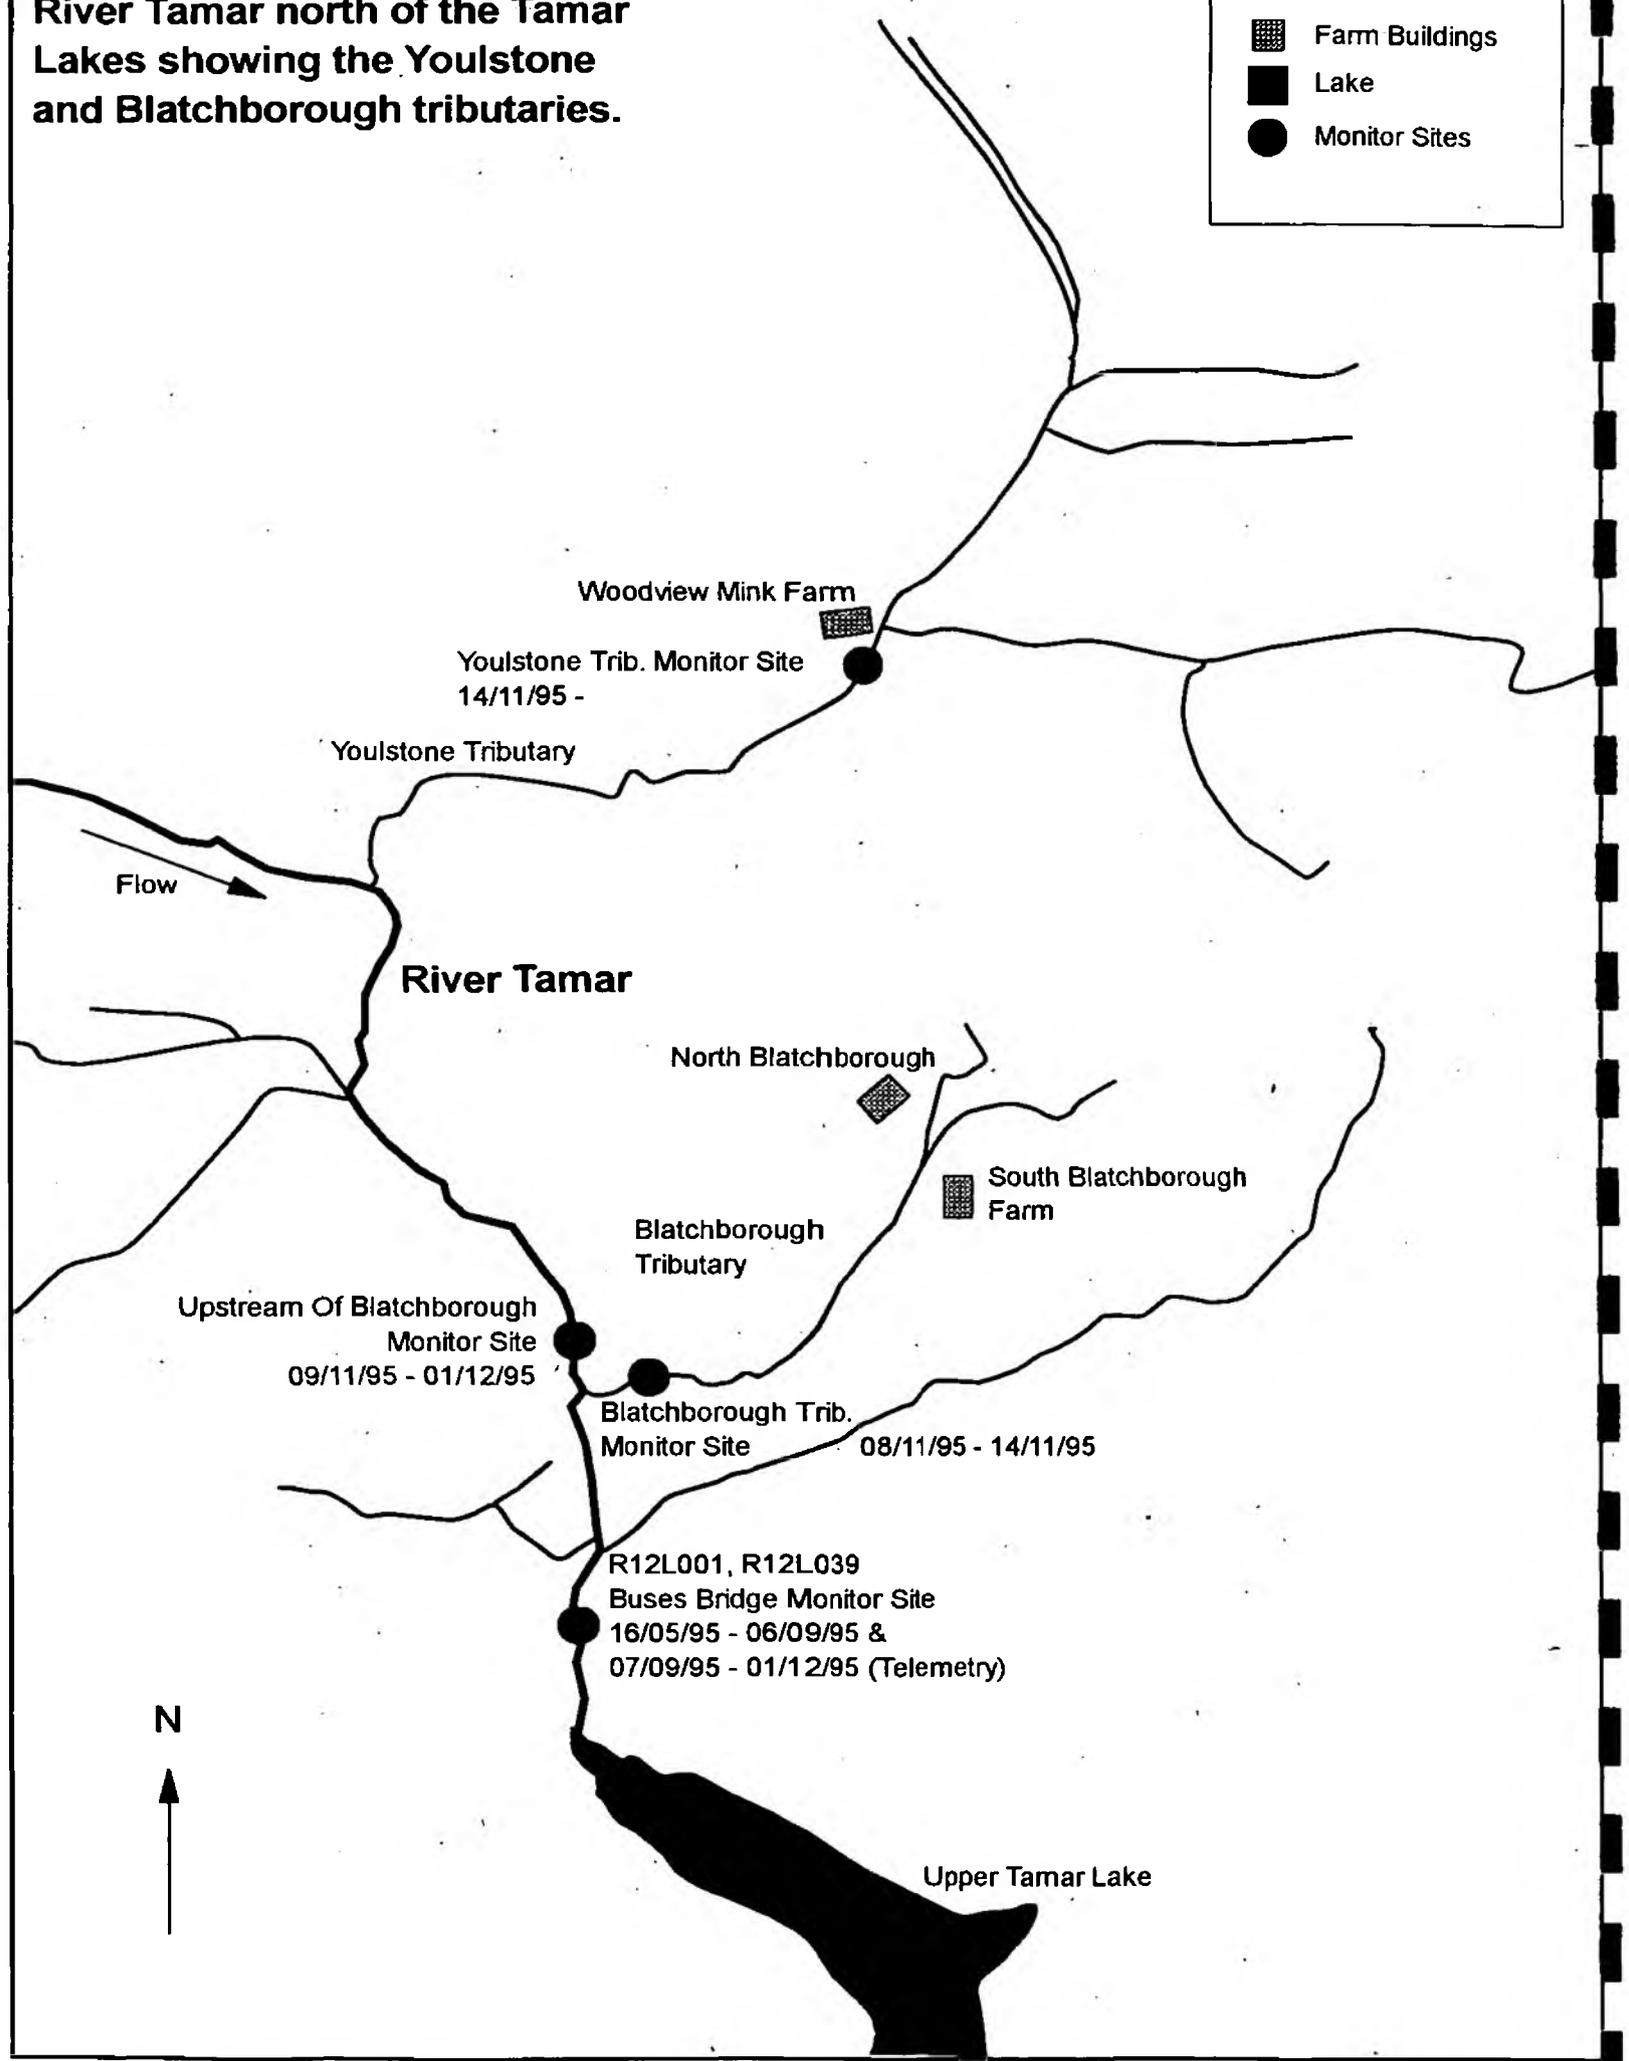
Fig 2.

Fig 2 Plan showing Woodview Mink Farm detail (Not to scale)

Following initial spot sampling programme and Catchment Inspection a Water Quality Monitor was installed at Buses Bridge. Simultaneous to this action Catchment Inspection found a discharge to be emanating from a site known as Woodview Mink Farm and entering a tributary of the River Tamar at Trentworthy Cross, Youlstone some 4.5 Km upstream of the monitoring point (R12L001/R12L039). On site readings and subsequent analysis of samples highlighted high ammonia content. Statutory samples were taken due to the discharge and a report submitted for instigation of legal action. By comparing the readings from the monitoring points on the Youlstone Tributary and the River Tamar at Buses Bridge the peaks of ammonium and conductivity can be seen to be related. The trend of the peaks indicate that Woodview Mink Farm is the principle source of ammonium causing non-compliance of the E.C. Freshwater Fish Directive at Buses Bridge. Following remedial action by the site owner, using water quality data and onsite photometer readings, it has been confirmed that the point source has been identified. Due to the nature of the site ie. Mink Farming, the discharge has been seasonal and at present animal stocking is low in comparison with the summer months. Remedial action by the owner is continuing along with onsite monitoring and water quality monitoring by the one monitor left installed on the Youlstone Tributary. As remedial action progresses it would appear that the peaks are becoming less frequent however in times of rainfall some discharges do occur. Once total remedial work has been completed it is envisaged that the site drainage will be on completely separate systems and therefore manageable. Whilst the Fresh Water Fish Directive has been breached the impact on the watercourse is thought to have been minimal due to the sporadic nature of the discharge, the nature of the pollutant ie. no high BOD content and the flow levels at time of discharge.
