Audit of 20 Rehabilitation Projects Environment Agency Thames Region

Janes, M. D. and Holmes, N. T. H.
River Restoration Centre
1998

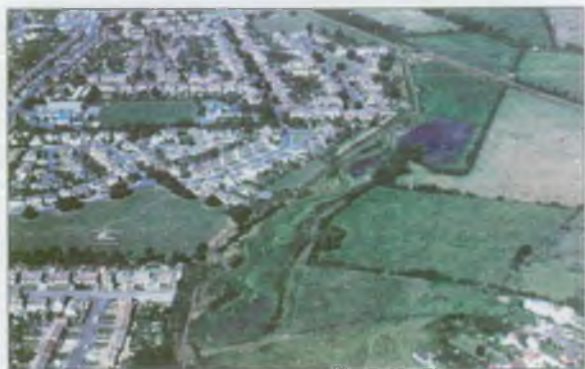
PLATE 1 Bear Brook along its new sinuous course.

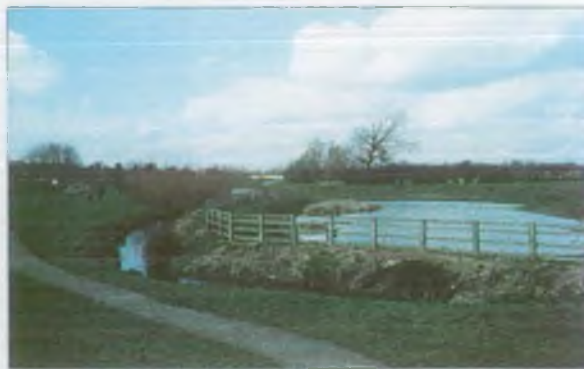
PLATE 2 Temporarily inundated flood storage area.
– March 1998

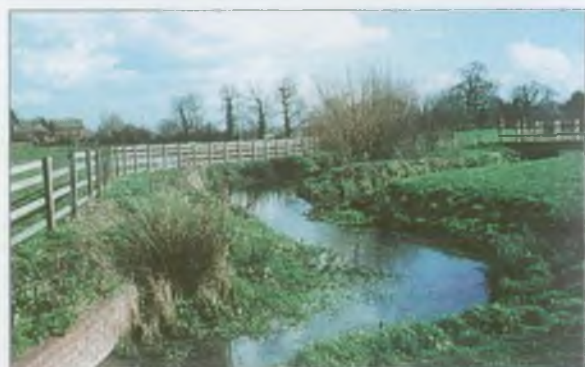
The hard engineering has not been so successful. Some of the concrete lattice protecting the Bedgrave Brook bed and banks has moved (probably due to vandalism) and is being undercut in places (Plate 8). The brickwork flume is totally out of character with the rest of the channel works and the concrete apron designed to prevent erosion is being undercut at its downstream end. The visual intrusion of the gated flume through the spillway detracts from the riverworks also, though this is

PLATE 3 Brook flowing into the brick flume.
This throttle ensures upstream overspill. – March 1998

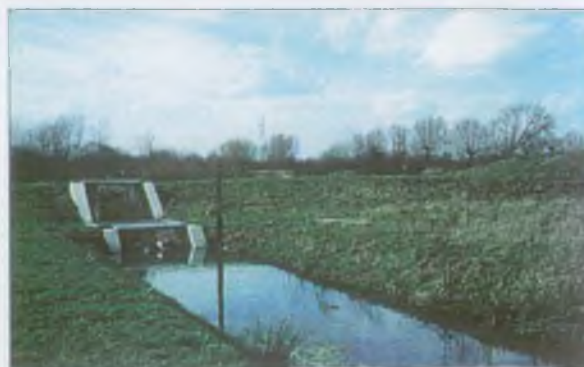
PLATE 4 Large grated flume structure set into the
flood embankment. – March 1998

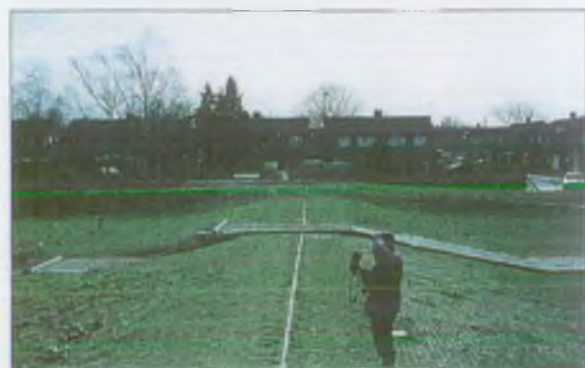
obviously necessary for the successful operation of the flood alleviation scheme. The concrete lattice forming the spillway is gradually grassing over and becoming visually 'softer'.

PLATE 5 Top of the embankment spillway.
Grassed concrete lattice. – March 1998

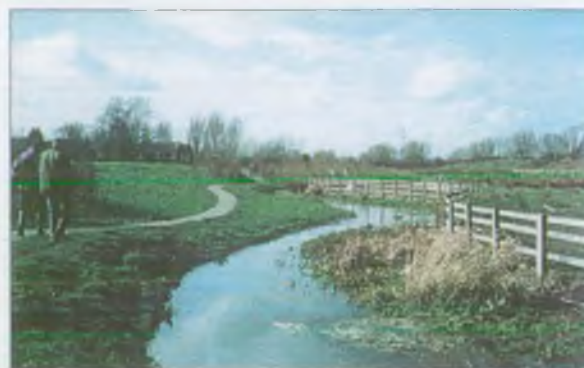
To allow increased access to the site a formal surfaced low-level path was built following the brook (Plate 6). New footbridges were constructed over Bear Brook and Bedgrove Brook, and informal rights of way agreed with the right bank landowner.

The post and rail fence is also very stark because of the open nature of the site and its proximity to the river.

PLATE 6 A formal low-level path follows the brook.
Opposite livestock access is restricted by a post
and rail fence. – March 1998

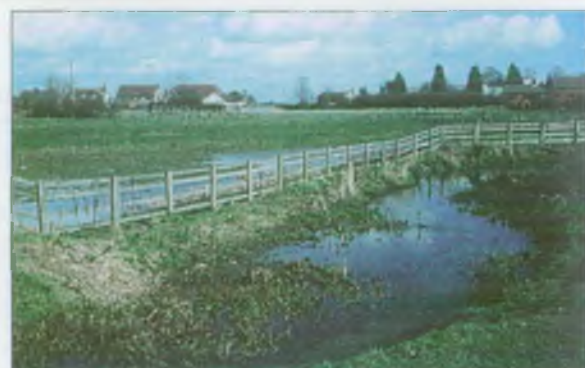
PLATE 7 A lowered spillway section showing significant
narrowing by vegetation encroachment and siltation.
– March 1998

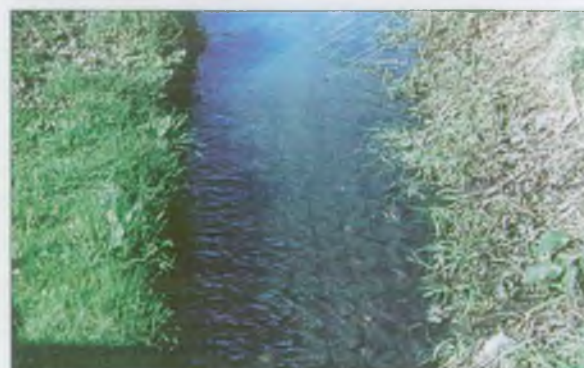
PLATE 8 Bedgrove Brook was also re-aligned but its
bed protected with concrete. This is beginning to be
undercut and displaced by vandals. – March 1998

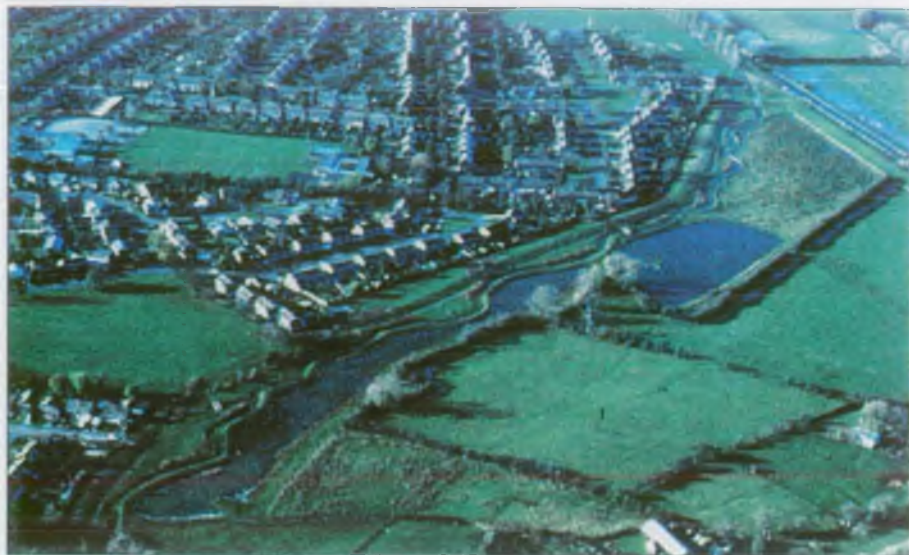
The storage areas to the right are working as expected and have established small stands of marginal vegetation (mostly *Typha* (bulrush)) (Plate 9). Further downstream the additional wet grassland area, increased by the flood storage scrapes, is colonising rapidly with *Juncus* (rush). Snipe, Teal, Moorhen and Heron are known to visit the site (Plate 10).

PLATE 9 Storage areas in flood. – December 1996

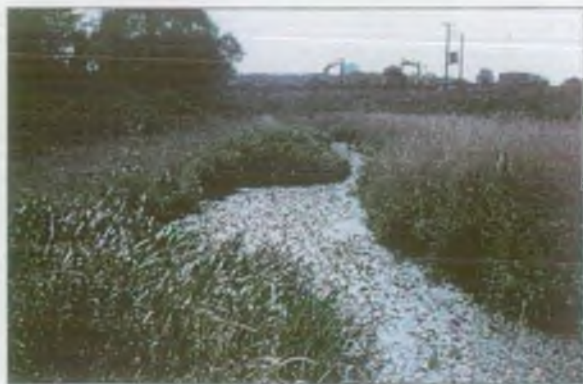
The river had been degraded by various gravel extraction works and channel diversions. The upstream section had a problem with excessive growth of *Potamogeton natans* (broad-leaf pondweed) (Plate 1). In the late 1980's construction of a new road began, joining the A31 to the M3 to bypass Aldershot and Farnborough. Due to the heavily urbanised nature of this area the road followed the Blackwater valley along the course of the River Blackwater. The road necessitated the diversion of the river at several locations.

PLATE 1 Northern section – Before. Channel choked with *Potamogeton natans*.

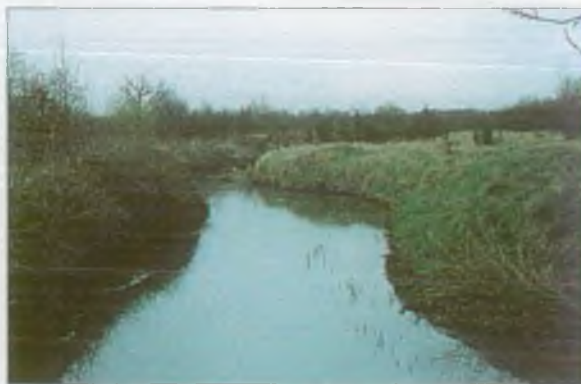
PLATE 2 Northern section – Remnants of sinuous course remain, but separated from the floodplain.
– March 1998

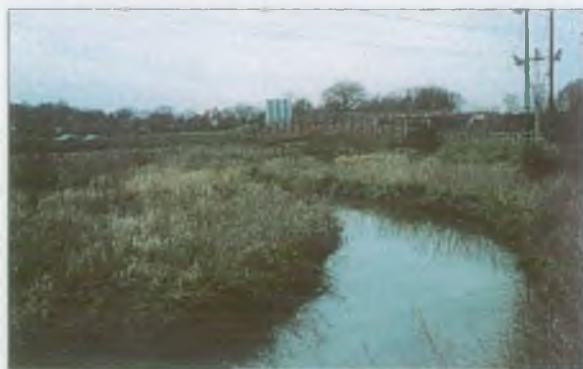
PLATE 3 Northern section – Two-stage channel with heavily vegetated berms. – March 1998

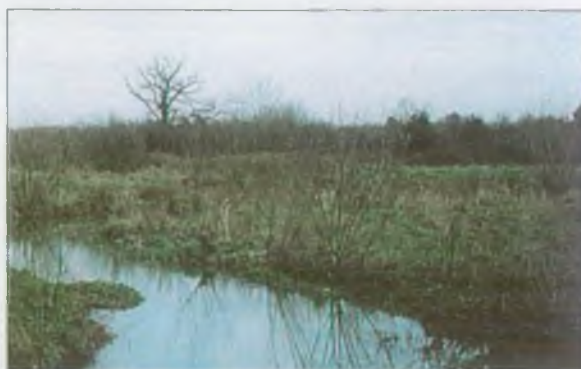
Further downstream within this section the new road cut off a large meander loop belonging to the original sinuous course. This meander was reinstated on the opposite side of the channel, using the same dimensions, whilst lowering the inside profile of the bend (Plate 4).

PLATE 4 Northern section – Meander loop reinstated with a gently sloping inside berm profile. – March 1998

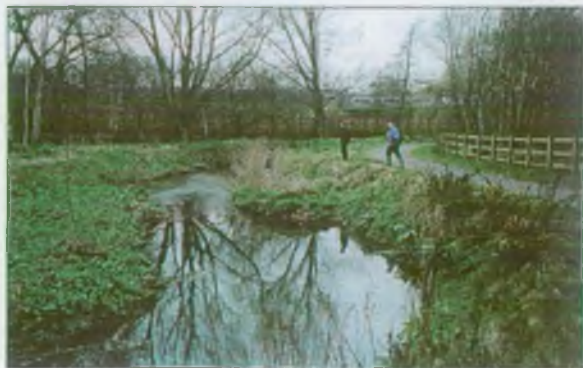
PLATE 6 Central section – Two-stage channel.
– March 1998

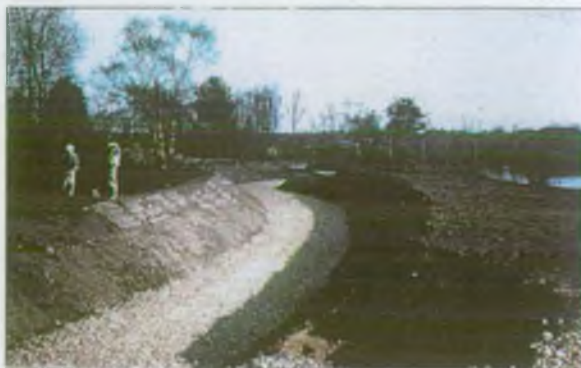
The design consists of a meandering channel with low berms on the inside of the bends, and outsides supported by live willow. Similar to the upstream lakeside reach, the channel was cut in the dry (Plate 7). Shallow 'riffles' (10-20cm) have been constructed using gravel to form a dish profile to narrow and focus the flow, in conjunction with 1m deep pools (Plate 8).

PLATE 7 Central section – The channel was cut in the dry and the bed lined with gravel.

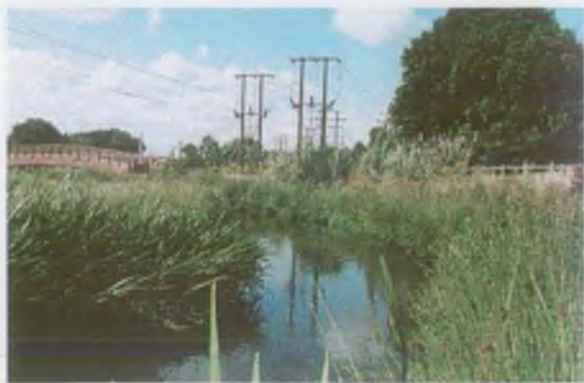
In-channel the establishment and growth of vegetation has also been very successful. Species in abundance include *Typha* (bulrush), *Phalaris* (reed canary-grass), *Sparganium* (bur-reed), *Callitriche* (water-starwort), *Juncus effusus* (soft rush) and *Elodea canadensis* (Canadian pondweed). In places the *Typha* has had the effect of narrowing the low-flow channel, simulating a run. This vegetation growth should also promote shoal development and further narrowing in places (Plate 10).

PLATE 10 Northern section – Narrowing by vegetation is introducing flow variation and substrate movement. – March 1998

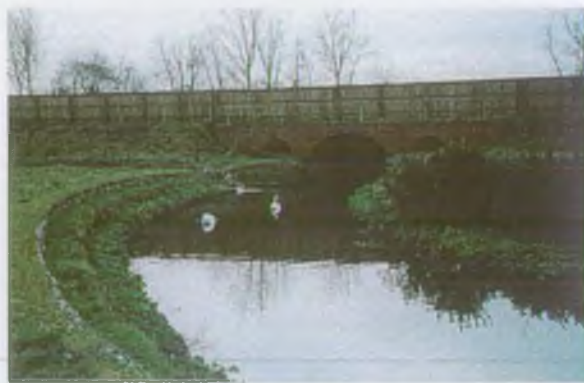
PLATE 11 Central section – Gabion bank reinforcement. Introduction of willow/alder would soften the engineered appearance. – March 1998

The gabion banks still look very artificial. A possible solution is to incorporate live willow/alder to screen the wire baskets and provide additional support/stability through the root system (Plate 11).

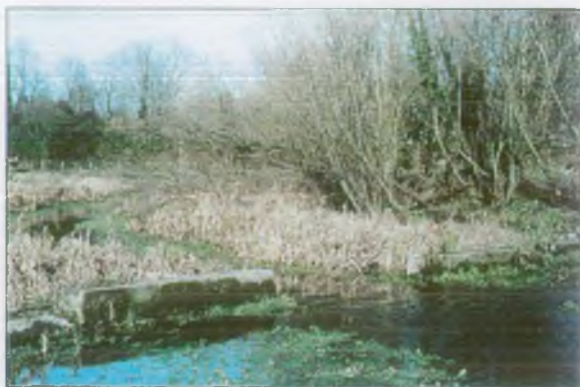
PLATE 1 Notched weir. – February 1998

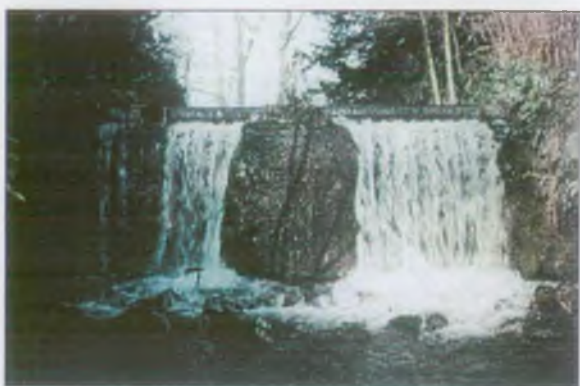
A major component of the 1994/5 enhancement works involved the replacement of the mill weir with the pool and traverse fish pass (Plate 3).

PLATE 3 Old mill weir, a barrier to fish passage.

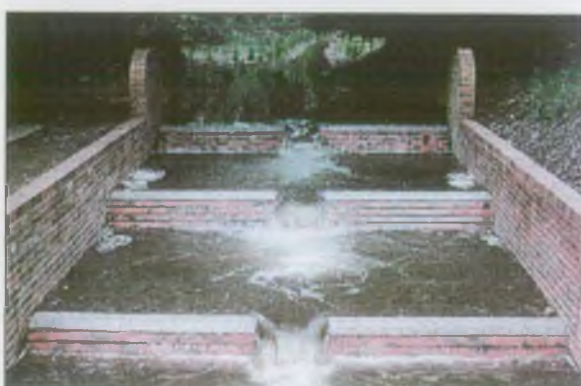
PLATE 4 New fish pass, lowered the crest by 1.5m. – February 1998

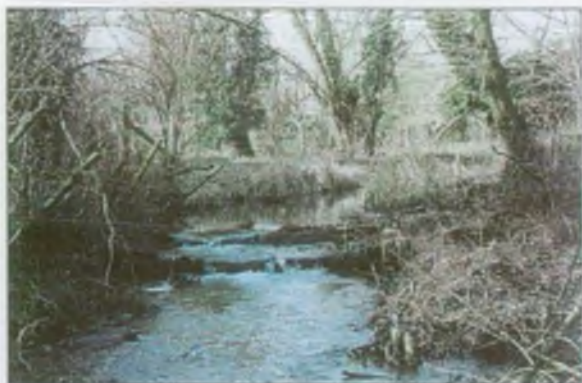
Towards the upstream limit of the works the impounding effect of the mill weir had been underestimated. Its replacement had resulted in a 250mm drop over a small weir which diverted water from the main stream into a small pond. To retain this feeder flow, two low rock weirs were erected together with hurdle deflectors to minimise the amount of fall at any one point. This work was carried out by hand due to the access problems for machinery (Plate 7). Further upstream a series of heather hurdles were used as deflectors to create flow diversity within the stream and to encourage narrowing by vegetation encroachment.

PLATE 7 Two small rock weirs were erected to retain a feed to the upstream pond. – February 1998

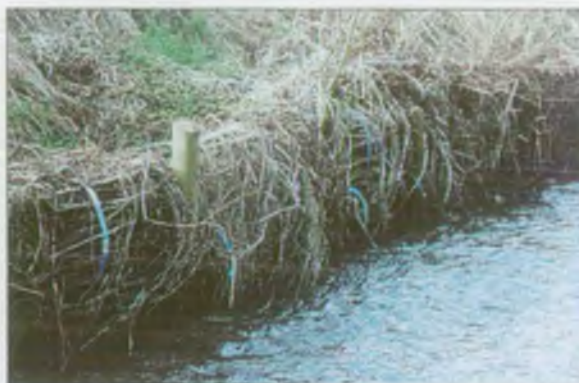
The narrowing of the stream has proved very effective in creating good instream habitat, but the height of the adjacent berms is such they remain high and dry. This also exposes the unsightly faggoting and blue plastic ties (Plate 8).

PLATE 8 Raised berm and faggots. – February 1998

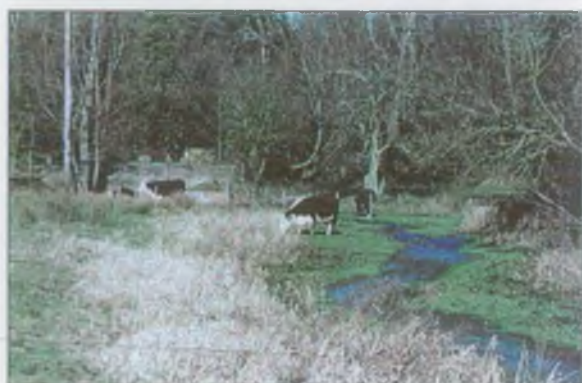
The effect of the downstream notch-cut has been very successful both physically and aesthetically (Plate 9).

PLATE 9 Notching the downstream weir has removed the previous backwater effect that covered the bed with silt. – February 1998

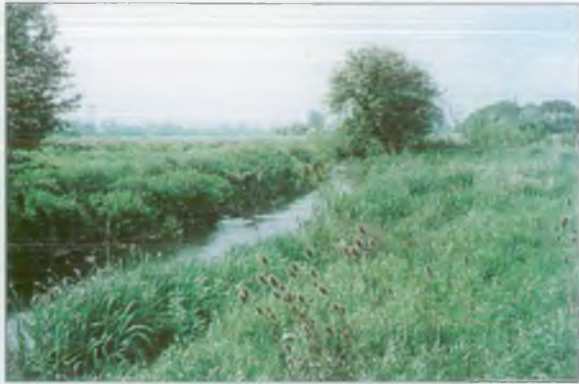
1. *Downstream.* - A 100m section, ledge at or below water level, rising to a 6m wide gentle uniform slope. The bank is fenced off from grazing stock as it is adjacent to the wetland (Plate 1).
2. *Lower-mid.* - A 40m length, ledge at water level, rising to a 4-5m wide gentle slope. The river edge is not fenced from stock.
3. *Upper-mid.* - A 30m reach, ledge at or above water level, rising to a convex 4-5m wide slope.

PLATE 1 No. 1 – Downstream, bank re-profiling and ledge vegetation establishment. – May 1998

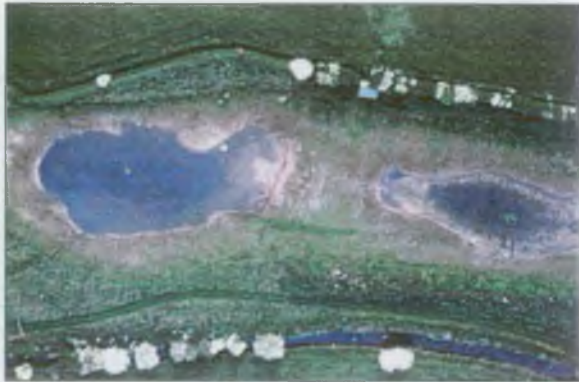
A wetland feature was excavated in an adjacent meadow, surrounded by ditches, which regularly floods. Approximately two acres, the linear scrape has two deeper (up to 1m) pools separated by a central 'spit' (Plate 3). The bed was found to be clay, with one seam of gravel that is now known not to connect to the river. The wetland is perched above the river level but retains water well after flooding, which occurs frequently (Plate 4).

PLATE 3 The River Cole and wetland, dry weather showing central 'spit'.

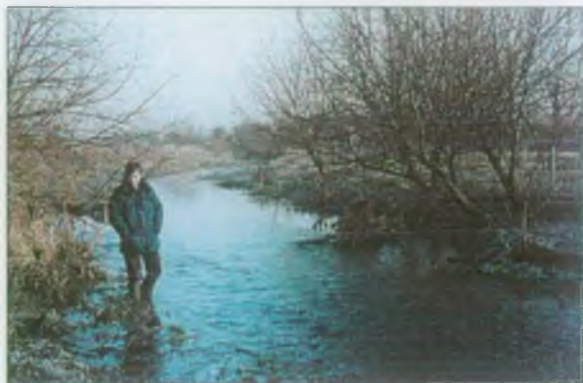
Gravel was imported to a design specification, fairly large coarse angular material, designed, in conjunction with the groynes, to stay in place (Plate 1). Gravel movement within the river was not desirable due to the proximity to central Watford and the perceived risk of flooding to properties.

PLATE 1 Constructed gravel riffle, *Ranunculus* starting to colonise. – February 1998

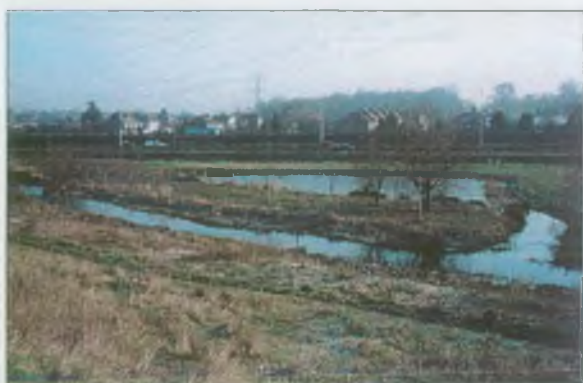
PLATE 2 Small backwater and connection to the river. – February 1998

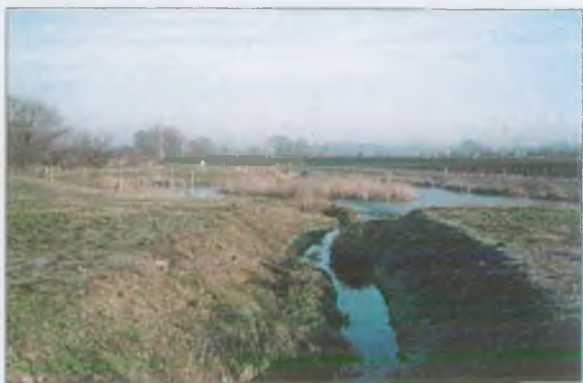
PLATE 3 Large reed fringed backwater, connected by a steep sided ditch. – February 1998

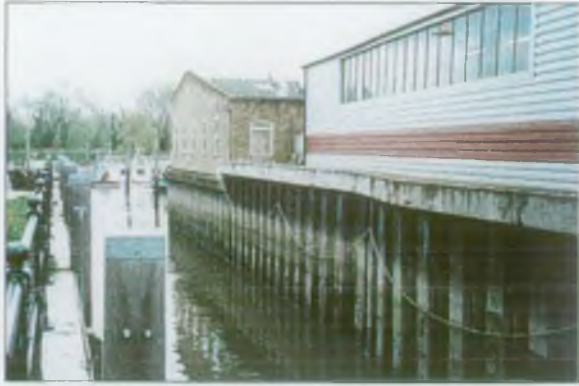
PLATE 1 Steel piling, the most common utilitarian solution. – April 1998

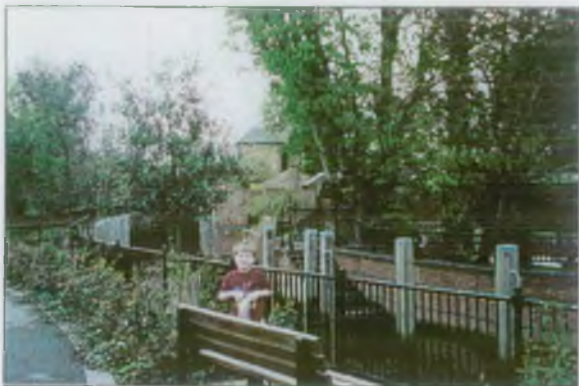
PLATE 5 View showing many of the enhancement techniques used. In particular note the retention of the impressive horse chestnut trees within an amenity area, and stepped access route leading to moorings and planted ledges. – April 1998

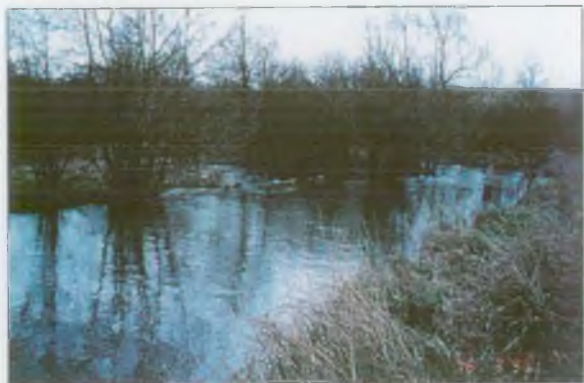
PLATE 1 Downstream limit. Levels impounded by makeshift weir.

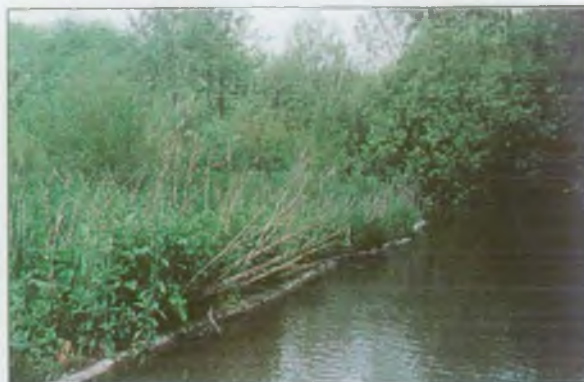
PLATE 2 Narrowing and ledge creation using willow and larch logs has been successful. – May 1998

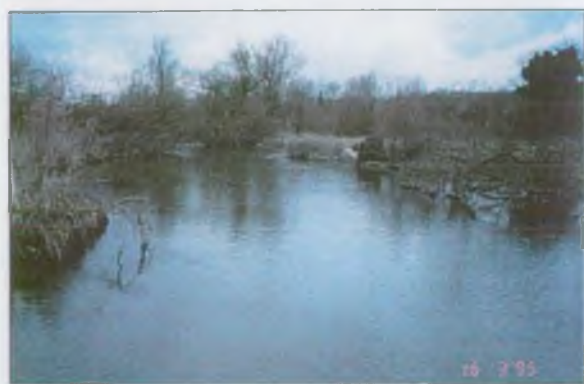
PLATE 3 Duck and rat activity had eroded the banks, up to 30m wide.

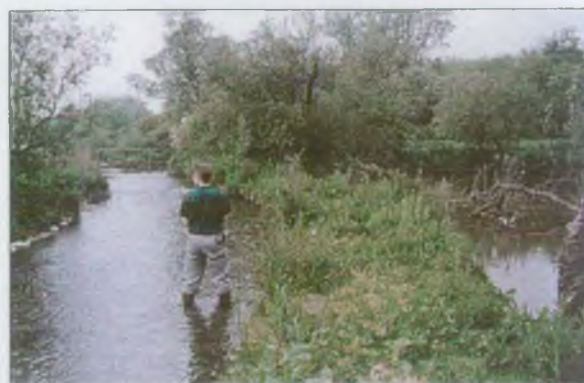
PLATE 4 The person is standing in the main channel, to the right remains a backwater (part of the old channel width).

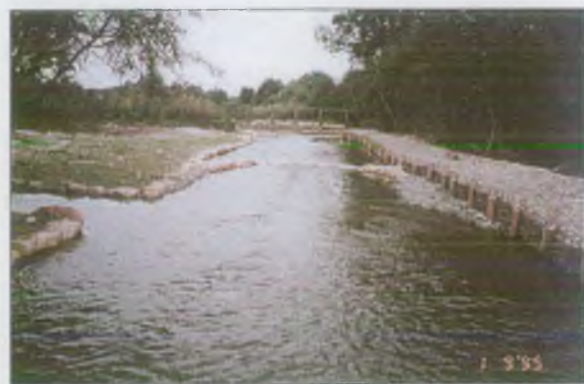
The right bank, formed using limestone blocks, was set at a much lower level to create a wet, boggy ledge (Plate 5).

PLATE 5 Hurdles and blockstone were used to redefine a hard bank.

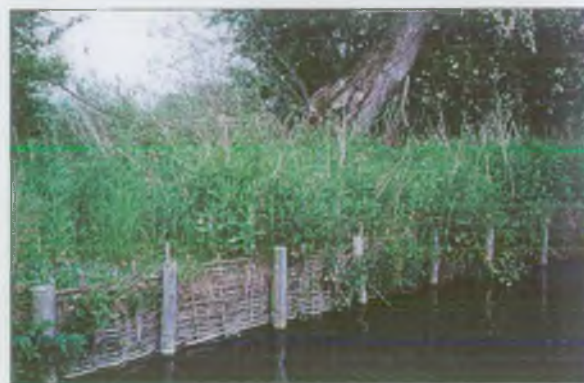
Various narrowing works were carried out over this section on both banks, using willow hurdles and blockstone. The height of the hurdle revetment increases downstream to 1m (Plate 6). Deflectors were also used to create flow diversity, whilst retaining small back channels fed by springs. The old overspill weir was replaced by a much lower blockstone crest, lowering water levels by 0.6m (Plate 7).

hazel shows signs of degrading, but the Geolon will prevent the natural softening and colonisation of the edge, and will become exposed once the hurdles have gone. The chalky, flinty material used to backfill the channel edge may have been sufficiently stable without any form of protection.

PLATE 6 Some willow hurdles stand proud of the river due to the substantial drop in levels. – May 1998

The hurdles should be inspected when the majority begin to degrade. It may be necessary to carry out some remedial works in terms of removing the Geolon and perhaps the posts. The fill material should be sufficiently well settled, after 3 years, to withstand high flows. Some scour and localised slumping may occur, but this will merely produce the desired bank diversity. In some areas macrophyte growth may be poor due to the amount of bank shading.

1. The use of a geotextile in a situation such as the one described above is unnecessary. If some initial stabilisation is desired, this should be limited to a biodegradable hessian type material, which will rot with the hurdles.
2. Narrowing may occur naturally, sometimes at a fast rate, once any impoundments are removed, however it is more difficult to predict the end result. Where downstream impact is not a concern, and the speed of recovery is not imperative, this option could reduce costs significantly, and produce a more 'natural' and varied edge habitat.

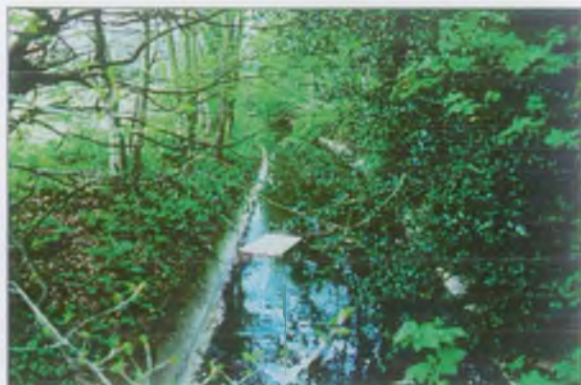
PLATE 1 Main channel - Gatwick Stream. Concrete bed and banks. - March 1998

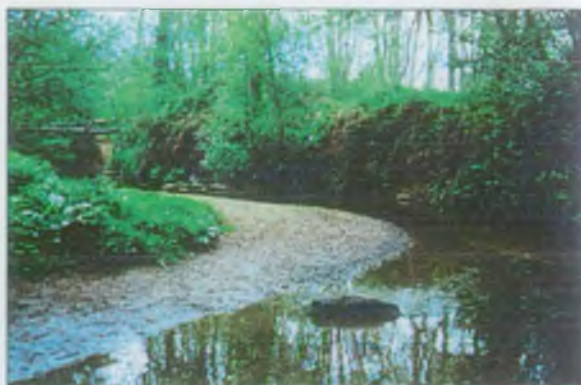
PLATE 2 Further downstream the channel reverts to steep but natural earth banks. - March 1998

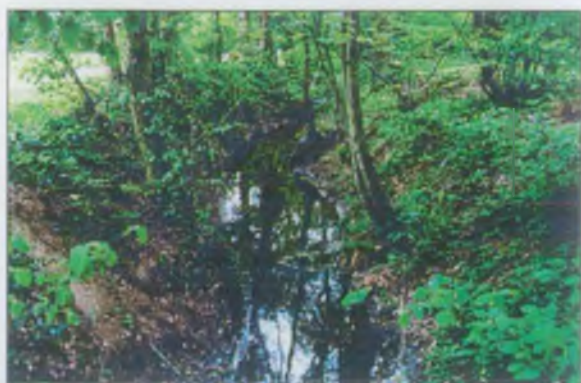
PLATE 3 Gratton's Park ditch, deeply incised. - March 1998

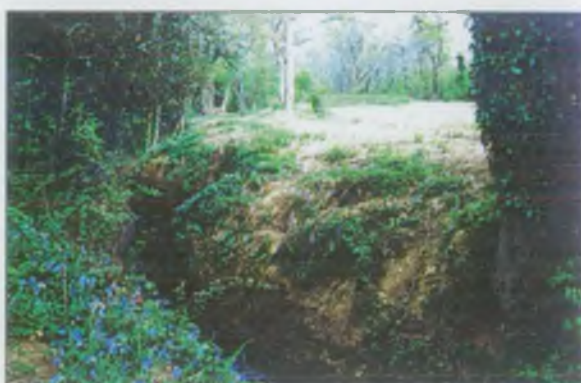
Downstream of the connection the ditch was dredged by up to 1m, uncovering a gravel bed, and in places the banks pulled back (Plate 4). The overall length, approx. 500m, was re-graded to a slope of 1:350 to tie in upstream and downstream

PLATE 4 Some bank re-profiling was possible. - March 1998

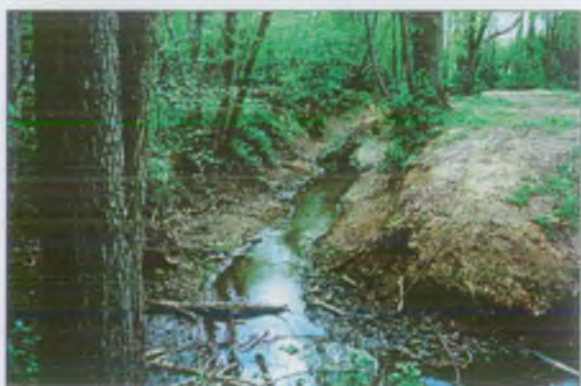
At the downstream end of the ditch (below the main concrete weir), reconnection to Gatwick Stream was made through a section of previously cut-off meanders. The meanders were much wider than the ditch, but at a higher level, with the old connection to the stream lost to sedimentation. A low flow cut was made in the bottom of the meanders at the bed level of the ditch (approx. 0.5m deep and 1m wide – Plate 5).

PLATE 5 The old meanders were reconnected with the river. Main channel down-cutting meant a low flow channel needed to be excavated. - March 1998

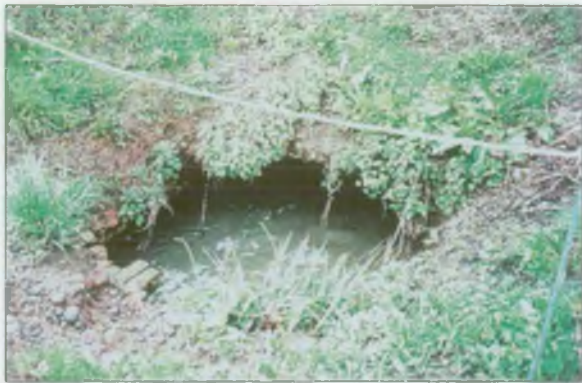
PLATE 1 Culvert collapse was occurring frequently.
– April 1998

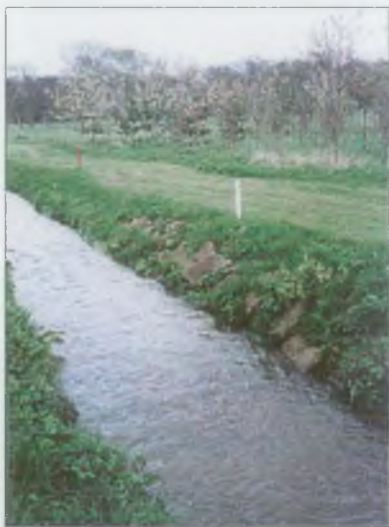
PLATE 3 Stone 'riffles' were built, but perhaps over-armoured.
– April 1998

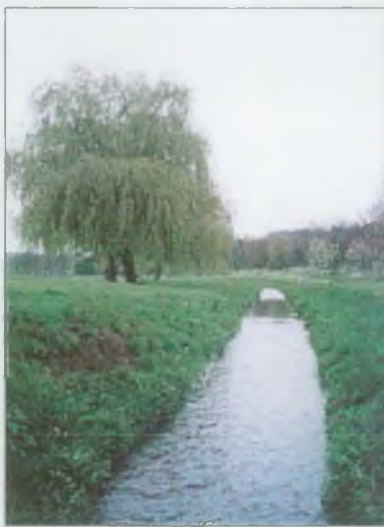
The new course was designed to avoid mature trees and root systems, and designed to suit the golf courses' requirements in terms of fairway layout (Plate 4). Where the brook crossed the fairways the banks were supported using dead hazel spiling to just above water level (Plate 5). The out-

PLATE 4 The new channel was excavated around the mature trees. The formal design was required to meet golf club objectives.– April 1998

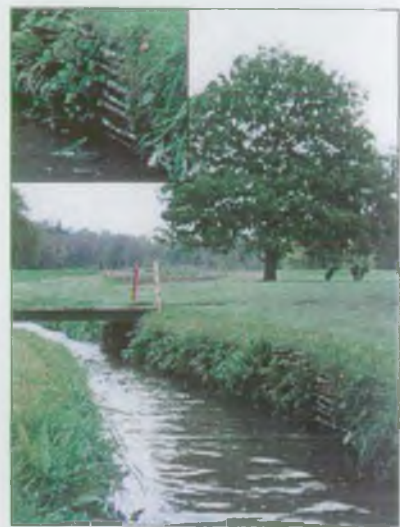
PLATE 5 Where used, hazel spiling revetment has prevented marginal vegetation from establishing.
– April 1998

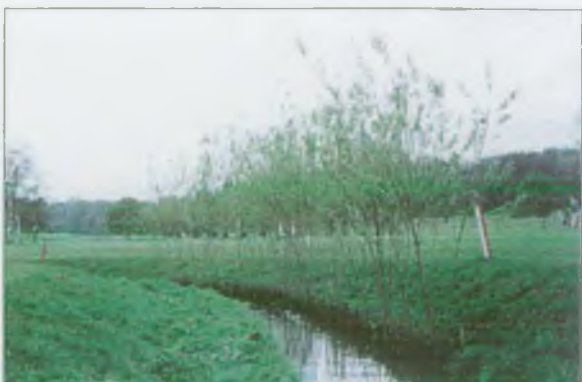
PLATE 6 Live spiling was used on the outside of the bends, but has since been pruned into standards by the golf course managers.– April 1998

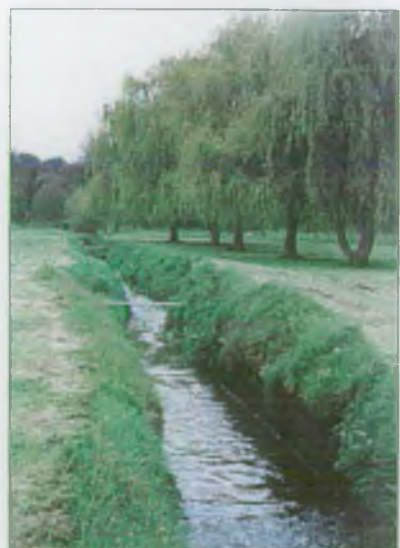
PLATE 7
Upstream the
Brook flows
through an open
but steep and
engineered
channel.
– April 1998

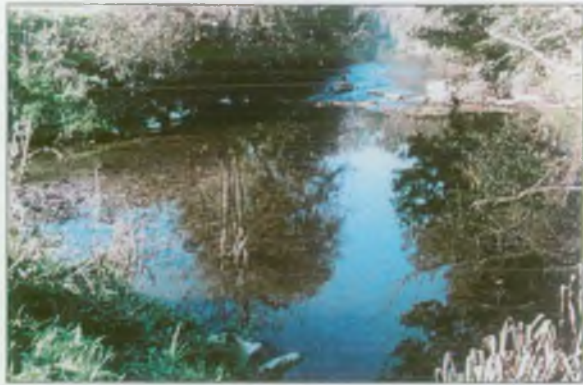
PLATE 1 Cut-off inlet to the left, blockstone weir ahead. – March 1998

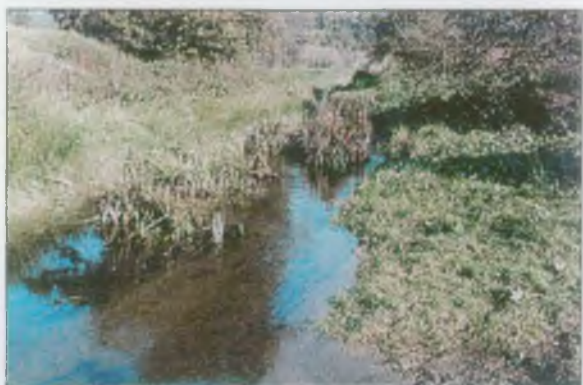
PLATE 3 Narrow low flow channel. – March 1998

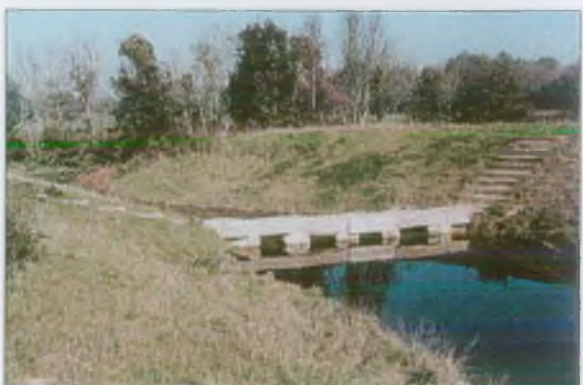
PLATE 5 Stone slab footpath. – March 1998

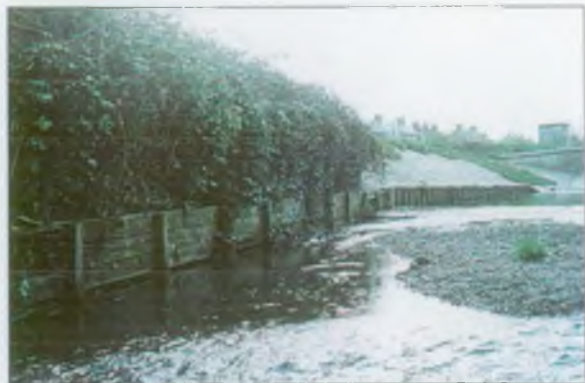
PLATE 1 Toe boarding was removed over 20% of the reach. – March 1998

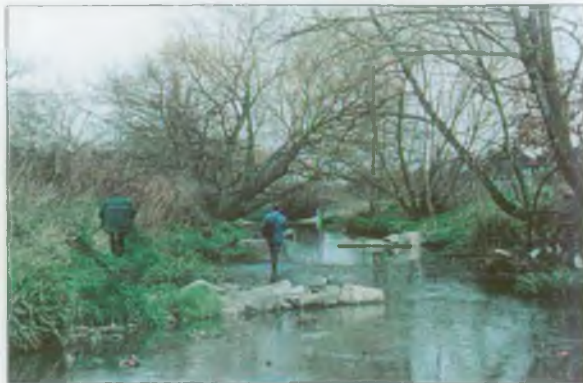
Blockstone deflectors were installed, either in pairs or singly, to diversify flow and to create localised scour (Plate 2). These were designed to minimise the possibility of bank erosion by keying them into the bank and ensuring a sloped top, falling towards the river. Also important was the need for interlocking, (preventing 'leakage' through the structure), and anchoring into the bed. Deflector sizes varied, most were only 20% of the channel width, with the largest 40%.

PLATE 2 Blockstone flow deflectors. – March 1998

Remedial works are needed to address the recently constructed deflectors. Without additional work these will probably either cause bank erosion or simply have no beneficial effect at all.

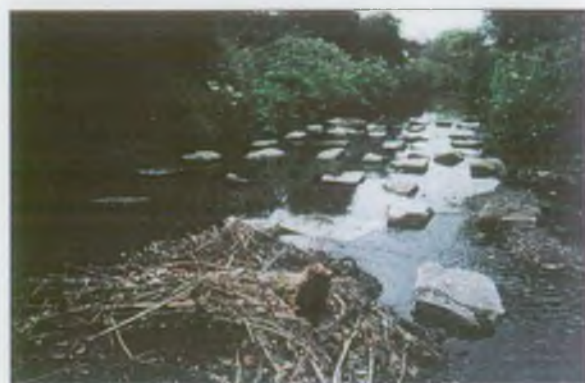
In addition large 'stepping stones' were placed in the river to create turbulence and act as fish lies. These blocks have since been moved to the channel side to form deflectors after problems with litter and failure to create the desired lies (Plate 3).

PLATE 3 Randomly placed 'stepping stones' created turbulence and acted as fish lies, but also collected rubbish.

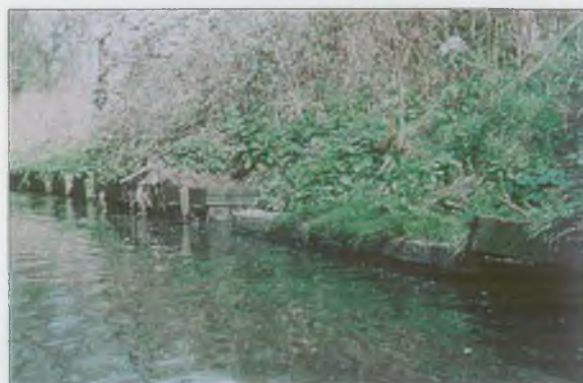
The fish shelters have remained free from sediment accretion, and have not been damaged. At the interface between shelter and original toe board there are signs of erosion and collapse of the old bank which may impact on the shelters. Due to the difficulties involved in surveying their use no data exists to show fishery benefits.

PLATE 4 The stone covered fish shelters were designed to be hidden, to blend in visually and to avoid vandalism. – March 1998

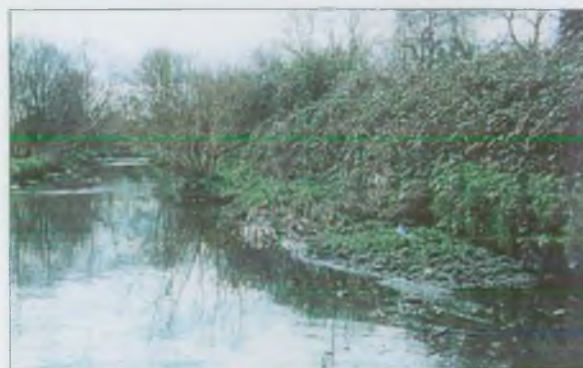
PLATE 6 Looking upstream at a deposited shoal being colonised. This was the largest deflector. – March 1998

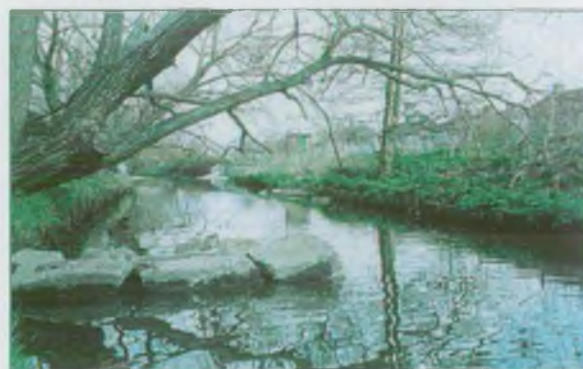
PLATE 7 The 'new' deflectors are at risk of eroding the bank because the fall is from the river towards the bank. – March 1998

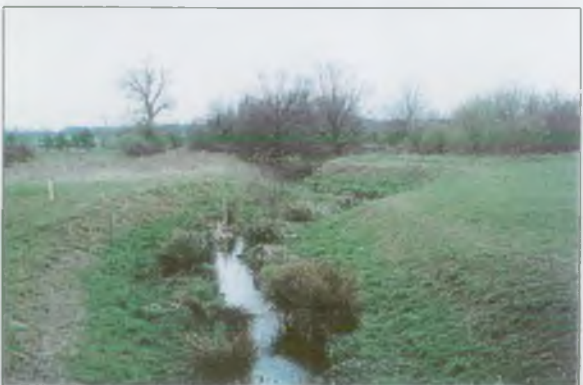
PLATE 5 After, Planted and re-profiled. – March 1998

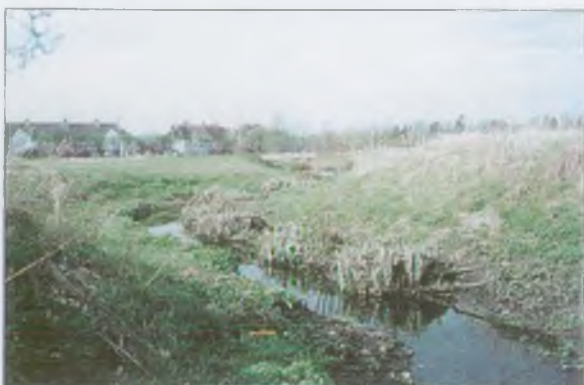
PLATE 6 Marginal vegetation narrowing the channel.
– March 1998

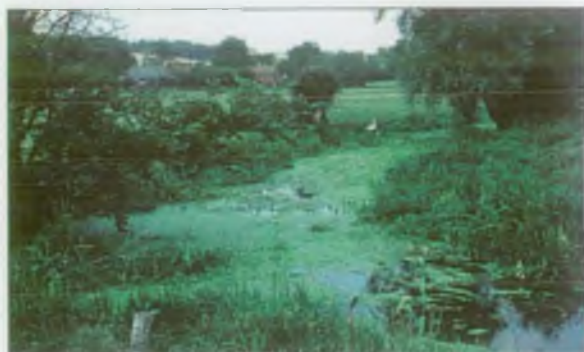
In 1990 a fisheries survey at Nether Winchendon revealed a fish biomass below the EC recommended standard of 20gm². The reasons for the low score were assumed to be poor water quality and impoverished habitat. The channel was very uniform with little habitat diversity. The banks were steep and eroding, and the bed consisted almost entirely of silt. Improving the habitat rather than restocking with fish was the only sustainable approach.

PLATE L1 Riffle No. 2 – before. Very deep and lack of surface movement.

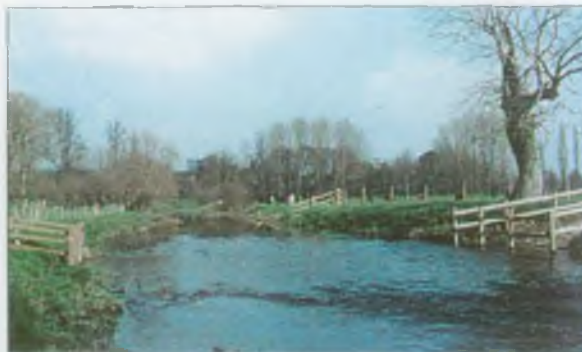
PLATE L2 Riffle No.2 – after. Fast shallow flow over well graded gravels. The cattle drink prevents poaching of the margins and allow the *Glyceria* to recover. – March 1998

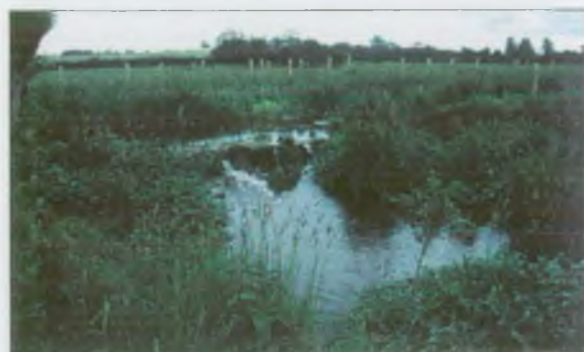
The old mill bypass weir (concrete wall with apron and a 1m drop into a deep pool - Plate L3) was replaced by a blockstone ramp, 10-15m long descending to the pool. The ramp was dished with a small low-flow central channel (Plate L4).

PLATE L3 The overspill weir – before.

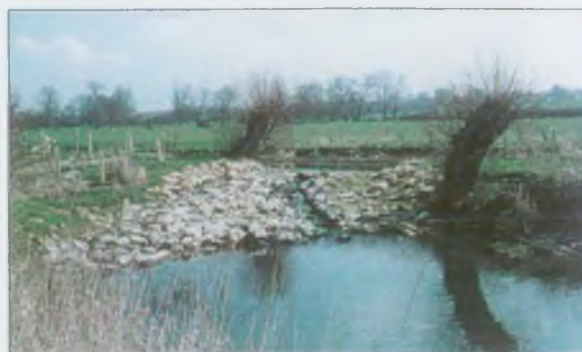
The side spill has not worked as well as planned due to a number of factors. Flow constraints recommended by Water Resources (EA), dictated that flow over the side spill could not be increased. A greater flow would have allowed a gentler slope with more depth. The depth of the pool was too great to extend the ramp long enough to increase the overall length, within budget. These factors have resulted in a structure that has too little water passing over it to allow free passage of fish except under high flows. The covering of gravel has been washed away.

PLATE L4 The new stone sidespill may be too steep to provide passage at low flows. – March 1998

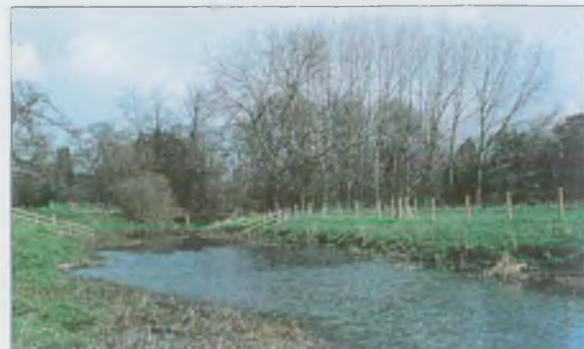
PLATE L5 All the appearance of a natural riffle. – March 1998

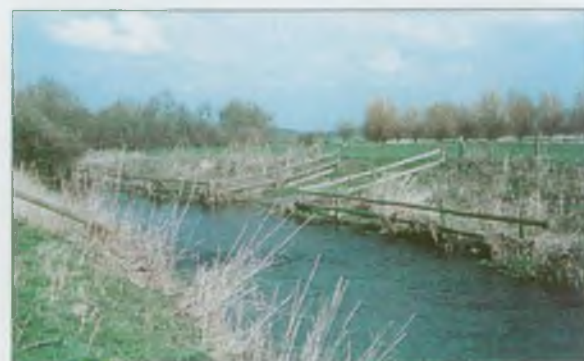
At all three of the sites some re-profiling was undertaken on the left bank. This involved grading back the bank, which was eroding due to animal poaching and grazing (Plate N1). A stoned cattle drink was provided and fencing erected to allow regeneration.

The re-profiling of the bank, has worked stabilising and protecting it against cattle erosion. It also provided ideal conditions for the natural development of a wet ledge habitat.

PLATE N1 Re-profiling the left bank and fencing has added stability and reduced erosion. – March 1998

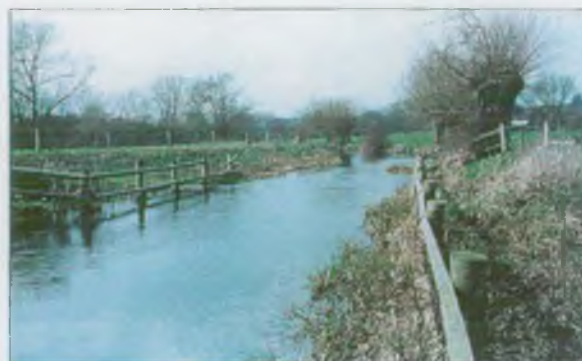
PLATE 2 The toe of the bank at the riffle was protected by blockstone. This was probably unnecessary and unsightly though it is now hidden by vegetation. – March 1998

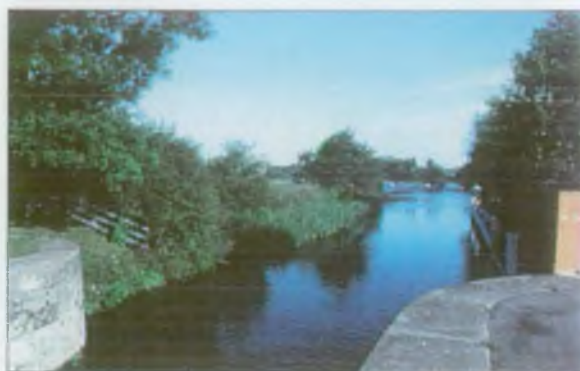
PLATE 2 Downstream of the lock cut *Phragmites* has formed a dense stand providing habitat for birds and wildfowl. – October 1991

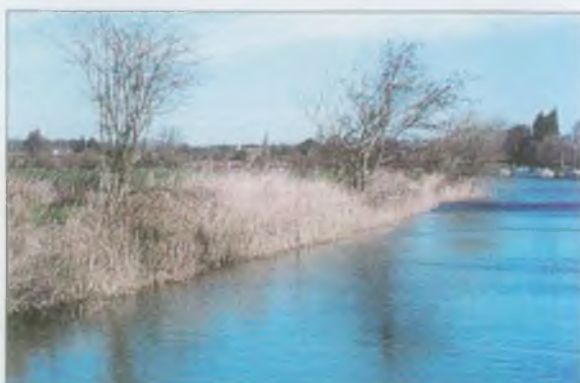
PLATE 3 The 'new' bank and its vegetation merge well with the downstream reed fringe. – March 1998

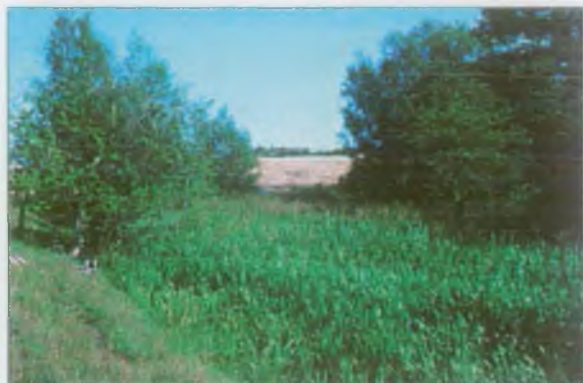
PLATE 1 Doctor's Island. The link with the R. Thames was heavily vegetated.

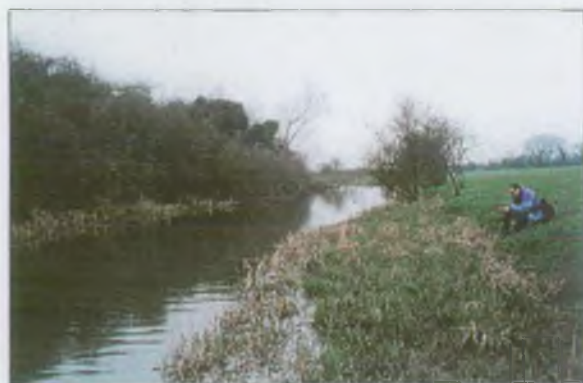
PLATE 3 Skinner's Island. Dredged to restore access for fish, invertebrates and waterfowl, but retaining a vegetated ledge. – March 1998

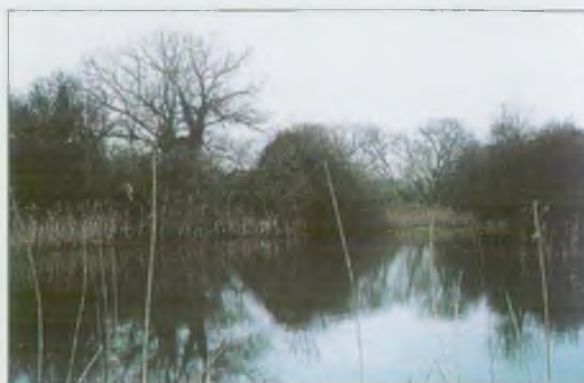
Further back from this point the backwater was still open with a reasonable depth, becoming significantly deeper at the large pool. In addition, substantial marginal stands of *Phragmites* had become established, but still allowed free passage for fish and waterfowl to a large area of the backwater (Plate 4).

PLATE 4 Skinner's Island. Backwater pool with large stands of *Phragmites*. – March 1998

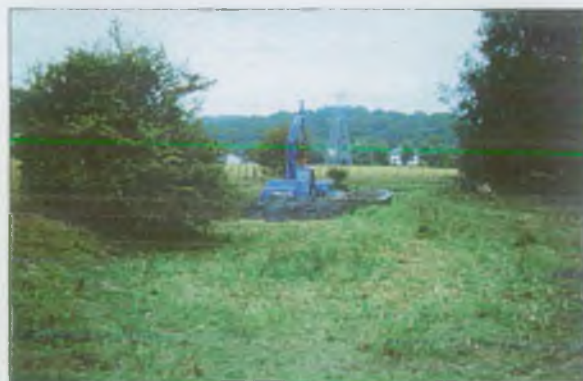
The cut-off at Doctor's Island was much smaller and much more heavily silted than the open water backwater at Skinner's Island. Terrestrial vegetation had colonised much of the upstream end, *Glyceria* had occluded the rest, and the backwater held no permanent water (Plate 5).

PLATE 5 Doctor's Island. Terrestrial vegetation had occluded part of the backwater. The rest was choked with *Glyceria*.

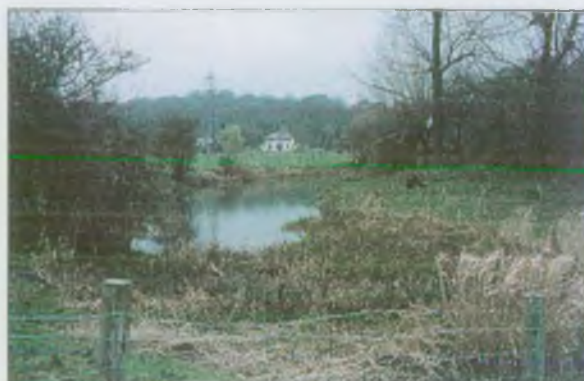
The excavation length was 120m by the width of the channel (approximately 8m) and as deep as was necessary to enable access for the dredger (c.2m). An area of wet reedbed and fallen trees was retained to ensure existing wildlife would not lose its previous habitat (Plate 6).

PLATE 6 Doctor's Island. Some of the reedy habitat was retained. – March 1998

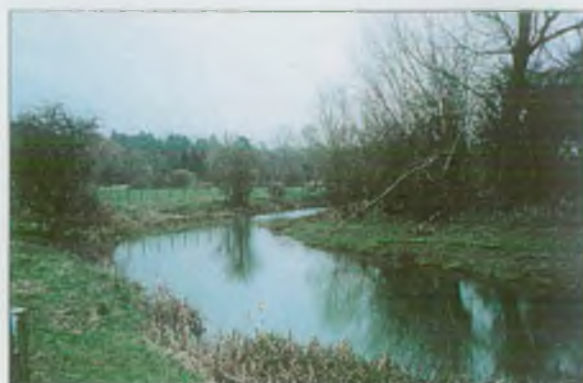
This channel was less than half the width of Skinner's, and due to the method of excavation - a grab dredger - it was not possible to profile the bank and create shallow sloping ledges. Therefore, where the channel narrowed towards the end of the backwater, the banks are relatively bare and steep. This does however increase overall edge diversity as there are many low, shallow, exit points still accessible to wildfowl (Plate 7).

PLATE 7 Doctor's Island. Due to the method of dredging steep, bare edges were unavoidable in places. – March 1998

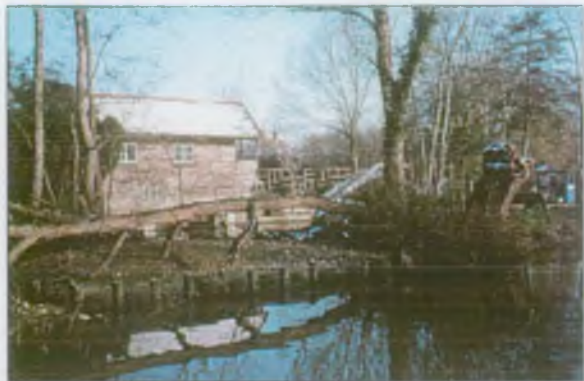
The river side, where a significant gap was appearing, needed protecting (Plate 1) as did the area to be extended on the opposite side (Plate 2). Rather than opting for the usual sheet piling a technique involving Nicospan was specified, to project only slightly above existing water levels.

PLATE 1 Nicospan used to retain material and form a hard edge.

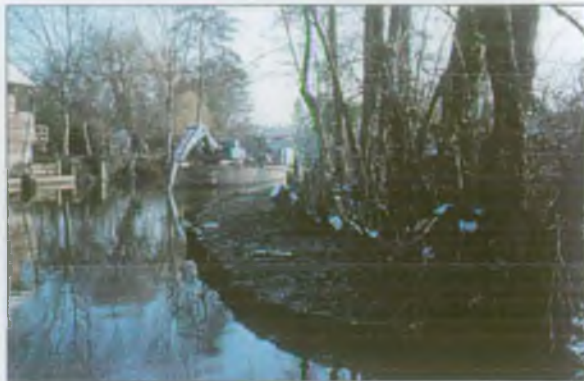
PLATE 2 Island extended into the newly dredged backwater.

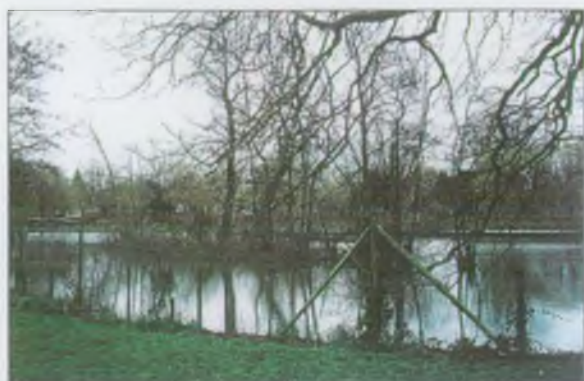
PLATE 3 View of the vegetated island from the owner's property. – March 1998
