Audit of 20 Rehabilitation Projects Environment Agency Thames Region

Janes, M. D. and Holmes, N. T. H.
River Restoration Centre
1998

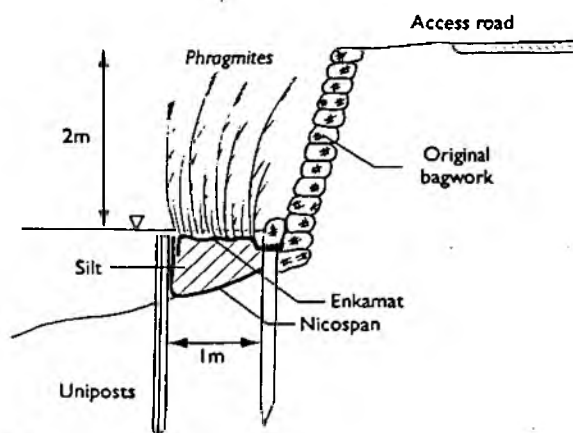
Nicospan shelf

Nicospan was used to form a retaining 'wall' approximately 1m out from the bank, supported by timber posts. The area behind the Nicospan was then backfilled with silt from the channel, retained by a cover of Enkamat, and anchored by a line of concrete bags placed hard against the original bagwork wall.

Initially, the silt ledge was washed out from beneath the Enkamat by high flood flows in 1991. This failure was largely due to bad luck in terms of having a large flood event so soon after completion. Subsequently, silt rich in *Phragmites* was placed on top of the ledge. This has now grown into a tall stand of marginal vegetation, providing good edge habitat.

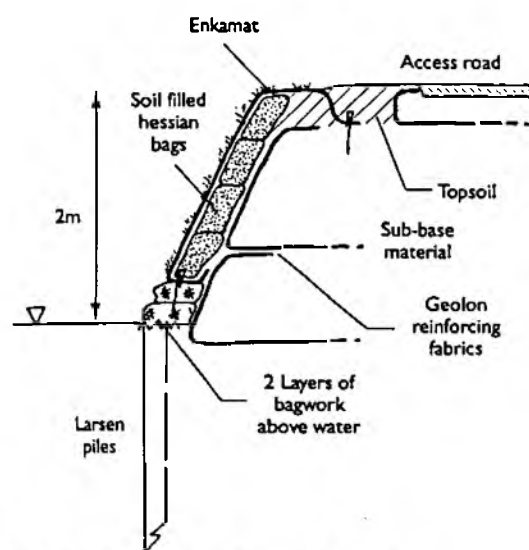
Soil filled pre-seeded hessian bags

Similar to section A, but at this point the bagwork was failing and subsidence evident. Cause most likely to be a combination of boatwash and slightly increased velocities associated with the outside of the bend. The incorporation of a ledge was not felt to be appropriate at this location.

Enkamat was then pinned into the bagwork with pre-seeded soil filled hessian bags placed on top, laying back to the regraded bank. Once the desired top height had been achieved the Enkamat was pulled up over the surface of the hessian and secured. Minor backfill between the hessian bags and the road used topsoil (Plate 2).

To ensure rigid protection of the bank toe larsen piles were driven into the bed to water level with two layers of bagwork above.

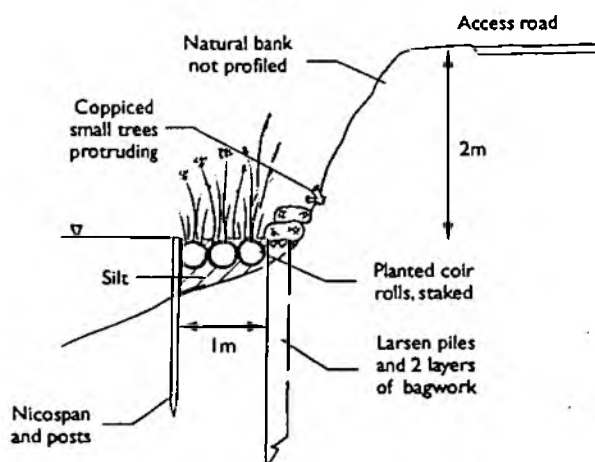
Nicospan and planted coir fibre rolls

Erosion of the upstream section of the access road bank required additional works to be carried out in 1995.

Here bagwork was absent and boatwash was having an obvious effect, in addition anglers were causing localised erosion when climbing down the 2m drop to the waters edge.

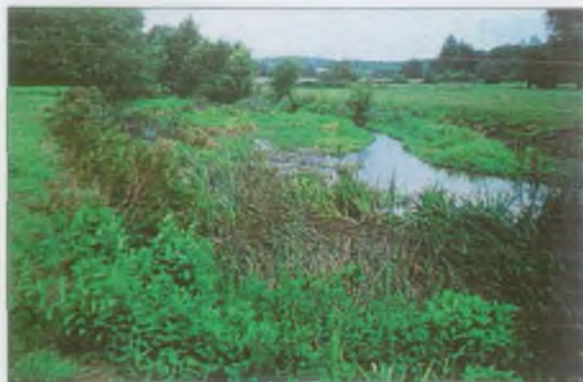
Low flows and low velocities had caused accelerated siltation and a resultant encroachment of emergent vegetation, predominantly *Scirpus* (club-rush). Dredging was necessary every 2-3 years. In 1990 and 1991 following complaints from two leasing angling clubs, the NRA inspected the site and found the channel totally choked, preventing angling, reducing the ecological diversity of the site and posing a potential flood defence problem (Plate 1).

PLATE 1 Pre-scheme the channel was choked with macrophytes, due to sluggish low flow velocities.

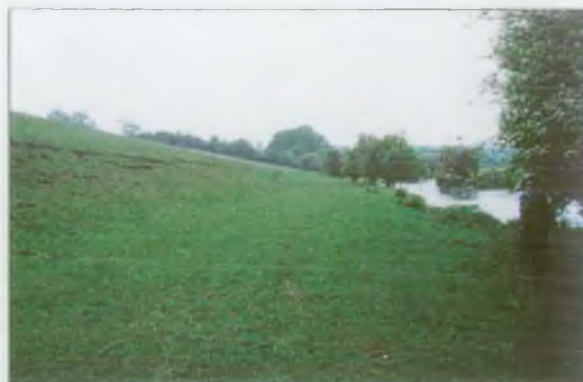
PLATE 2 A new access track was excavated into the slope to benefit the landowner and gain additional backfill material. – May 1998

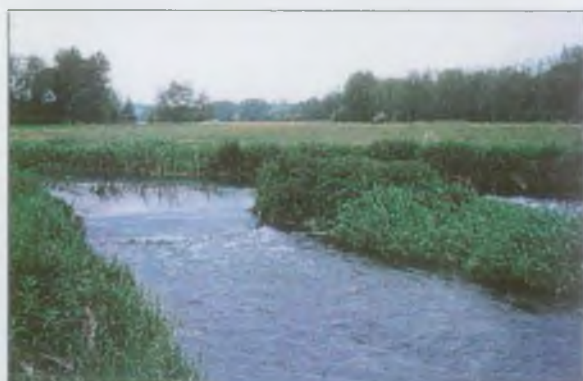
PLATE 3 Downstream a pair of 'spawning riffles' were installed, one either side of the island, incorporating aeration pipes. – May 1998

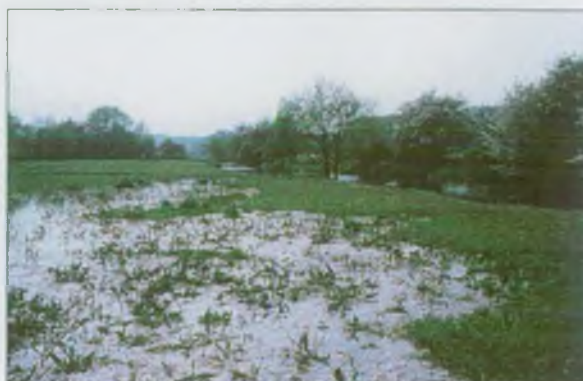
The landowner is happy with the scheme in terms of the enhancement of the river and improved fishery, and also the improved safety for his sheep (sheep loss in high flows was a problem previously) and better summer grazing as a result of restored summer water levels. A section of riverside meadow has become isolated from the river (aided by machine compaction/tracking/etc., during the works period). This is developing into a shallow perched wetland, fed by rain and floodwater (Plate 7). The landowner is happy for this to remain as it is.

PLATE 7 Water ponds on the adjacent field surface resulting in improved grazing. – May 1998
