Environmental Management Audit THAMES BARRIER and associated on-site activities.

January 1996

AUDITEE Thames Barrier Operational Site,
Charlton, London,
and associated on-site activities.

DATE OF AUDIT 22/23 November 1995.

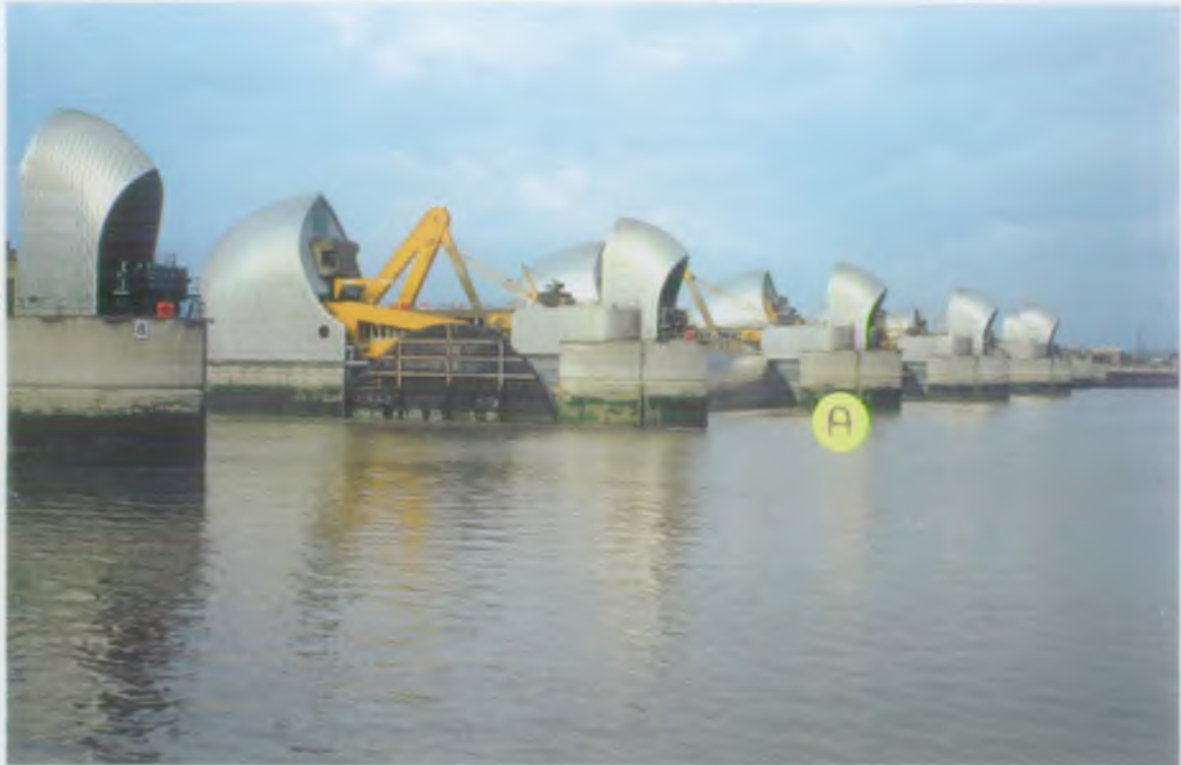
Photograph 1 A general view of the Barrier structure. (A) Gate in the closed position to allow maintenance.

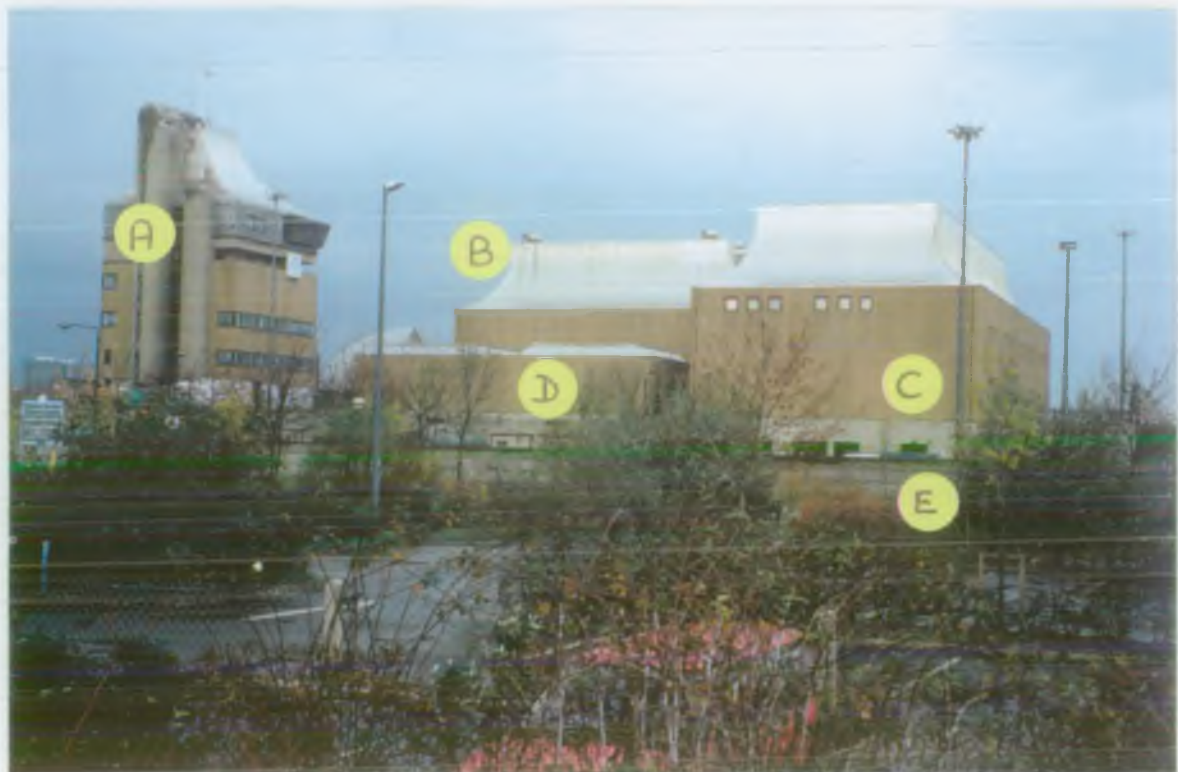
Photograph 2 The operational area of the Barrier seen from the parking area. (A) Control Tower, (B) Generator House, (C) Workshop, (D) Electrical Sub-stations, (E) Walled Compound.
