domesday *to the down of the*

new millennium

ENVIRONMENT AGENCY

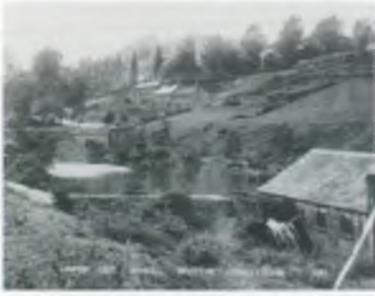
UPPER CUT WHEEL DAM ON RIVER RIVELIN
A good example of the dams which were constructed to provide water to the mill of a cutlers grinding operation. The mill wheel can be seen in the foreground

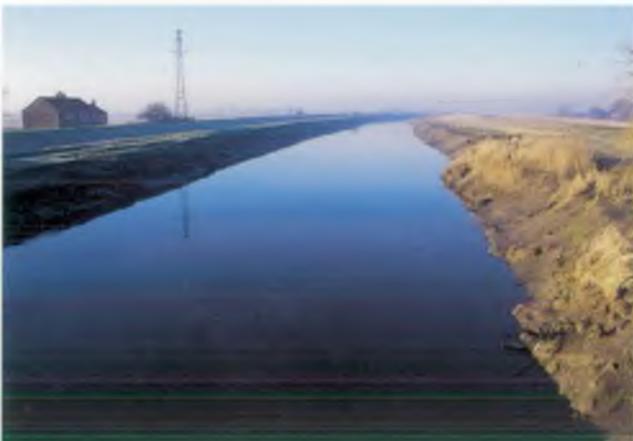
DUTCH RIVER

The channel constructed by Vermuyden to alleviate the flooding to land on the north side of the river which his drainage of the Hatfield Chase had caused

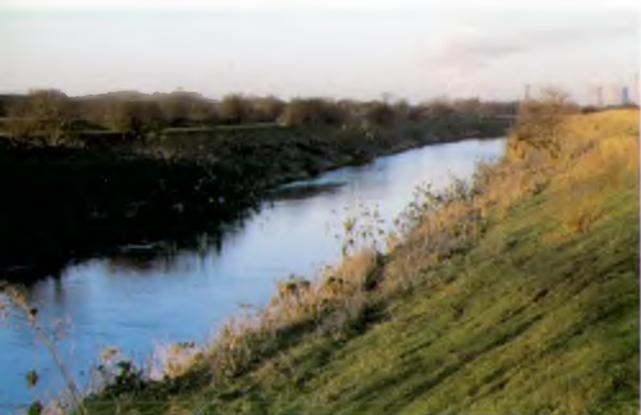
FLOOD DRAIN, DOWNSTREAM OF DONCASTER
The flood drain was constructed to take excess water from the newly constructed navigation

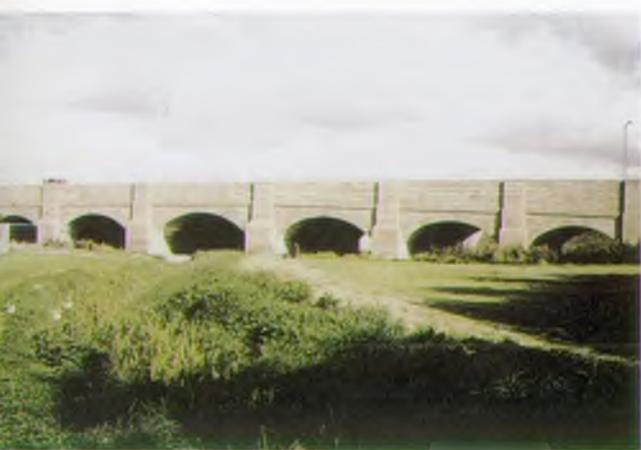
FLOOD ARCHES
These arches allow passage of flood water along the flood channel of the Don at Doncaster

Between Doncaster and Stainforth, where the Dun Drainage Commissioners had raised and strengthened the flood banks, provision had been made for controlled over-spill of flood water by means of a series of earthen spillways constructed in the northern flood embankment. The most upstream of these was at Black Pond on the opposite side of the river from where Doncaster Prison now stands. During extreme floods land to the north operated as a flood relief route and the extent of flooding was controlled by a secondary barrier bank constructed some 600 yards (548.5 meters) to the north of the main river bank. This route for relieving flood waters in Doncaster operated during the floods of 1886, 1892, 1931, 1932 and 1947.

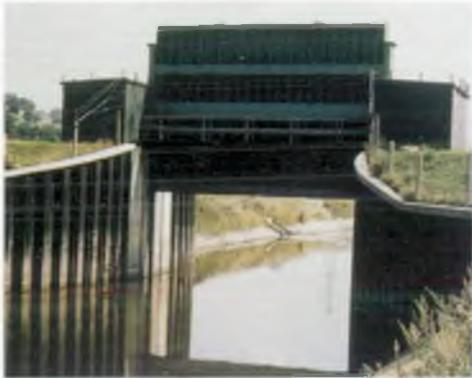
CANKLOW REGULATOR
One of the control structures on the River Rother which helps to protect areas on the lower Don around Doncaster from flooding

were formalised at Canklow, Treeton and Woodhouse Mill and in 1959 a regulator was installed in the Woodhouse Mill washland to enable more efficient use of the available area for flood water storage.

A further flow regulator was constructed in 1969 at Canklow in a revised scheme to allow for the construction of the M1 motorway and A630 trunk road across the washlands.

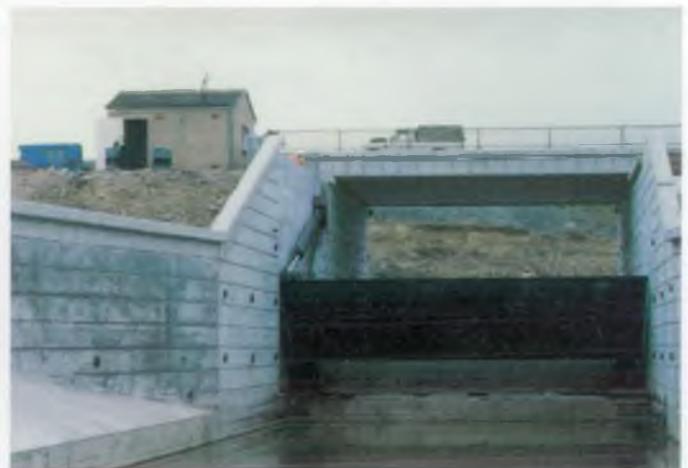
MEADOWGATE REGULATOR
This regulator controls flood water on the Rother below Staveley and in extreme conditions helps to flood the washland areas which are part of the Rother Valley Country Park Complex

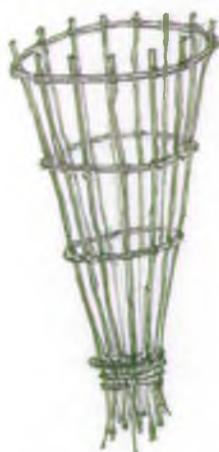
SKETCH OF A TYPICAL SALMON HECK
Hecks were used to catch salmon as they attempted to jump the weirs which obstructed their passage up the river system. They were fitted to the front of the weir and trapped fish which failed in their attempt to ascend.

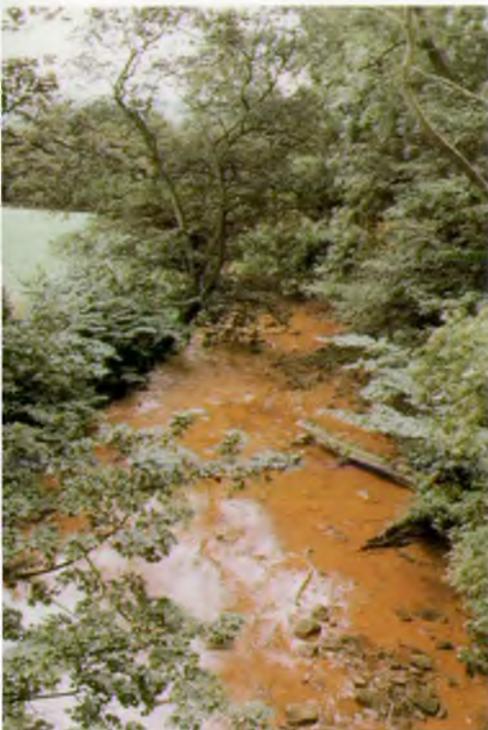
COLLIERY MINE WATER
Ochre (Iron Hydroxide) covers the bed of the River Don
below the Bullhouse minewater discharge

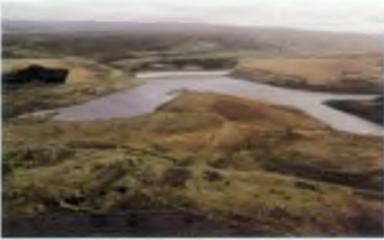
WINSCAR RESERVOIR
Built to replace the smaller Dunford Bridge Reservoir in the 1970's. It serves as a compensation reservoir which provides the base flow to the upper River Don

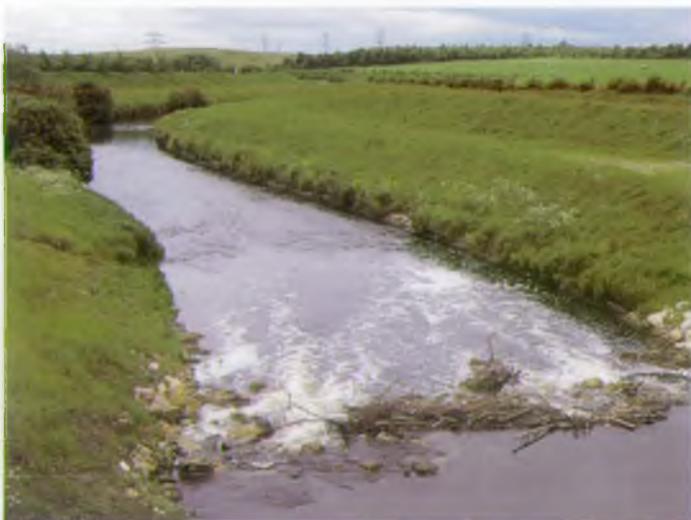
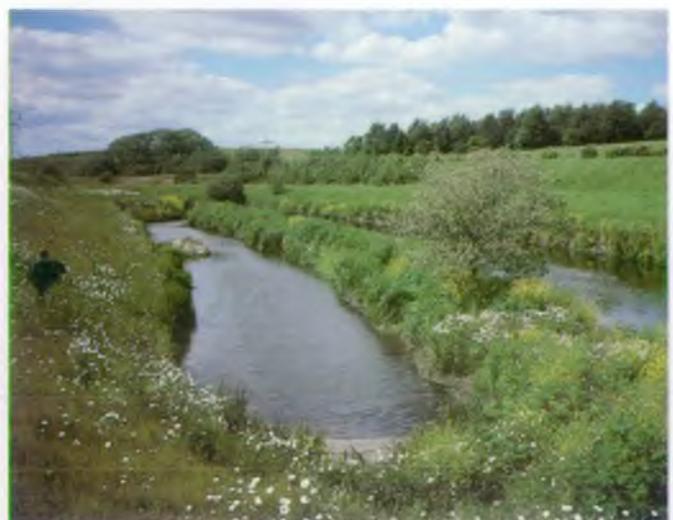
WEIR & BAY ON RIVER ROTHER LOOKING DOWNSTREAM
These improvements were carried out to assist in the rehabilitation of the fishery on the river at Rother Valley Country Park

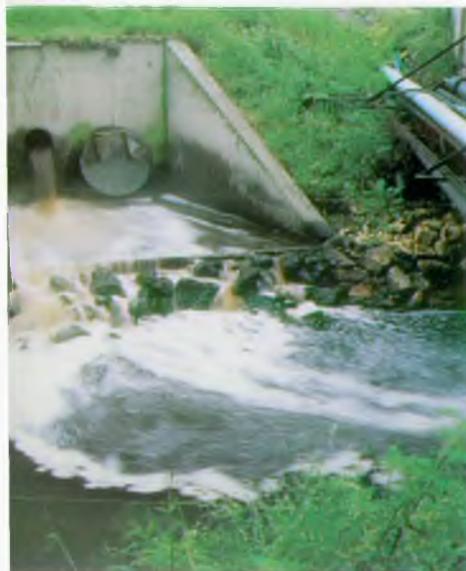
POLLUTING DISCHARGE
A typical discharge from a coking plant during the early 1980's

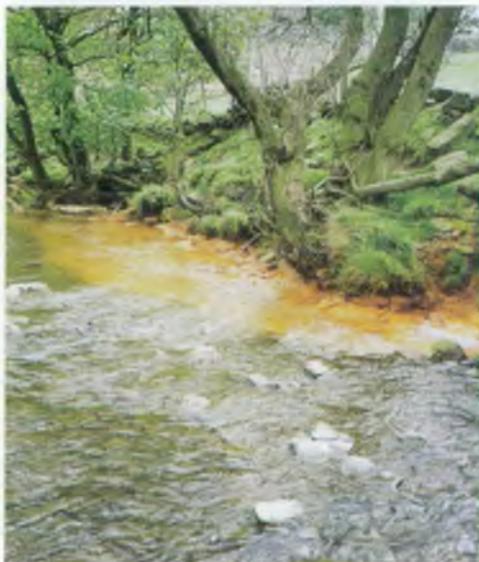
OCHRE
The effects of the abandoned minewater discharge into the Don
at Bullhouse above Penistone
